**USAAVLABS TECHNICAL REPORT 70-71A  
ANALYSIS OF HELICOPTER STRUCTURAL CRASHWORTHINESS  
VOLUME I**

**MATHEMATICAL SIMULATION AND EXPERIMENTAL  
VERIFICATION FOR HELICOPTER CRASHWORTHINESS**

January 1971

CONTRACT DAAJ02-69-C-0030

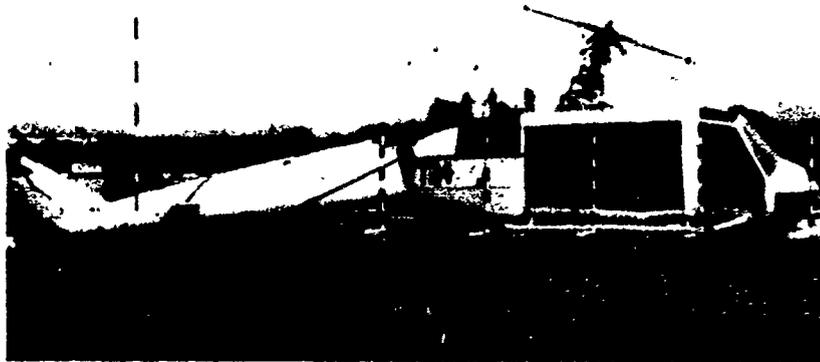
The landing gear cross tubes distorted outward and upward, permitting the fuselage to contact the concrete pad. The cross tubes did not fail but were permanently distorted, permitting the fuselage to rest on the concrete pad (Figure 58). The fuselage remained within 1 inch of the pad after all simulated fuel was drained from the tanks. The lowest point of the loaded fuselage prior to the drop was slightly over 14 inches.

Figure 57. Overall Posttest View.

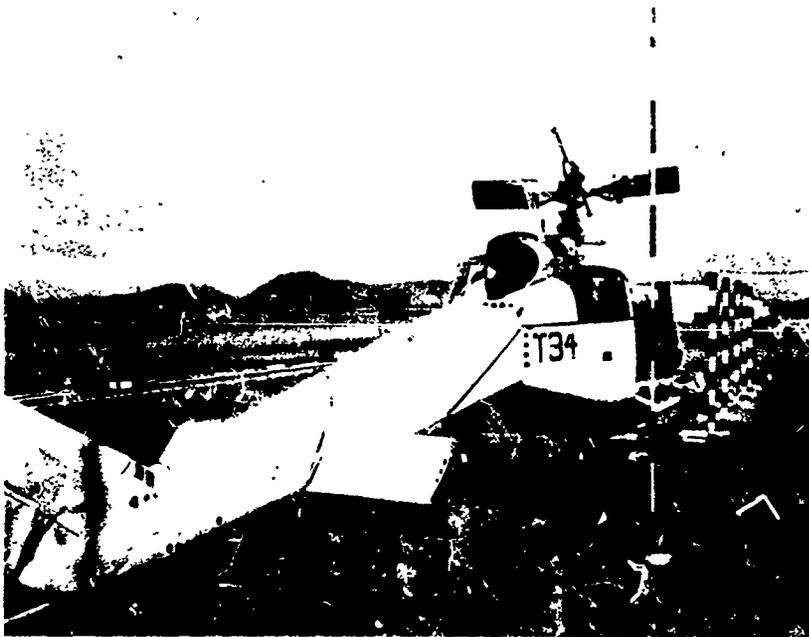
Figure 69. Final Position of Tail Boom.

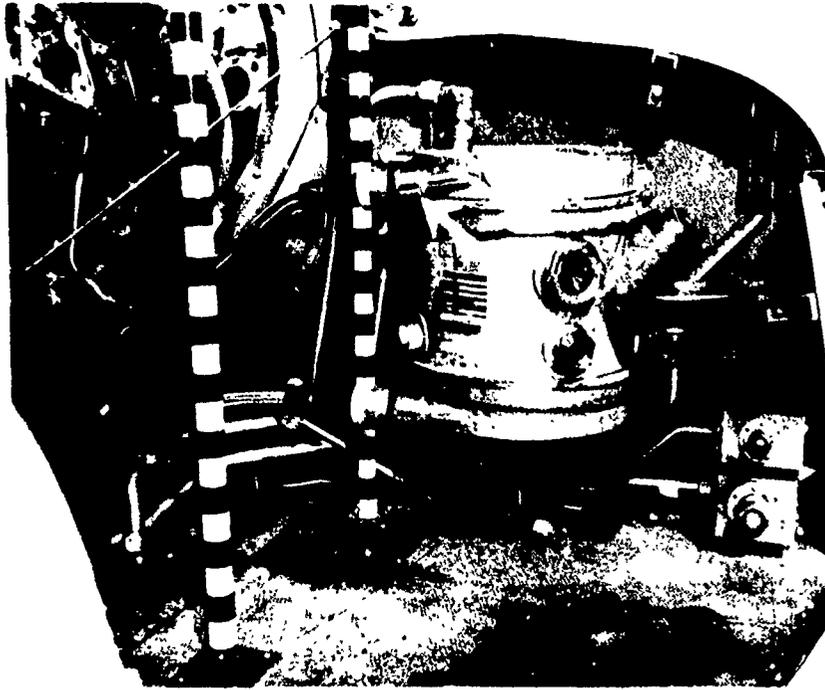
The oil system remained intact throughout the impact sequence, and no oil loss occurred. The displacement of the engine did remove all slack and apply a load to the 3/4-inch oil breather line attached to the upper boss at the rear of the oil tank. This loading did not fail the elbow end fitting, but it did deflect the boss on the oil tank downward, as shown by the arrow in Figure 78.

Figure 78. Bent Oil Breather Line  
Boss on Oil Tank.

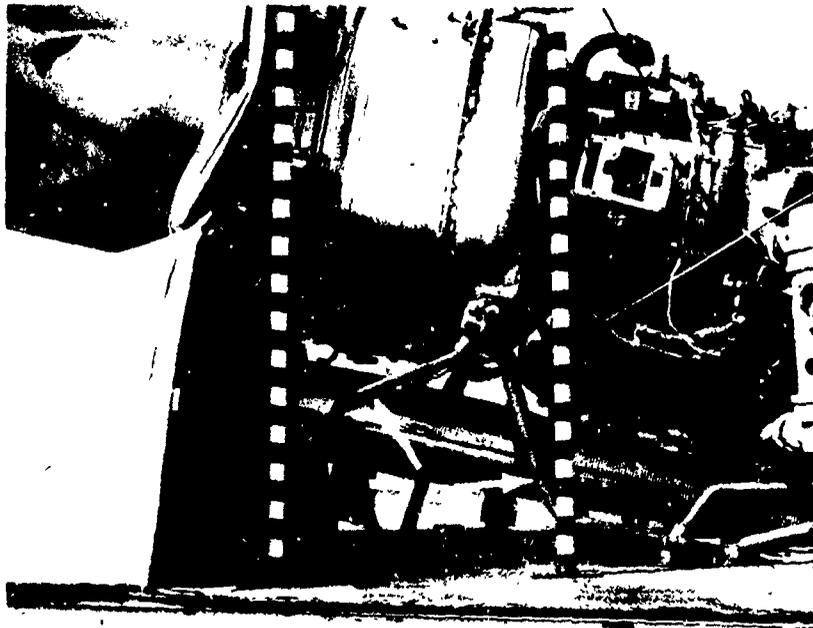
Figure 79.. Damage to Right Engine Mount.

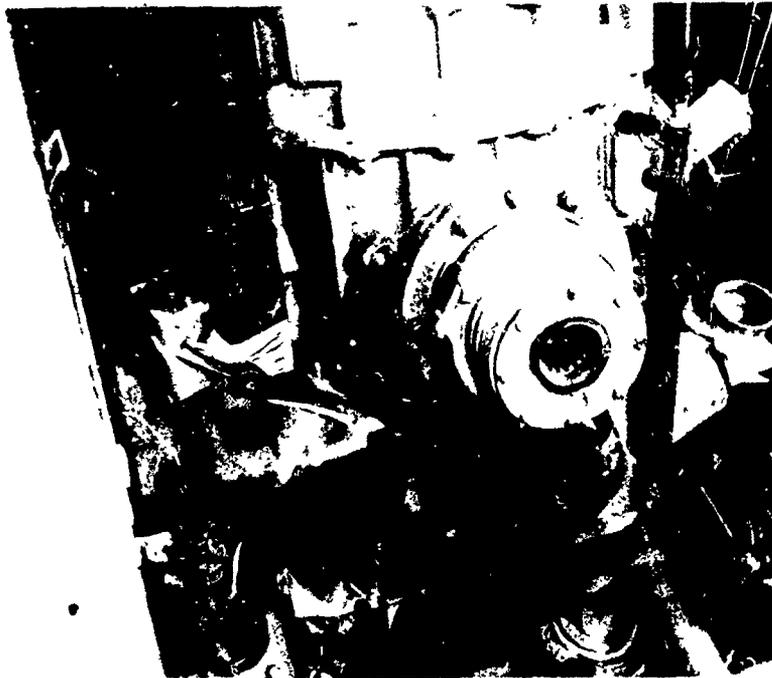
Figure 81. Damage to Transmission Support Base.
