FTC-TR-71-26

CATEGORY II ICING TEST OF THE HH-53C HELICOPTER

TECHNICAL REPORT No. 71-26
JUNE 1971

AIR FORCE FLIGHT TEST CENTER
EDWARDS AIR FORCE BASE, CALIFORNIA
AIR FORCE SYSTEMS COMMAND
UNITED STATES AIR FORCE

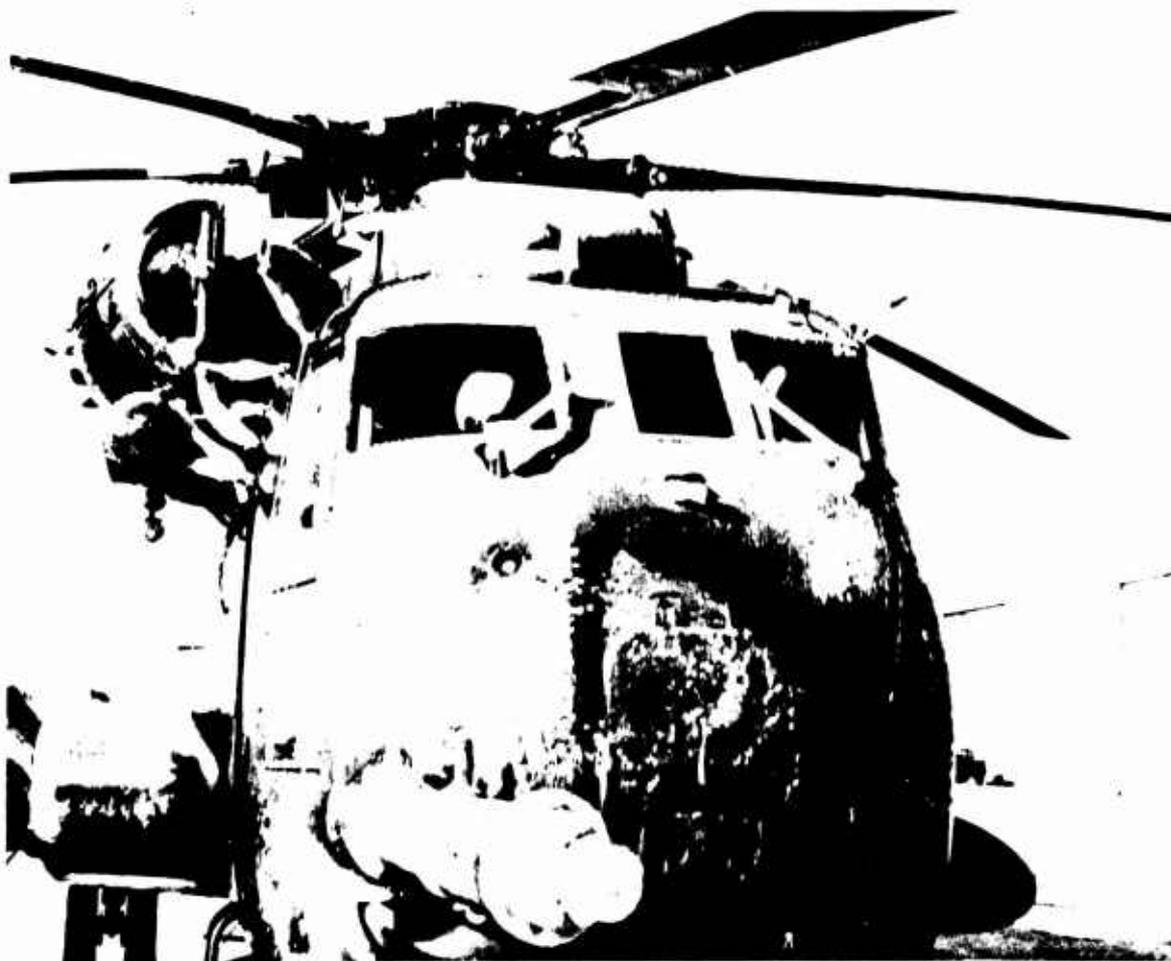
Figure 4 Typical Ice Accumulation on HH-53

Ice accumulated on the vertical pylon, horizontal tail, rotor hub, flight controls, refueling boom, external sponsons, tanks and aircraft nose (figure 4). The rescue hoist accrued heavy ice throughout most of the test conditions. Maximum ice thickness of 1-1/4 to 1-1/2 inches was accrued on the previously mentioned airframe areas from artificial icing conditions of icing flights 9, 14 and 15. No structural damage was inflicted on the HH-53C airframe during all icing tests. Ice accumulation did not hinder flight control operation.

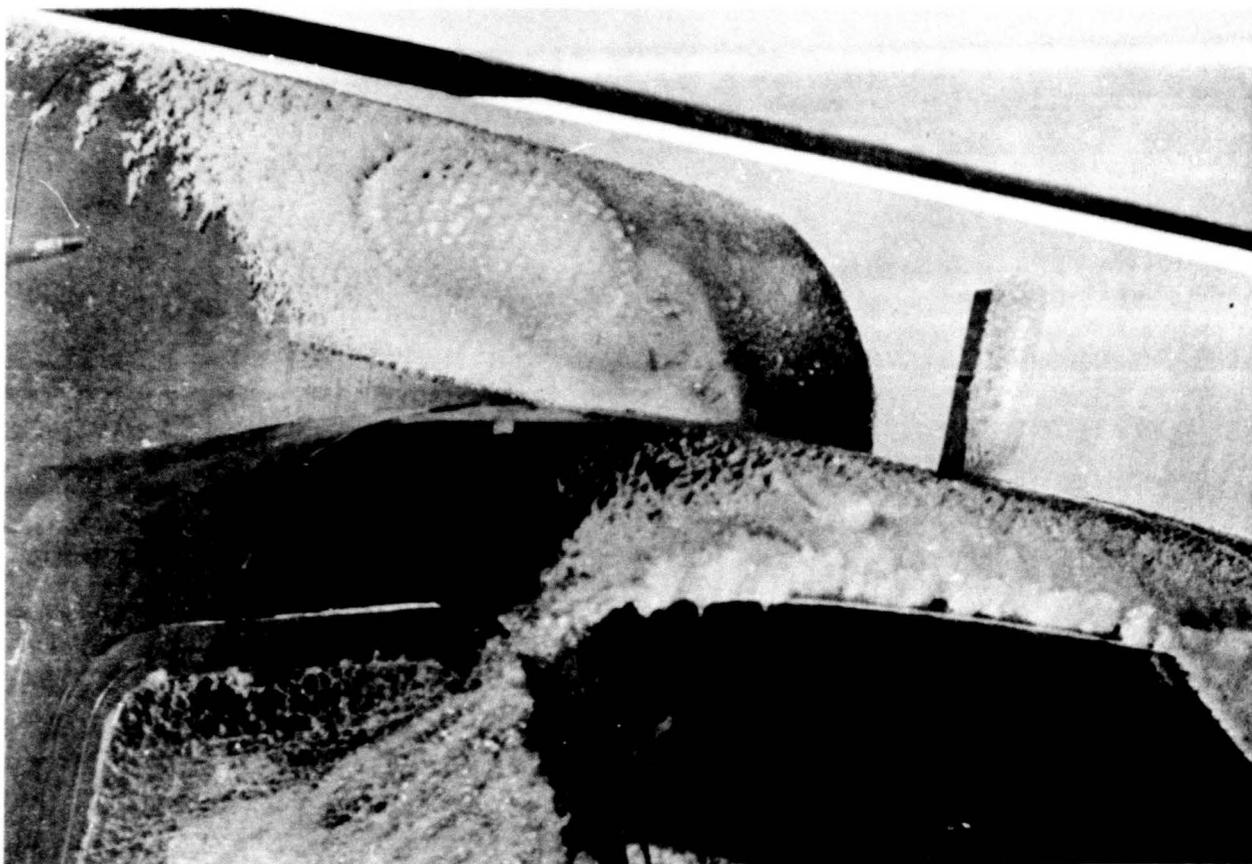
Figure 5 Iced-Over Heater Inlet Duct Screen

The cabin heater inlet screen had an estimated 75 to 90 percent airflow blockage on icing flights 8 and 9 respectively, due to glime ice formation on the screen (figure 5). Subsequent tests conducted at colder outside air temperatures (OAT) had minor (10 percent) blockage of the heater screen area (icing flights 14 and 15). The cabin heater was inoperative throughout part of the artificial icing tests; however, it was believed that this condition did not significantly change the pattern of the ice buildup on the heater screen (appendix II). The heater inlet screen could be totally blocked off by ice formations should light or moderate icing conditions at OAT's from 0 degrees C through -13 degrees C be encountered for extended periods of time. The heater was inoperative during most of the flights when significant ice accretions on the heater inlet occurred. Possible heater system damage or erratic operation due to reduced airflow might result from heater operation after the heater inlet duct was iced over. If reduced airflow from the heater outlet ducts is realized while flying in icing conditions the heater should be turned off to preclude possible heater damage. A NOTE to this effect should be included in section IX of the Flight Manual. (R 1)¹

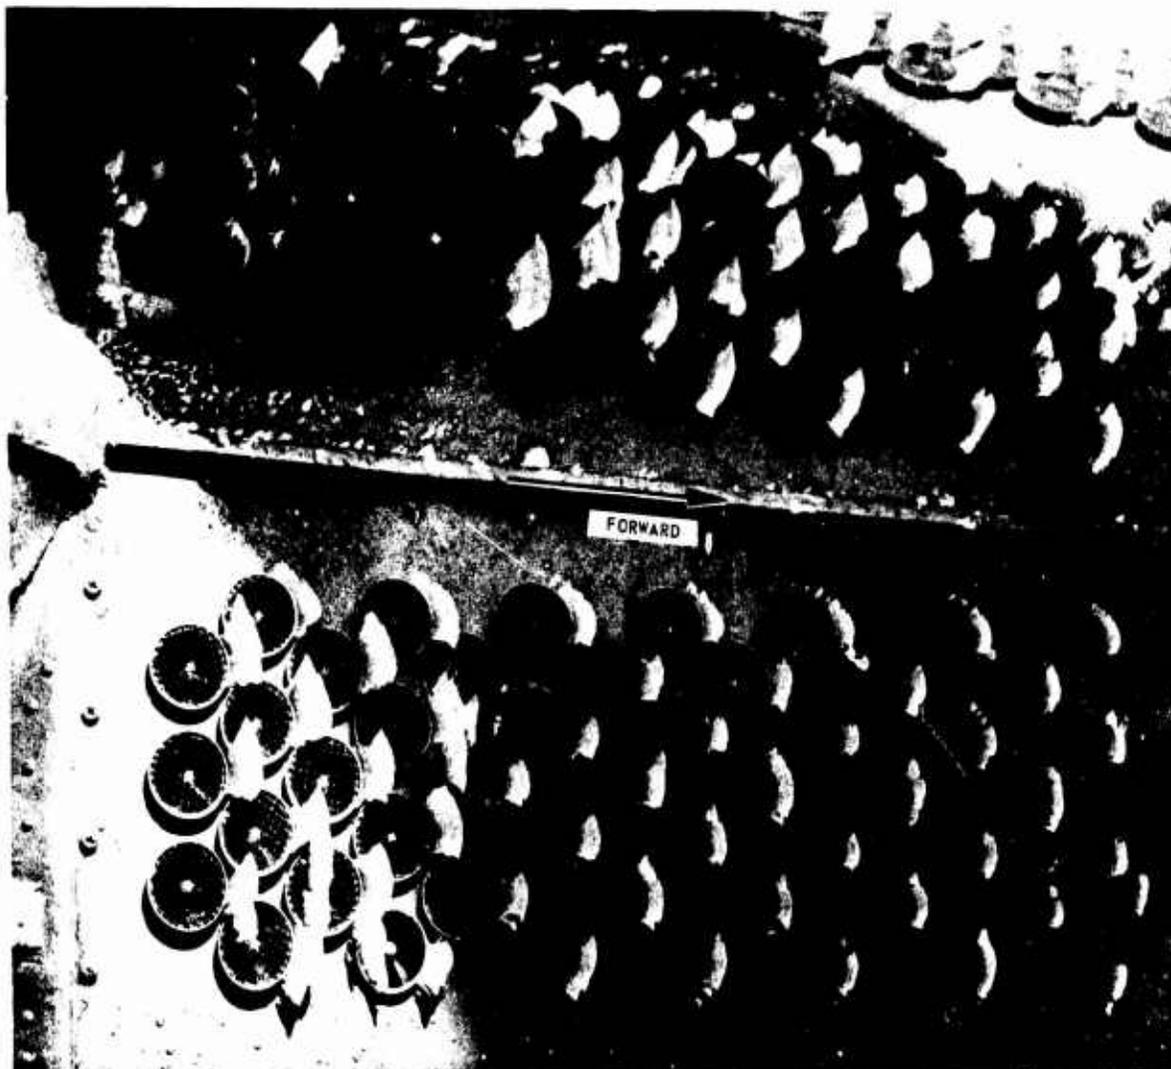
Figure 7 Ice Fingers on EAPS Mini Screens

A trace of ice buildup was noticed inside the EAPS ducting after icing flight 11 (EAPS doors opened). A maximum of 1/4 inch glime ice collected on the EAPS inlet lips and door edges. Ice fingers built up and out from the EAPS mir. screens on the forward one-third of the EAPS (figure 7).

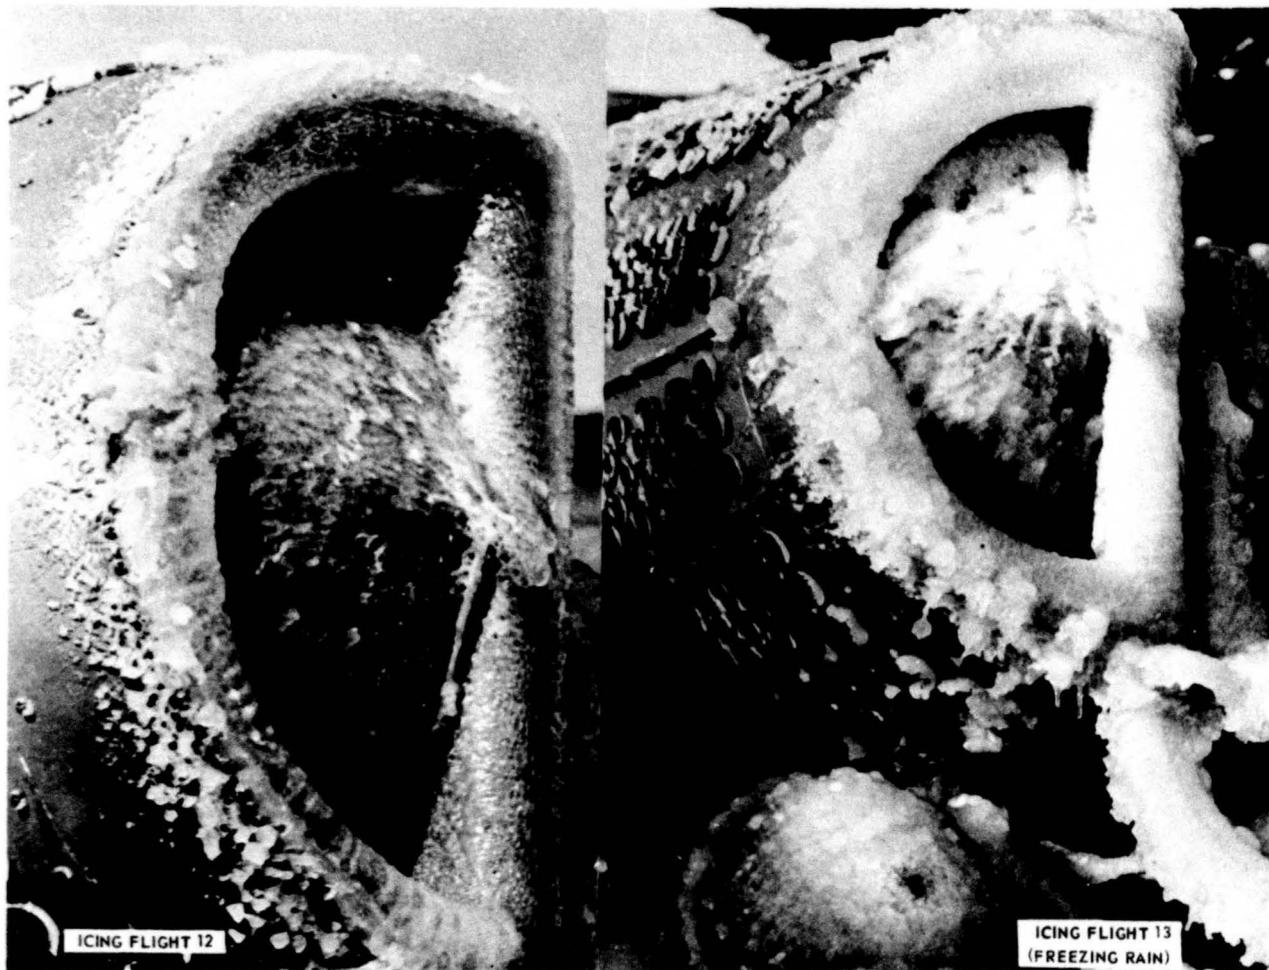
Figure 8 Solid Sheet of Ice on EAPS Lips and Doors

Icing flights 12 through 15 were conducted with EAPS doors closed. Ice accumulated 15/16 inch and 1-1/2 inch thick on the EAPS inlet lips during icing flights 12 and 14 respectively (appendix II). A solid sheet of ice formed over the doors and lips during icing flights 12 and 14

(figure 8). The approximate maximum thickness of ice on the doors was 3/4 inch on icing flight 14. No ice was noticeable inside the EAPS during the artificial icing tests with the doors closed. Ice fingers formed on the leading edges of the mini screens on the bottom and the vertical inboard EAPS panel (figure 9). Maximum EAPS mini screen ice blockage was estimated at five percent on icing flight 14, appendix II.

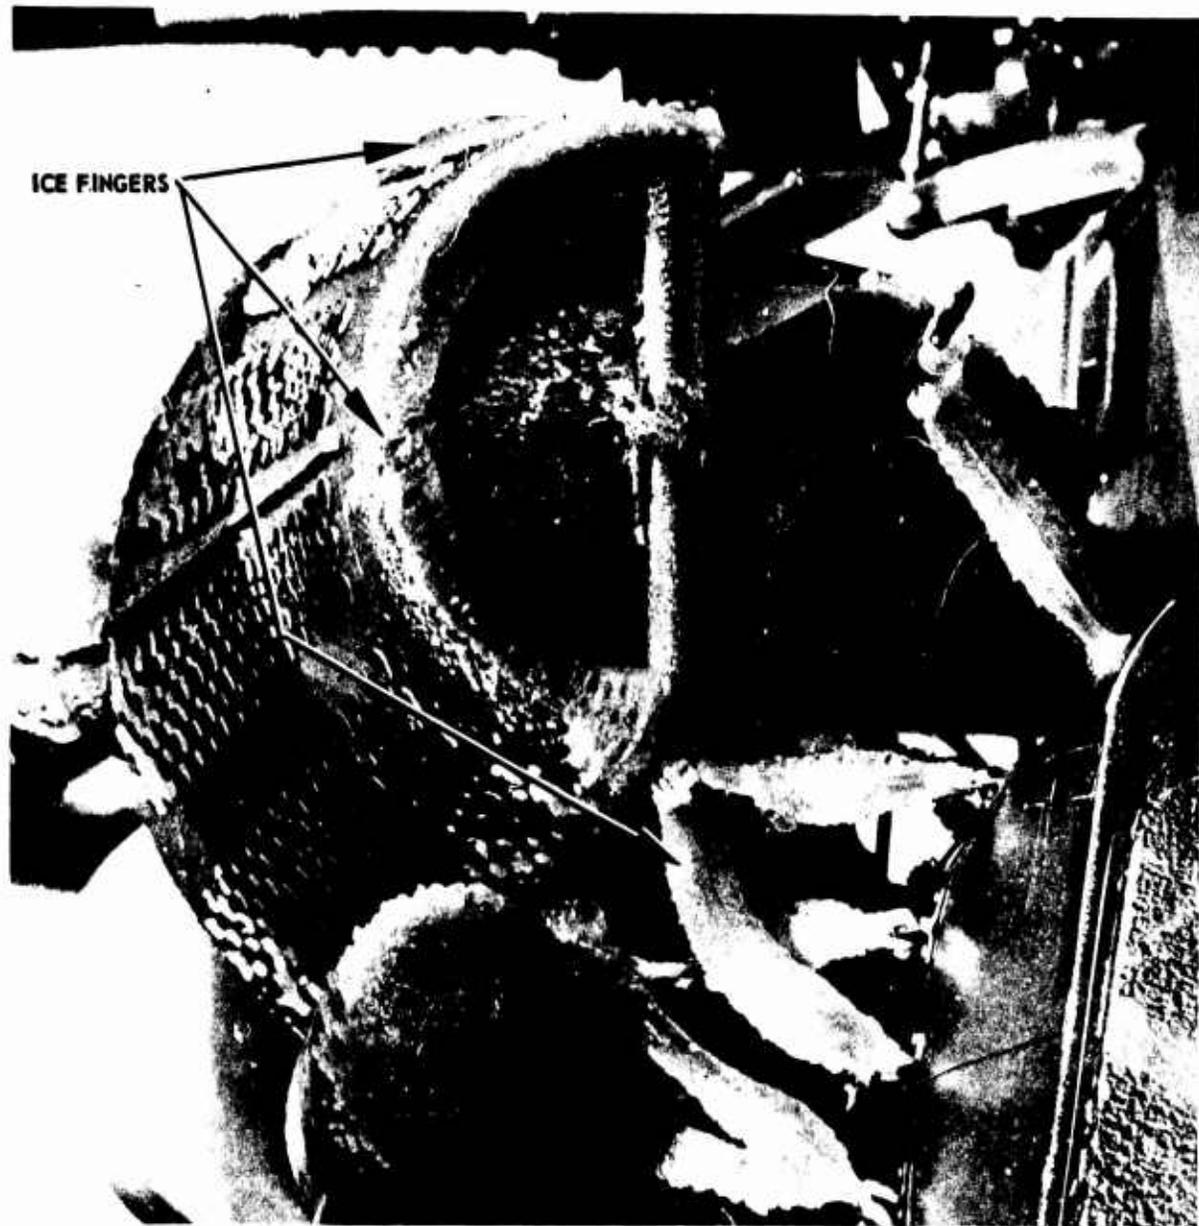
Figure 9 Ice Fingers on EAPS

Approximately 20 of the 759 EAPS mini screens were blocked with 1/8 inch ice on icing flight 13 (appendix II). The inboard EAPS panel was 30 percent blocked off with ice. Ice fingers were 1-15/32 inch long on the leading edge of the mini screens and on parts of the screens on the forward 1/3 of the EAPS. Ice was 5/16 inch thick inside of the closed EAPS on the forward lower surface, due to water runback.

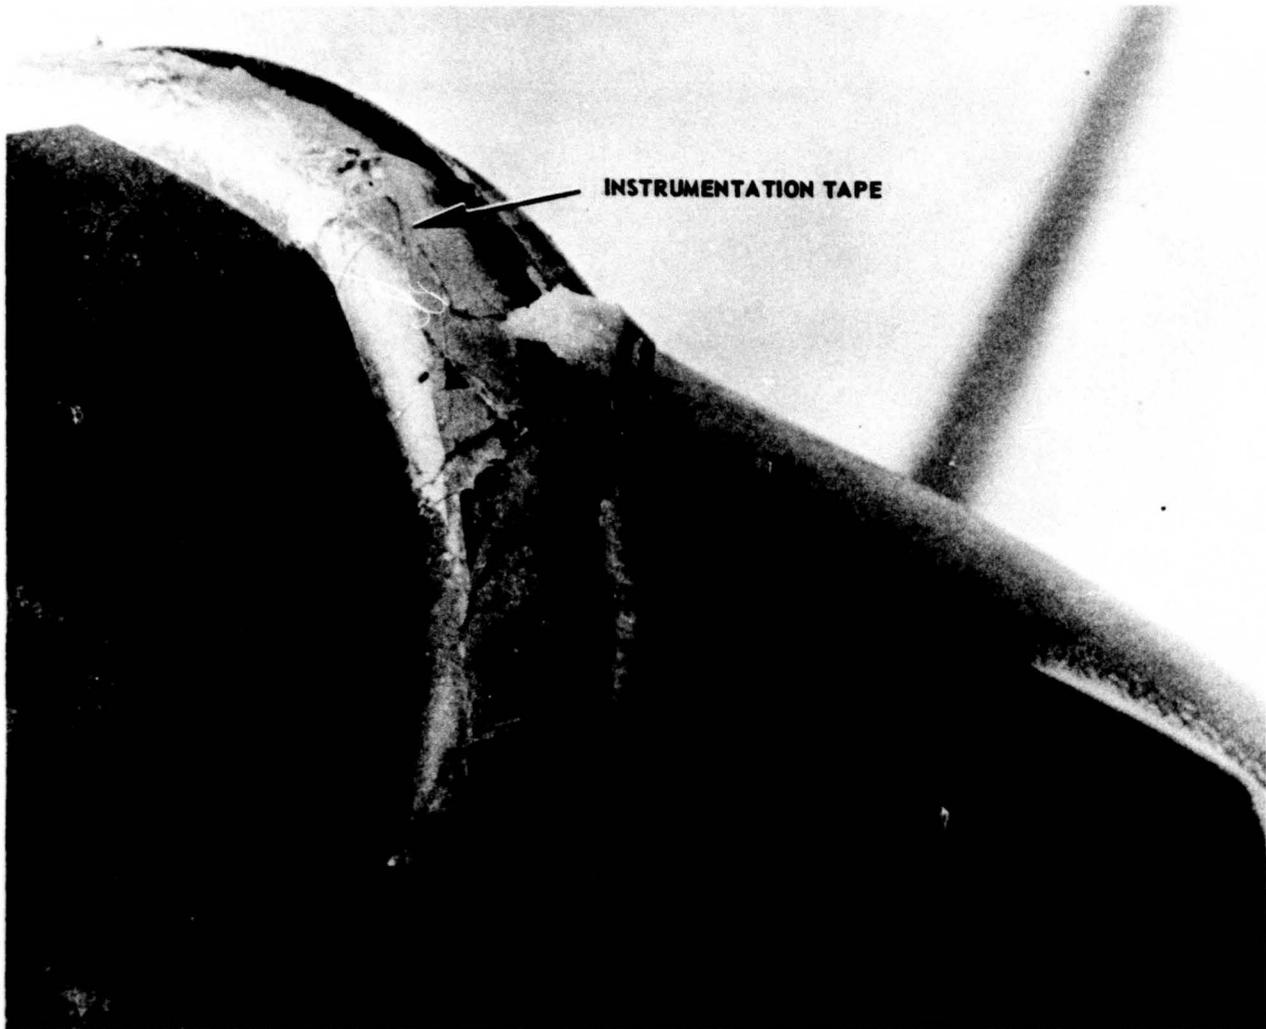
Figure 10 Natural Ice on EAPS Aft Support Rings

The EAPS performed satisfactorily under all natural icing and snow conditions encountered. The EAPS doors were usually left in the open position during cruise until the first indications of icing were observed. At that time, the doors were closed and left closed until the inlet lips and doors were visually checked to be ice free. The maximum amount of natural ice was collected on the EAPS on icing flight 21. About 30 percent of the leading edges of the mini screens on the inboard (vertical) EAPS panel were observed to have rime ice formations.

The EAPS should be cleared for flight in icing conditions up to moderate with the doors closed. If icing conditions are encountered in flight with EAPS installed, the EAPS doors should be closed immediately to prevent the possibility of engine FOD from ice shed from the rotor system or off the EAPS inlet lip or doors. Once closed, the EAPS doors should not be opened again until the EAPS doors are visually checked clear of all ice in flight, or the helicopter is on the ground with the engines stopped. (R 2, R 3, R 4)

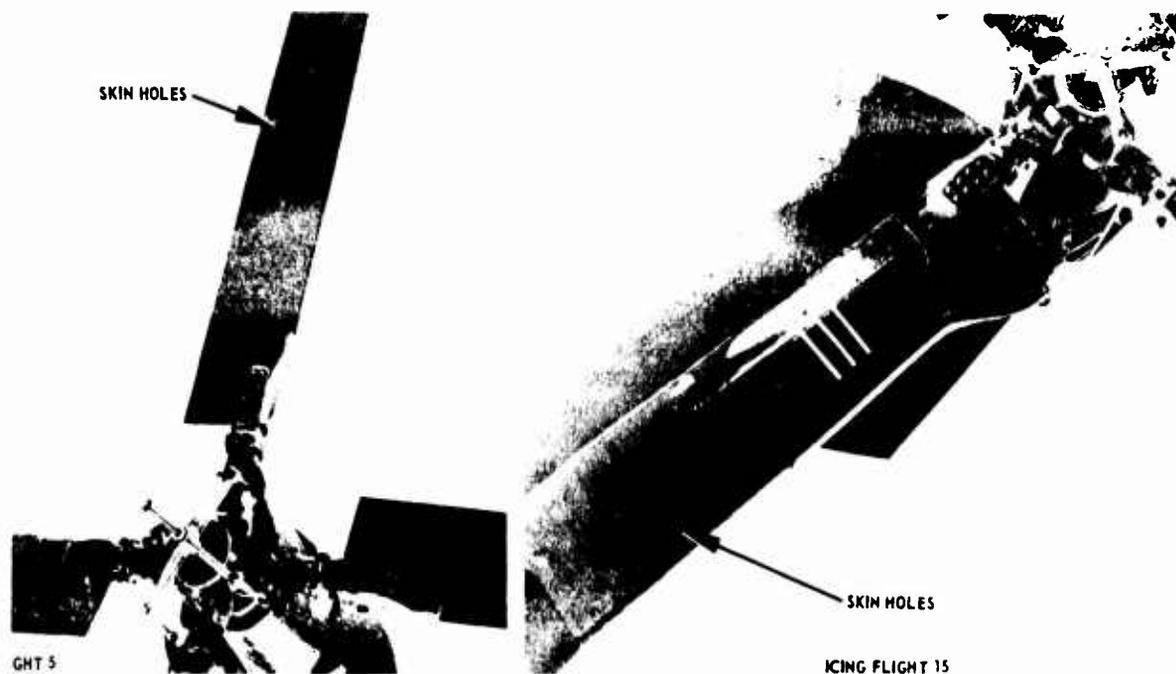
Figure 15 Damage to Tail Rotor Blades

Typical blade ice shedding occurred first from the tail rotor blades and then from the main rotor blades. Shedding usually occurred from the midspan and tip areas, and was generally asymmetric. Main rotor blade ice shedding was random throughout the circumference of rotation, but the ice thickness at which shedding occurred could be predicted, based on the measurement of ice remaining on the rotor blades at the termination of the flight and an assumed approximate average rate of ice accumulation, (appendix IV). Ice from the main and tail rotor blades typically shed when the accumulated ice thicknesses reached approximately 1/2 and 1/4 inch, respectively. Tail rotor ice shedding did not cause any airframe damage or aircraft control degradation. Main rotor blade shedding was significant and caused main and tail rotor blade damage and airframe vibrations. Ice shedding that occurred on icing flights 5 and 15 resulted in minor dents and holes on the tail rotor blade pocket skin. After icing flight 5 one tail rotor blade had two holes, 3-3/4 by 2 inch and 2 by 1 inch, and after icing flight 15 two tail rotor blades had a total of three holes of 7/8 by 1-1/4, 1/2 by 1/4, 2-1/2 by 1-1/4 inch (figure 15). The damage did not degrade the structural integrity of the blades and did

not present any immediate safety of flight hazards. Generally tail rotor blade damage occurred at colder OAT's, when ice accumulated on 100 percent of the main rotor blade span. Colder temperatures (-18 degrees C) caused the ice to form farther out toward the main rotor blade tips, which resulted in a larger angle of incidence between shedding tip ice and the tail rotor blade plane of rotation. Damage, in the form of dents, was inflicted on the tail rotor blades consistently throughout the icing tests, however, the only damage requiring tail rotor blade replacement occurred during icing flights 5 and 15. Main rotor blade damage occurred occasionally in the form of small dents in the pockets due to ice strikes.

Postflight inspection after flight No. 5 revealed tail rotor damage requiring the changing of one blade. Two holes approximately $1 \times 1\frac{1}{2}$ inches were found in the blade pockets on the outer side of the blade. Up to this time, the standard procedure had been to land from a hover following each icing flight. Heavy ice shedding had been observed during the low speed portion of the approach and as the helicopter came to a hover for landing. It should be noted that the pitch of the tail rotor blades was greatest in a hover, exposing a larger area of the tail rotor blade pockets to the rotational axis of the main rotor blades. From these facts and the entry angle on the holes in the tail rotor blade pocket, it was concluded that the damage probably occurred in slow speed flight, in a hover or when changing the tail rotor pitch for ground taxi turns. Later icing flights demonstrated an additional factor could contribute to possible tail rotor pocket damage. As the OAT decreased, the main rotor blades accumulated ice further out the span towards the blade tips. Ice shed from the immediate tip area had a greater tangential velocity and a greater strike angle relative to the tail rotor blade plane of rotation, thus increasing the possibility of an ice strike on a tail rotor blade pocket at such an angle as to cause penetration. In order to reduce

At no time during the icing tests was it felt that the magnitude of the tail rotor blade dents and punctures experienced in the blade pockets compromised safety of flight. It was concluded from the artificial icing tests that minor rotor blade damage in the form of dents may occur in flight in any icing condition as a result of random ice shedding. Tail rotor damage in the form of skin punctures may occur if ice is shed in slow speed flight, a hover or during taxi turns on the ground. A CAUTION should be added to the Flight Manual, recommending landing procedures when the aircraft has an ice accumulation. (R 6)

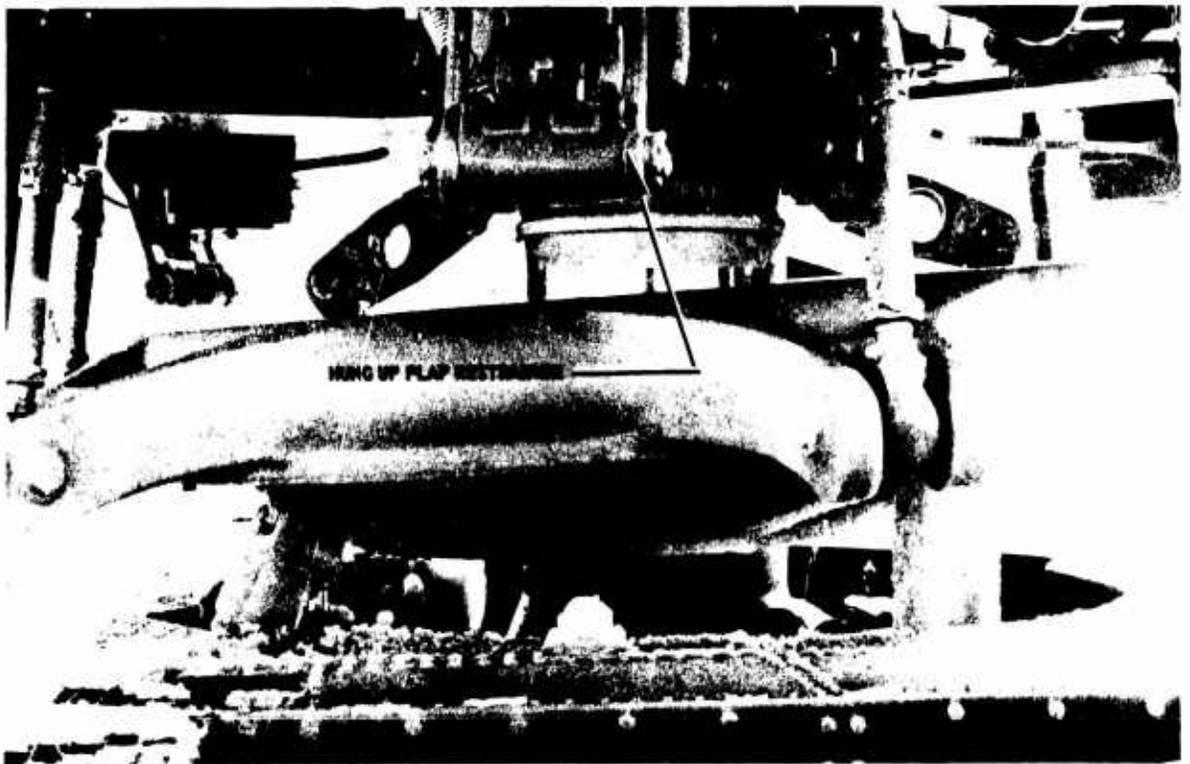
Figure 20 Ice on Flight Servos and Anti-Flapping Restrainers

During artificial icing flights when significant depth of ice was accumulated (1/4 to 1/2 inch, light icing for five minutes and all moderate icing flights) one or more of the main rotor blade anti-flap restrainers hung out in the flight position during rotor shutdown (figure 20). This represented no operational or safety problems during the icing tests since there was no significant wind blowing during shutdowns. The anti-flap restrainers returned to the non-flight position as soon as the ice melted. Pilots and ground crewmen should be alerted for main rotor blade flapping during rotor shutdown in windy conditions after ice has accumulated on the main rotor head. Under these circumstances it will be necessary to park into the wind to minimize chances of blade/fuselage or rotor head damage during shutdown. A CAUTION should be placed in the Flight Manual describing procedures to follow on rotor shutdown after icing conditions have been experienced. (R 9)

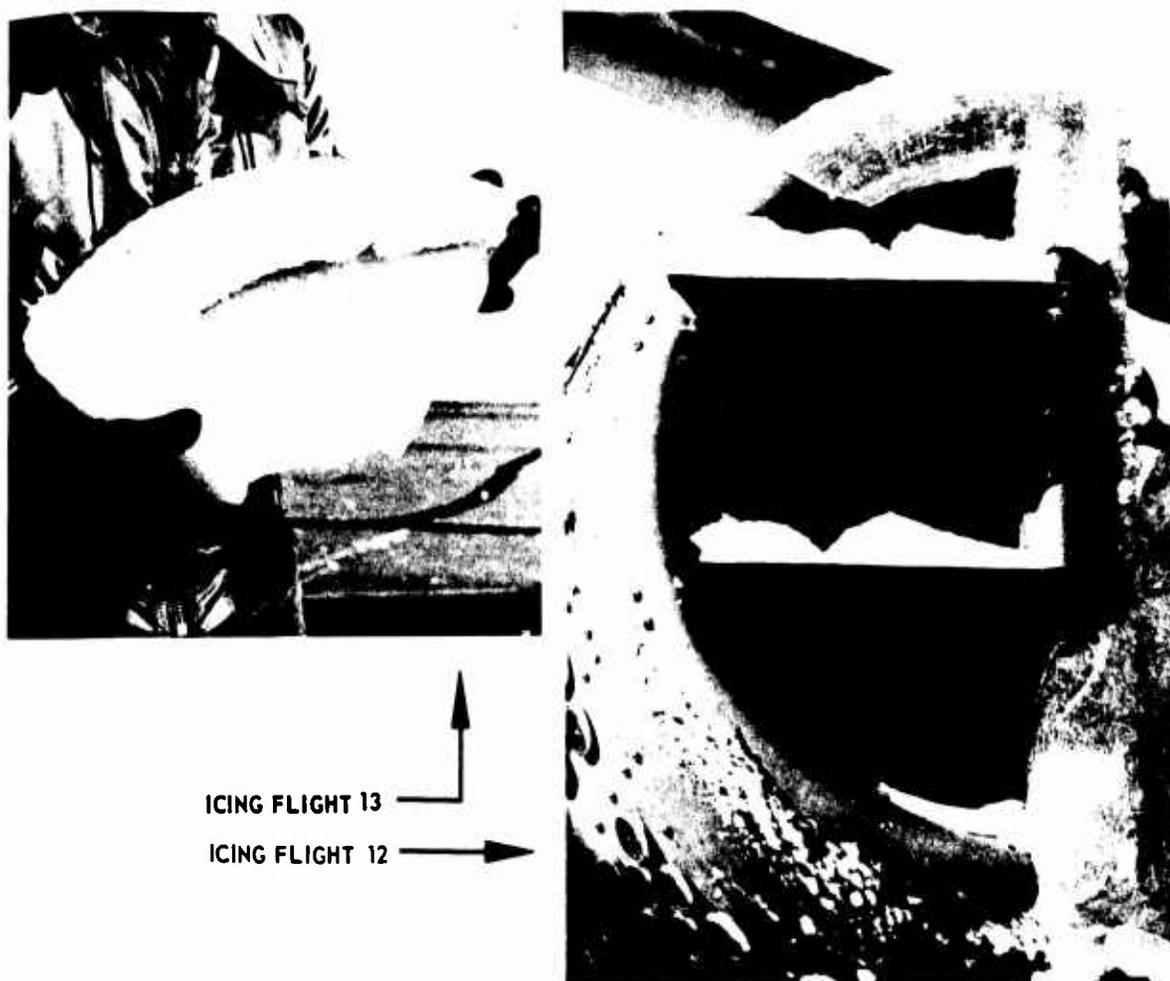
Figure 21 Ice Slab from EAPS Door (Flight 13)

Iced over EAPS doors were electrically opened without difficulty on the ground during postflight inspections. The engine was not running. The solid sheet of ice (up to 3/4 inch thick) over the inlet doors broke away easily, once into numerous large fragments, another time into two equal halves (figure 21).

Due to possible engine ingestion of ice fragments, iced over EAPS doors should not be opened until the engine has been shutdown after landing. (R 15)

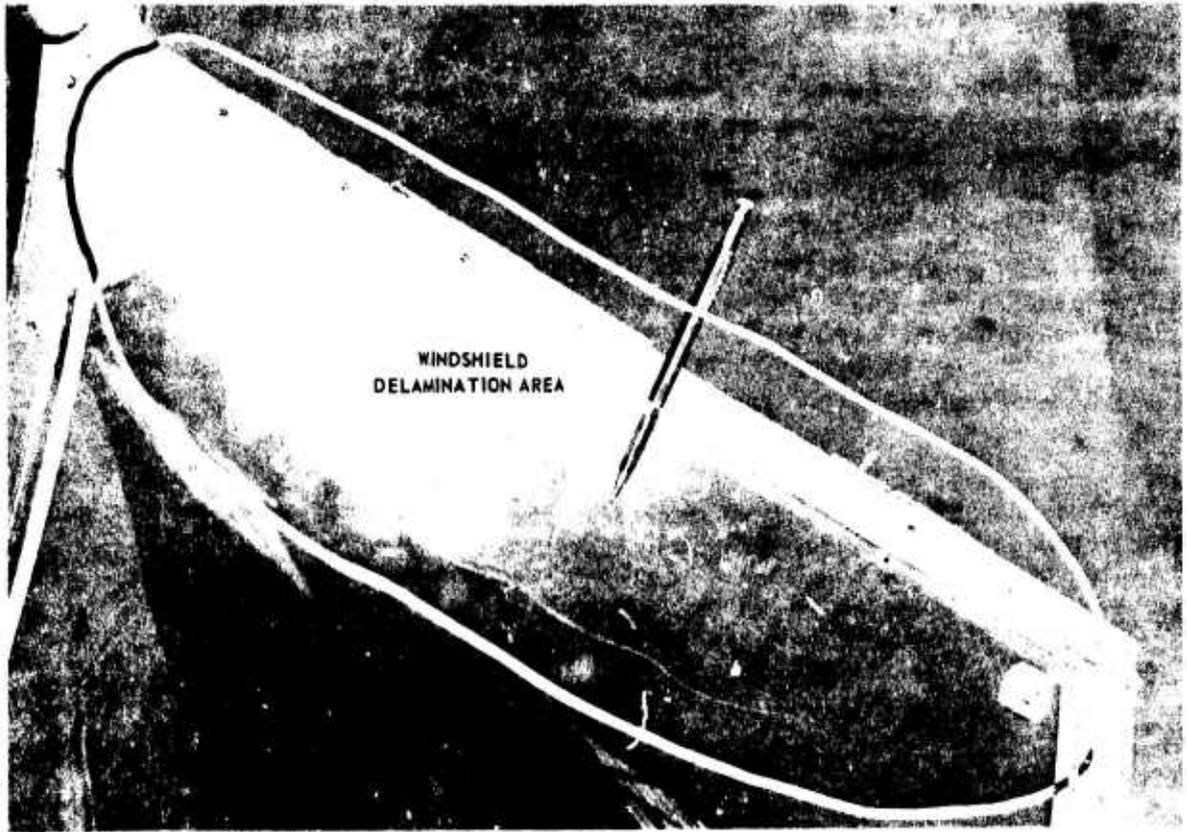
Figure 22 Windshield Delaminations

One third of the center windshield lost all anti-ice capability after icing flight 9. This portion of the windshield had a delamination

in which a burned or smoky area, immediately adjacent to the imbedded bus bar, was visible. The windshield anti-icing systems were in use for approximately 7 hours during the artificial icing tests and approximately 10 hours during the natural icing tests. As evaluated, the windshield anti-icing system was highly effective in maintaining ice free vision up to and including moderate icing conditions when turned on one minute prior to encountering icing conditions. The windshield was unsatisfactory in terms of its extremely short service life when using the anti-ice heating capability, due to frequent delaminations. The quality control inspection procedures employed during manufacturing and acceptance should be improved and/or the windshield design improved to eliminate the delamination problem. (R 19)

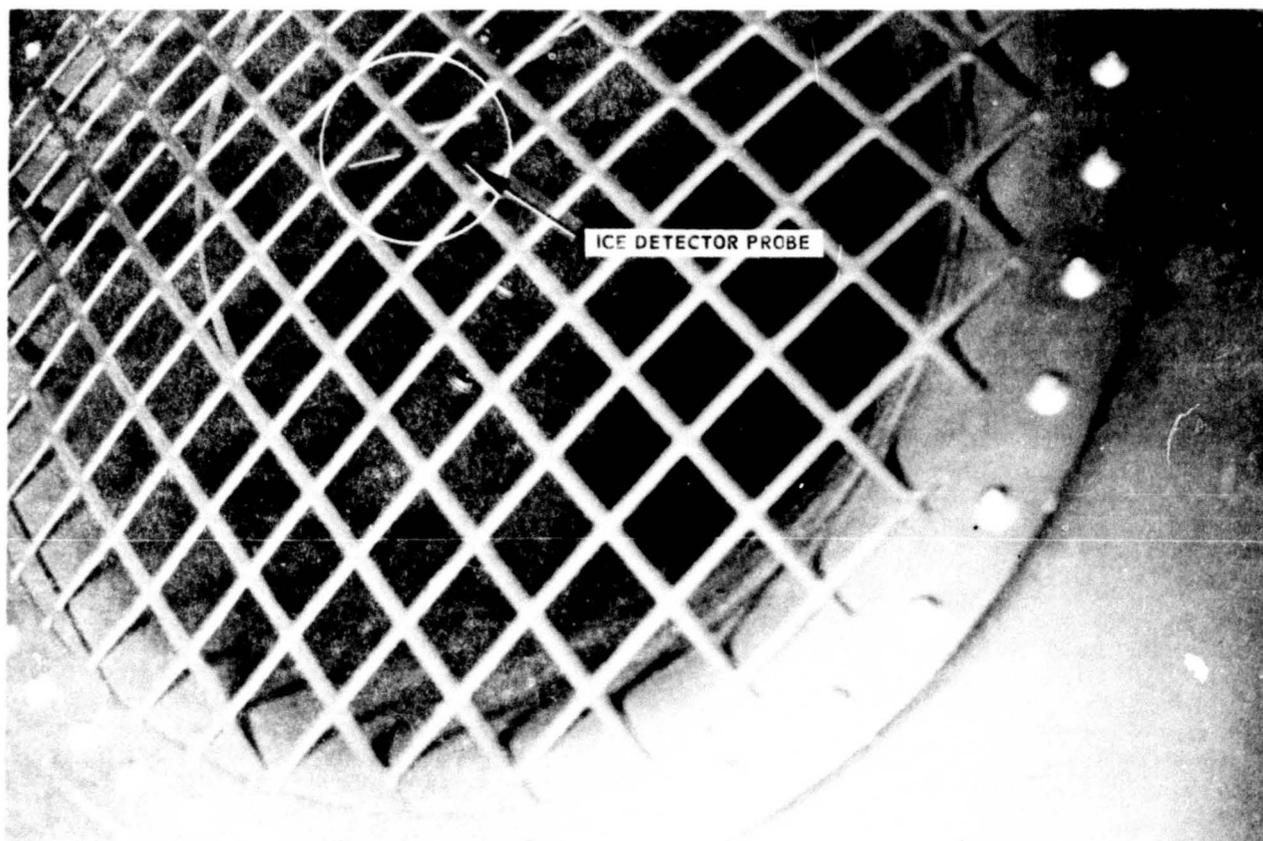
Figure 24 Heater Inlet Screen with Ice Detector Probe Inside

The ice detector probe, located in the cabin heater inlet duct, was unreliable during the test program (appendix VII). During test point 12, an artificial icing condition, the ice detector system did not activate until it had been in a light icing condition for 8 minutes and on other flights it activated frequently, prior to entering the icing cloud. Also, during a flight in search of natural icing, the ice detector system activated in clear air, with no icing evident. The cabin heater was inoperative during part of the artificial icing/freezing rain tests, but was operational during the natural icing test phase.

The intermittent operation of the ice detector probe was possibly caused by its location within the cabin heater duct, and/or air flow blockage due to ice accumulation on the heater screen (figure 24). The ice detector system was unreliable. The operation of the ice detector probe should be checked and the sensor relocated to an area that would be more conducive to ice accretion in unrestricted airflow. (R 27)
