REPORT NATF-EN-1132

BAK-14 RETRACTABLE HOOK-CABLE SUPPORT SYSTEM
COLD-WEATHER TESTS AT GALENA, ALASKA

27 AUGUST 1974

Final Report for Period 15 through 20 January 1974

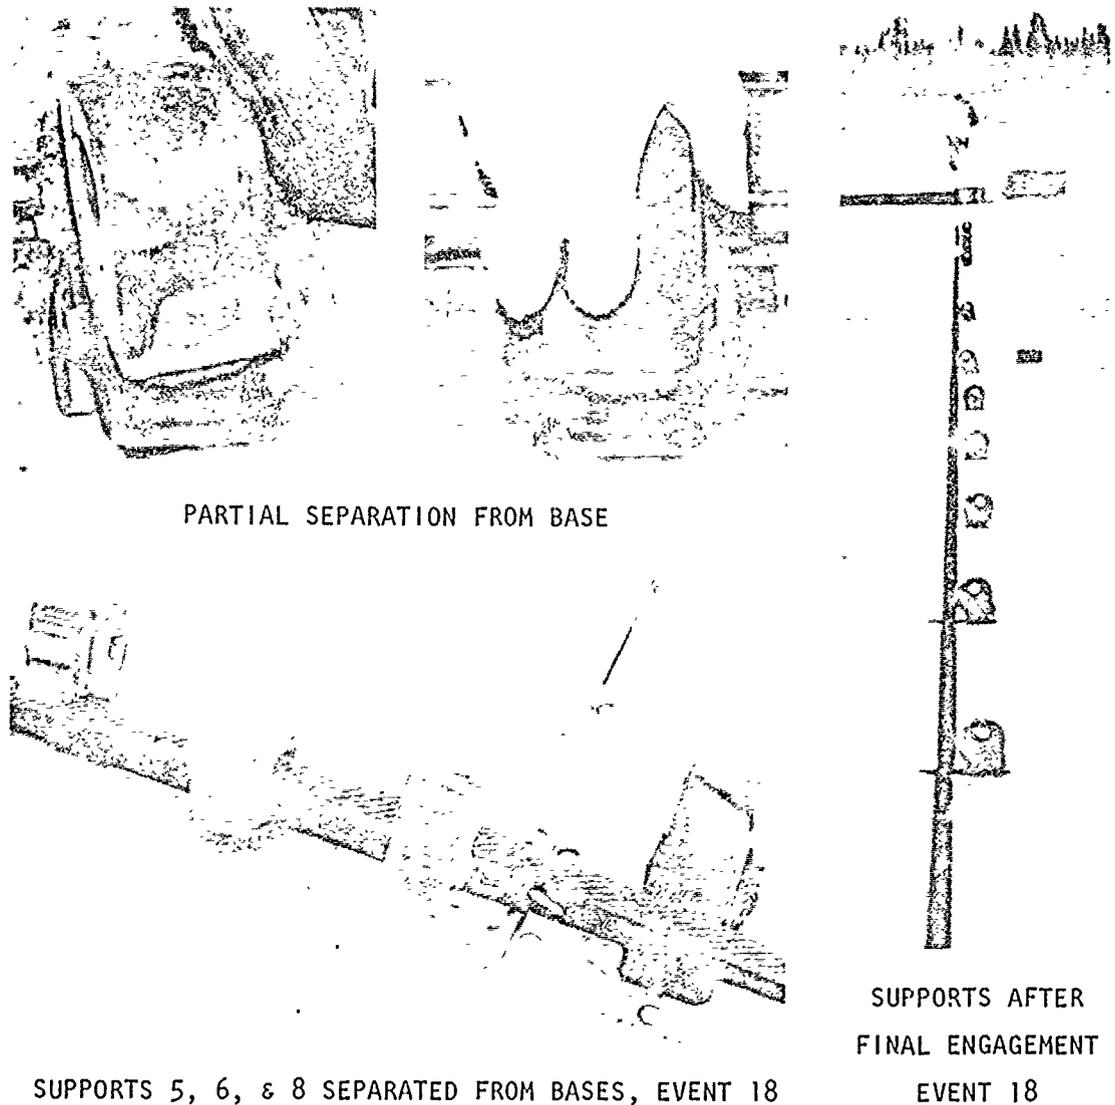
(b) The more serious area of failure occurred within the metal frame base of the support as shown in Figure 13, where the rubber partially separated from the base. After the last arrestment, supports 5, 6, and 8 were separated from their bases, and supports 5 and 6 remained attached to the hook cable during the arrestment and retrieve (see Figure 13). All the remaining supports were split and partially separated from their bases (see Figure 13). The failure mode indicates that both the nylon-restraint and the pivot-shaft through holes decrease the area of the load carrying cross section and seriously weaken the support within the metal frame base.

FIGURE 13 - VIEWS OF FAILED CABLE SUPPORTS

2. The neoprene rubber support blocks were unsatisfactory because of their hardened condition at the low ambient temperatures. The loads imposed during arrestments caused partial to complete separation of the 14 blocks from their bases. (Section IV, Paragraph B1b)

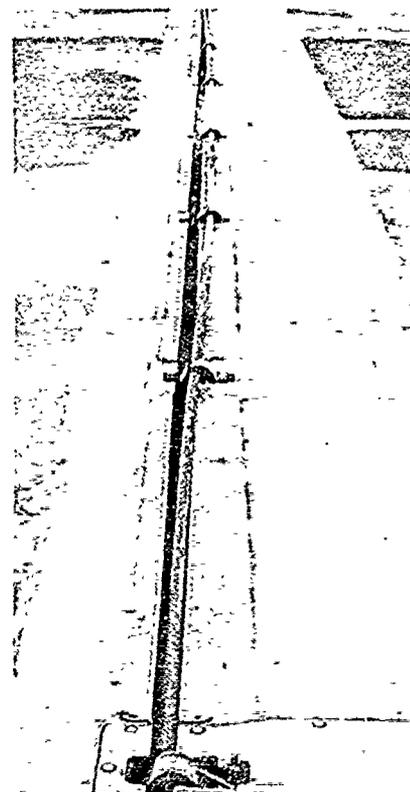
2. CYCLE TESTS: After the aircraft tests were completed, the BAK-14 was returned to operating condition for the 100 cycle tests as follows: the 14 damaged supports were replaced; support box 8 pusher block was realigned; the bent latch pivot shaft of support box 9 was straightened; the pivot shafts of support boxes 8 and 9 were reinstalled with their brackets fastened to the support arm with 10-32 x 1/2-inch-long screws; and 5 support-block latches were adjusted. After the repairs were completed, system cycle operation was satisfactory; however, when the initial 50-cycle test was started, the latch of support block 4 would not retract and prevented retraction of the entire cable (retract hangup) as shown in Figure 15. Adjustment of the latch corrected the problem.

FIGURE 15 - HOOK-CABLE RETRACT HANGUP
CAUSED BY JAMMED SUPPORT
LATCH
