SHRIKE AND SPARROW MISSILE BASELINE  
COOKOFF TESTS

Naval Weapons Center

Naval Missile Center

October 1974

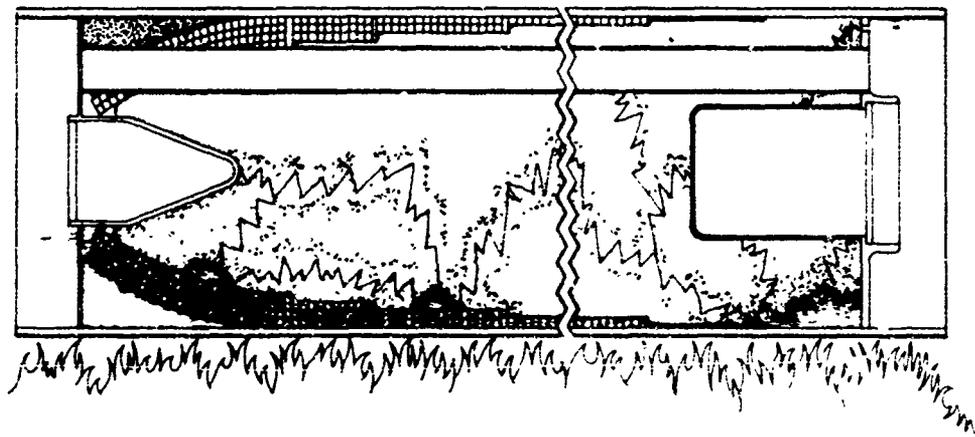
FIGURE 4b. Possible SHRIKE Warhead Explosive Cracking Creating New Burning Surfaces.

The failure of the SHRIKE warhead is hypothesized to be due to over-pressurization within the steel casing, which causes the crack as shown in Figure 4b. Inadequate venting exists for the SHRIKE warhead, and it explodes before 169 sec, e.g., SH-13A, 128 sec; SH-14A, 109 sec; SH-16A, 169 sec. If the excess explosive-gas can be vented, then there may be deflagrations instead of explosions. Both types of reaction are illustrated in Figures 4c and 4d.

In the SHRIKE warhead section such ventilation is recommended, particularly for the aft bulkhead and also in the steel casing itself. Also the forward cone should be uncrimped and refastened with an adhesive. The aft fuze cavity should be removed by chemically milling the weld joint, and refastened with a suitable adhesive. Holes could also be drilled in the fuze booster cup itself, which should then be relined with a suitable sealant.

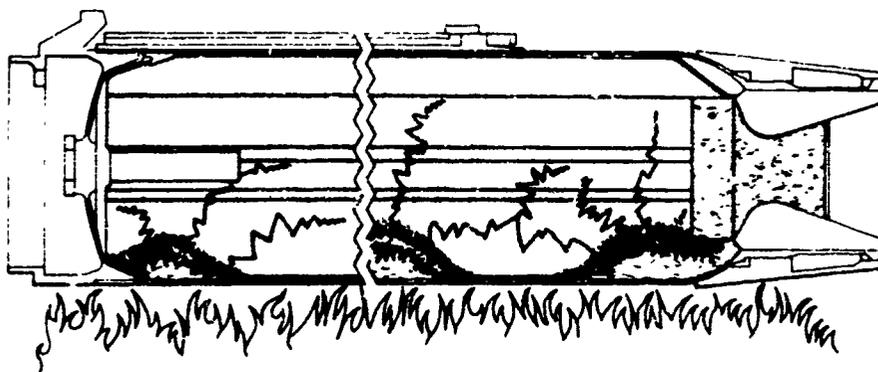
FIGURE 5b. Possible SHRIKE Motor Propellant Grain Cracking Creating New Burning Surfaces.

The failure of the SHRIKE rocket motor is hypothesized to be due to over-pressurization within the steel casing, which causes solid propellant cracks (Figure 5b). If the excess propellant gas can be vented (e.g., SH-7A, SH-8A, SH-12A) then the reaction will be one of deflagration; otherwise an explosion may result (e.g., SH-16A). Both types of reactions are illustrated in Figures 5c and 5d.

*Ventilation* of the bottom portion of the rocket motor case is recommended and can be realized by machining or chemical milling, which would weaken the casing at high temperatures. A glass/resin doubler with suitable heat diffusion filler would then be applied to maintain its external configuration and low-temperature strength. This retrofit is applicable to both the SHRIKE Mk 39 Mod 7 and SPARROW Mk 39 Mod 0 motors.

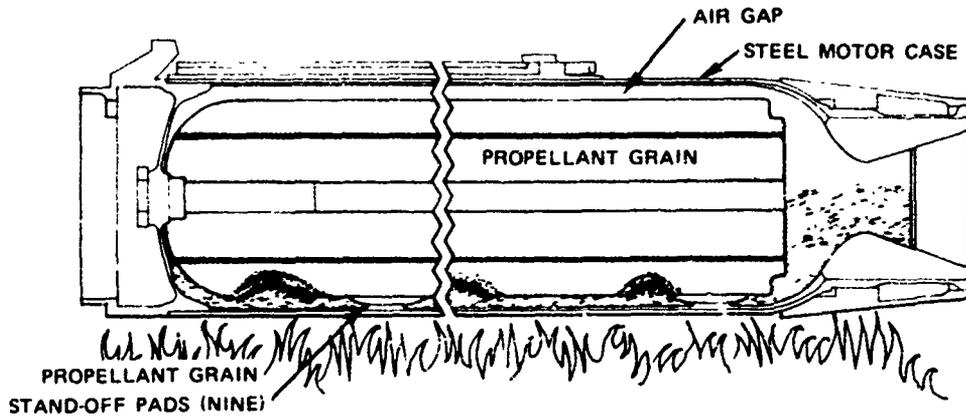
FIGURE 7a. SPARROW Motor Propellant Igniting at Lower Surface.

The exothermic heating produced from the liner and/or other material used to prepare the steel case for graining ignited the propellant sooner than if heating only by conduction from the fire existed without chemical reactions. The solid propellant is shown burning at the lower surface in Figure 7a.

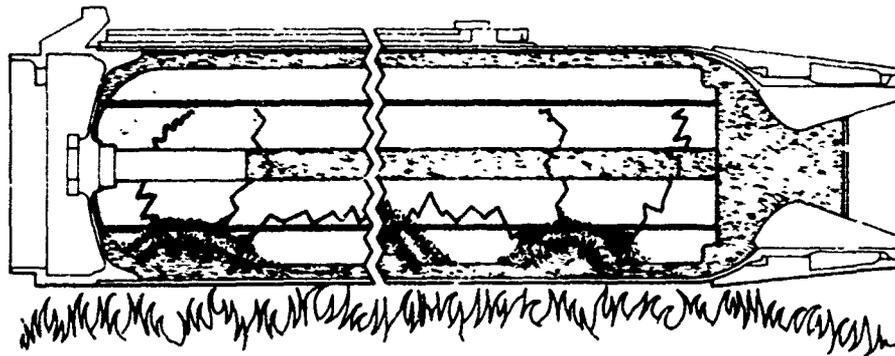
FIGURE 7b. Possible SPARROW Motor Propellant Grain Cracking Creating New Burning Surfaces.

The failure of the Mk 38 Mod 0 SPARROW rocket motor is hypothesized to be due to over-pressurization within the steel casing, which causes the solid propellant to crack, as shown in Figure 7b. If the propellant gas can vent, then the reaction may be one of deflagration, as shown in Figure 7c. Otherwise an explosion may result, as shown in Figure 7d.

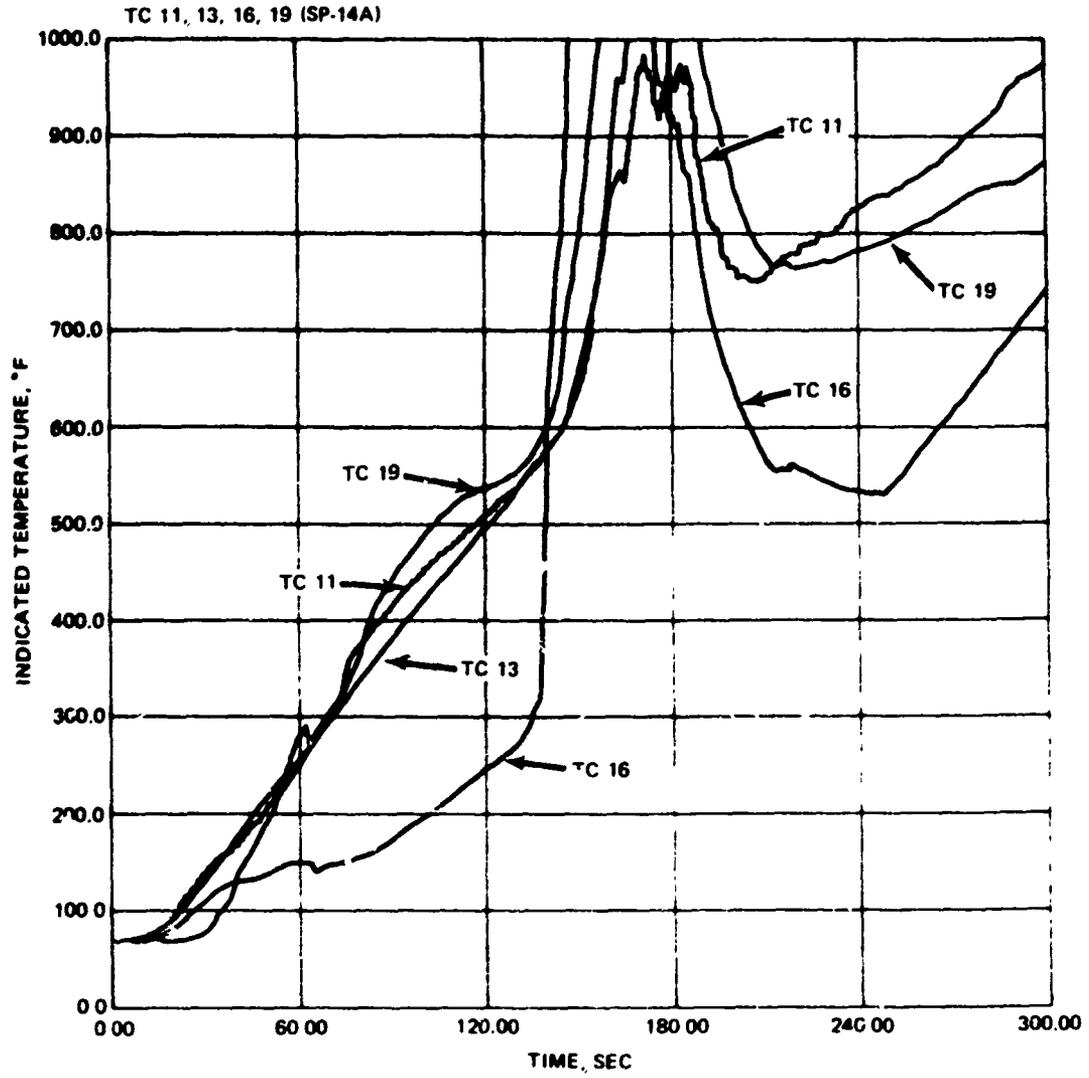
FIGURE D-40. TC 11, 13, 16, 19 Response. SP-14A

Outputs from thermocouples 11-23, located in the warhead, are shown in Figures D-39, -40, and -41. Thermocouple 21 was inoperative. The outputs of TC 12, 14, 20, and 22, located on the magnesium liner, are shown in Figure D-39. Again apparent exothermic behavior is observed for all thermocouples. It is possible that both the magnesium liner and explosive were ignited by 152 sec, since TC 14 was fractured at that time. The data for TC 11, 13, 16, and 19 located on the steel

rod/potting material interfaces, are found in Figure D-40. Again apparent exothermic reactions occurred between 134 and 240 sec. The temperatures recorded in this time domain surely would ignite the warhead explosive which in turn would have ignited the magnesium. Significant aft venting of the warhead had already started at 84 sec, as suggested by TC 23 shown in Figure D-41. Evidence that explosive/magnesium gas venting had occurred by 130 sec is given by TC 15, 17 and 18 in Figure D-42. It is possible that the safe/arm device exploded at 495 sec.
