INVESTIGATION OF HELICOPTER DOOR,  
WINDOW, AND ACCESS PANEL LOSSES

Naval Air Development Center

Naval Air Systems Command

15 January 1975

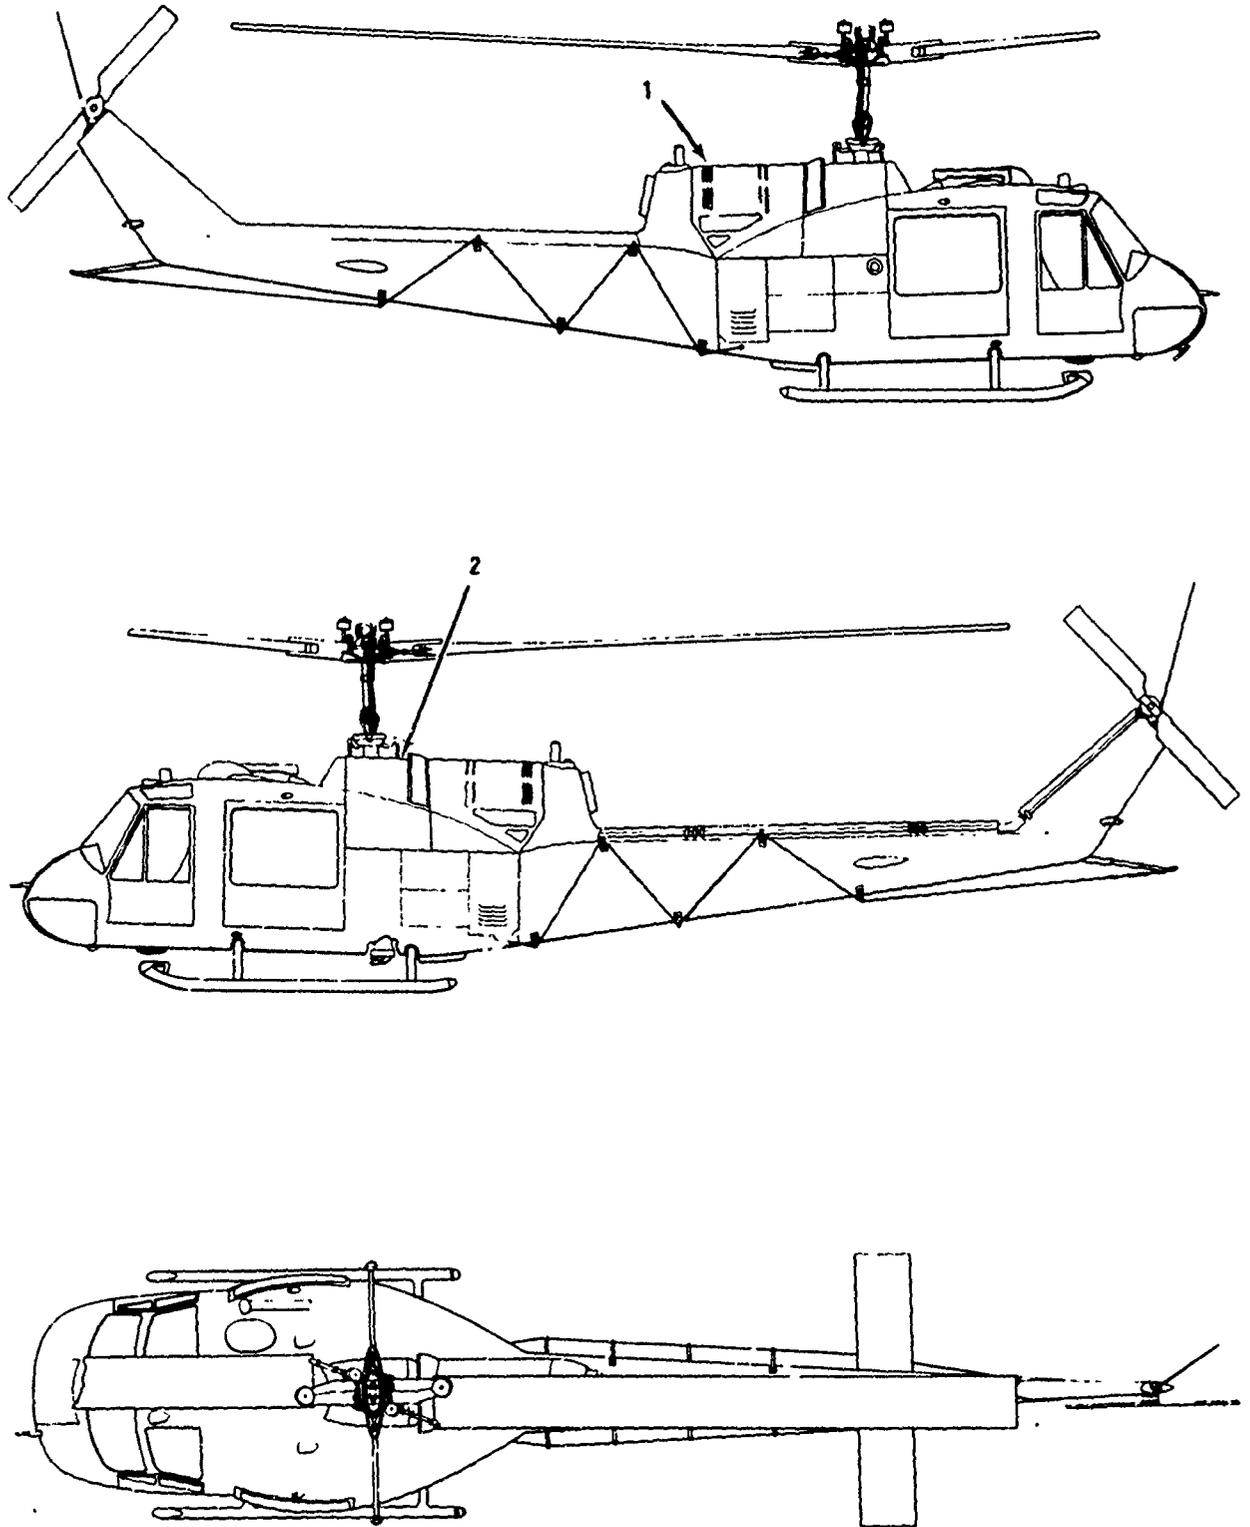
FIGURE B-2. UH-1E HELICOPTER - AIRFRAME GROUP

Information obtained from the NAVSAFECEN computer compilation demonstrated that the Transmission Cowling Panel is the primary problem area on this aircraft. Specifically, material failure of the latch mechanism was most critical. History indicates the need for a positive retention feature for the Transmission Cowling. In-flight Transmission Cowling problems accounted for 55% of the UH-1E reports. Figure B-1 provides a general view of the UH-1E aircraft, and the panel details are highlighted in Figure B-2. Figure B-3 summarizes the findings of the analysis of the NAVSAFECEN reports on the H-1 helicopters.

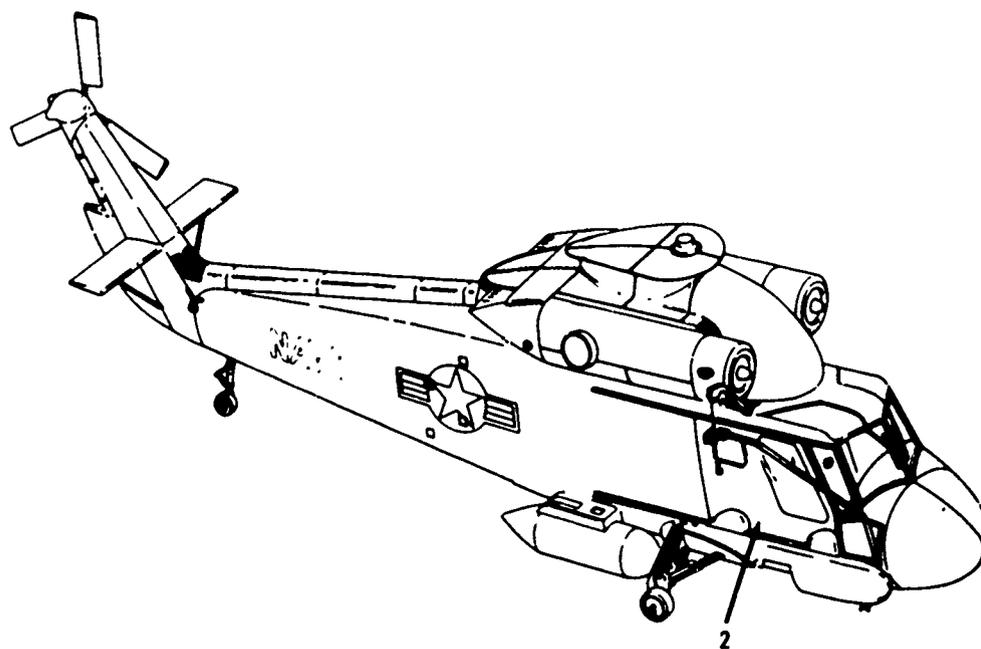
FIGURE C-1. UH-2C HELICOPTER

On the H-2C and the H-2D helicopters, the Engine Oil Access Panel has caused the most problems. These rectangular panels open horizontally on each side of the aircraft and are nicknamed "diving boards". The NAVSAFECEN compilation did not indicate a high frequency of in-flight openings of the Engine Oil Access Doors; but in each case reported, the doors became involved in the Rotor System. In two cases the aircraft were lost and the airmen were casualties due to Rotor unbalancing. The panels which are located just aft of the Rotor Blade Hub and just below the blades can be pushed together and closed without being secured. In one of the cases mentioned above, the accident investigation revealed that the panels were not fully locked. During the flight they vibrated open and finally separated from the aircraft on the landing approach. Realizing the critical nature of the panel, some of the active squadrons have made adjustments in their procedures. Some make a last minute, prior to flight, visual, double check to

The Pilot's Rescue Door is an important problem area on the H-2 helicopters. In the NAVSAFECEN study, the Pilot's Rescue Door was the most frequently occurring in-flight discrepancy. The major causes were identified as the lower attachment structure/ bracket/slide track. Normal wear, vibration, and fatigue were all pinpointed as possible reasons for failure. A similar attachment and sliding design is used on doors on each side of the aircraft fuselage. The doors have adjustable plates which screw over a flange on the airframe. This design makes the entire door jettisonable for emergency egress. In evaluating existing designs, it appears to be more effective to securely restrain the door and design the windows with an emergency egress capability. On the aircraft inspected in the active squadrons, there was very little adjustment available, and the doors were adjusted to maximum tightness. However, there was still looseness in the door runners that could cause the door to tear free in the event of severe vibration and wind currents.

ascertain that these panels are fully secured. Secondly, the underside of this panel, which is visible from the ground, has been painted bright striped colors to maximize the probability of observation. Thirdly, since the panel can be closed and may not latch, some squadrons have adopted the policy that any time the panel is not fully open, it is fully closed and latched. During visits to squadrons, it was observed that a locking pin has also been added to the latch to insure that panels do not open.

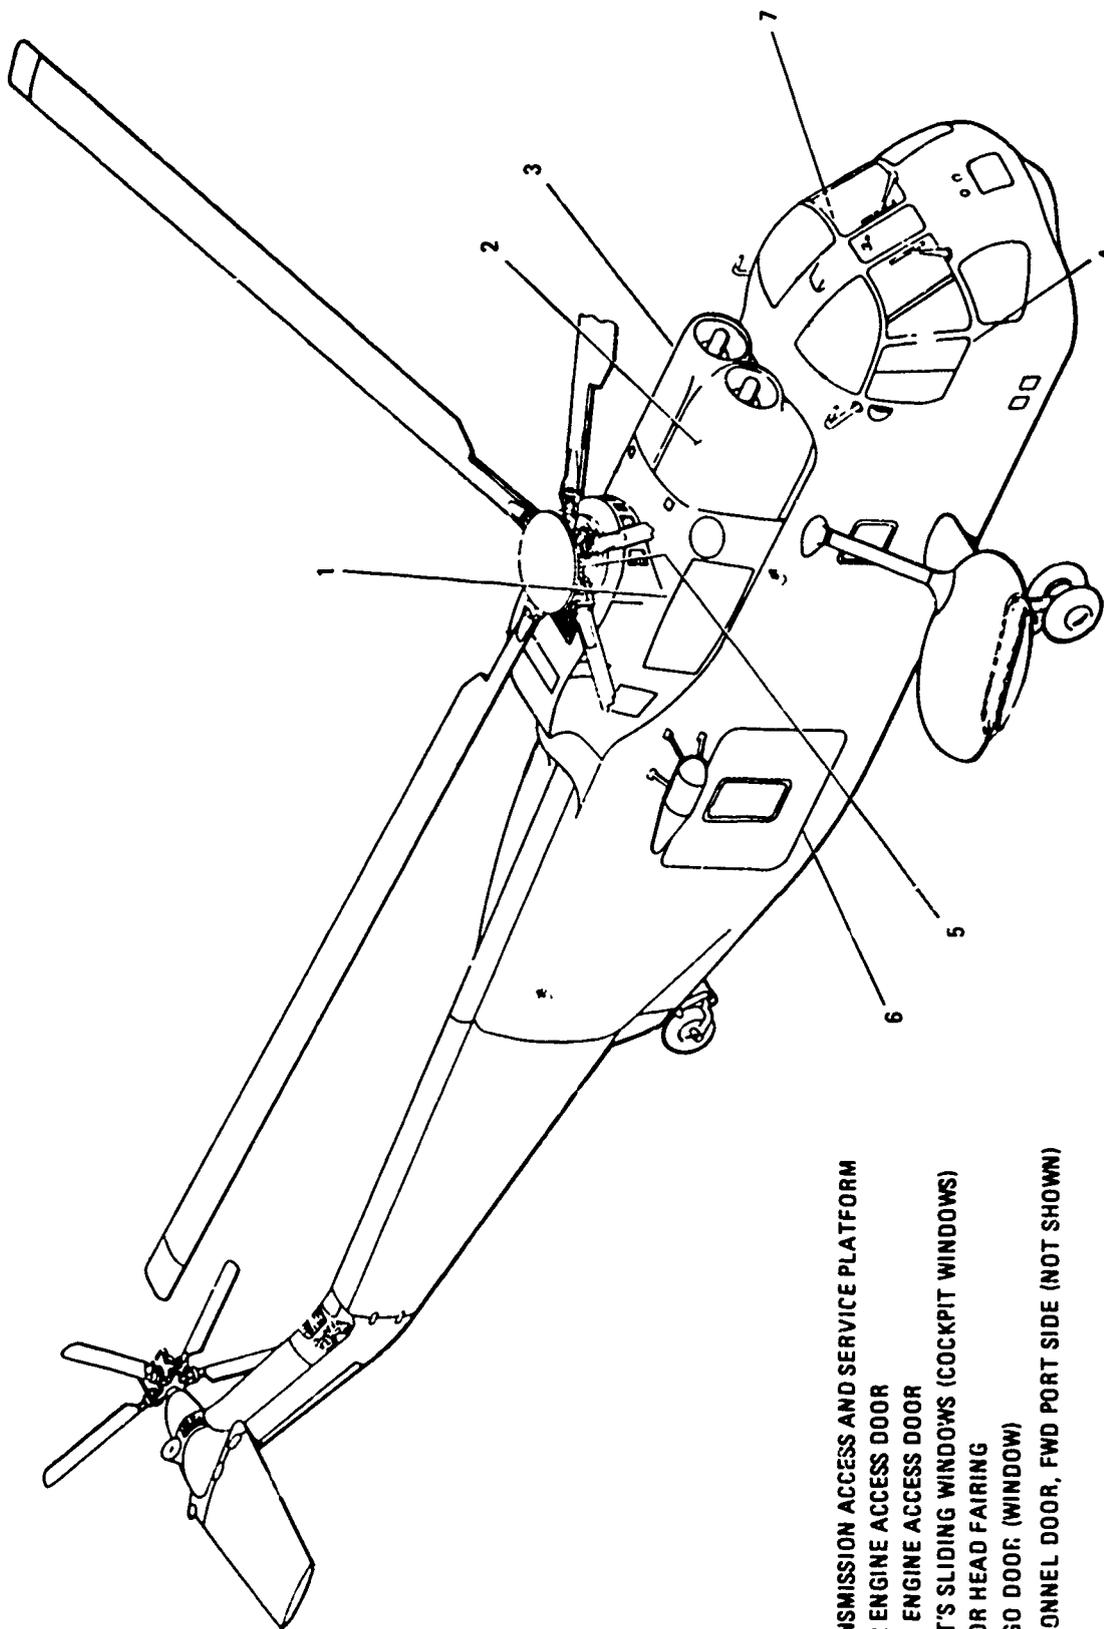
FIGURE D-2. H-3 HELICOPTER - GENERAL ARRANGEMENT EXTERIOR

The NAVSAFECEN compilation indicated that loss of the Cargo Door Window (starboard emergency exit) is the most frequently occurring in-flight discrepancy. Unless this component fails, it generally does not require maintenance as shown by the low 3-M response.

Squadron interviews revealed that the Cargo Door Window has an emergency release handle which is shear wired. Overpressure, fatigue, vibration, normal wear and human error contribute to its failure. The window is relatively small and lightweight which minimizes the possibility of damage to the aircraft. Experience has shown that, because of the airflow around this aircraft, the starboard windows separate and tend to fly away harmlessly. Port-side panels, on the other hand, have a tendency to be blown back against the airframe and cause possible damage.

The Engine Service Platform does not have a high frequency of failure but its size and proximity to the Rotor Blades make it hazardous if it opens in flight. The platform is secured to the airframe with two "J" hooks which are operated by a handle on the outside of the panel. This handle can close the platform flush

The lower Personnel Door is held by a slamming lock with a spring-loaded bolt on each side of the door. A handle is turned to a detent position to lock the bolts in a closed position. Wear of the slamming lock mechanism has caused the door to become unlocked. In addition, there is not enough overlap between the bolts and the striker plate on the airframe to insure locking. The H-46 and H-53 aircraft have similar Personnel Doors but they have about 1 to 1.5 inches of steel rod overlapping the striker plates. The H-3 upper Personnel Door is secured to the lower door by a single slamming lock. In-flight vibration causes these doors to open. The upper door displays a greater tendency to separate from the aircraft and has a greater potential to strike the Tail Rotor System. The lower door will generally stay with the aircraft. The 3-M compilation indicated that these doors required more maintenance actions than any other panel component on the H-3 aircraft.

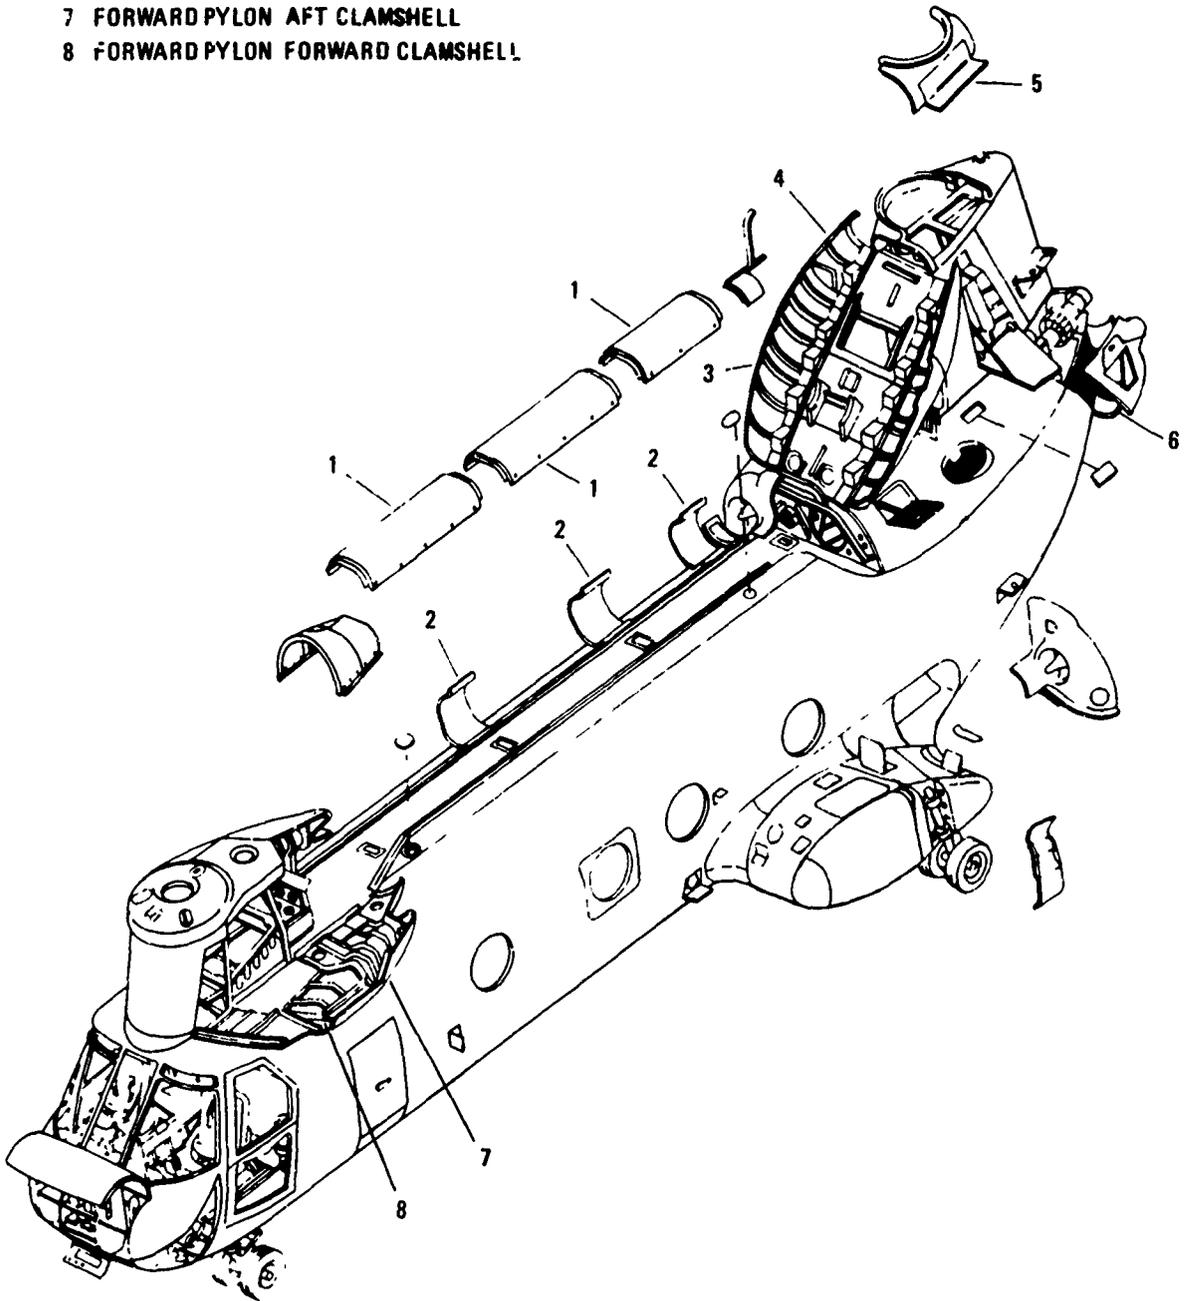
FIGURE E-2. H-46 HELICOPTER ACCESS DOORS

Together the Forward Pylon Forward Clamshell and the Forward Pylon Aft Clamshell doors accounted for the largest number of reports from the NAVSAFECEN and 3-M data. The Forward Pylon Clamshell Doors received about equal emphasis with the Aft Pylon Clamshell Doors on the squadron visits. The squadrons placed most of the blame for the loss of the Forward Pylon Forward Clamshell Door on the warping of the leading edge. This panel becomes warped by maintenance personnel stepping outside the Work Platform area. Another cause suggested by some of the NAVSAFECEN reports and by some of the squadrons is the failure to properly secure the forward latch. It is difficult to see if the latch is properly secured because the latch is internal and located on the upper forward end of the panel. If the latch is not secured, the panel may flex enough to allow the windstream to get under the leading edge and open the panel. If the panel separates, it has the potential of striking either of the rotors.

The Aft Pylon Clamshell doors (Reference: Figure E-2, Annotations 3 and 4) provide another problem area on the H-46. According to the NAVSAFECEN data, Aft Pylon Forward Clamshell Doors are lost more frequently than the Aft Pylon Aft Clamshell Doors. However, the aft doors are more dangerous to lose because of their proximity to the rotors. Those who cite the latches as the main cause say that flexing of the doors causes the latches to fail or that the latches are not properly adjusted causing the failure. Those who report the hinges as the main cause contend that the hinges become loose allowing excessive vibration in the doors and that either the hinges fail first followed by the latches failing, or that vibration causes the latches to fail.

The Swashplate Access Panel (Reference: Figure E-2, Annotation 5) accounts for a significant number of losses. It does have a potential for striking the Rotor Blades (two out of the 21 NAVSAFECEN reports indicated this). The panel is relatively small and light and the possibility of seriously damaging the Rotor Blade and causing the aircraft to go out of control is small, but it does exist. The problem with the Swashplate Access Panel is that the Camloc fasteners are not securing the panel adequately. Failure could be caused by not using enough fasteners, the inability of the fasteners to withstand vibration, or incorrect fastener size.

The synchronous Shaft Inspection Panels (Reference: Figure E-2, Annotation 2) have been troublesome. They usually open in flight and hit the fuselage. They have separated from the aircraft but no cases of them striking the Rotor Blades have been reported. Fastener failure has been the problem. These panels become distorted from either coming open and being banged against the fuselage or by personnel walking on them. They can become so distorted that they rub against the synchronous shaft. Their frequent need for repair or replacement makes them an appreciable maintenance problem.

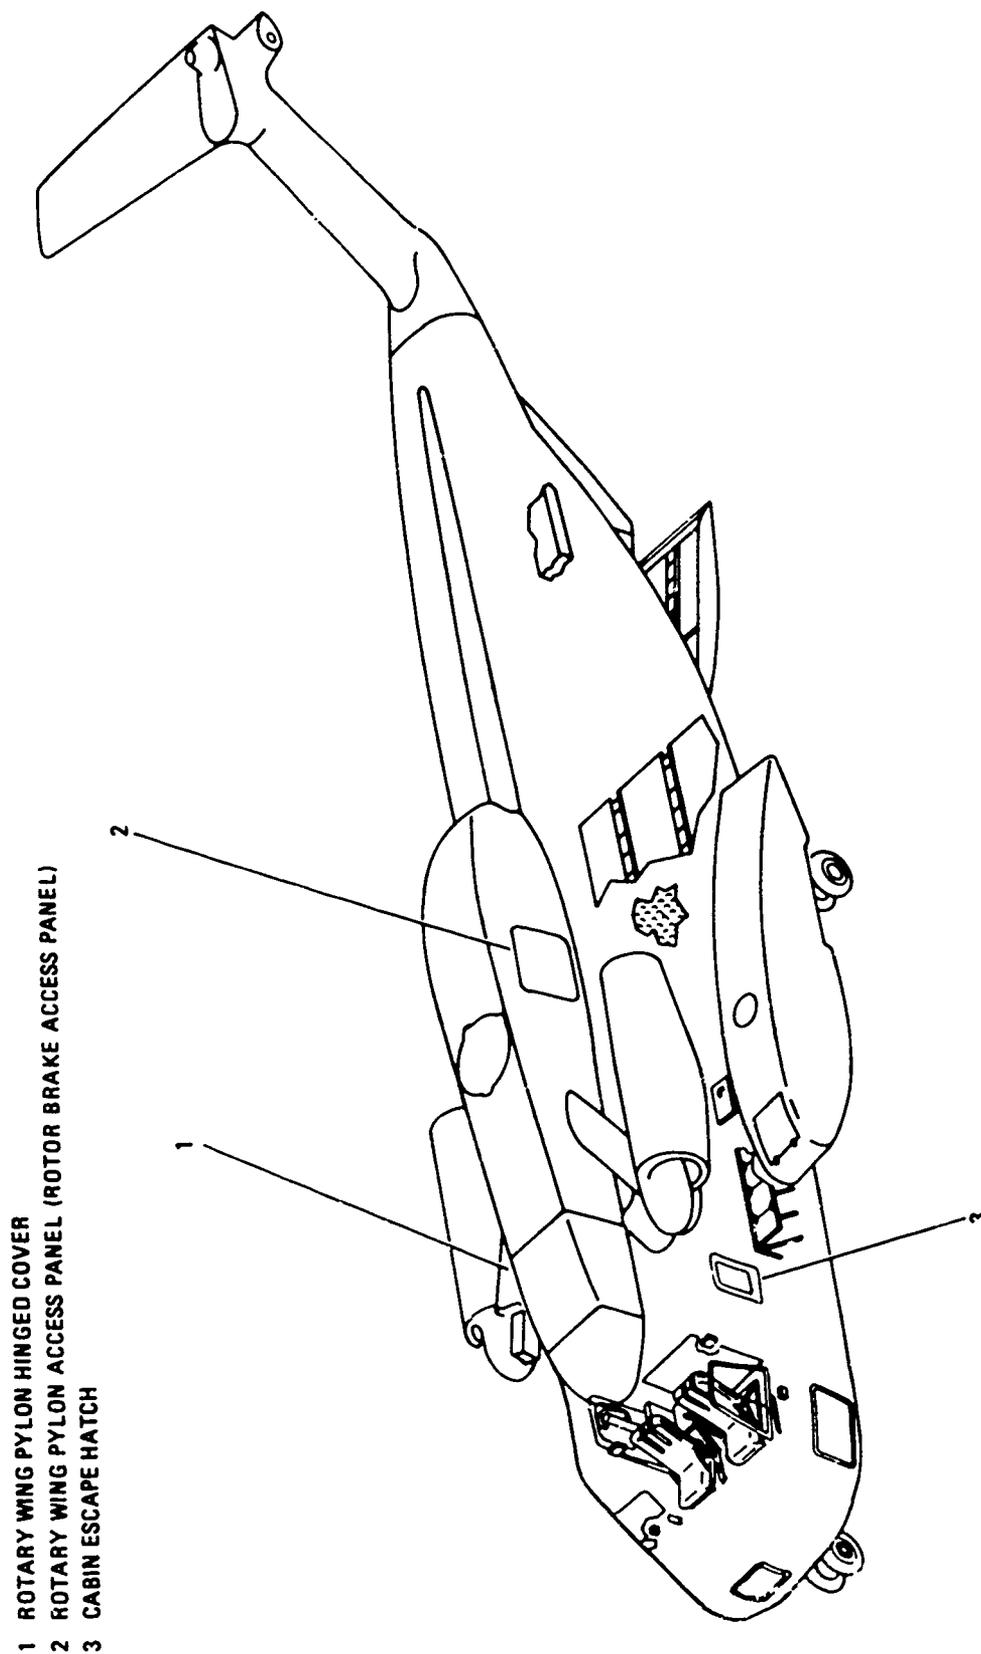
FIGURE F-2. CH-53A AIRFRAME EQUIPMENT AND FURNISHINGS

The Rotor Brake Access Panel which is just aft of the Work Platform (Reference: Figure F-2, Annotation 2) stands out in all three data sources as being the major problem on the H-53. The NAVSAFECEN data shows the Rotor Brake Access Panel to be the constant contributor to in-flight incident reports (22.4% for all H-53's, 37.2% for H-53D). The 3-M data indicates it is the panel most frequently in need of maintenance action. This panel was also emphasized by squadron

personnel. Problems with this panel are caused by its size, lack of weight and flexibility which make it susceptible to being torn off the aircraft if air is allowed to get under it. The Camloc fasteners which secure the Rotor Brake Access Panel do not keep the leading edge flush enough to prevent air from getting under the panel. The fasteners are too loose either due to wear in the receptacles or an improper size being used. The frequency of loss of the Rotor Brake Access Panel is alarming considering this panel's potential of hitting the Rotor Blades. Because of the windstream around the aircraft, the port panel is more apt to strike the Rotor Blades than the starboard panel. Fortunately, the starboard panel is lost more frequently than the port panel.

The Escape Hatch (Reference: Figure F-2, Annotation 3) accounted for nine percent of the incidents reported in NAVSAFECEN reports. The mass of the Escape Hatch makes it a potential hazard because it would cause extensive damage to the Rotors if it was to strike them (No such occurrence has been reported). The hatch would also cause personnel or property damage if it fell in a populated area. Frequently the hatch is removed for better in-flight cabin ventilation, for weapon installation or for gravity fueling of internal tanks. Frequent removal causes the hatch to become insecure. With age the latching mechanism flexes allowing the securing pins to drop out of their guides. Also it is difficult to see if the pins have properly seated in the side of the frame. If a crewmember attempts to remove the hatch in-flight, the wind blast will most likely tear it from his grasp. Squadron personnel have suggested the possibility of forward-hinging the hatch to improve the ability to secure the hatch while still retaining the opening capability. The design philosophy of the H-53E is to maximize commonality of parts with earlier models. Consequently, the H-53E port Emergency Escape Hatch is designed the same as the earlier models.

The Hinged Doghouse Cover (Reference: Figure F-2, Annotation 1) represents only 2.2 percent (3 cases) of the NAVSAFECEN reported incidents, although each case has resulted in the cover hitting the Rotor Blades. Two of the three reported cases were due to improperly securing the cover prior to flight. The cover is hinged on its leading edge, and even if the cover is not secured it should not open in level flight. Certain maneuvers could cause it to open and hit the Rotors. The squadrons visited have indicated that it sometimes takes an excessive amount of time to close and secure the hinged cover. This problem is caused by the cover being large and flexible and the frame being very susceptible to distortion.
