ANALYSIS OF LIQUID ROCKET TANKAGE

Bell Aerospace Company

Air Force Rocket Propulsion Laboratory

REPORT DOCUMENTATION PAGE		READ INSTRUCTIONS BEFORE COMPLETING FORM
1. REPORT NUMBER AFRPL-TR-74-82	2. GOVT ACCESSION NO.	3. RECIPIENT'S CATALOG NUMBER AD-A008 535

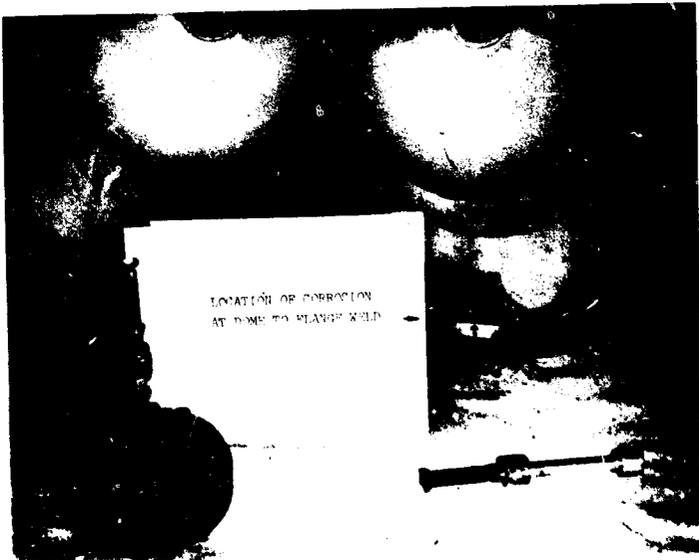
Local area of corrosion at arrow is magnified in
Detail Failure Analysis Section.

Figure 44. Surface Appearance of A-286 Stainless Steel Tank
(No. 17, Martin S/N 023) Loaded with Cl_2
For over One Year.

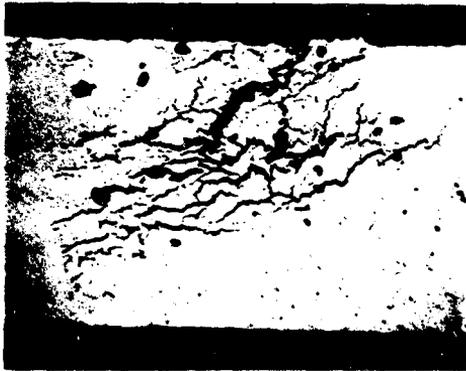
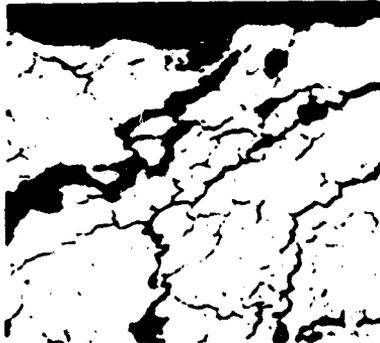
Figure 46. Cross Section of Manifold Tubing Weld Leak Shown in Figure 45 Martin 10-gallon Tank S/N 005. Note Inter-dendritic Corrosion Path

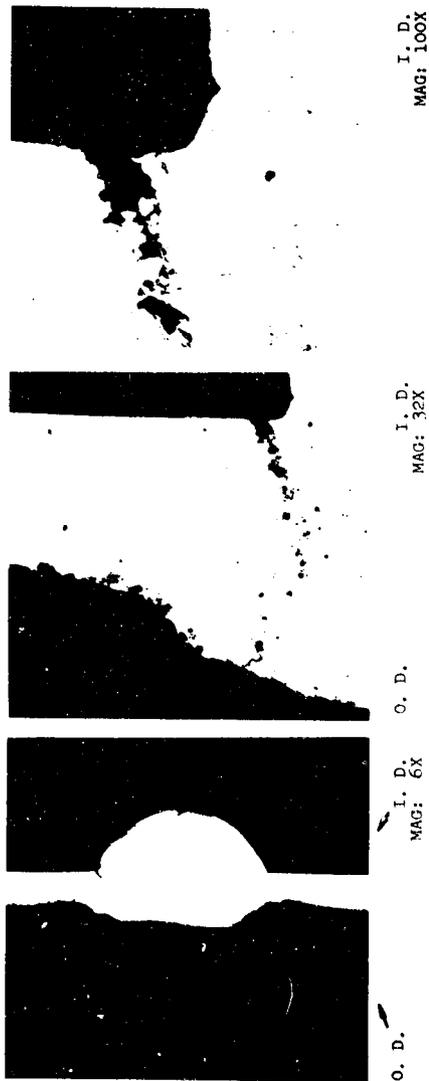
Figure 53. Cross Sections of Corrosion Leak Occurring at Edge-of-Weld in the 6061 Aluminum Inlet Tube of 2024 Aluminum Alloy Tank No. 1 (S/M9) used to Store ClF_5 Propellant for Eight Months

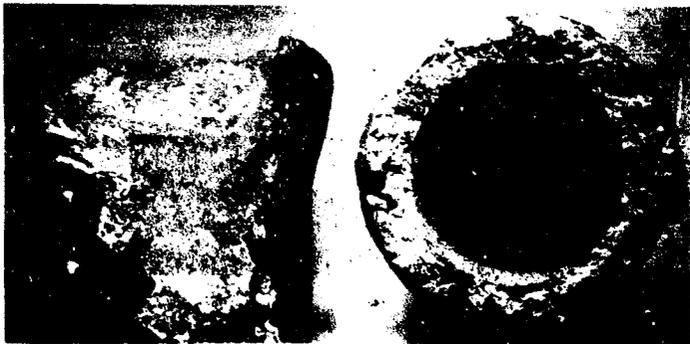
a. Side view of hole and weld joint showing fracture face

b. Close-up of fracture surface showing penetration from weld

Figure 1. Fracture of 6061 Al Tube to RPL
 After 2000 Hours of Operation in 10-gallon Tank
 at 1000 PSI, 1000 RPM, for
 Immediate Release

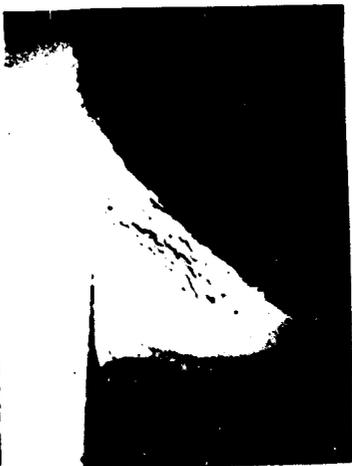
- a. Overall view showing corrosion. b. Cross section showing weld corrosion.

Figure 1. Corrosion Observed in Flange to Tube Weld of Martin 15-gallon Tank No. 1 after Six Months Exposure to ClP_3 .

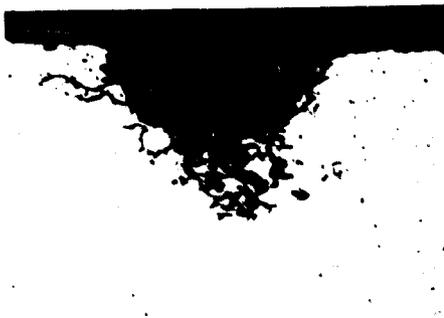
a. View of pitted surface near bottom pole of tank

b. Cross section of one of pits showing corrosion penetration of sealant barrier

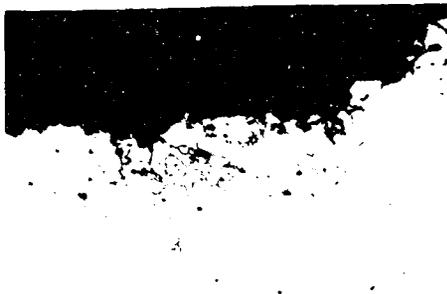
Figure 68. Cross Section of Typical Shallow Pit Seen on Internal Surface of 1-quart Aluminum Alloy Container S/N 19

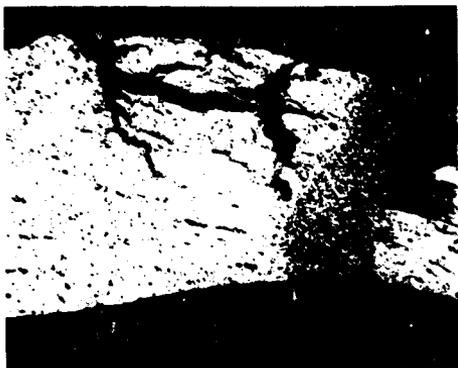
NOTE:
Origin of
attack is
on external
surface and is
concentrated in
weld metal near
edge of weld.
Crack at arrow
is shown in
Figure 76.

Figure 75. External Surface of Corroded and Perforated Weld
Showing Direction of Flow of Corrosion at Other Edge of Weld from
Perforation

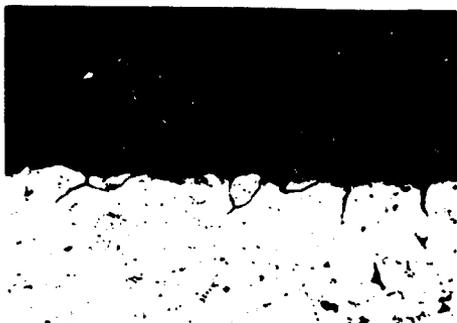
Note intergranular attack along surface

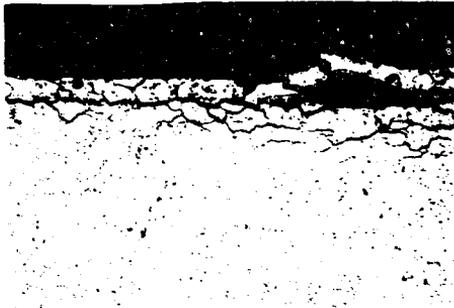
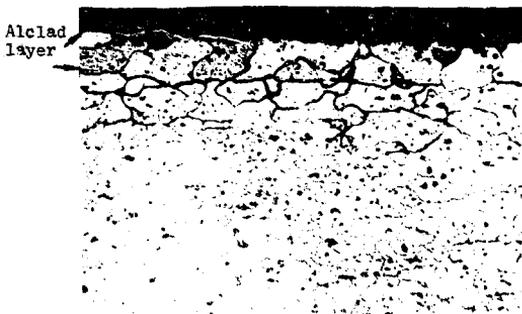
- a. Unetched view showing corrosion attack under Alclad layer causing lifting and loss of cladding in spots

Figure 81. Metallographic Sections Showing the Corrosion on the External Surface of the Solid State Bonded Tank

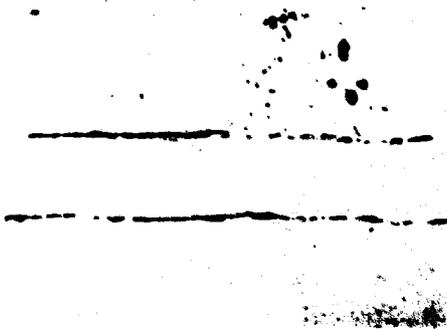
Figure 92. Smaller Discontinuities Observed in same Regulator Body Shown in Figure 91

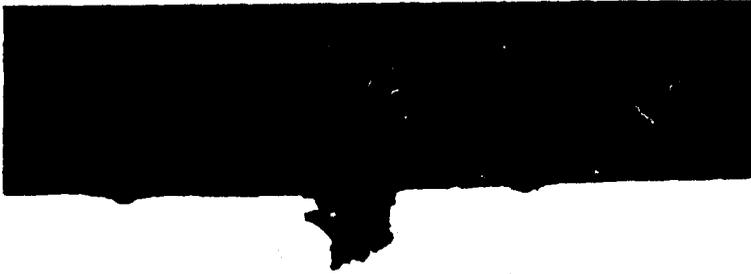
Figure 93. Cross Sections of Two of the Largest Stringers Observed in Regulator Valve Bodies Removed from Storable Prepackaged Propellant Systems

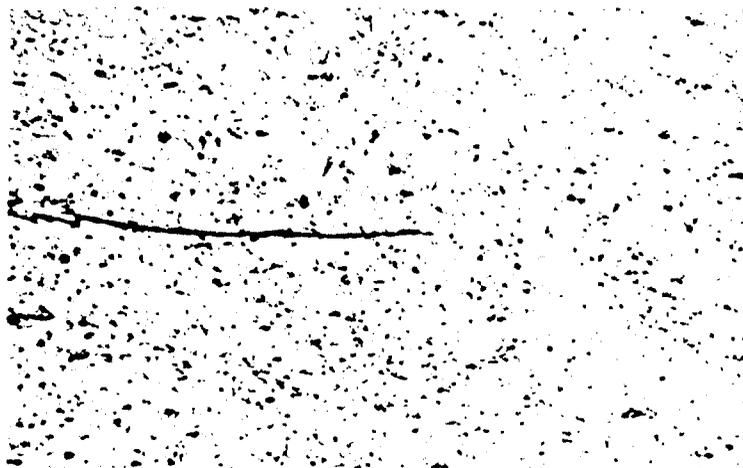
- b. Unetched view showing transition from unbonded to bonded region
