EXPLOSIVE TESTS OF BLAST CELL,
NAVAL TORPEDO STATION, BANGOR ANNEX

J. M. Ferritto

Technical Report

R 823

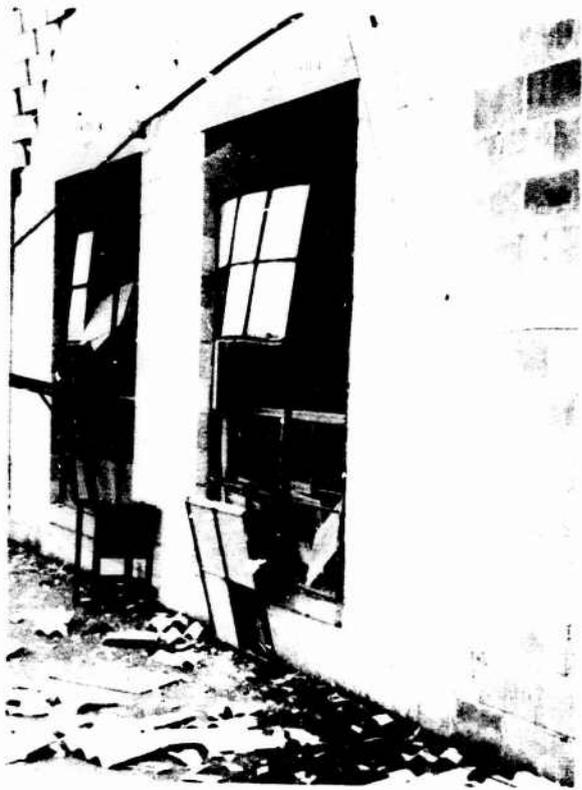
Exterior view of movement of exterior wall.

Figure 7 (cont).

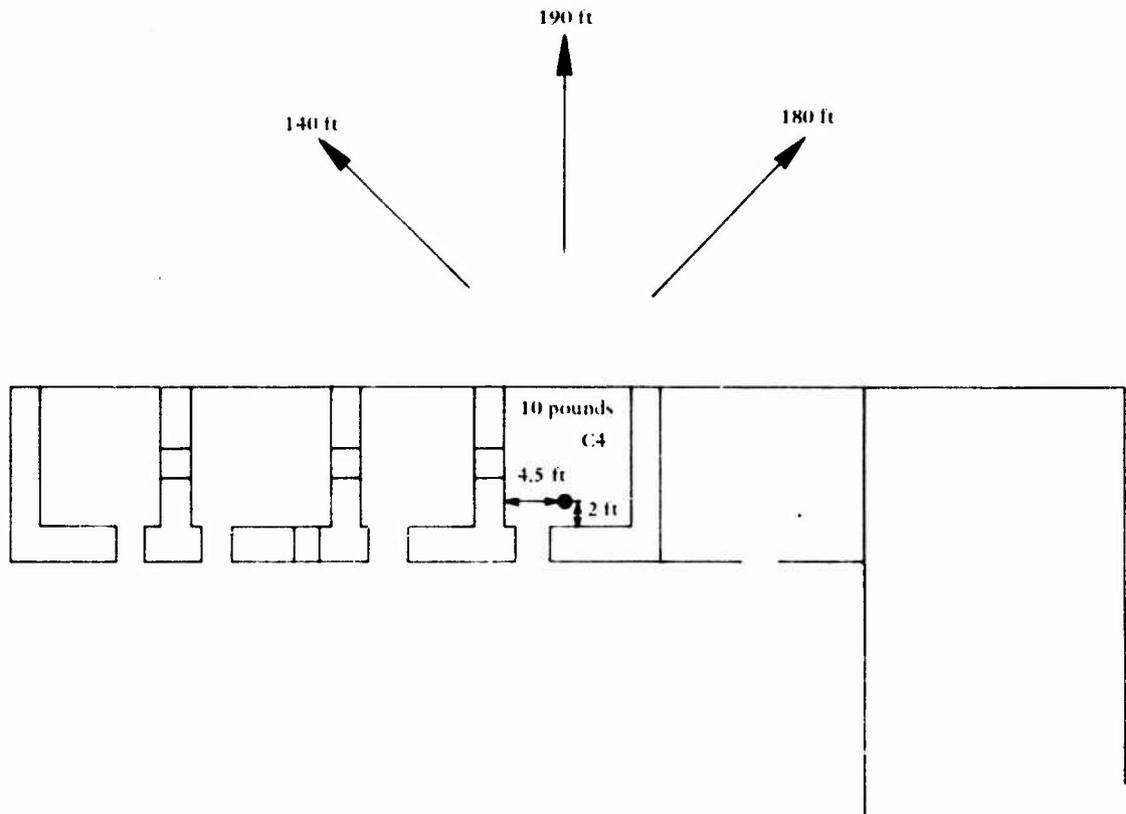
explosive was centered between the sidewalls, 2 feet from the backwall. Figure 8 indicates the distance debris was blown from the building. The roof over all the blast cells was blown off. The ceiling of the cell test was blown out. The debris grating in the adjacent cell was still in place although it had become dislodged from its supports. It did catch much of the ceiling blown down; however, the debris grating in cell 3 failed. The debris grating in cell 4 remained and functioned satisfactorily, catching the ceiling blown down.

Figure 8. Distance of travel of building debris, shot 1.

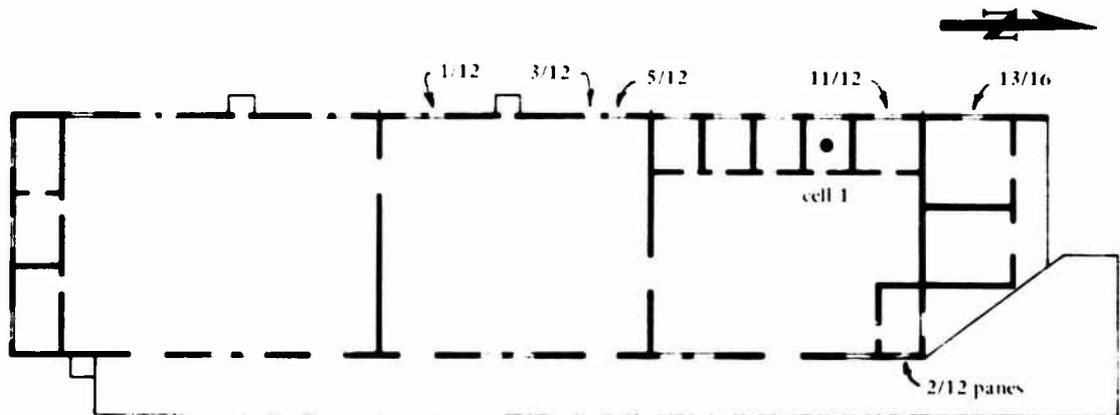
The windows in cells 3 and 4 were blown outward, indicating the pressure spilled over the sidewall across the structure into those cells, rather than out the frangible window wall of the cell and around which would cause the windows to be blown inward. The roof over the pump room adjacent to cell 1 was blown inward; the reinforced masonry block wall of the pump room was deflected outward several inches. The roofing behind the cell had been cracked in places but remained intact. No spalling was observed in this test or any subsequent test.

Figure 9. Window breakage from shot 1. Definition of numbers: 1/12 = of twelve original intact panes, one pane was broken.

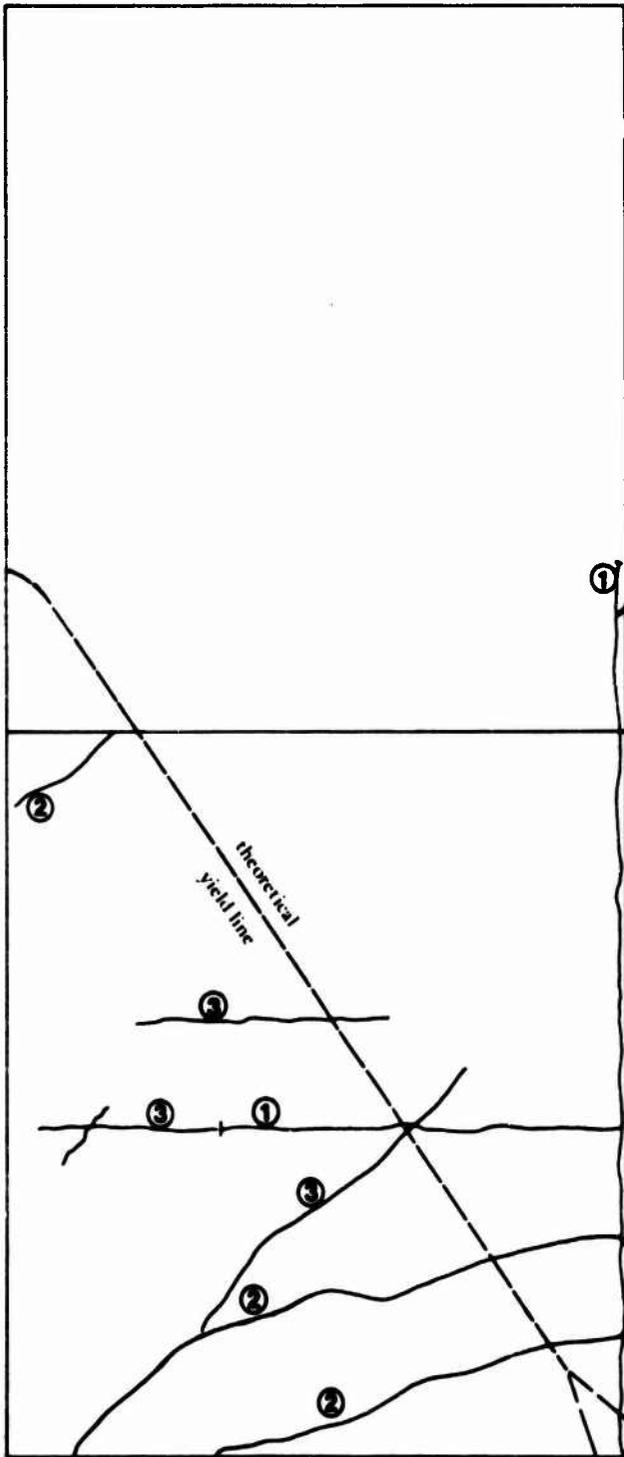
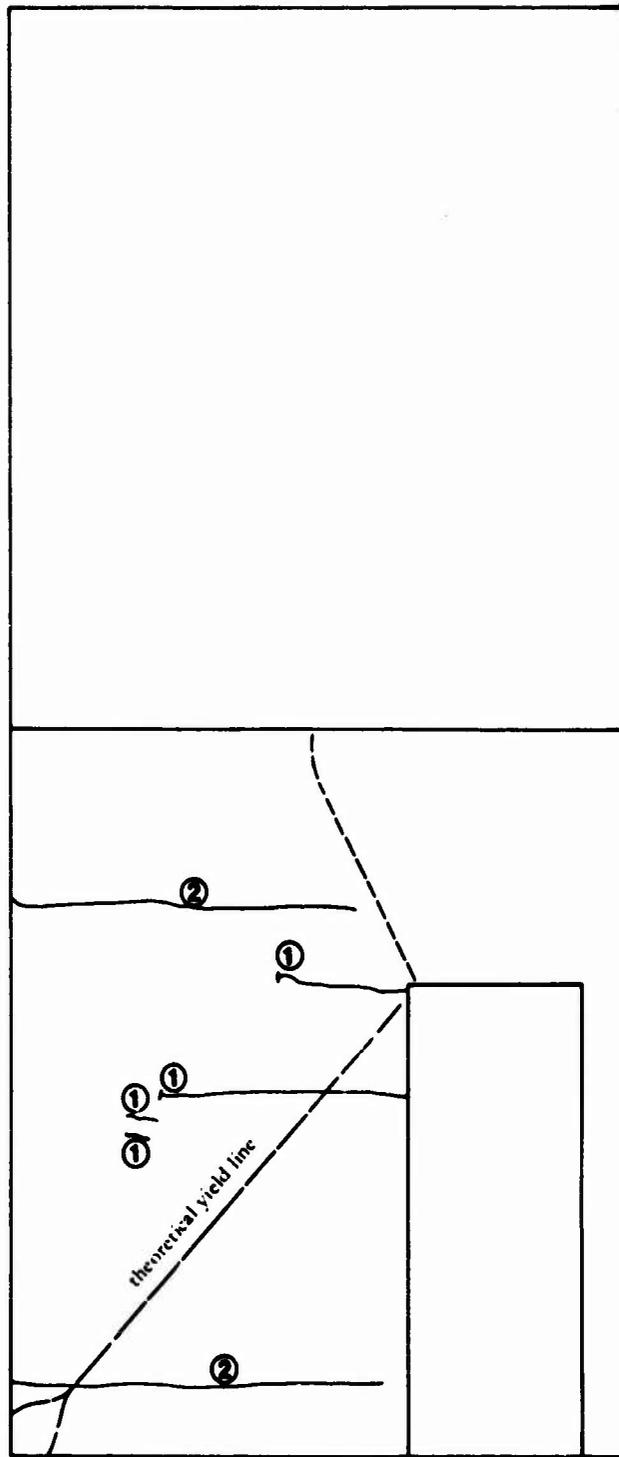
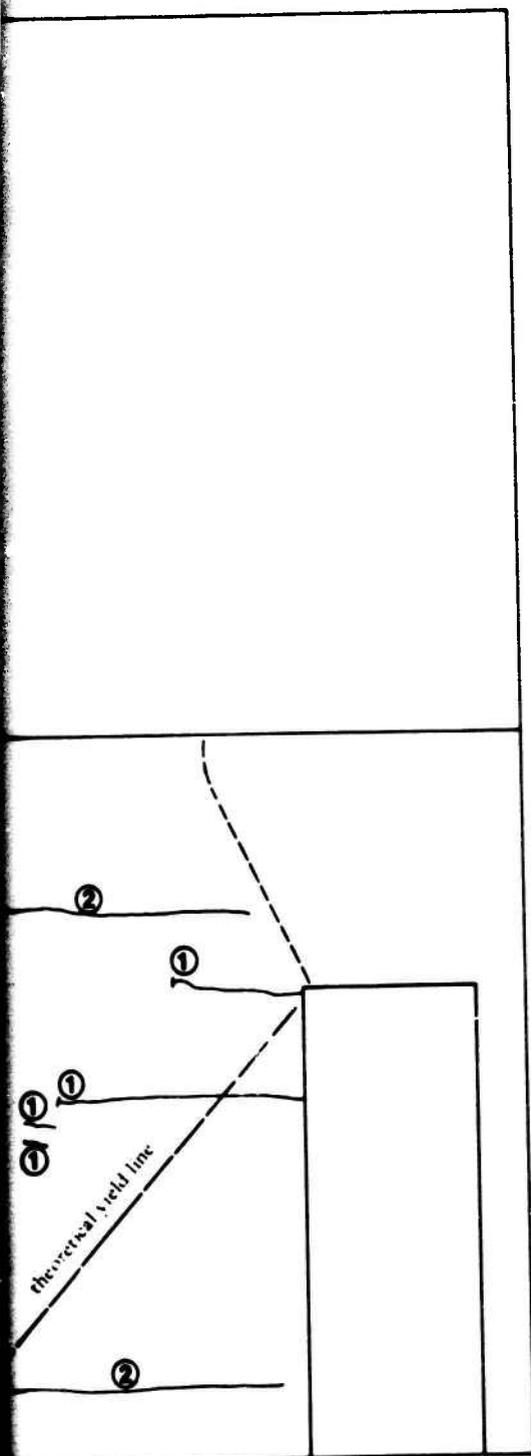
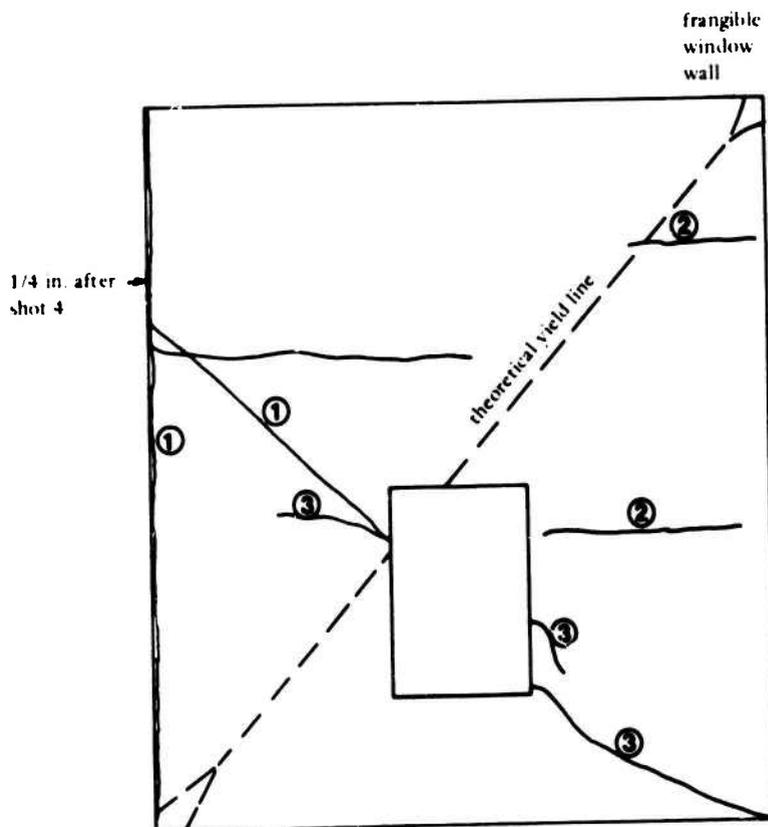
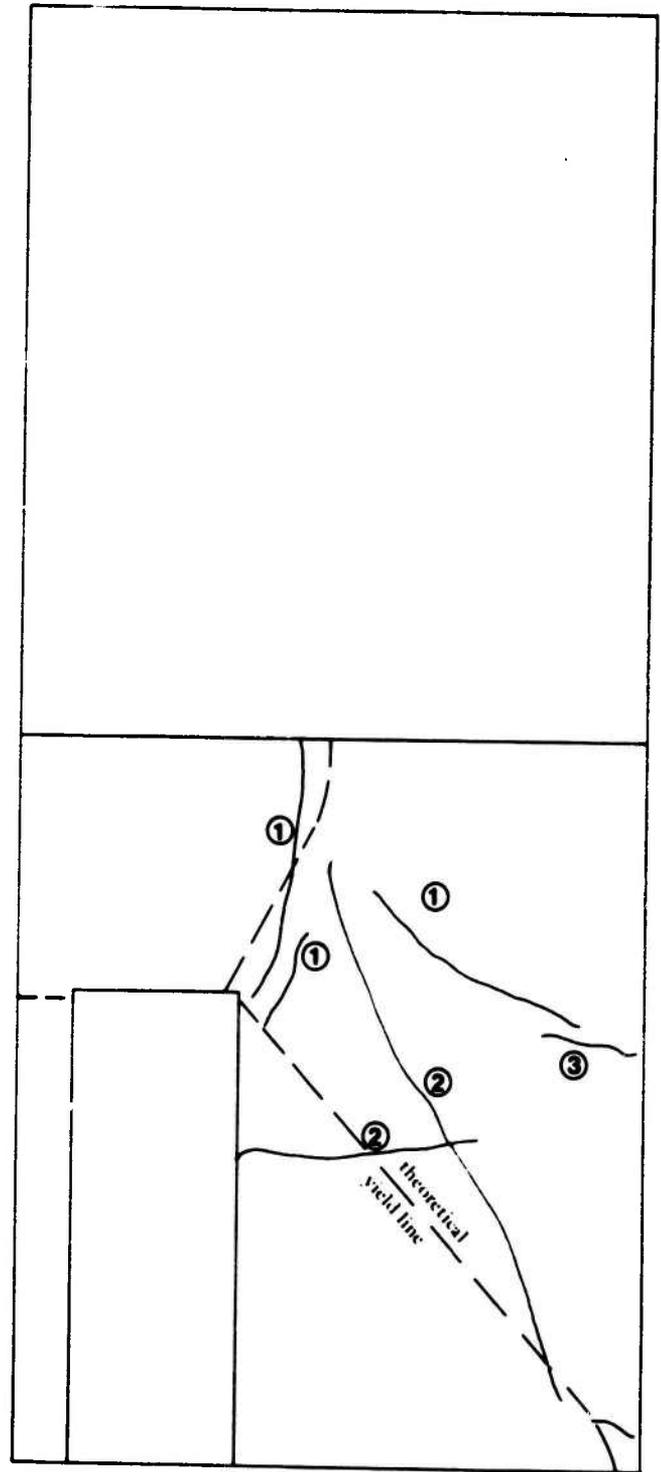
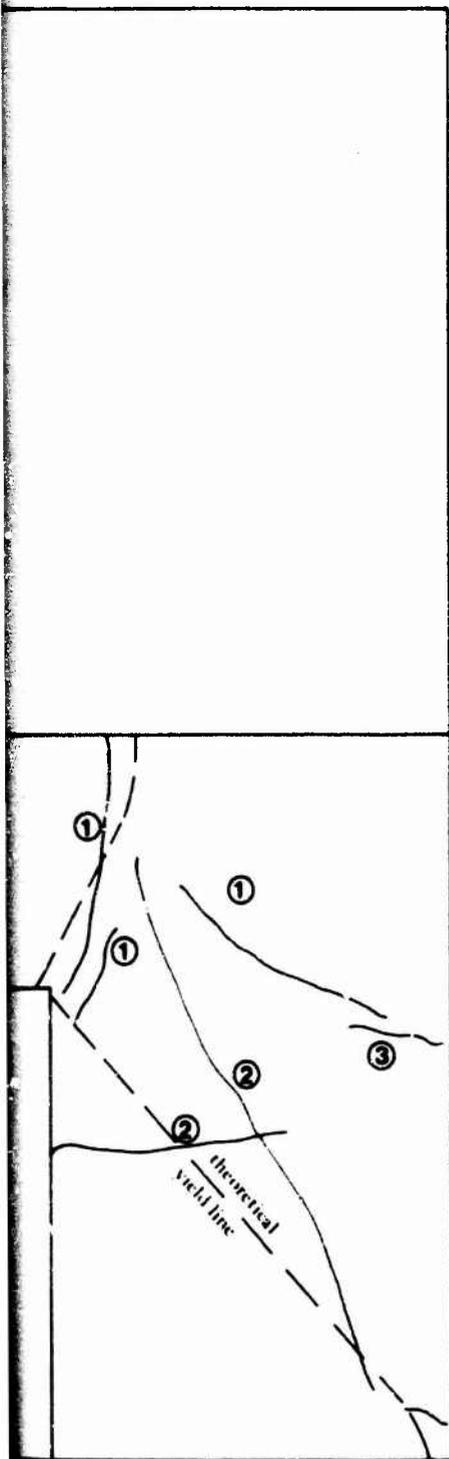
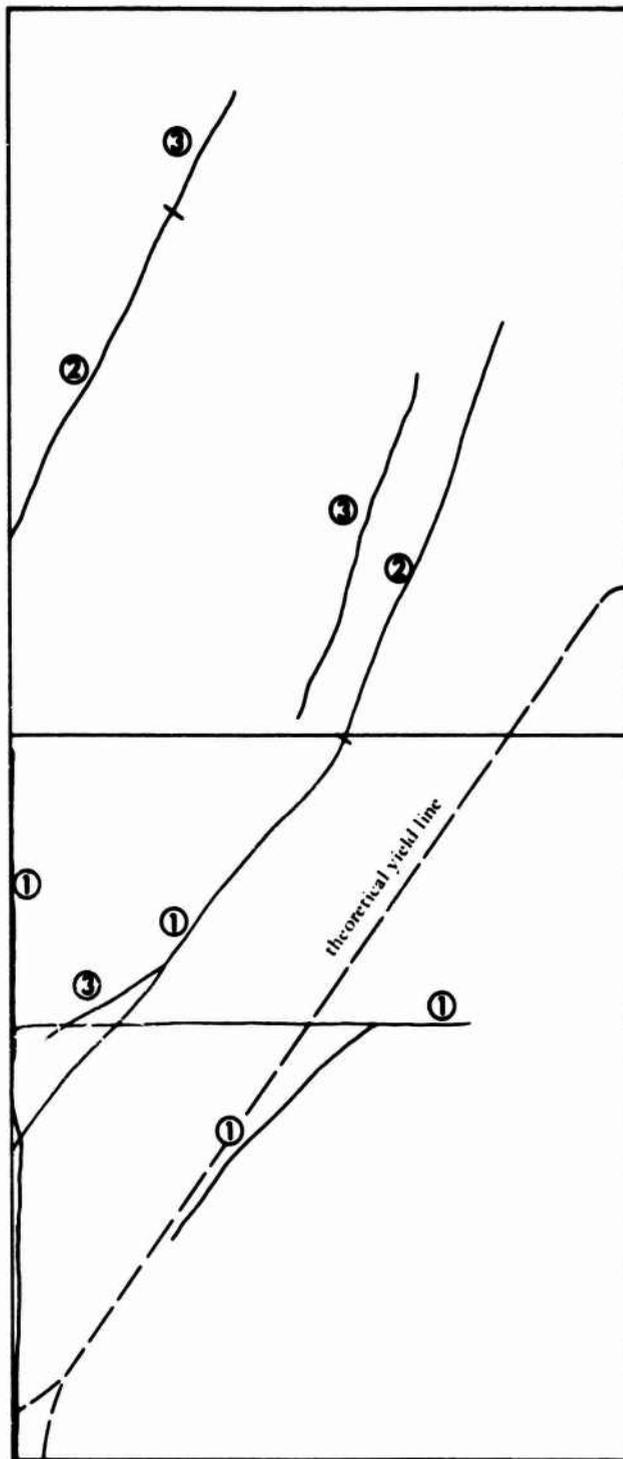
Figure 10. Crack patterns in walls of cell 1 after 10-pound detonation.

Permanent deflections of the sidewalls were measured to be about 3/16 inch outward. No permanent deflection could be measured in the blast door or passthrough door. Window breakage is shown in Figure 9. Figure 10 shows the crack pattern observed in the blast cell walls. The numbers correspond to shot numbers. No evidence was observed of shear failure of the door frame.

1/4 in. after
shot 4

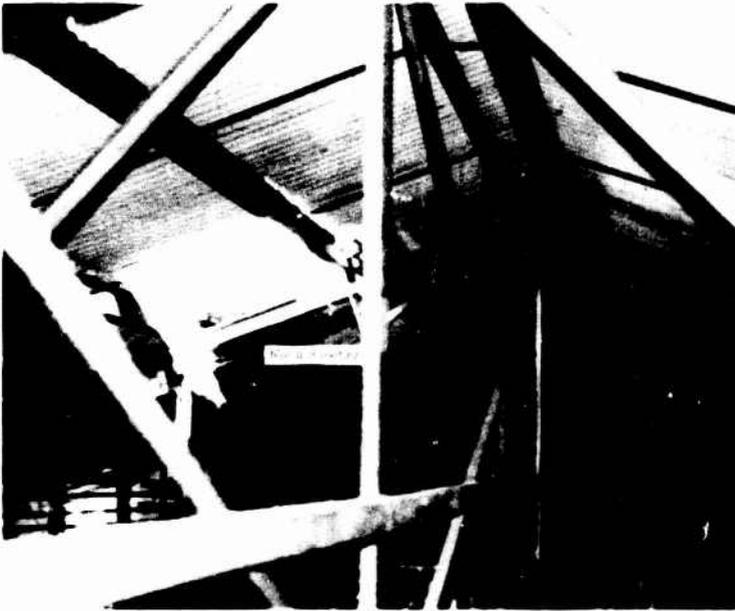
Shot 2 - 10 Pounds, Cell 1. For the second shot the explosive was centered between the sidewalls and between the backwall and window. This shot caused a section of the roofing behind the blast cell to be blown inward (Figure 11). Additional roofing was blown in over the pump room. The passthrough door on the sidewall rebounded off its supports, however, the door on the other side of the wall was still intact. The blast door, although still adequately supported, failed its bottom support guides by outward rebound. Roof failure was noted in the northwest portion of the middle bay. Minor amounts of ceiling were blown down. Figure 10 shows the additional cracking of the cell walls. No measurable additional permanent deflection was noted. The door to the pump room from the main room behind the cells was blown into the building by pressure spilling over the cell wall.

Interior roof damage facing north.

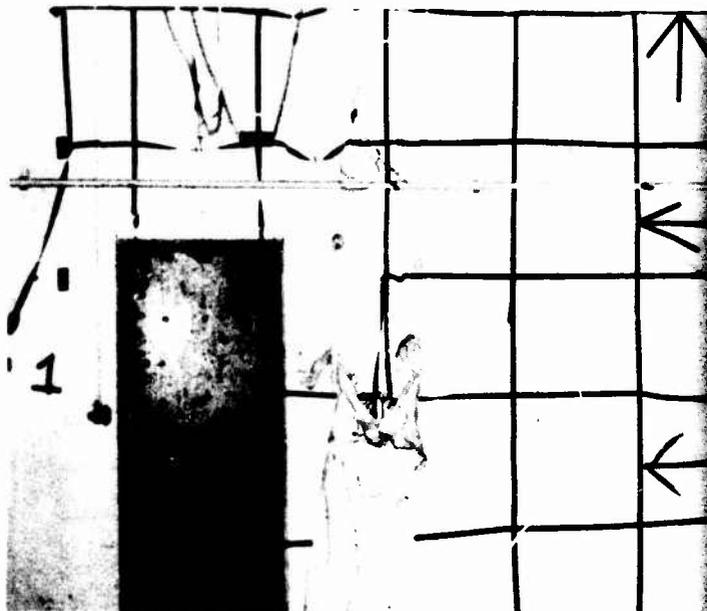
Crack in cell walls.

Figure 11. Observed damage after shot 2.

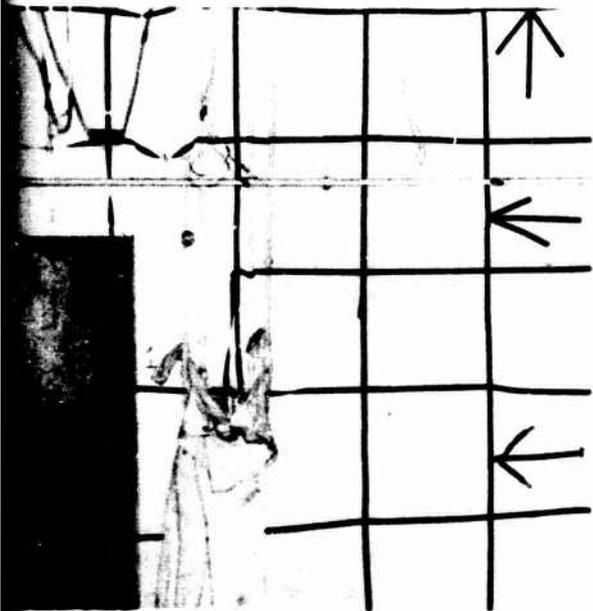
Crack in cell walls.

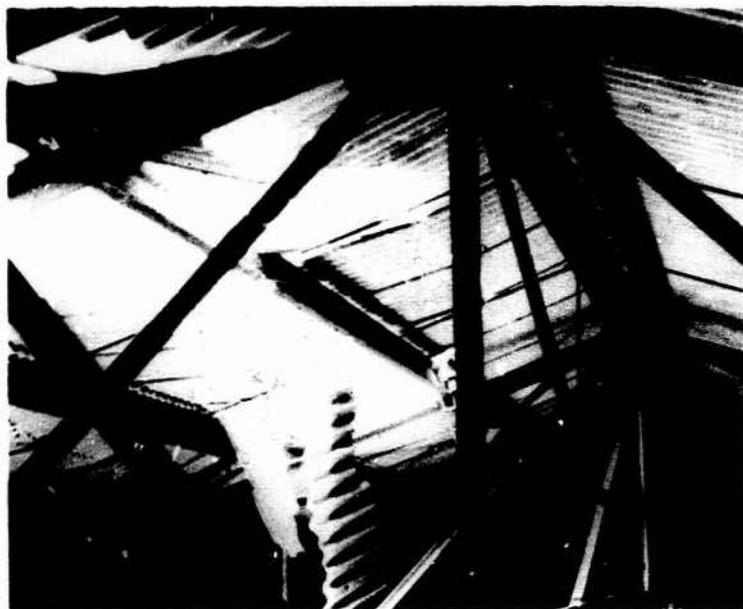
Interior roof failure.

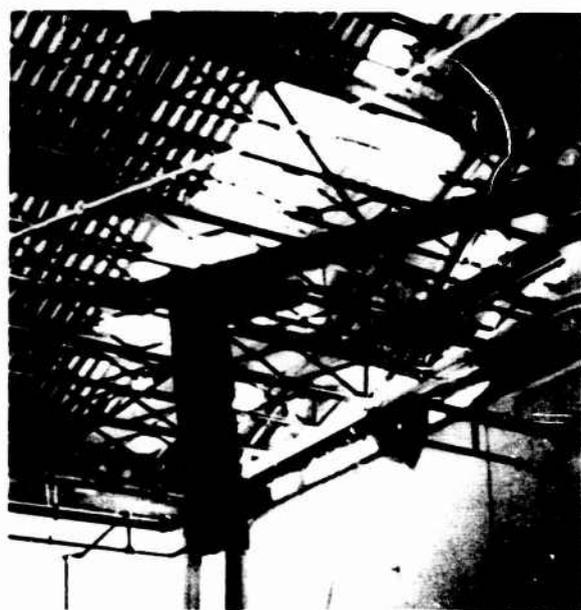
Roof damage of middle bay.

Figure 12. Observed damage after shot 3.

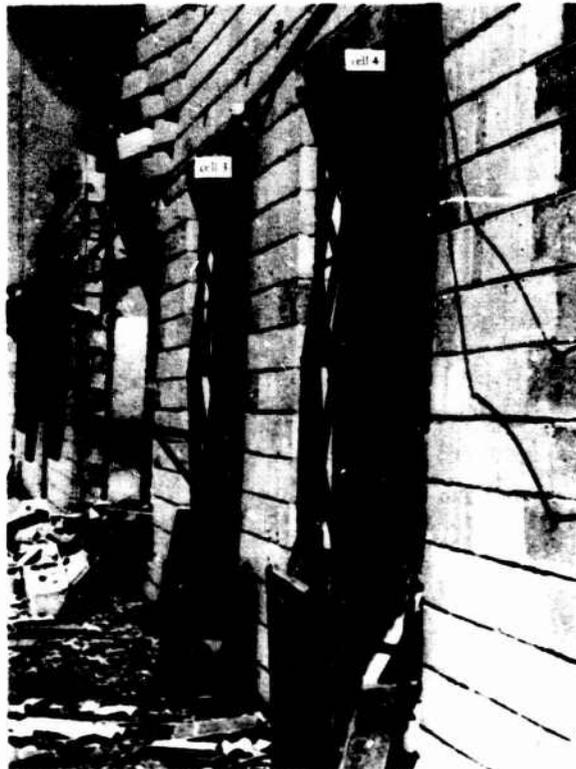
Exterior wall damage looking north.

Observed damage after shot 4.

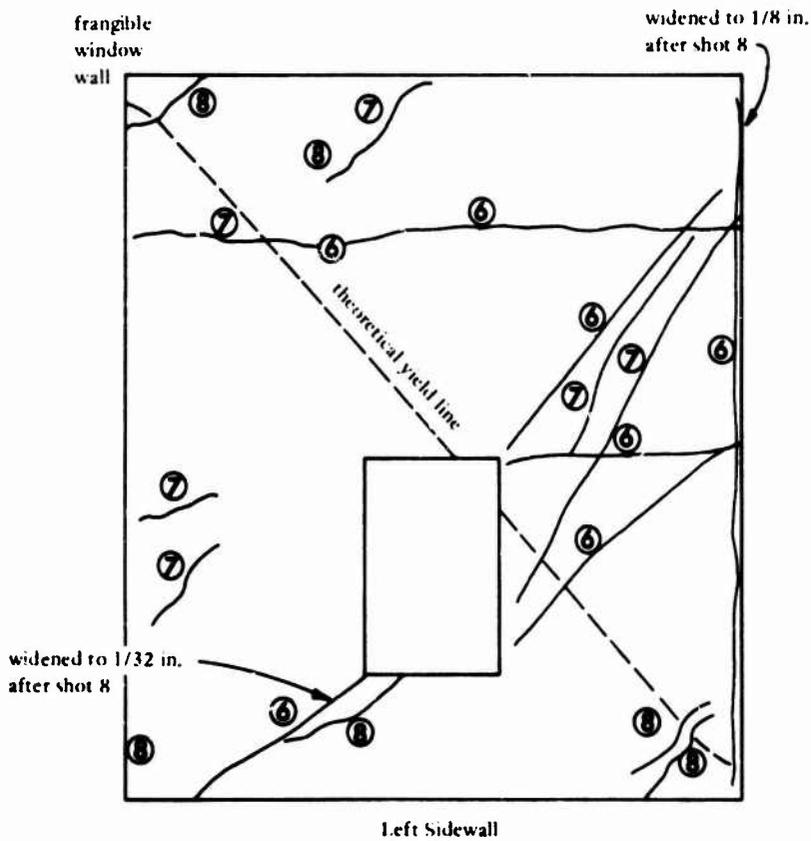
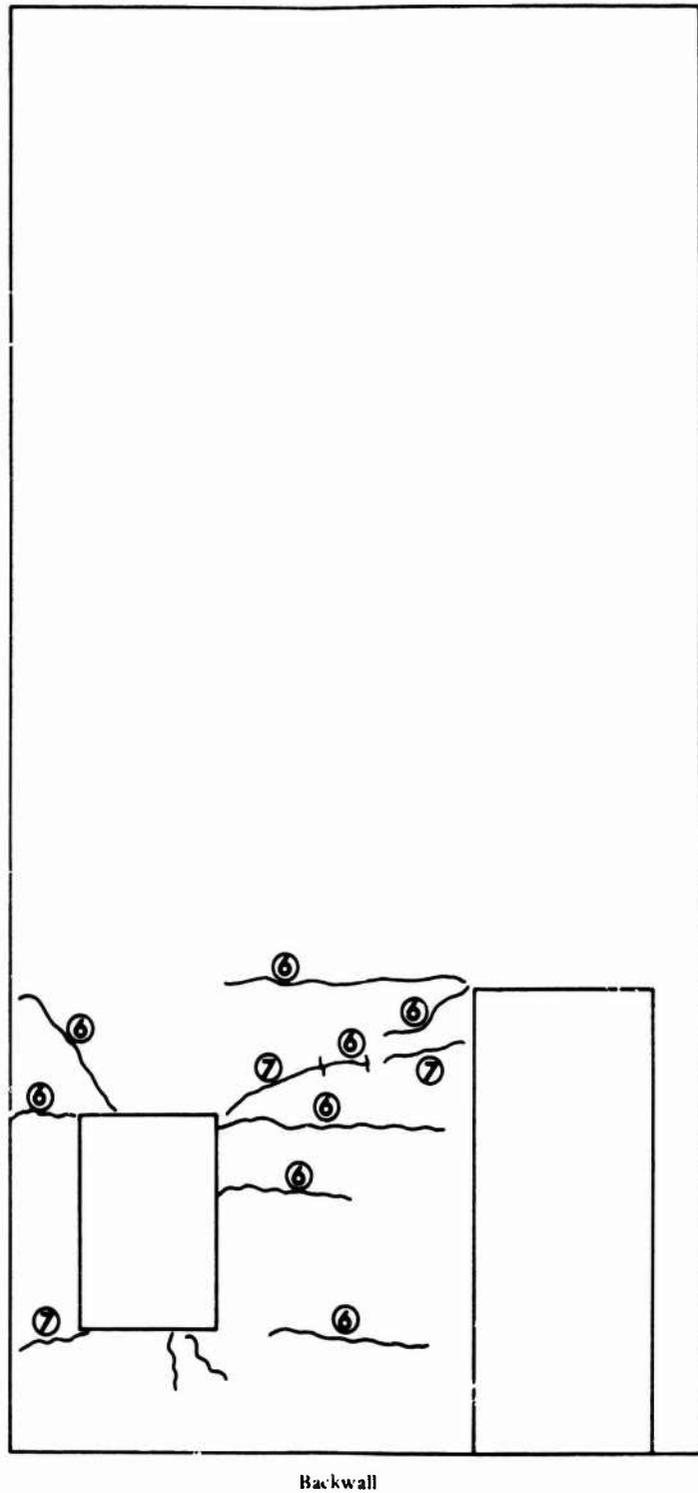
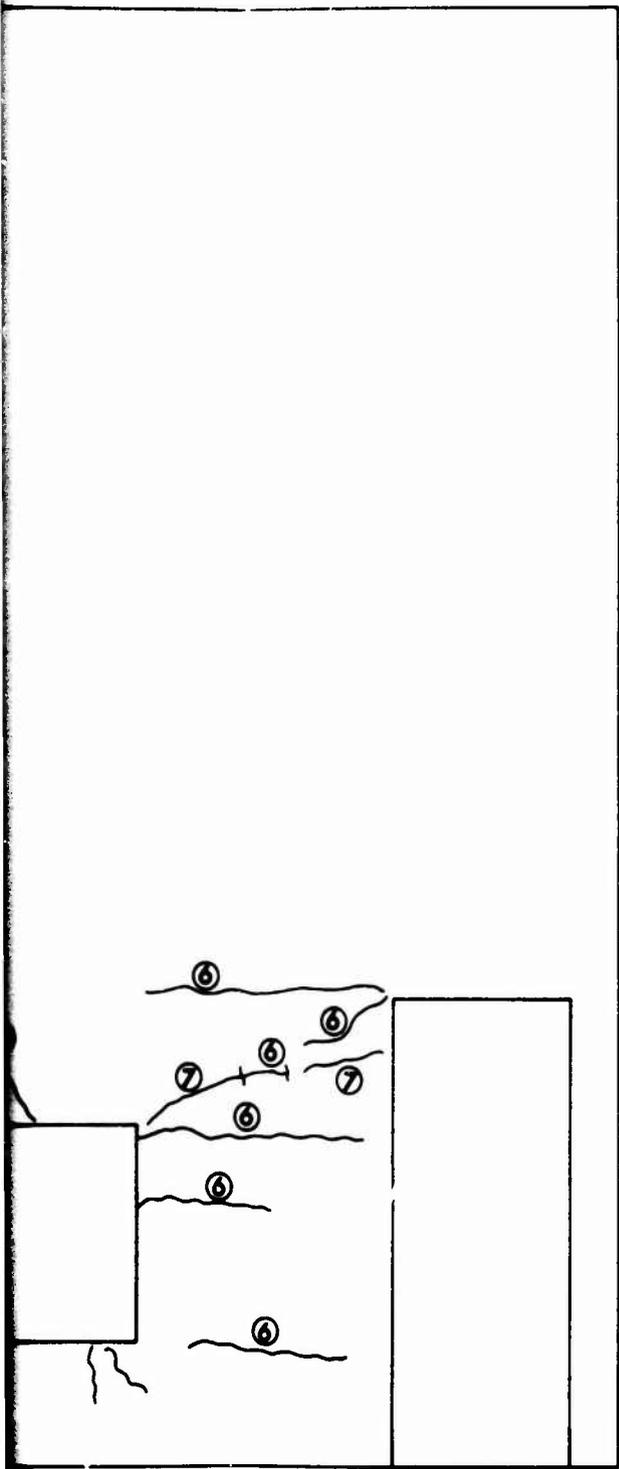
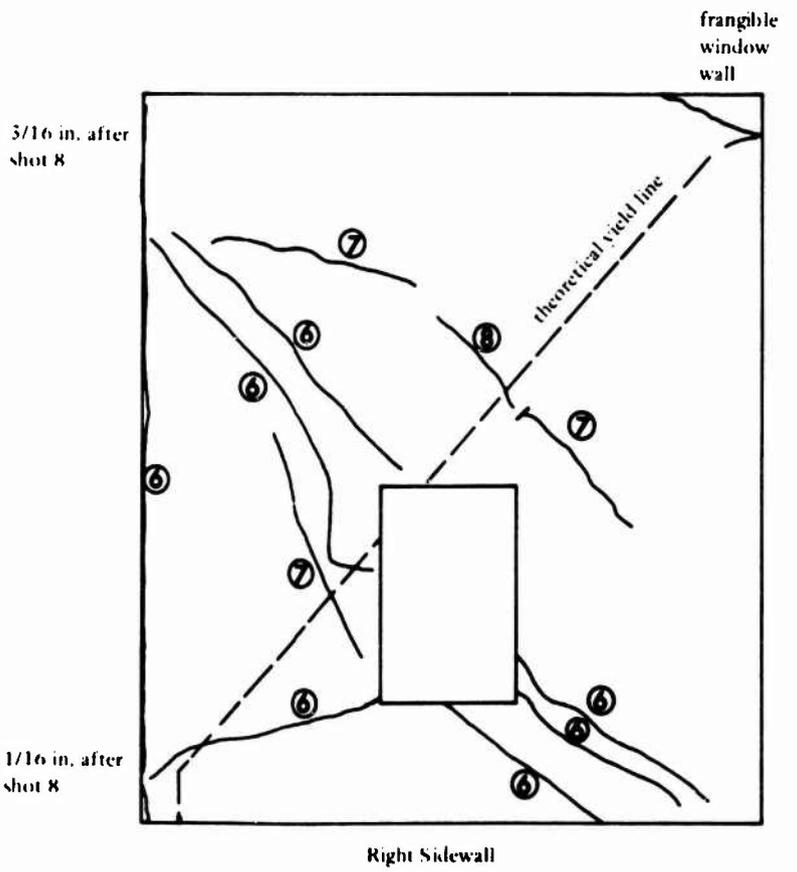
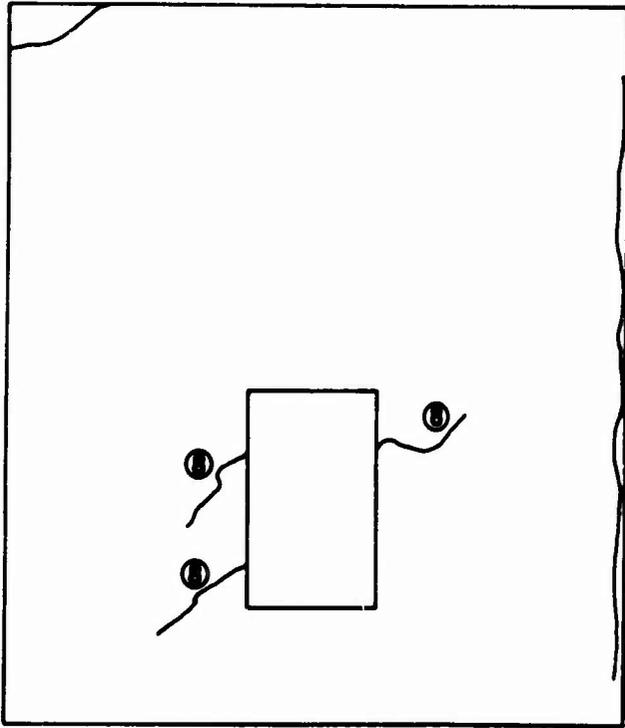
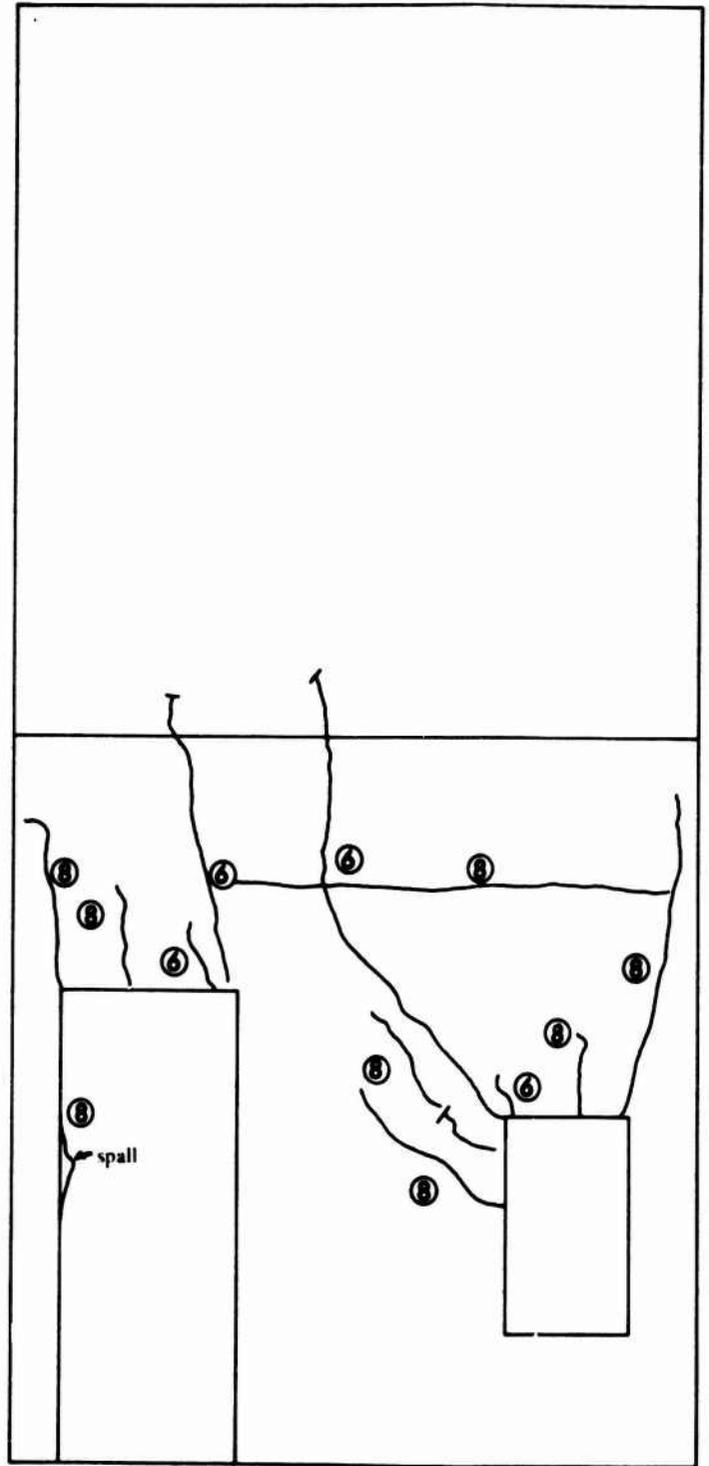
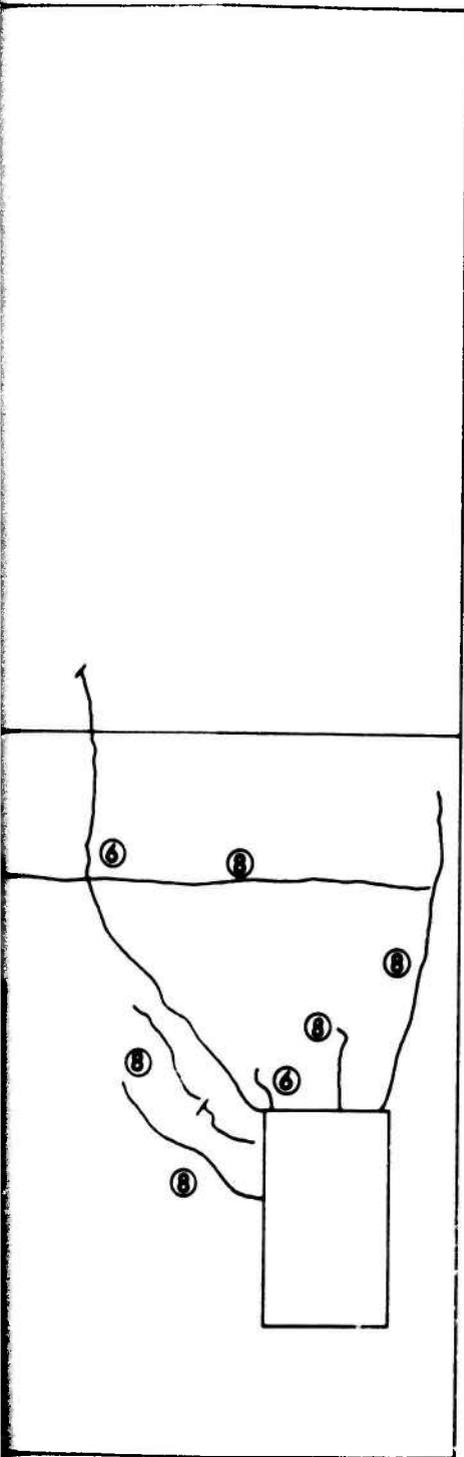
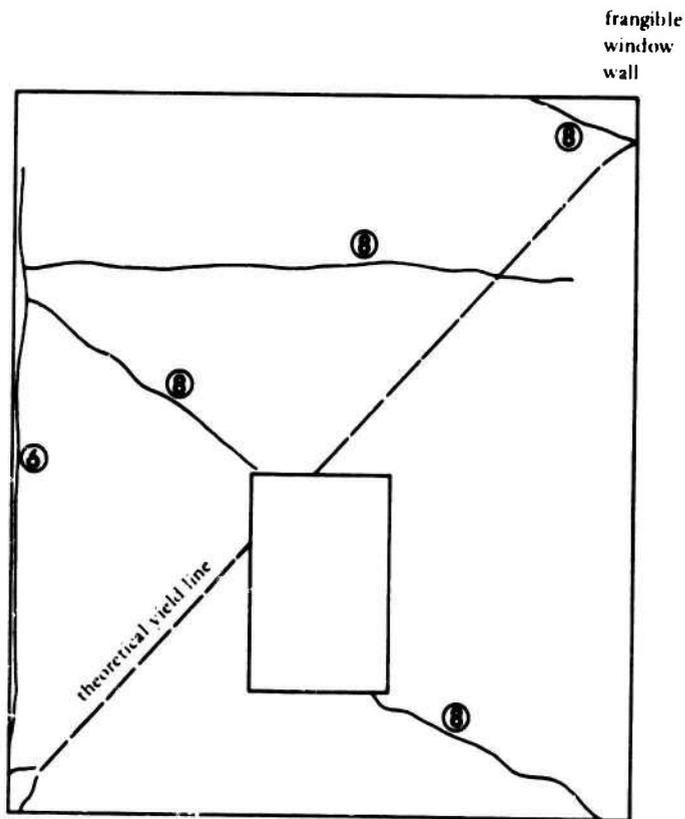
Figure 15. Crack patterns in the walls of cell 3 after 20-pound detonation

door was still operable. Figure 14 shows photographs after the shot; Figure 15 shows cracks in the cell walls. Window breakage is shown in Figure 16.

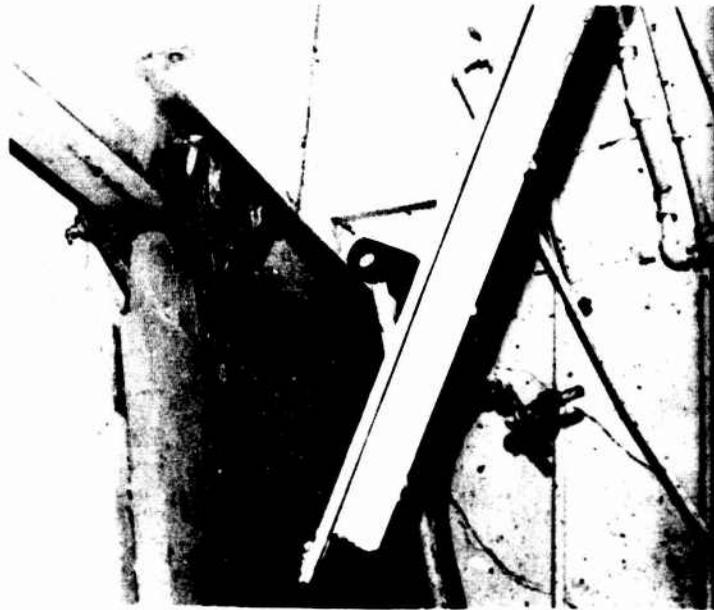
Shot 7—20 Pounds, Cell 3. This was the second shot of 20 pounds in cell 3. The charge was positioned 2 feet from the backwall and 2 feet from the sidewall between cells 3 and 2. Some roofing in the middle bay was blown in. Portions of roofing cracked by earlier shots failed. Additional ceiling was blown down; however, most of the roof on the leeward side of the building (east side) was still in place. The blast cell sidewalls had an additional permanent deflection of about 5/32-inch. The passthrough door in the backwall rebounded off its supports. This 2-by-3-foot, 1-inch-thick steel plate has a permanent deformation of 1/2 inch at its center. The blast door was still operable with no measurable permanent deflection. The rebound supports failed. Figure 17 shows photographs after the shot.

Blast door cell 3.

Figure 17. Observed damage after shot 7.

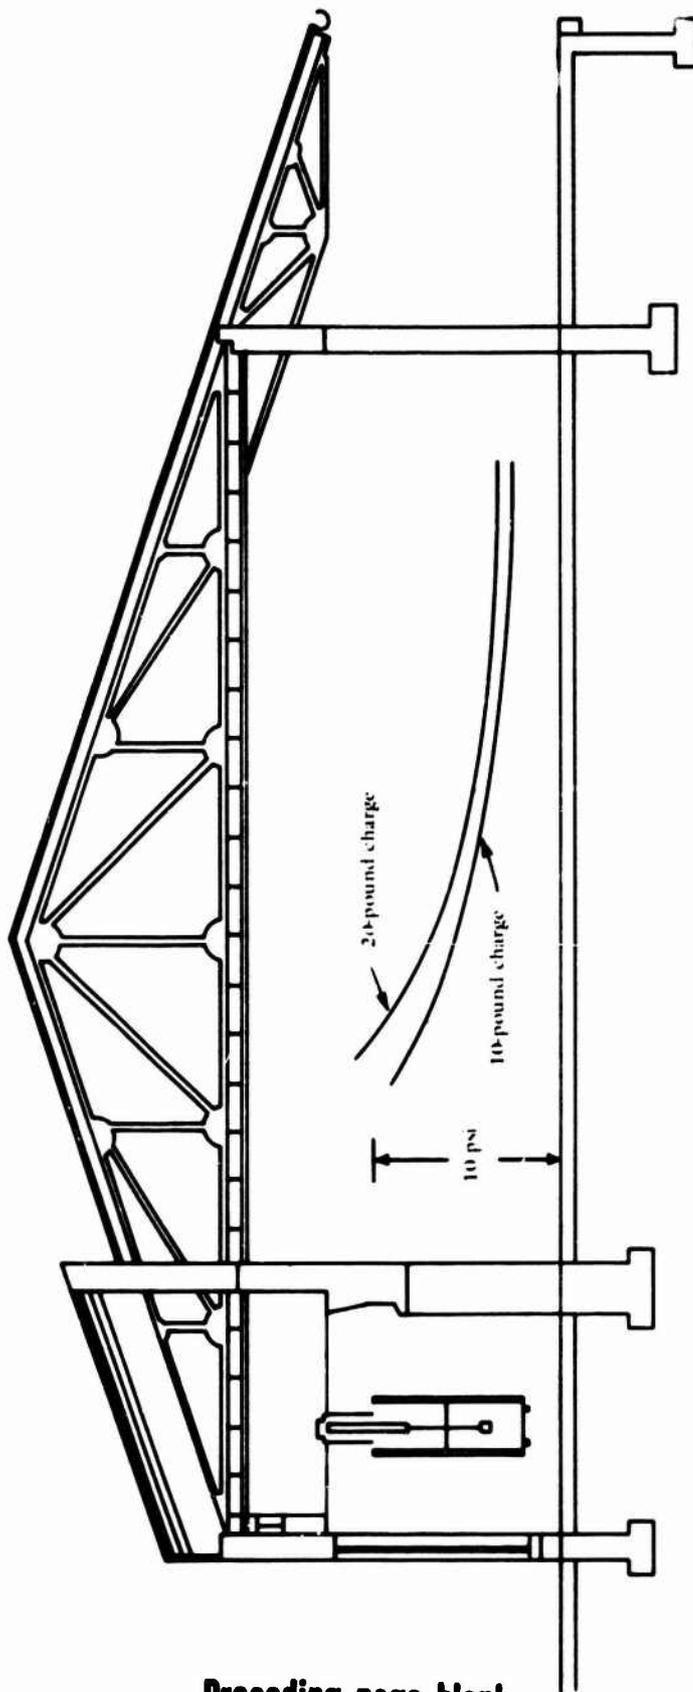
Data was reduced and peak pressures obtained. Figures 18 and 19 give the peak pressure on the floor from an average of the 10- and 20-pound tests. This pressure was caused by leakage around the blast door. It is of a high enough level to cause injury. Figure 20 gives the pressure at the ceiling level. Figure 21 gives the pressure on the roof. As noted in Figures 20 and 21, the pressure immediately behind the back wall of the blast cell is higher when the roof is in place over the cell. This is understandable in that the frangible roof remains intact long enough to deflect the pressure wave downward. This would not occur if the roof were not there. Figure 22 shows this, if a roof over the cell does not exist, the shock wave will travel upward, leaving a low-pressure area immediately behind the cell.

The leakage pressure around the blast doors is probably the most serious deficiency noted in the test and affects most existing facilities. Figure 18 shows the pressure levels. Reference 3 gives the following:

An operator standing behind the backwall would receive threshold lung damage. Personnel in adjacent cells would also receive threshold lung damage.

Figure 18. Peak pressure at floor level.

1. The high pressures leaking out around the blast doors would injure an operator in the vicinity of the door. Proper seals must be used to protect personnel in the area immediately behind the doors.
2. Debris screens must be attached to substantial structural members which will remain in place.
3. The formation of yield lines used as the basis of the calculation of wall capacity should be investigated. The computation of wall stiffness should also be reviewed. Both of these areas can significantly influence the behavior of a wall, as noted in this test.
4. Conventional corrugated cement asbestos roofing can withstand up to 6-psi dynamic overpressure with only minor damage.
5. Areas of conventional construction adjacent to blast cells can survive reasonably well.
