SEAWATER CORROSION OF FASTENERS IN
VARIOUS STRUCTURAL MATERIALS

by
Harvey P. Hack

April 1976

Report 76-0034

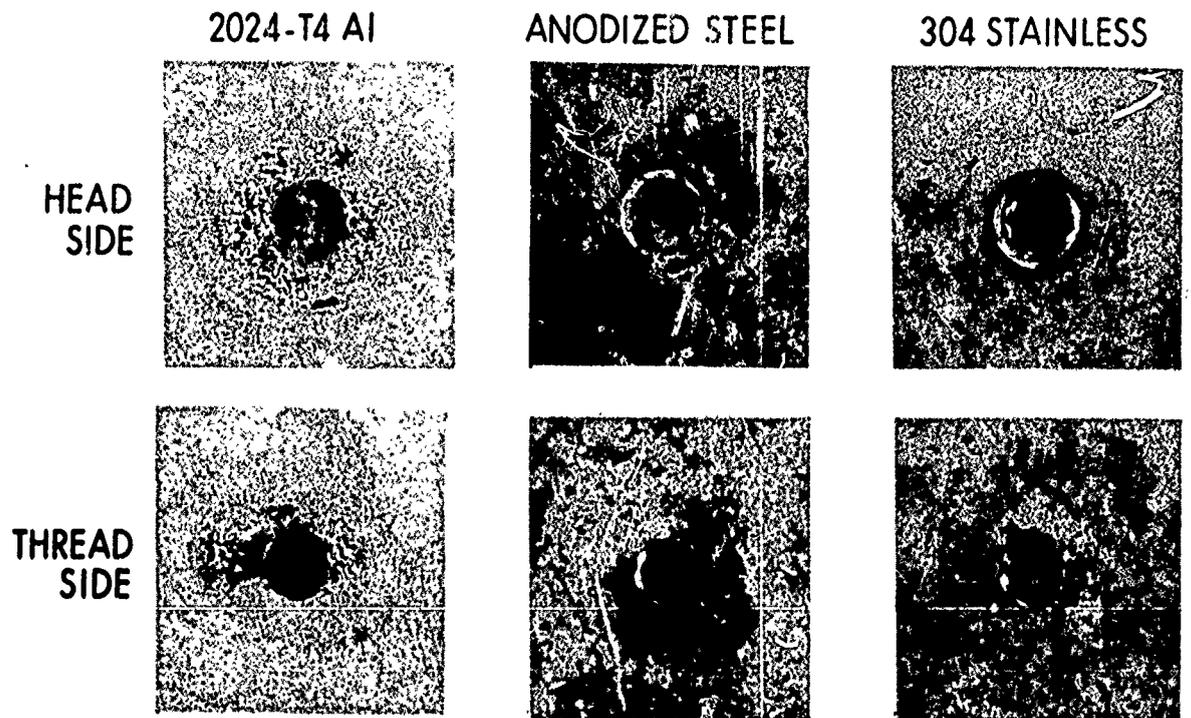
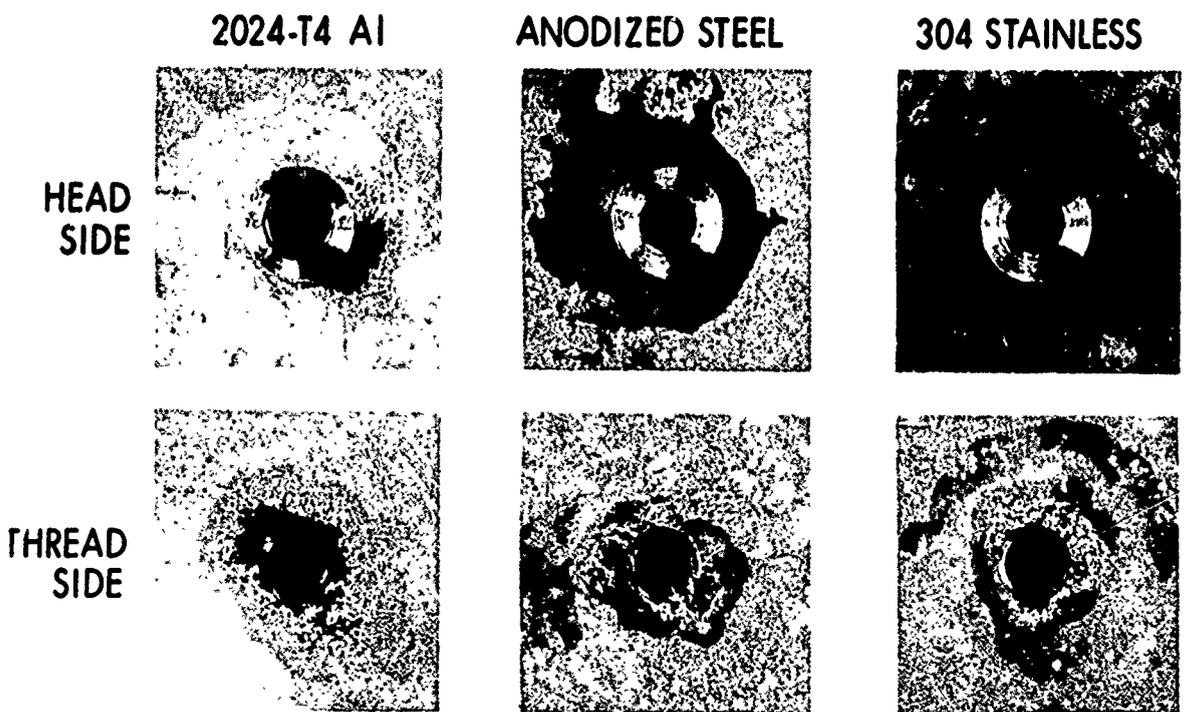
The corrosion attack on the aluminum panels was usually in the form of mild pitting and local attack at the plate edges. Also present was a mild-to-intense form of localized intergranular attack, up to 3/16 inches (5 mm) deep at the bolt hole. This attack is shown for both front and back of each panel in figure 3.

It is not surprising that most of the aluminum panels which had bolts of the materials more noble than aluminum (steel, the stainless steels, A286, MP35N and titanium) experienced galvanic attack. However, the panel with aluminum bolts also experienced very intense galvanic attack at the bolt holes. It should be noted that 2024 aluminum is slightly more noble than 5456 aluminum. The intensity of the attack on the panels did not appear to be related to the relative position of the bolt material in the electromotive series, as the most intense attack took place on the panels with aluminum bolts and the least attack took place on the panels with A286 bolts. Use of the sealant tended to reduce galvanic attack near the bolt head but had no systematic effect on the attack on the opposite side of the panels near the threaded shank, where sealant had not accumulated.

Use of a sealant material is highly recommended for aluminum alloy 5456 structures as this material appears to reduce the localized galvanic attack on the structure. Bolts of 2024 aluminum are not recommended as they will pit significantly. All of the other bolt materials in this study, although not suffering degradation themselves, could cause localized galvanic attack of the structure. They should be considered only if a form of corrosion protection, such as painting, liberal use of sealant to cover the entire bolt, or cathodic protection, is employed.

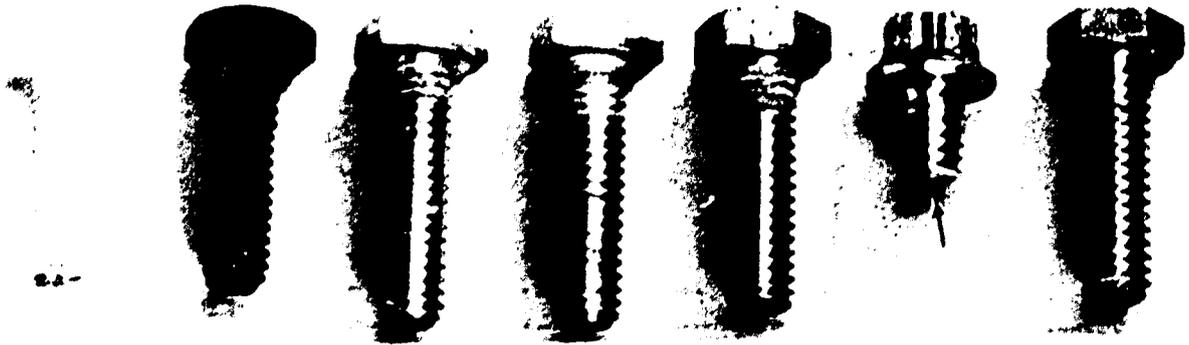
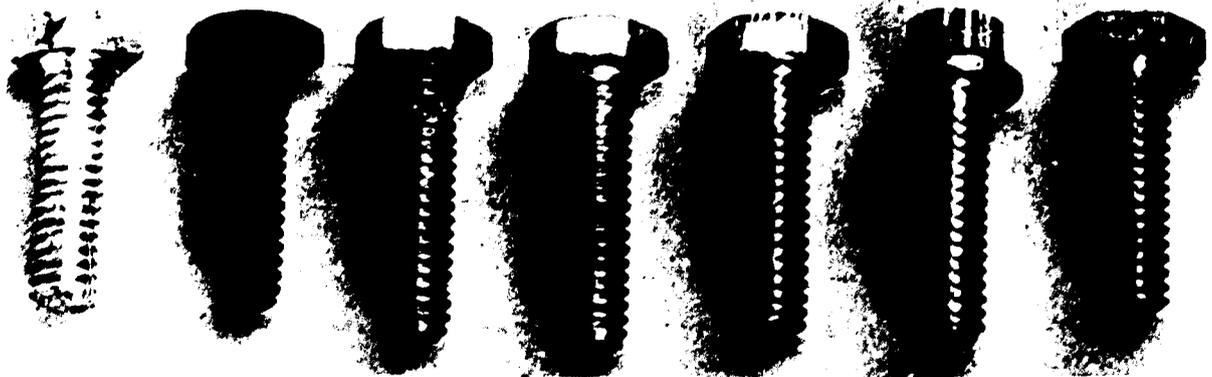
Figure 12
Corrosion Attack on Bolts in Fiber Glass Panels
(Arrow Indicates Mechanical Damage)

Figure 12 shows the corrosion attack on the bolts from the fiber glass panels. The aluminum bolts experienced pitting in the threads, especially at the cut end of the bolt, and intense pitting of the head of the bolt applied with sealant. Both steel bolts experienced a mild general attack, with some protection afforded under the sealant. The 304 stainless steel bolts suffered mild crevice attack which was somewhat reduced near the bolt head where sealant had been used. The 316 and A286 bolts suffered a mild crevice attack which amounted to only a slight etching. Use of the sealant completely eliminated this attack, however MP35N and titanium bolts were unaffected by the exposure.

Generally, use of a good sealant is recommended for bolting of fiber glass structures as it reduces the extent of crevice corrosion on the bolts subject to this type of attack. Both titanium and MP35N are highly recommended fastener materials for this application. The A286 and 316 stainless steels are subject to mild crevice corrosion but would probably perform satisfactorily. Crevice corrosion on 304 stainless steel is of sufficient magnitude to make this material unsuitable for this application. Steel bolts are generally easy to obtain and may be suitable for short exposures; however, the general corrosion rate for steel makes it unsuitable for long exposures. Aluminum alloy 2024 is subject to considerable pitting and is not recommended for use in fiber glass structures.

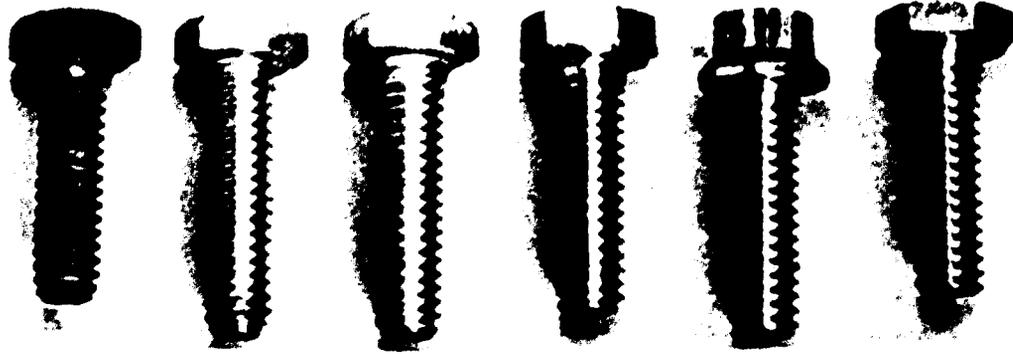
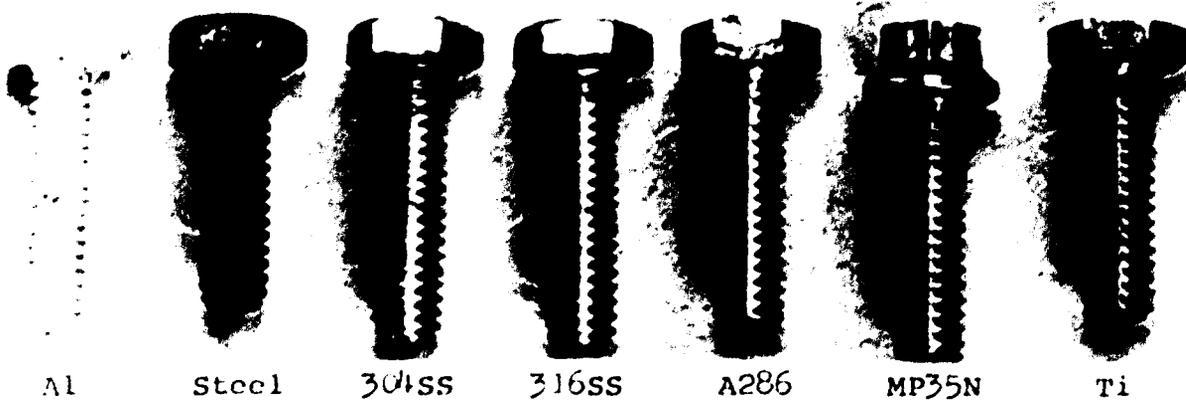
Figure 13
Corrosion Attack on Bolts in Aluminum Panels

Bolts in the aluminum panels, illustrated in figure 13, all received adequate galvanic protection to eliminate all corrosion attack with one exception. The aluminum bolt applied with sealant experienced intense pitting on the exposed threads. This was not expected, as 2024 aluminum is slightly cathodic to 5456 aluminum in seawater.

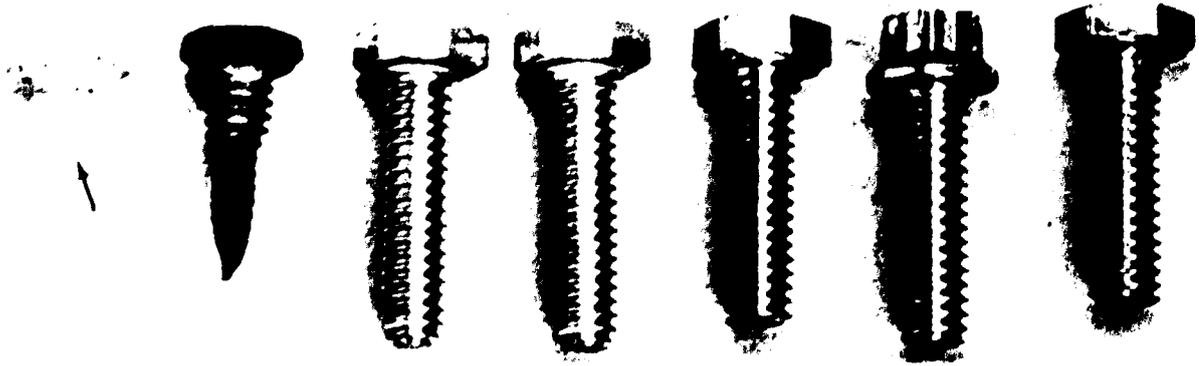
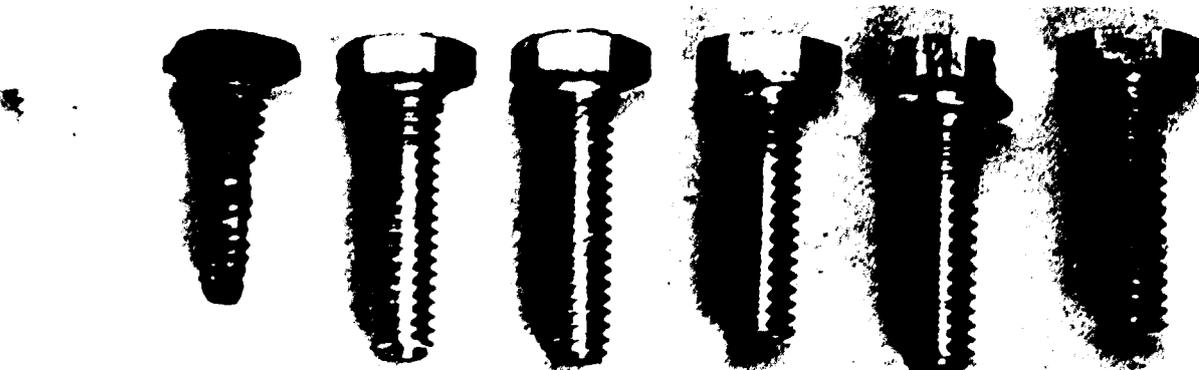
Figure 14
Corrosion Attack on Bolts in HY-130 Panels
(Arrow Indicates Mechanical Damage)

As can be seen in figure 14, all bolts, except those of aluminum and steel, received adequate galvanic protection from HY-130 panels to reduce their corrosion attack. The entire surface of the aluminum bolts, except that under the sealant, was uniformly pitted. The end of one of these bolts was broken off during the test. Although some galvanic corrosion of the steel bolts was expected, as they should have been slightly anodic to the 5Ni steel in seawater, the actual attack was much more intense than would be predicted. Although almost complete protection was afforded in the crevices, extensive corrosion attack occurred on the exposed surfaces.

Bolt sealant is also recommended for HY-130 steel structures as it appears to prevent localized attack under the bolt heads. Aluminum and steel fasteners are not recommended due to their high rate of galvanic corrosion. All other materials in this study appear to be satisfactory, from a corrosion standpoint, for this application.

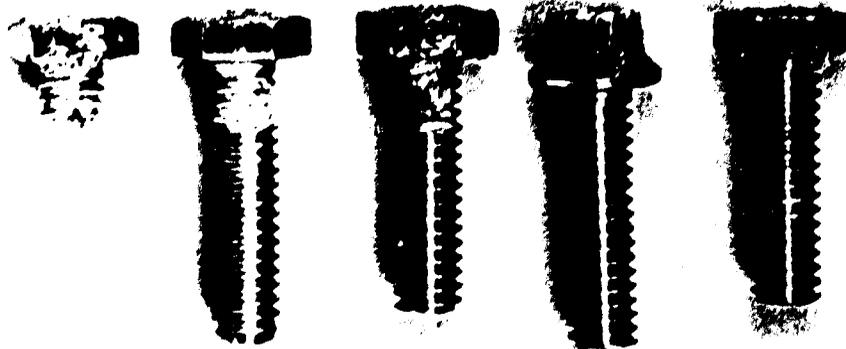
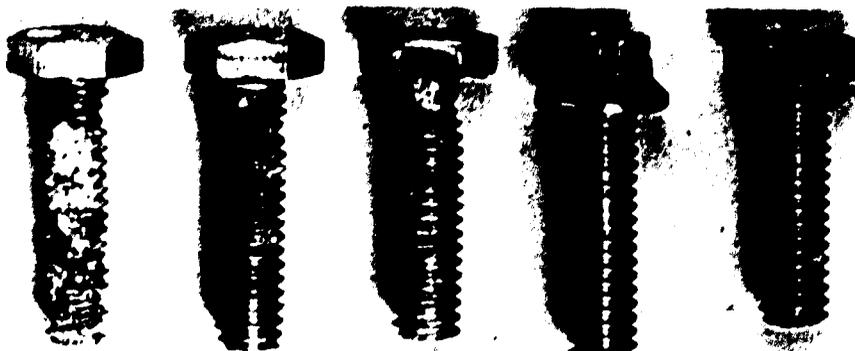
Figure 15
Corrosion Attack on Bolts in Titanium Panels

The titanium panels generally caused very extensive galvanic attack on the bolts, as seen in figure 15. The entire aluminum bolts, except for the areas in the crevices, were completely corroded away. The steel bolts were missing, and it can be deduced, since the threads in the panels were intact, that these bolts either corroded away completely or suffered sufficiently extensive attack to allow them to fall out of the panels. The 316 stainless steel bolts were riddled with holes, and the attack on the 304 stainless steel bolts, although limited to the threads in or near the crevice, was still quite intense. The only time in the entire test series where A286 experienced major attack was in these panels. This attack was most intense in the crevice area but was also very significant in the head of the bolt without sealant and under the sealant in the head and threads of the bolt with sealant. Generally, the sealant afforded no protection against the galvanic attack on any of the bolts. In contrast to the others, the MP35N and titanium bolts experienced no corrosive attack whatsoever.

Bolt sealant is not necessary to mitigate corrosion in bolted titanium structures. Its use appears to have no significant effect on the corrosion behavior of the fasteners. Titanium and MP35N are the only fasteners tested that are recommended for this application. The A286 and stainless steel fasteners would suffer serious pitting and crevice corrosion in this application, whereas the steel and aluminum fasteners would suffer serious galvanic attack.

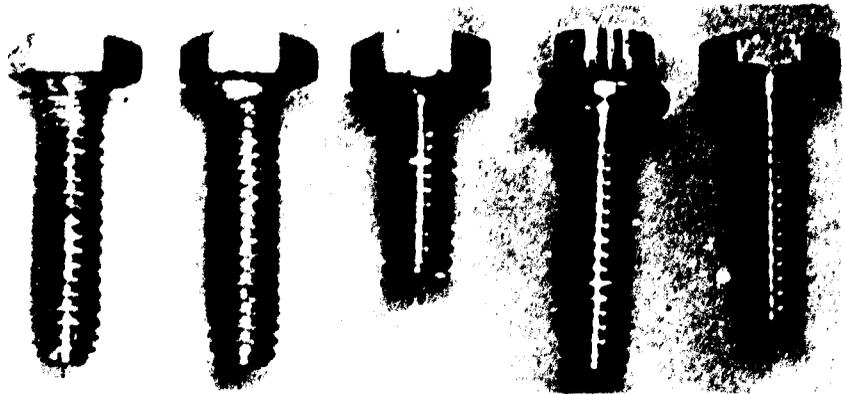
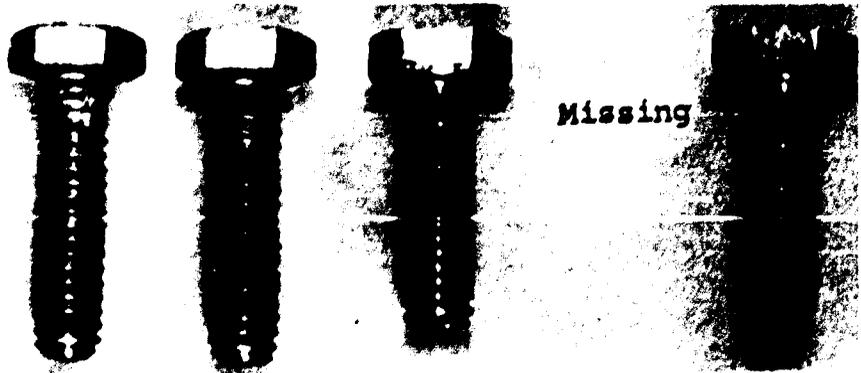
Figure 16
Corrosion Attack on Bolts in 17-4PH Panels

The attack on the standard-sized bolts in the 17-4PH stainless steel panels, as pictured in figure 16, appeared to be considerably less than the bolts in the titanium panels. Galvanic corrosion of the aluminum bolts was quite variable. One bolt was almost completely corroded away, except for the portion inside the crevice, while the other bolt experienced some pitting on the head and the cut end of its threads which was minor by comparison (although still considered significant). The steel bolts were both missing. Since the threads in both panels were still intact and since the areas around these bolts holes were stained with rust, these bolts probably either corroded completely or fell out after extensive attack had occurred. Extensive crevice attack was apparent on the 304 stainless steel bolt with sealant, while some attack was present but not as obvious in the threads and under the head of the bolt applied without sealant. None of the other bolts in this panel experienced

significant attack. The A286 bolt applied without sealant was broken during the test, however. In addition, one of the MP35N bolts was missing. Examination of the panel housing this bolt shows extensive corrosion, with complete destruction of the threaded hole. This evidence, along with the appearance of the other bolt, leads to the conclusion that the MP35N bolt fell out of the plate as the plate corroded away.

There is some inconsistency in the behavior of the 304 stainless steel fasteners in the 17-4PH stainless steel panels. The nominal 1/4-inch bolts suffered crevice attack, as previously mentioned and illustrated in figure 16, whereas the smaller flat head and pan head fasteners suffered essentially no attack under almost identical circumstances, as described above and illustrated in figure 17. The reason for this anomalous behavior is not known.

Use of a sealant material on 17-4PH stainless steel structures is definitely contraindicated. The sealant tends to establish a tighter crevice, increasing the likelihood of crevice corrosion on the structure. Unless the entire structure is well painted, use of aluminum or steel bolts is not recommended due to their high rate of galvanic attack, and use of 304 stainless steel is undesirable due to extensive crevice corrosion of the fasteners. Use of A286, 316 stainless steel, MP35N, and titanium is favored from the viewpoint of fastener corrosion; however, some means of corrosion protection is necessary to prevent crevice attack of the structure.

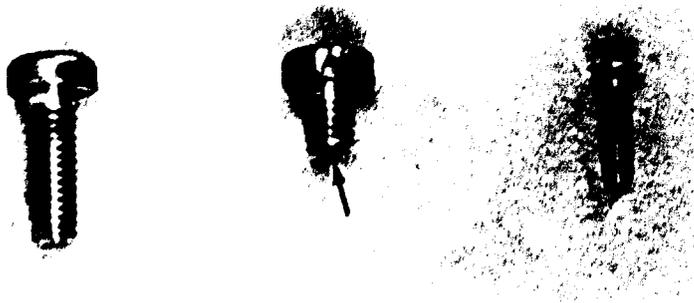
Figure 17
Corrosion Attack on Small 304 Stainless
Bolts in 17-4PH Panel
(Arrow Indicates Mechanical Damage)

The appearance of the small 304 stainless steel fasteners that were exposed in a 17-4PH panel is shown in figure 17. All of the small flat head fasteners, except the one shown, were destroyed for analysis. All were free of attack and similar in appearance to the one shown in figure 17. Likewise, the pan head fasteners were free of corrosion, except for slight etching of the threads in one fastener which is shown at the upper left in figure 17. One fastener had been put in a hole in the panel which subsequently had the threads completely corroded away. This fastener was missing after exposure and probably dropped out of the panel intact.
