NAEC-ENG-7868

31 Mar 1976

FINAL REPORT

THE CORROSION CONTROL OF
FASTENING SYSTEMS FOR
AIRCRAFT CARRIER STEAM CATAPULTS

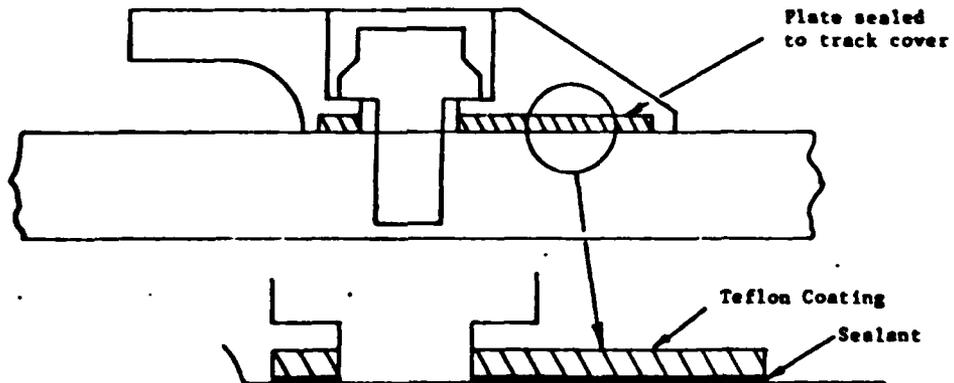
Figure 3. Proposed Two-Piece Bridge Arrester Track to minimize lateral seepage of corrodent into blind bolt hole

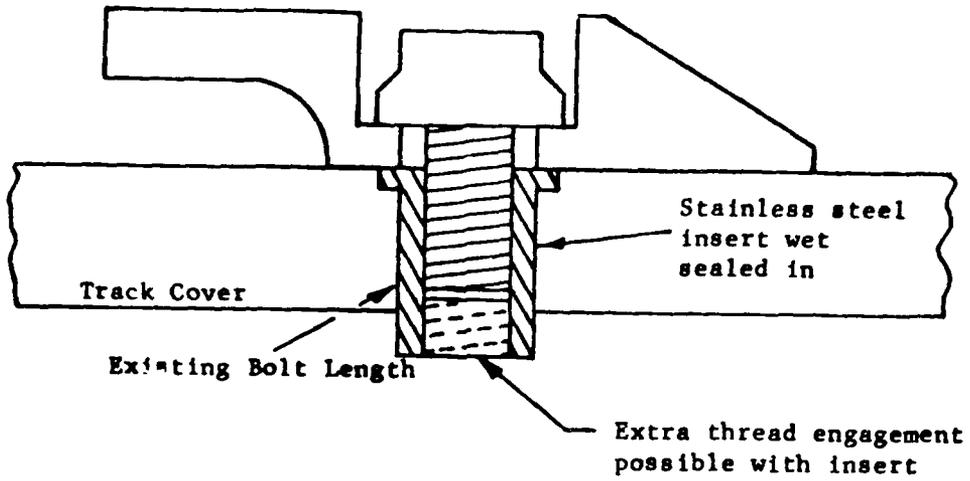
Figure 4. Wet sealed insert provides extra threads and corrosion resistant installation.

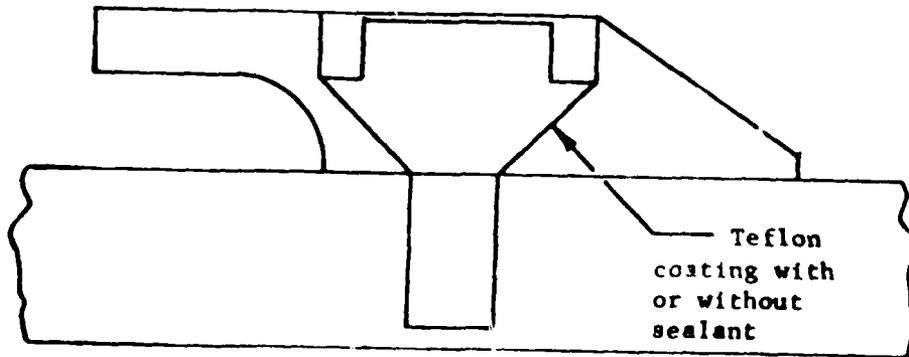
Figure 5. Proposed bridge track arrester bolt with countersunk head.

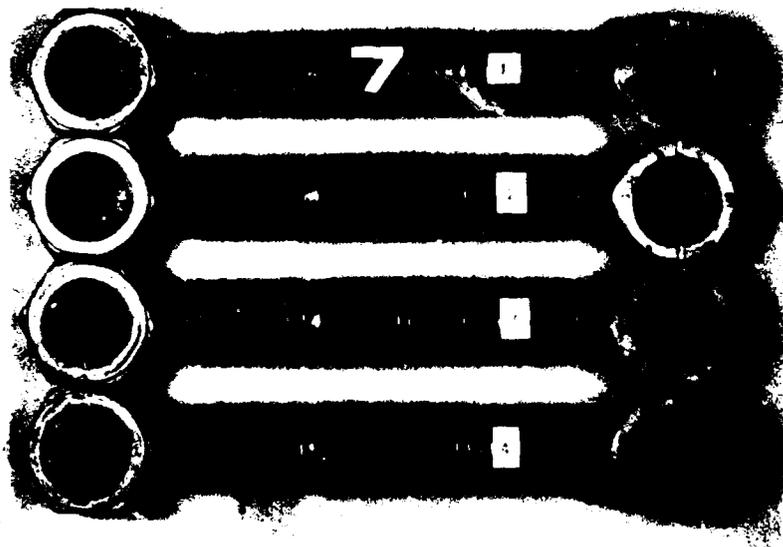
Photo 52. Electroplated nickel + SermeTel W coating system on studs and nuts allowed some rusting after the 9 month exposure at Ocean City. See Table XXV.

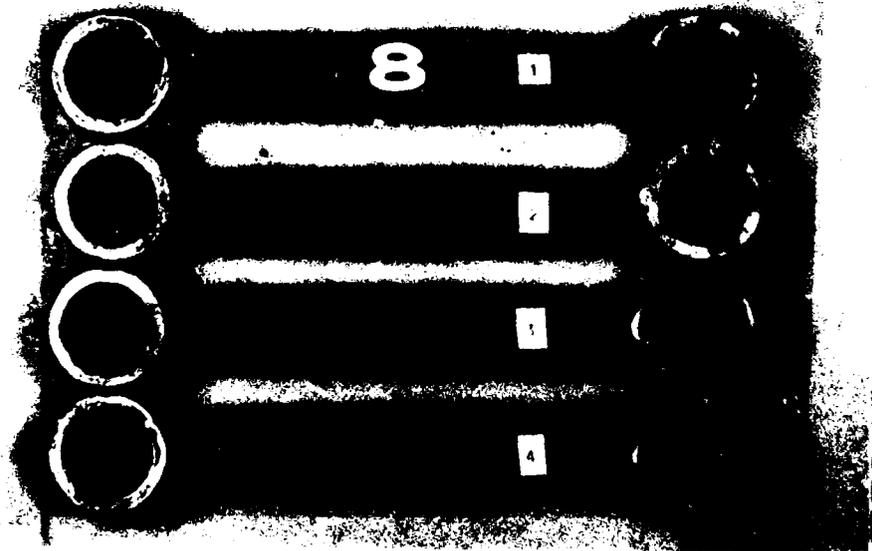
Photo 54. SermeTel W with a low temperature cure on studs and nuts allowed rusting to occur after 9 month exposure at Ocean City. See Table XXV.

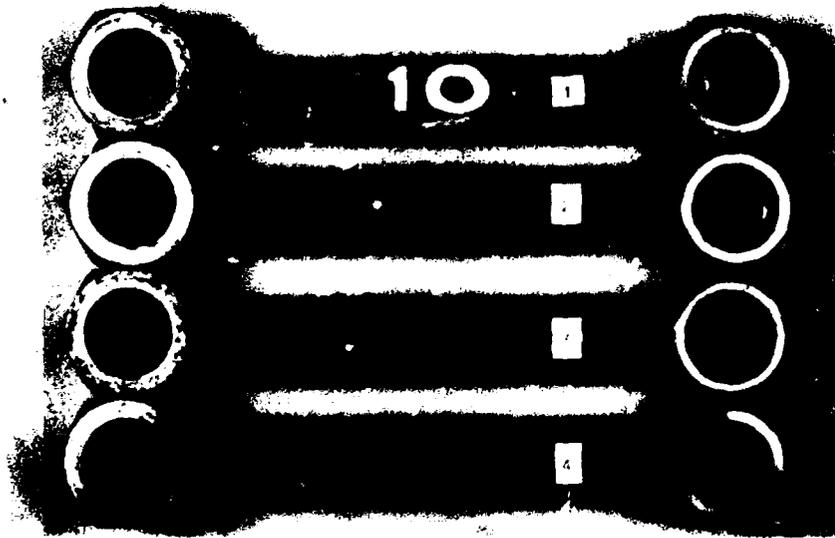
Photo 58. Inco 718 studs and nuts show no corrosion after a 9 month exposure at Ocean City. See Table XXV.

6. Inconel 718 alloy provides the best solution to preventing corrosion of launch valve studs and nuts.
