AFRPL-TR-77-25

ANALYSIS OF PROPELLANT STORAGE TANKS AFTER FOUR YEARS
HYDRAZINE STORAGE

FINAL REPORT - MAY 1976 - APRIL 1977

BELL AEROSPACE TEXTRON
DIVISION OF TEXTRON, INC.
P. O. BOX ONE
BUFFALO, NEW YORK 14240

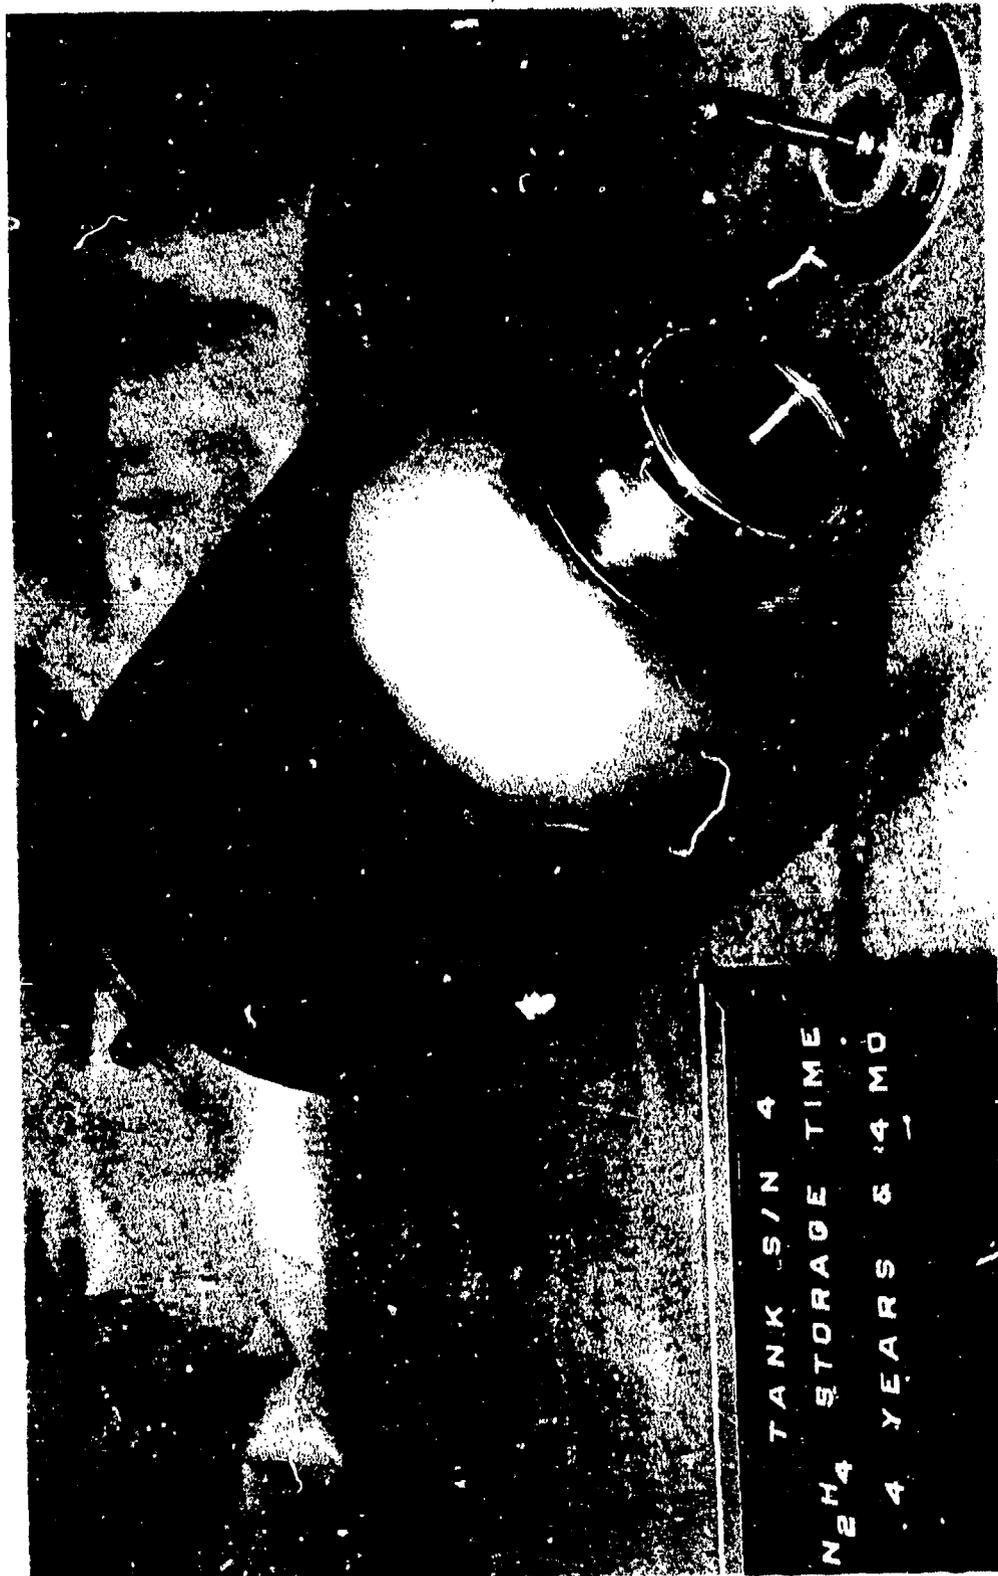
FIGURE 9. TANK S/N 4 IN THE AS-RECEIVED CONDITION AFTER STORAGE TESTING.
THIS TANK, LIFE S/N 1, HAD LEAKED AROUND THE SOFT METAL GASKET
SEE. AT THE FURNACE ETC.

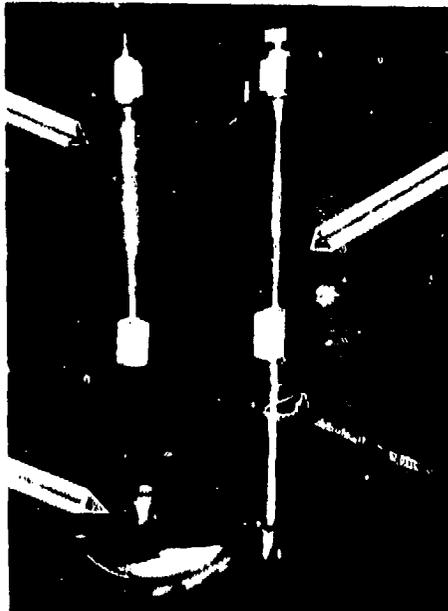
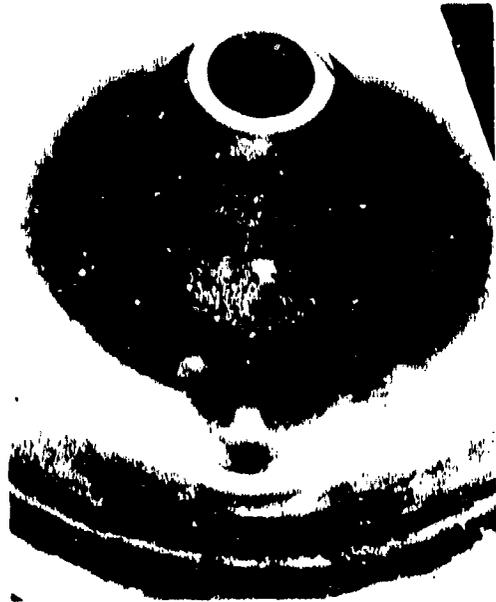
a) View of outlet tube components
received from tank S/N 5 com-
pared with unsectioned compo-
nents of tank S/N 1 illustrating
segment missing from original
shipment

b) Tube extension from corroded
outlet fitting showing slight
surface etching but no sig-
nificant corrosive attack.
Etched regions are indicated
by black arrows, unetched areas
by white arrows.

c) Overall view of outlet
fitting showing etched area
and pit at bottom.

d) High magnification view
showing localized corrosion.

FIGURE 11. DETAIL VIEW OF OUTLET PORT REGION OF TANK S/N 5 SHOWING EVIDENCE OF CORROSIVE ATTACK IN BOSS.

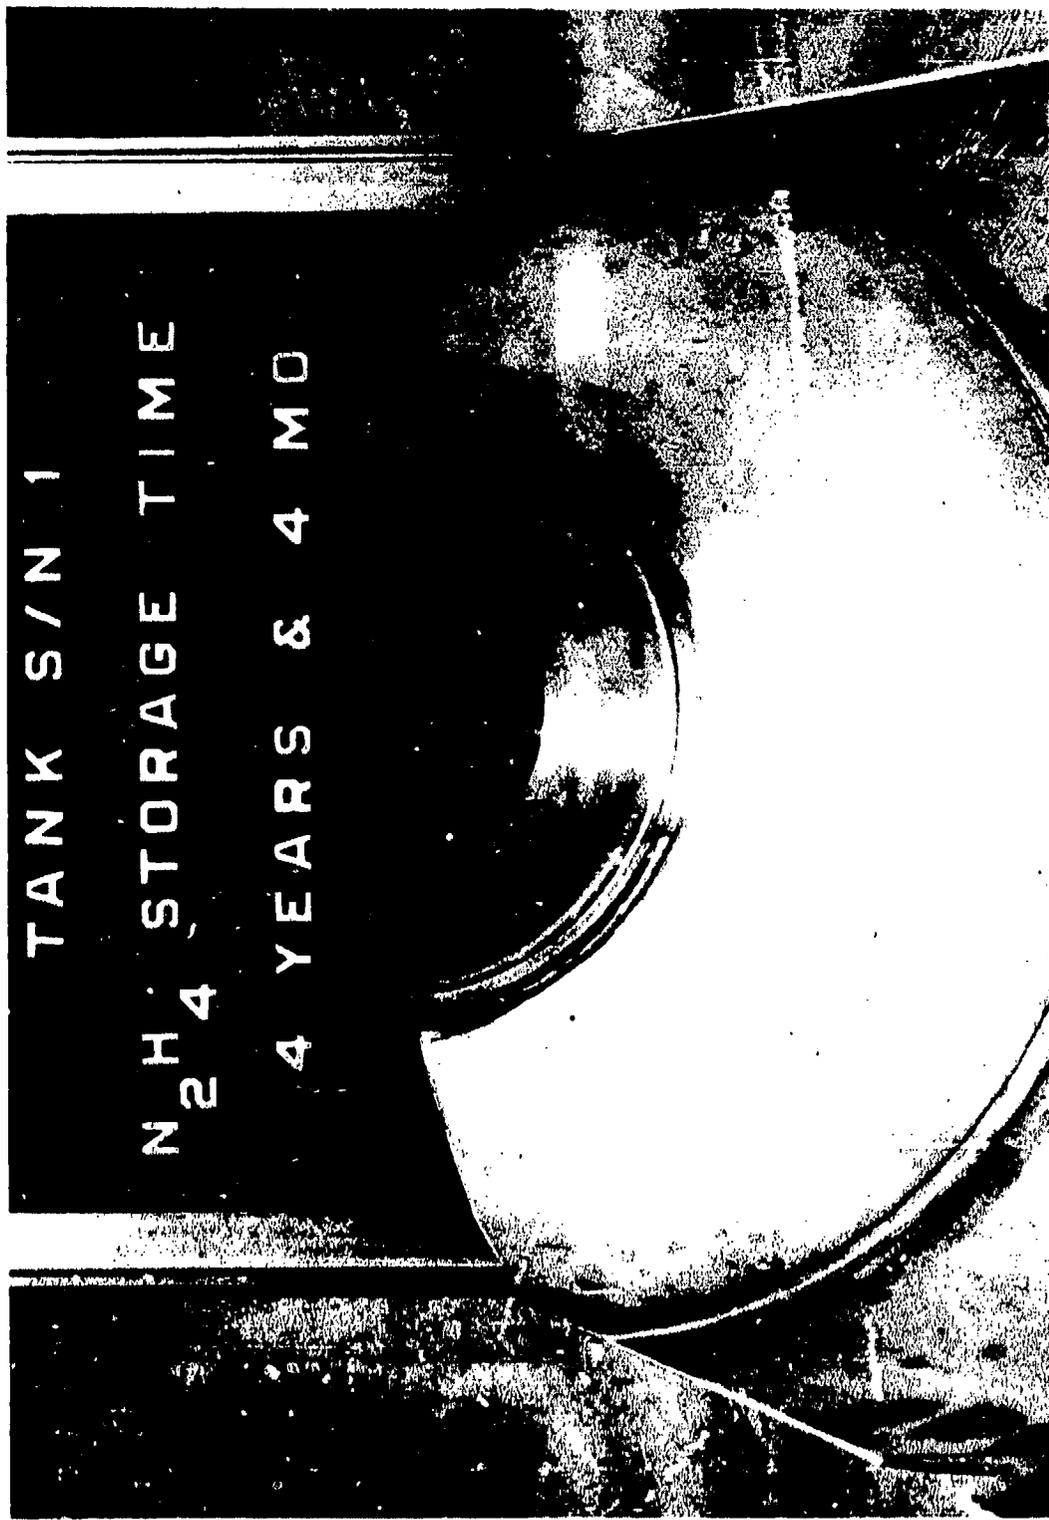
FIGURE 12. TANK S/N 1 IN THE AS-RECEIVED CONDITION AFTER SECTIONING SHOWING MARKINGS SIMILAR TO WATERLINES. THEIR PRESENCE IN THE FLANGE AREA MAY BE A RESULT OF POSITIONING AFTER REMOVAL FROM THE STORAGE RACKS.

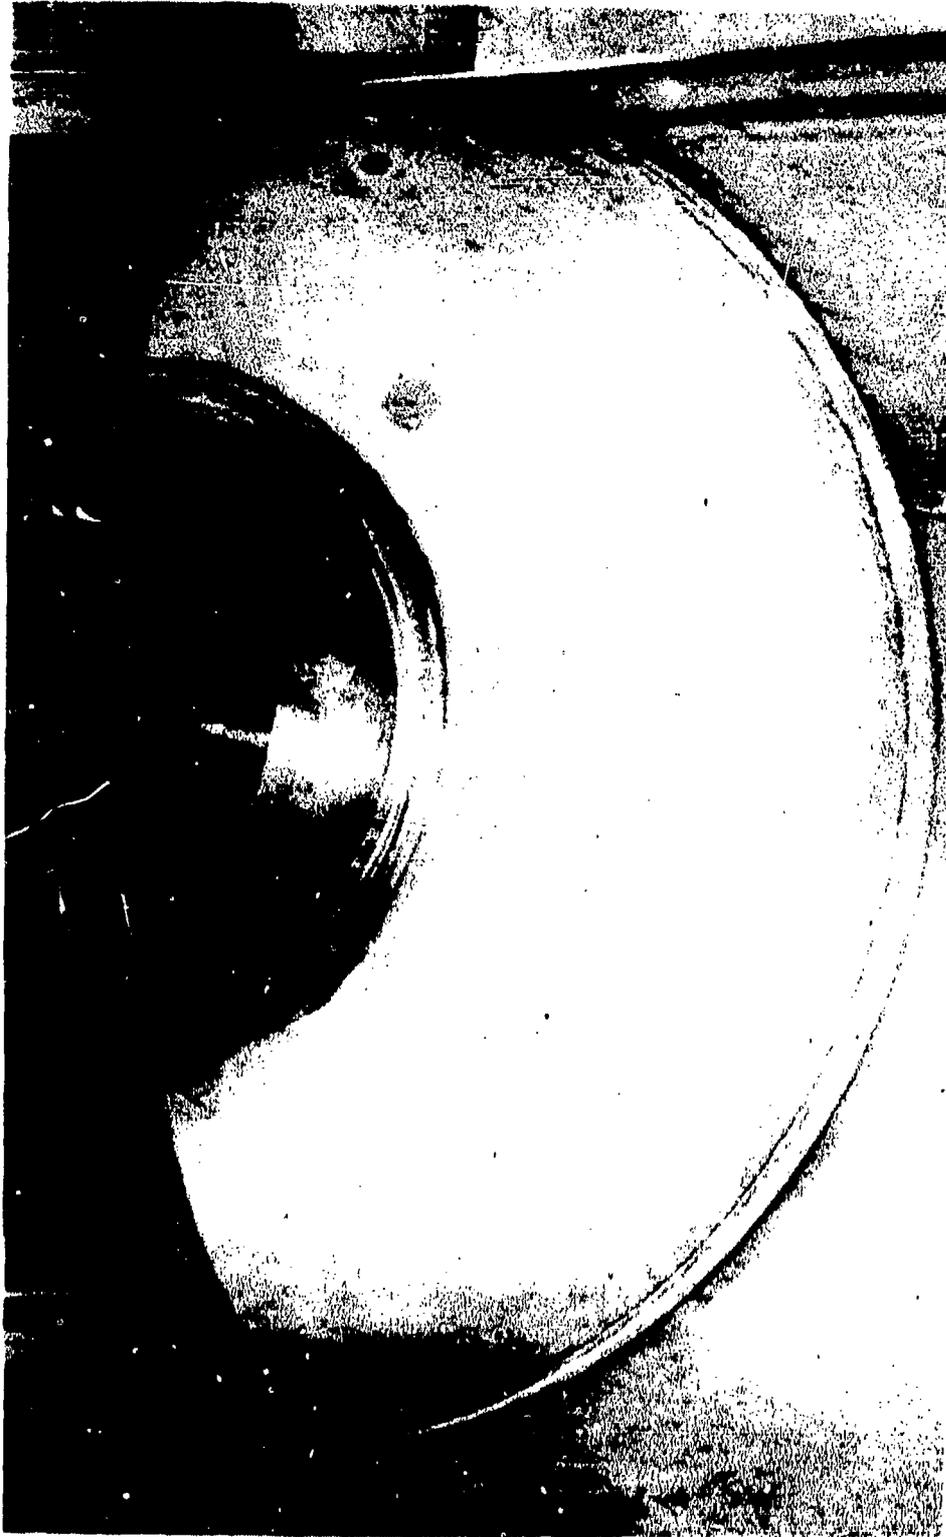
FIGURE 13. OPPOSITE HALF OF TANK S/N 1 IN THE AS-RECEIVED CONDITION SHOWING THE SAME TYPE OF MARKINGS AS SHOWN IN FIGURE 12. THESE PHOTOMICROGRAPHS SUBSTANTIATE THE OVERALL INTERIOR CONDITION OF THIS TANK. NO EVIDENCE OF CORROSIVE ATTACK WAS OBSERVED IN EITHER HALF OF THIS TANK ON A MACROSCOPIC BASIS.

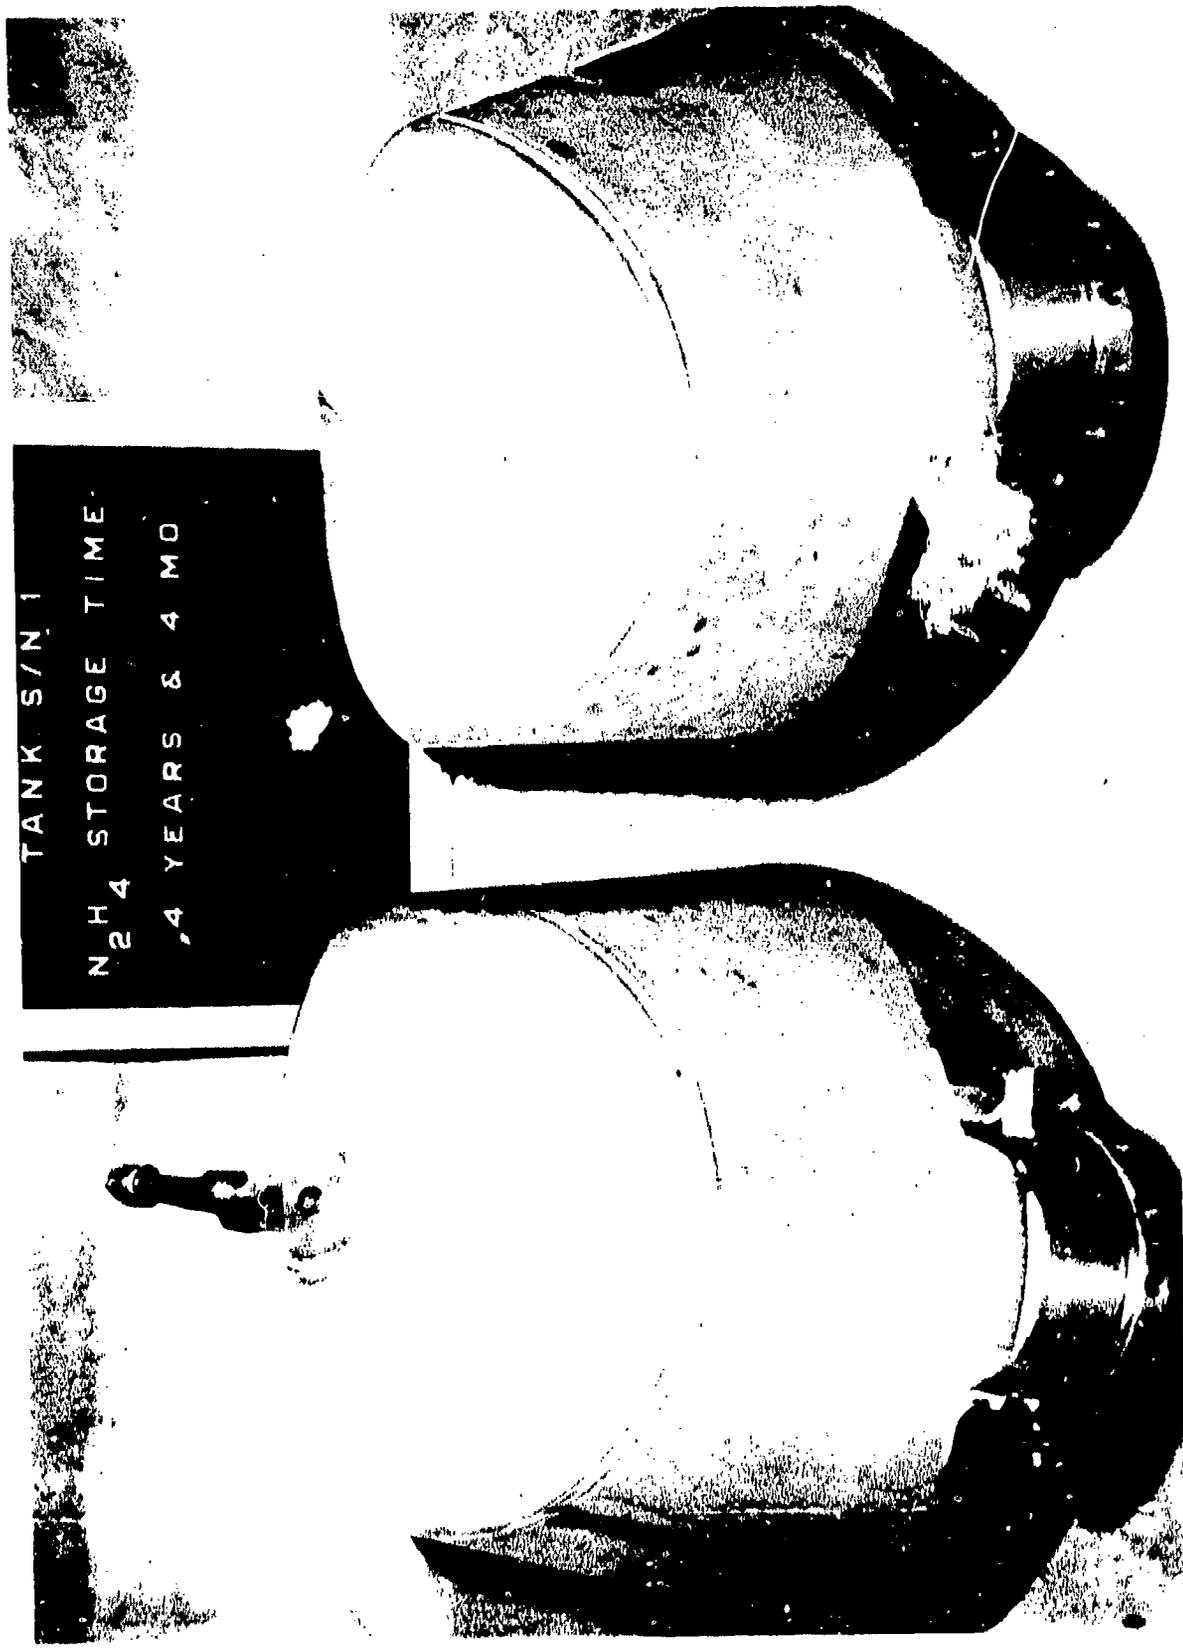
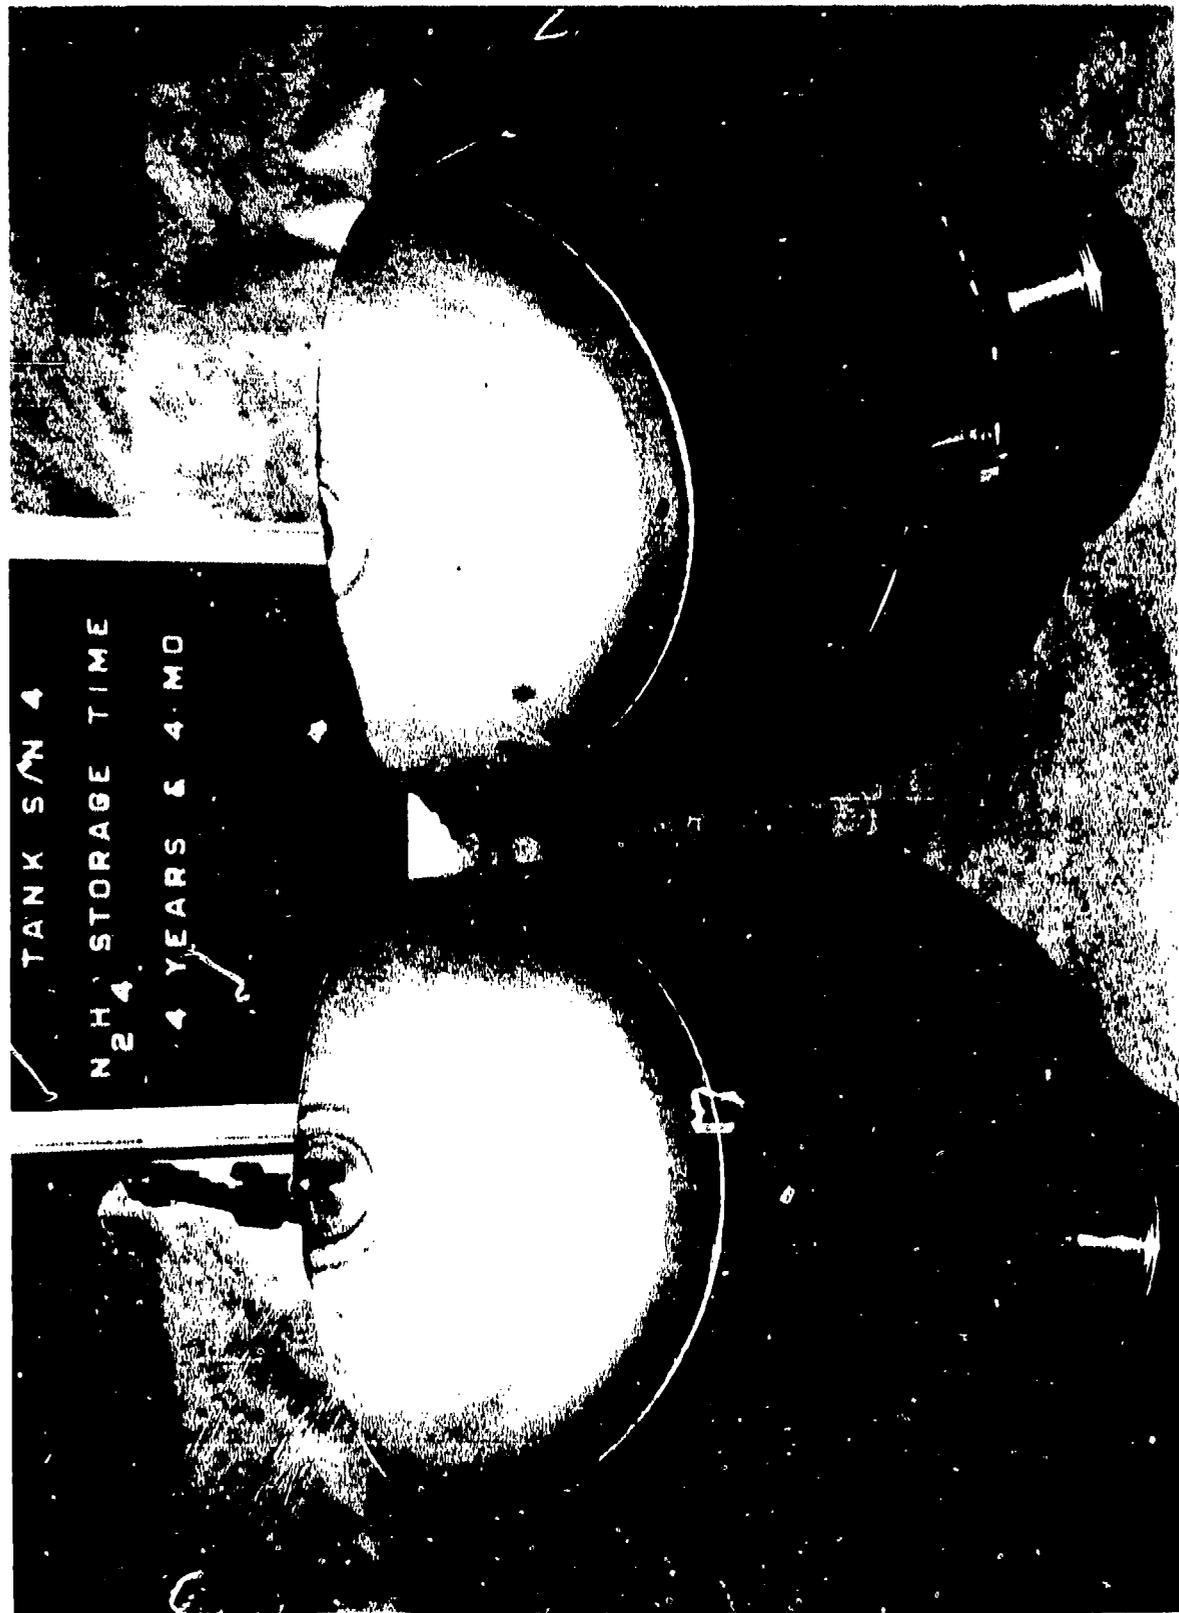
FIGURE 15. TANK S/N 4 SH. SLIP MARKINGS SIMILAR TO WATERLINES AT THE BOTTOM OF THE TANK. FROM THE MANNER IN WHICH THE TANKS WERE SLIP, THIS IS THE AREA WHERE MARKINGS OF THIS TYPE WOULD BE EXPECTED IF RESIDUAL N_2 WERE PRESENT.

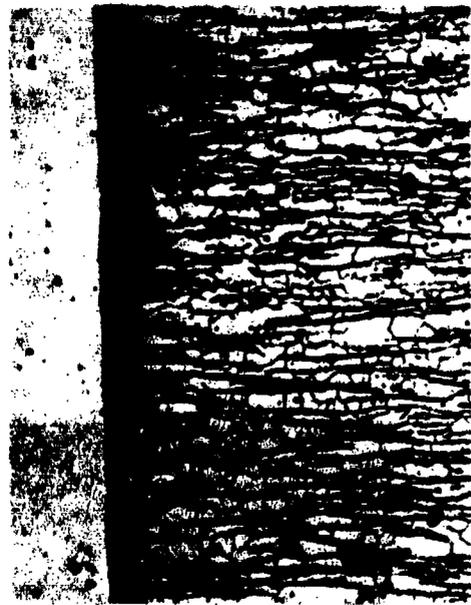
a) Flange to tube weld showing no corrosion in extended crevice

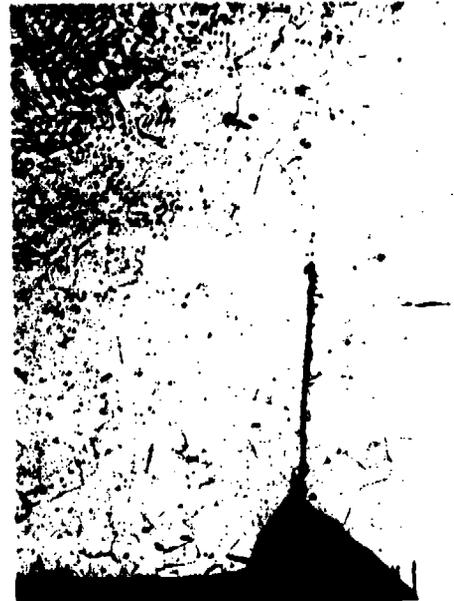
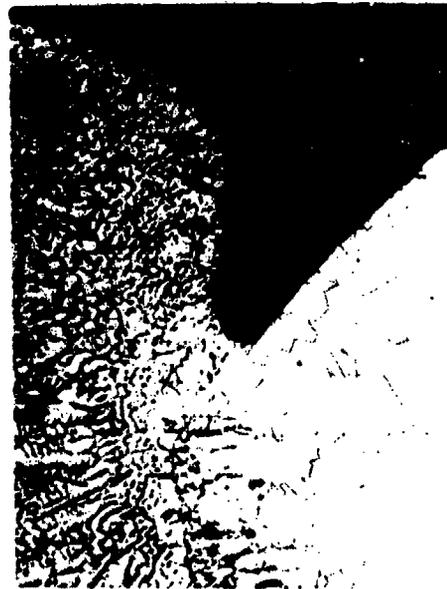
- a) Overall view of weld joint showing considerable amount of original joint preparation still visible

FIGURE 34. TUBE WELD FROM TANK S/N 4 (OUTLET CONNECTOR FITTING TO EXTENSION TUBE), SHOWING POOR LOCATING OF WELD TO ORIGINAL JOINT PREPARATION, GIVING CONSIDERABLE LACK OF FUSION BUT NO JOINT LEAKAGE.

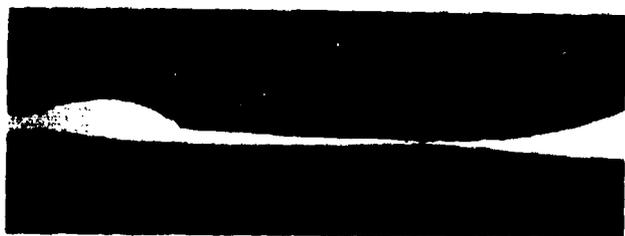
- b) Cross section of outlet fitting showing extreme thinning from machining plus corrosion

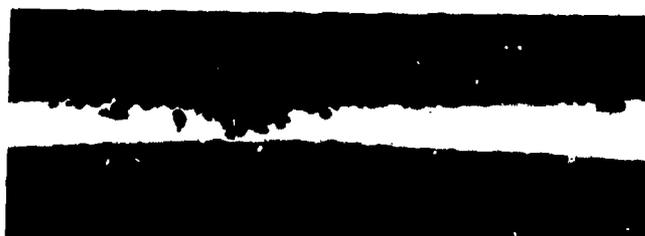
- c) View of corroded region showing extensive corrosion on exterior surface

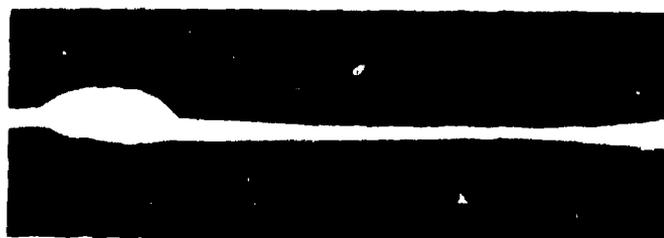
- d) Cross section in outlet fitting of Tank S/N 4 showing thinning but not to extent of Tank S/N 5

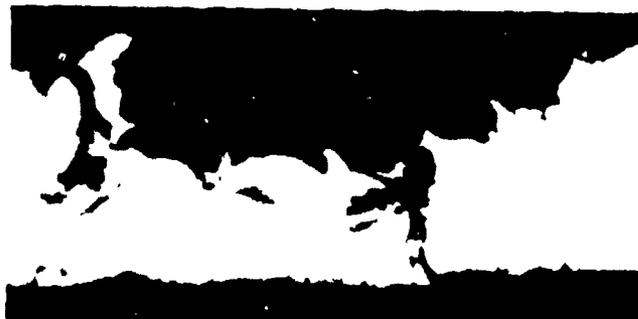
- e) Close up view of corrosion attack and penetration to interior

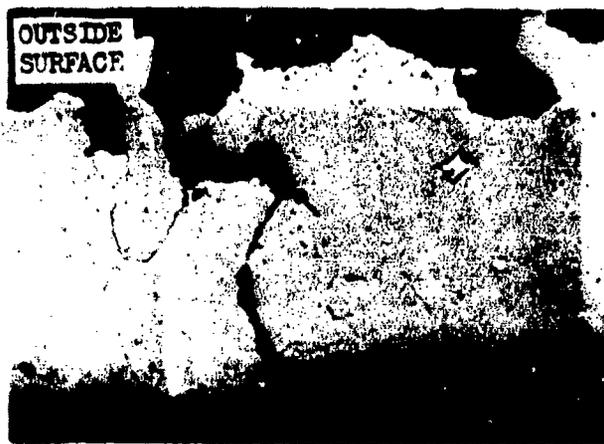
- c) Detail view of area where attack is proceeding along ferrite to martensite phase boundary.

- d) Detail view at leakage or complete penetration site.

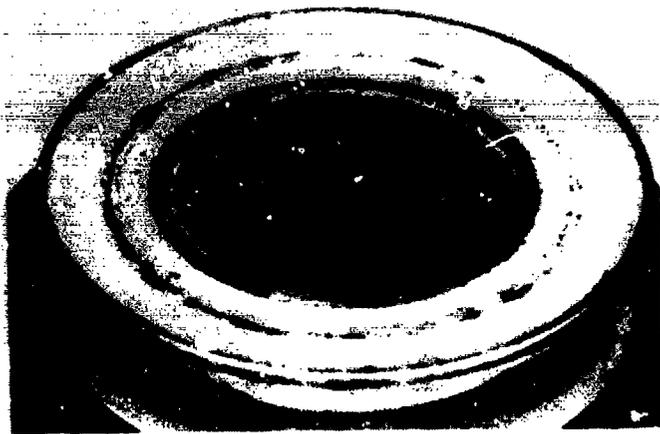
- a) Overall view of RPL fitting sealing member showing deposits on inner surface in vapor phase.

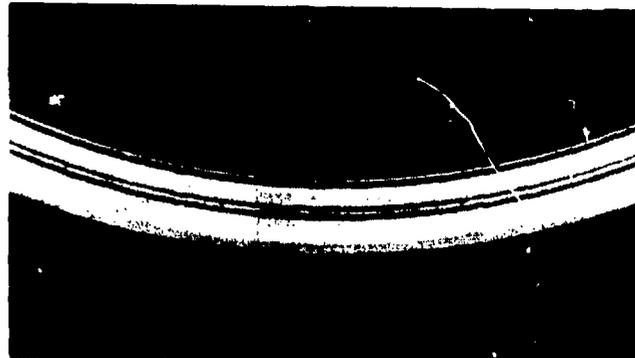
b) Side of ring in contact with flange after removal. Note staining on hydrazine side up to first sealing ridge.
