Report No. CG-D-62-77

# FIRE PERFORMANCE OF INTERMODAL SHIPPING CONTAINERS

October 1977

Final Report

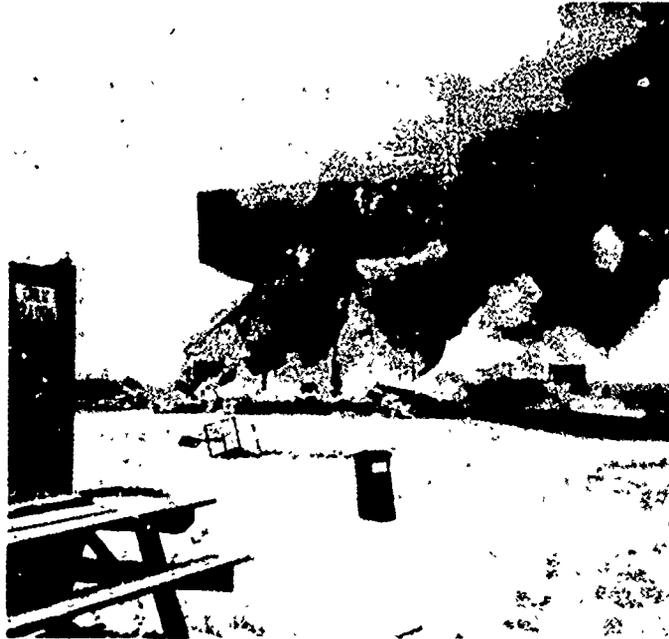
**Figure 15 — Containers Held in Place  
by Bridge Fittings**

E. The stacking and lashing fittings currently used provide an adequate amount of structural stability under fire conditions. In Test 6, the bridge fittings maintained the top row of containers in position even though the bottom end containers had collapsed (Figure 15).
