AFFDL-TR-77-12

PRESSURE CYCLING FATIGUE TESTS OF F-111 CREW MODULE GLASS TRANSPARENCIES

Experimental Branch
Structures Division

March 1977

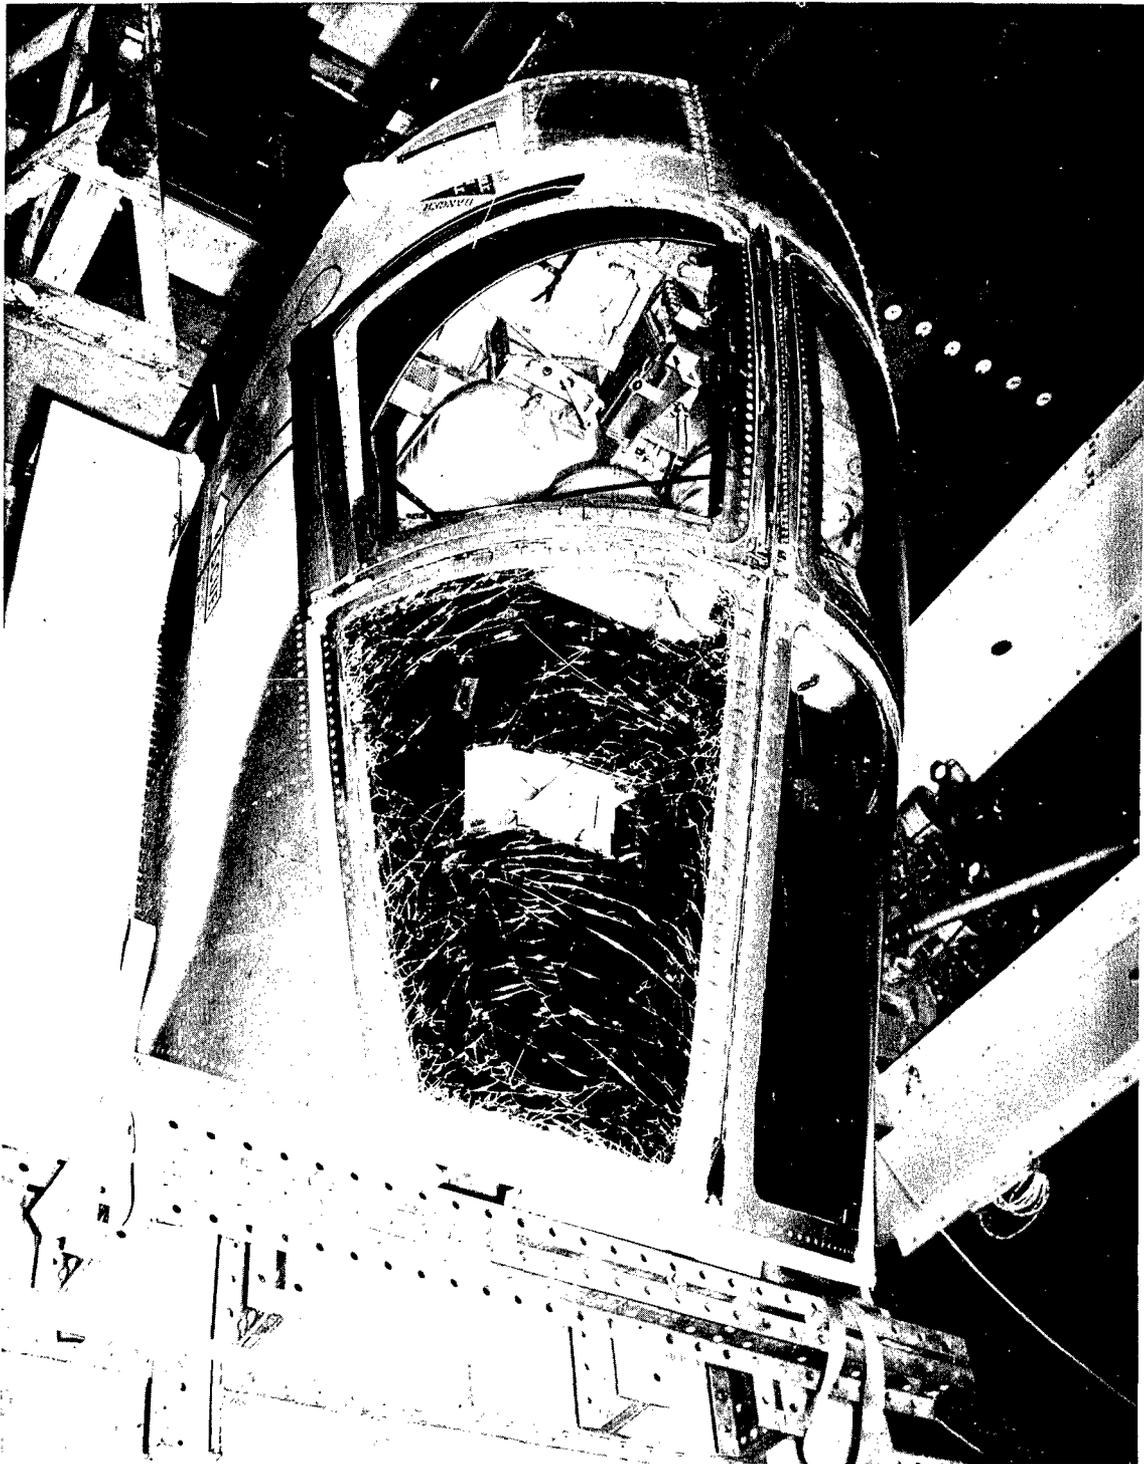
Two complete ship-sets of transparencies were used in this program. The first set had been used in service and had debonded areas in the edge members (Figure 1). The right windshield arrived with its outer titanium edge member strap removed and an attempt was made to rebond it using a technique developed by the Air Force Materials Laboratory (MAAE) and reported in Air Force Materials Laboratory Technical Memorandum MAA 69-9 Rev-1. The outer laminate failed in the final cool down phase of this repair procedure. The failure initiation point was found to be in an area in which a glass chip had been pulled during removal of the titanium edge member. Since one laminate is theoretically capable of carrying all design loads and no replacement with the proper shim was available, this windshield was used in the first part of the program. This ship-set of debonded transparencies, including the right windshield with its failed outer laminate, is shown installed in the module in Figure 1. (The pressure bottles inside the module were used to take up volume to reduce pumping time.) The transparency serial numbers were:

Figure 1. Ship-Set of Debonded Transparencies with the Outer Laminate of Right Windshield Crazed in Edge Member Repair Procedure, Installed in Crew Module

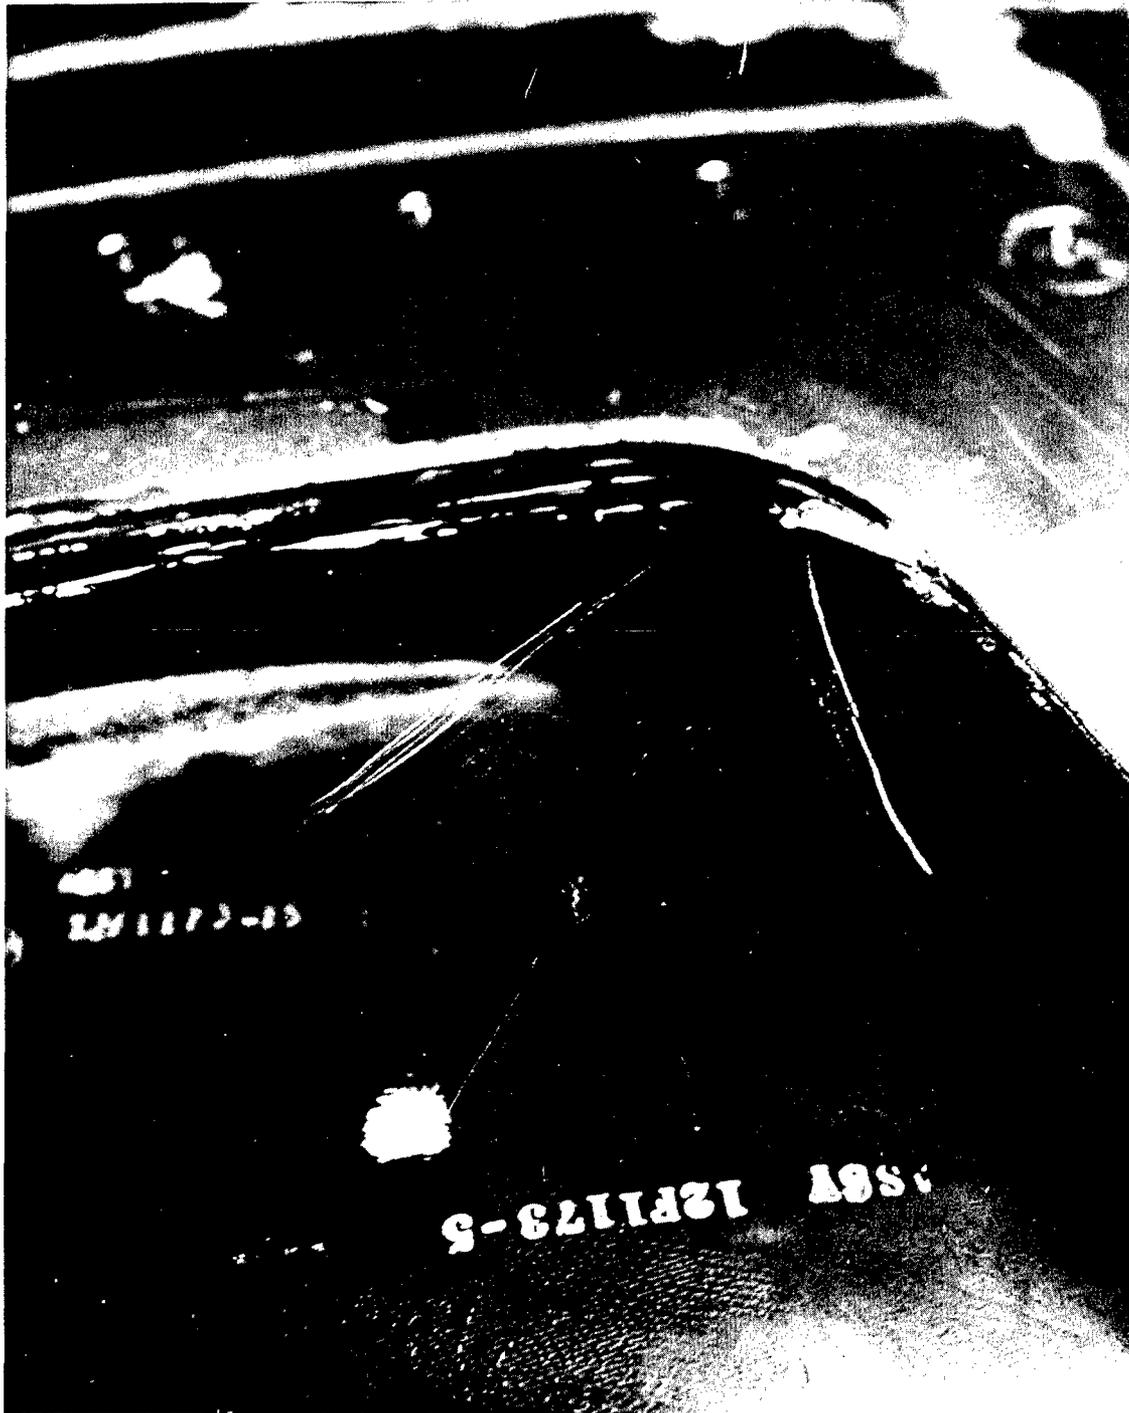
Radial scratches (Figure 3) and cross scratches (Figure 4) were added to the transparencies at the end of four lifetimes of testing to evaluate their tendency to start cracks. Ten more loading blocks representing 2000 service hours were conducted with no apparent crack initiation.

Figure 3. Radial Scratches on Transparencies

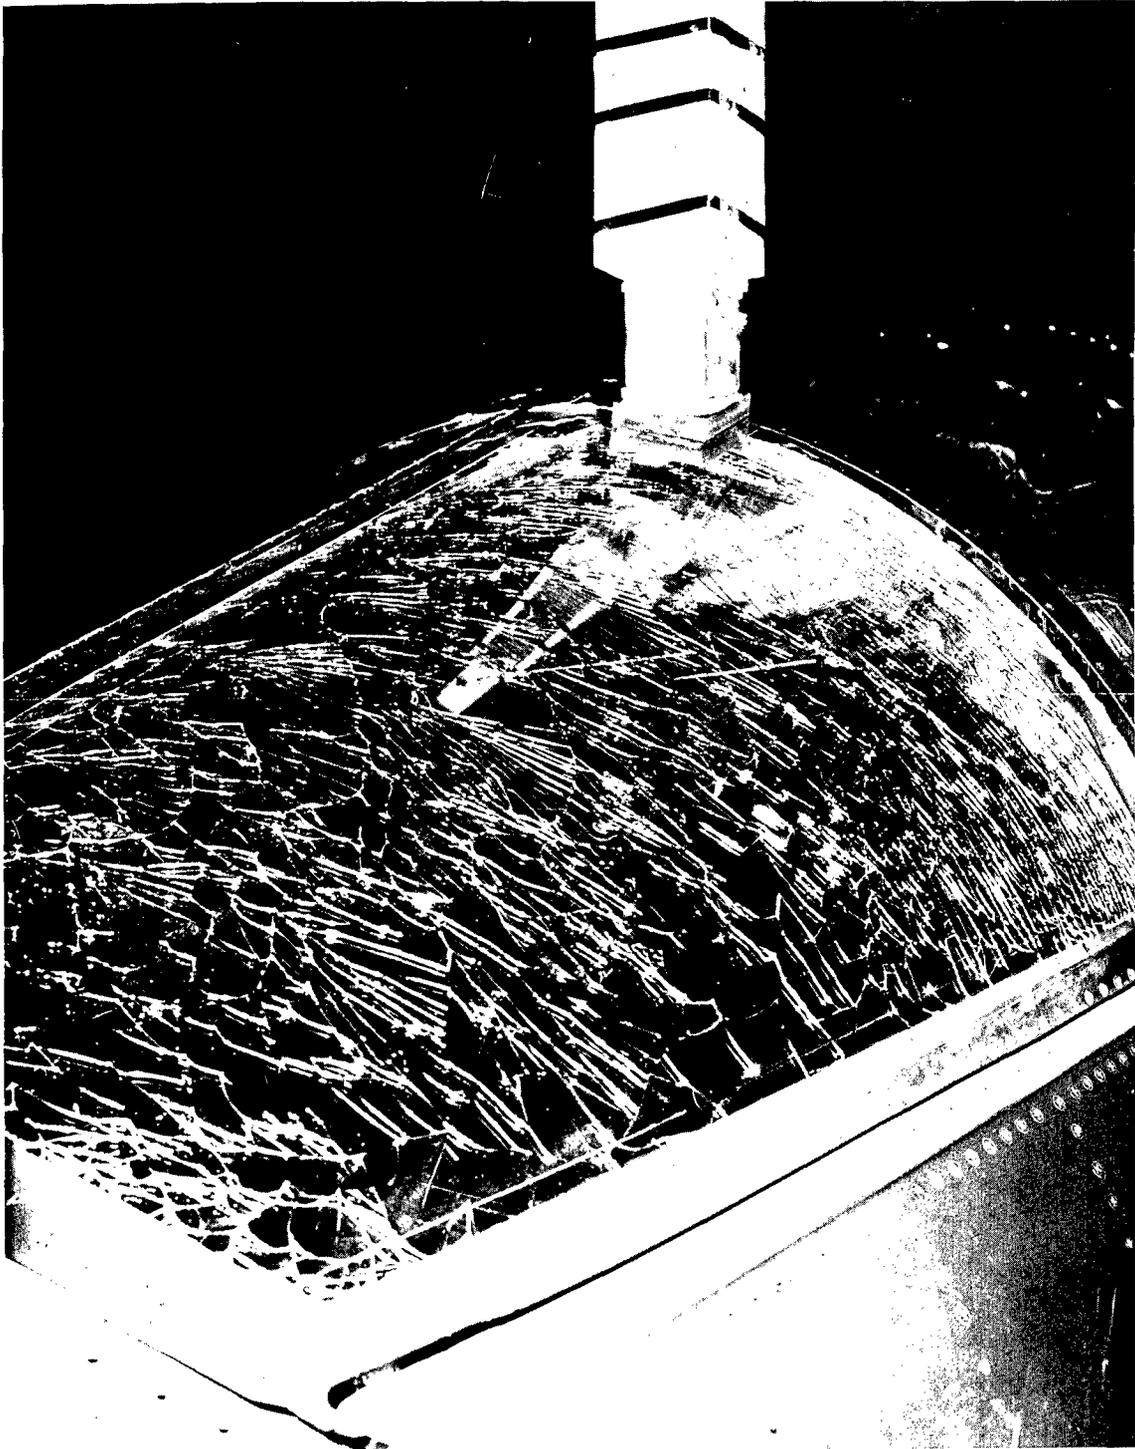
The left windshield failed in the blunt object impact test when struck by a fifty pound weight from a free-fall height of 16.5 feet. The internal pressure of the module was kept at ambient. The failure is shown in Figure 18, with the striker block still in the test position.

Figure 18. Blunt Object Impact Test Failure

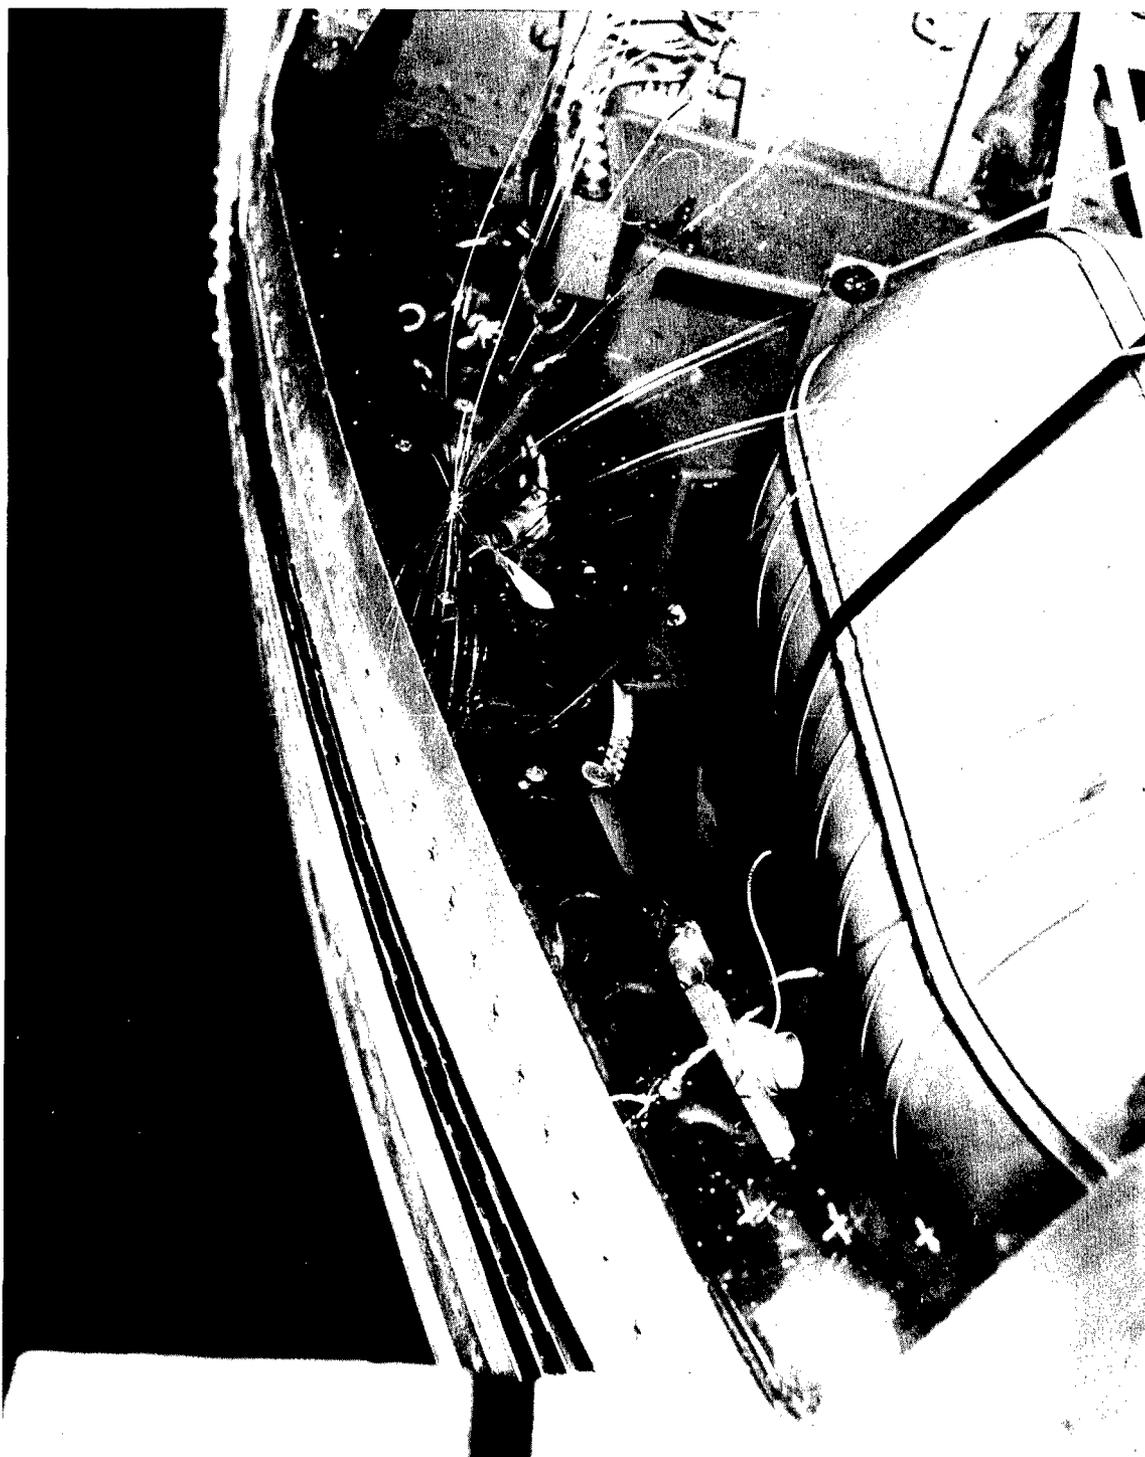
The left canopy failed when struck by a 1 pound 6-1/2 ounce plumb bob from a height of 6 inches in the sharp object impact test. This failure is shown in Figure 19. The internal pressure was kept at ambient.

Figure 19. Sharp Object Impact Test Failure

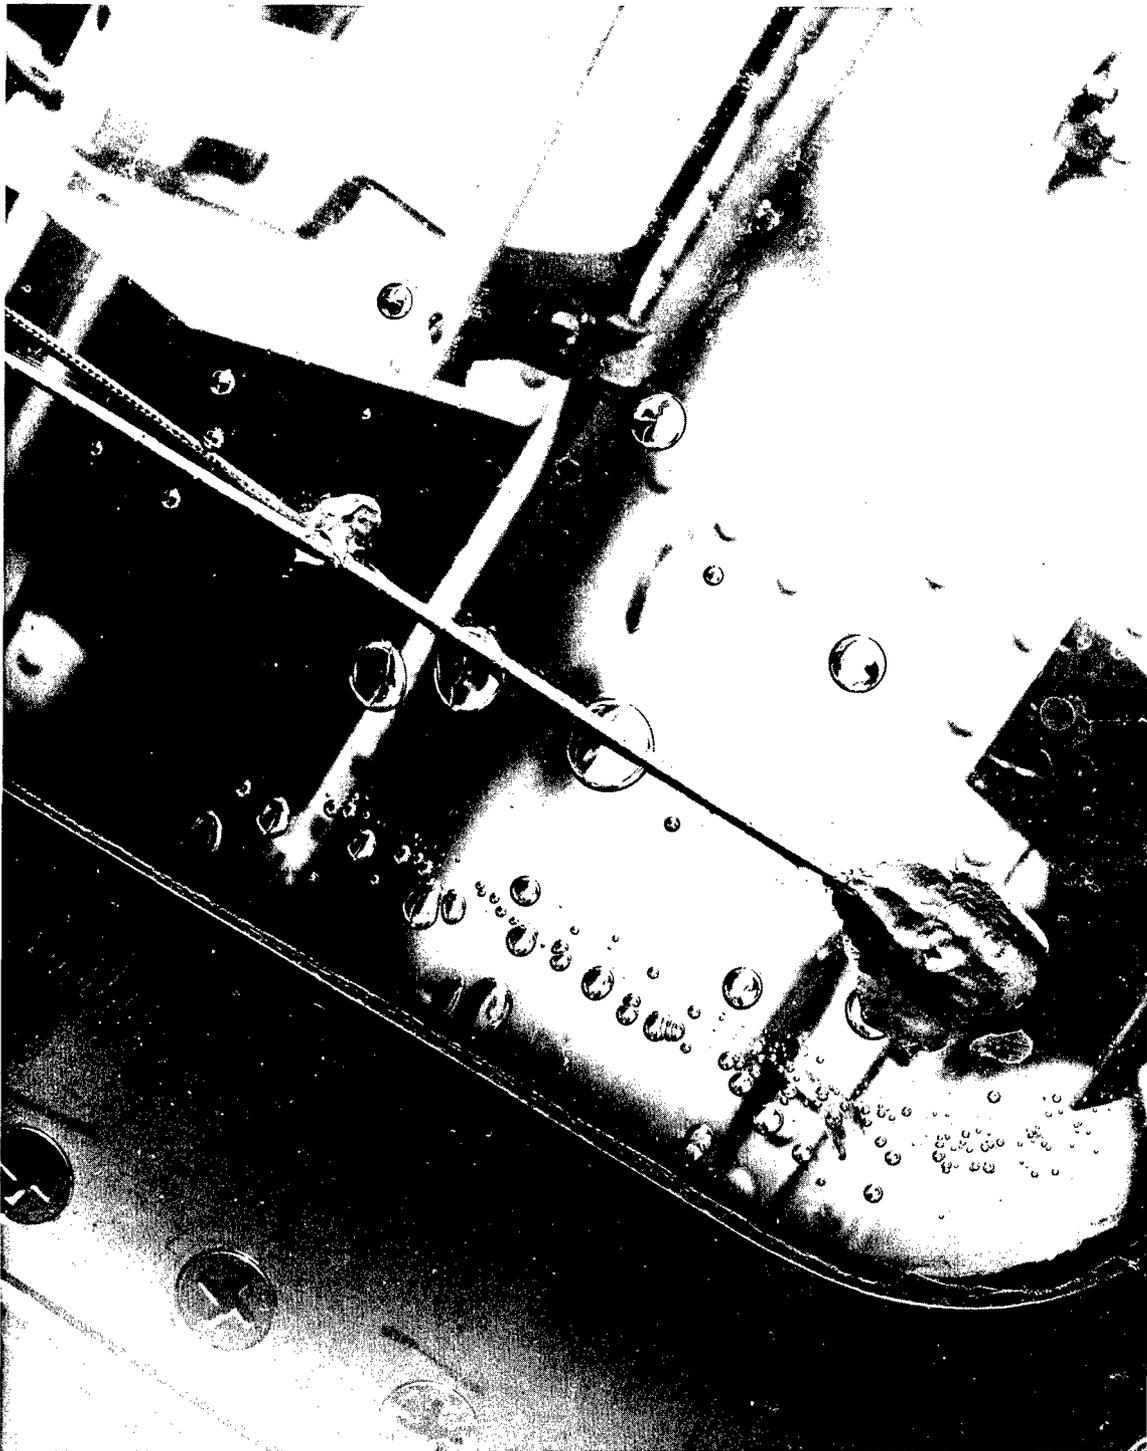
At the end of one lifetime of simulated usage the only damage noted, besides the continued chipping of the failed outer laminate of the left canopy, were bubbles forming in the interlayer at the forward end of both right and left windshields. The bubbles are shown in Figure 20.

Figure 20. Bubbles in the Interlayer at the End of One Lifetime of Testing

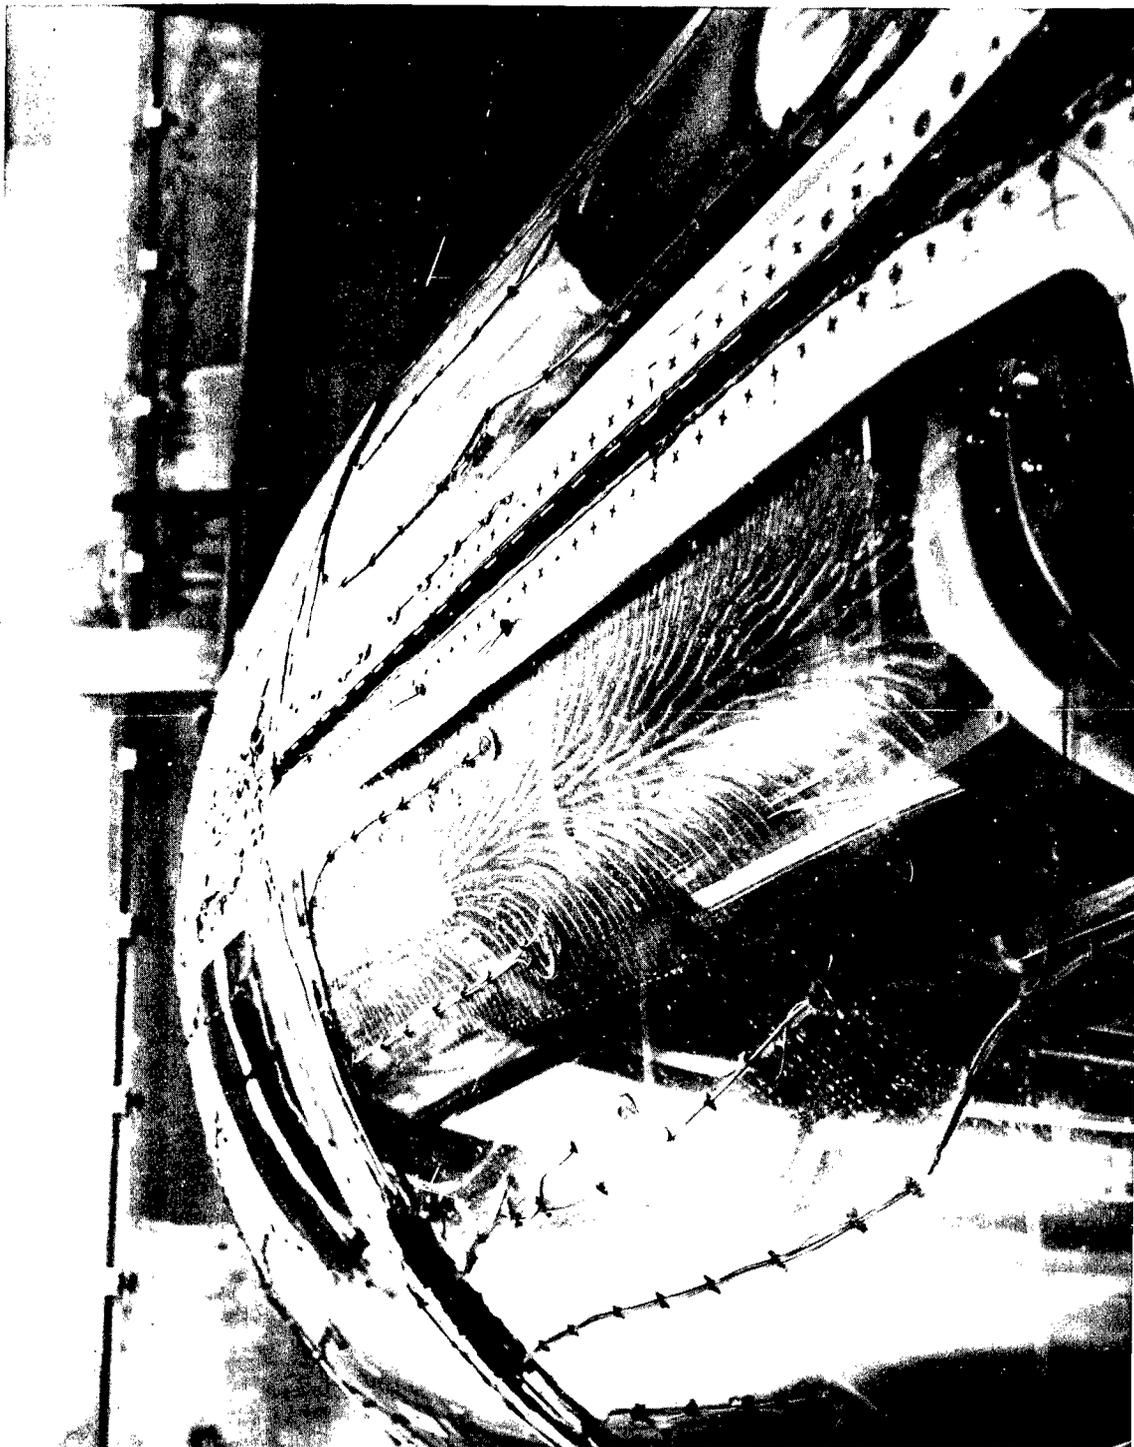
At the end of the third lifetime (12000 hours) a large leaf-like delamination had appeared in the interlayer of the right windshield. This delamination is shown in Figure 21. A section of the outer laminate of the left canopy had fallen out exposing the C.I.P. (Figure 22).

Figure 21. Leaf Shaped Delamination of the Right Windshield Interlayer at the End of the Third Lifetime of Testing

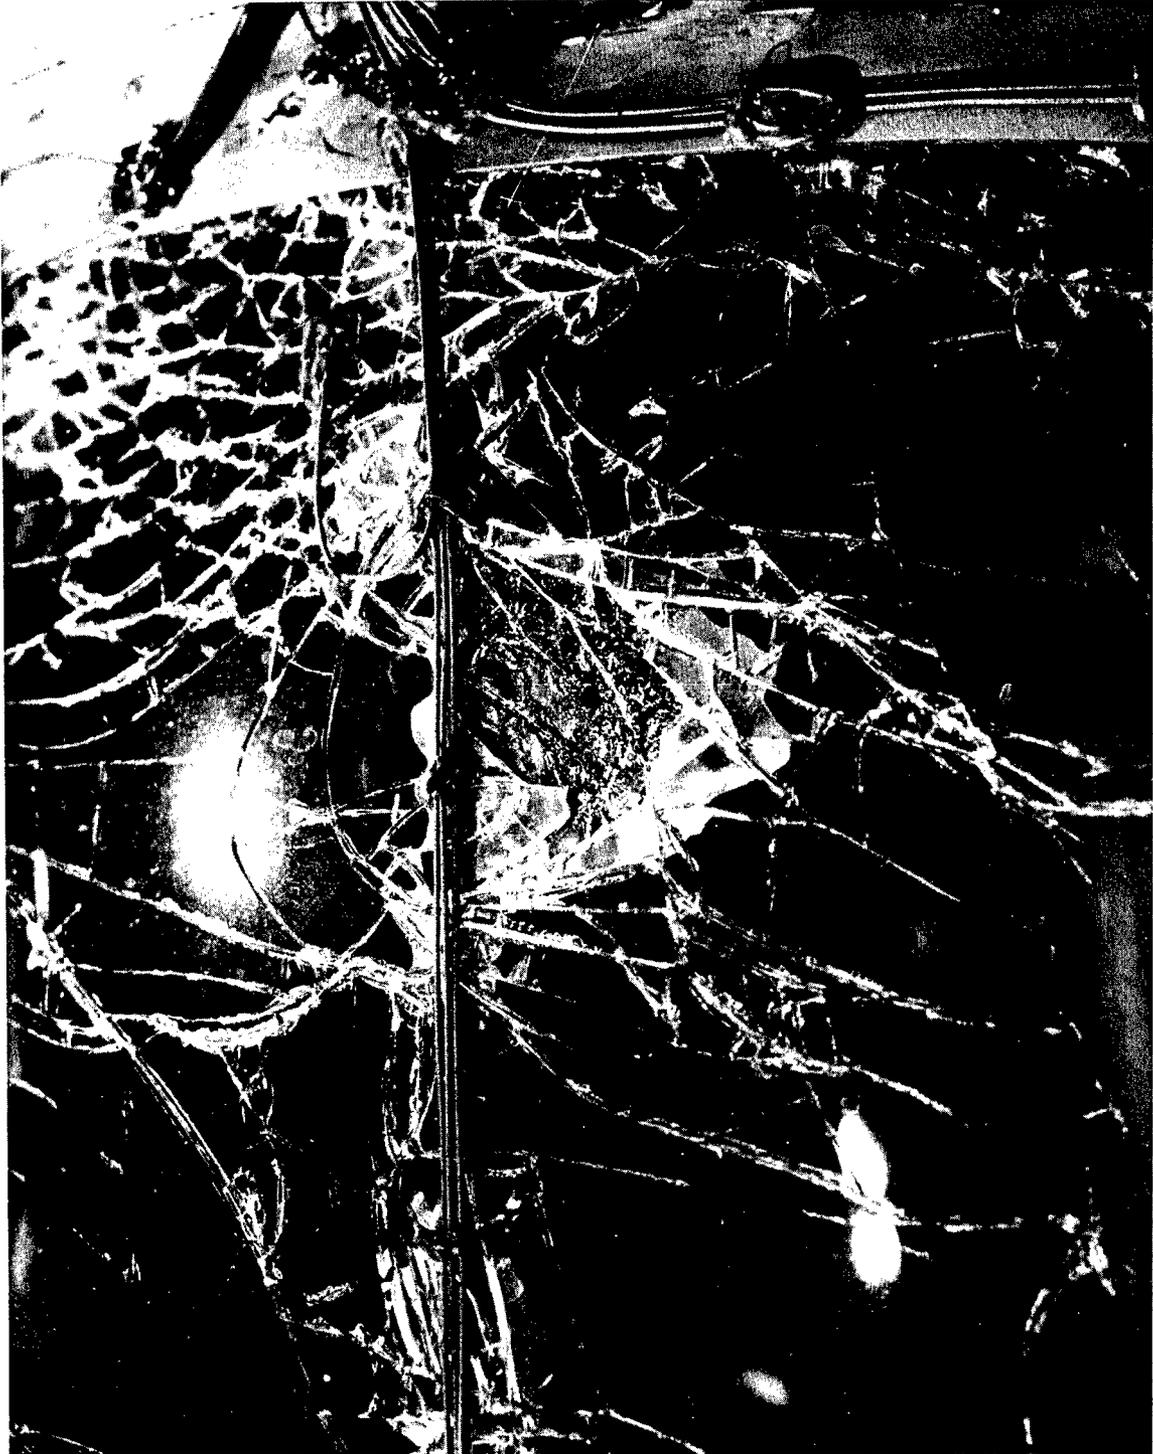
Figure 22. Exposed Cast-In-Place Interlayer of the Left Canopy at the End of Three Lifetimes of Testing

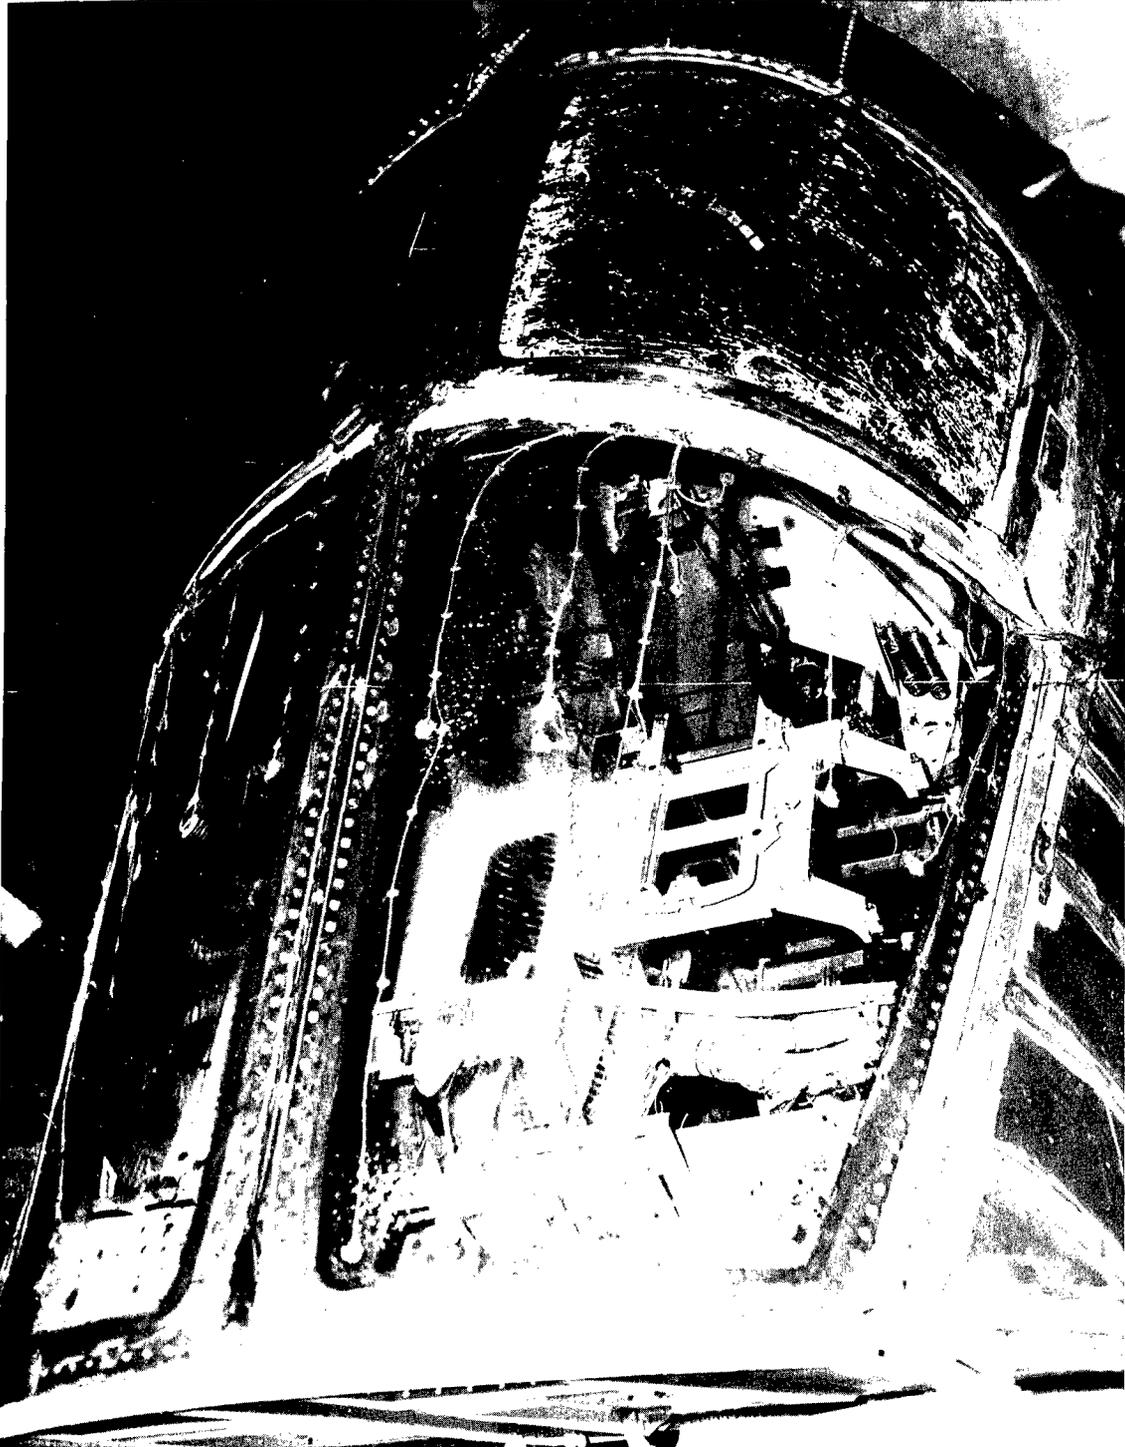
At the end of the fourth lifetime (16000 hours) a leaf-like delamination had appeared in the left windshield (Figure 23) and a second one started in the right windshield. Although the optical qualities were very much deteriorated the transparencies were still structurally sound. It should be noted however, that no attempt was made in this program to measure the optical properties of the transparencies.

Figure 23. Leaf Shaped Delamination in the Interlayers of Both Windshields at the End of Four Lifetimes

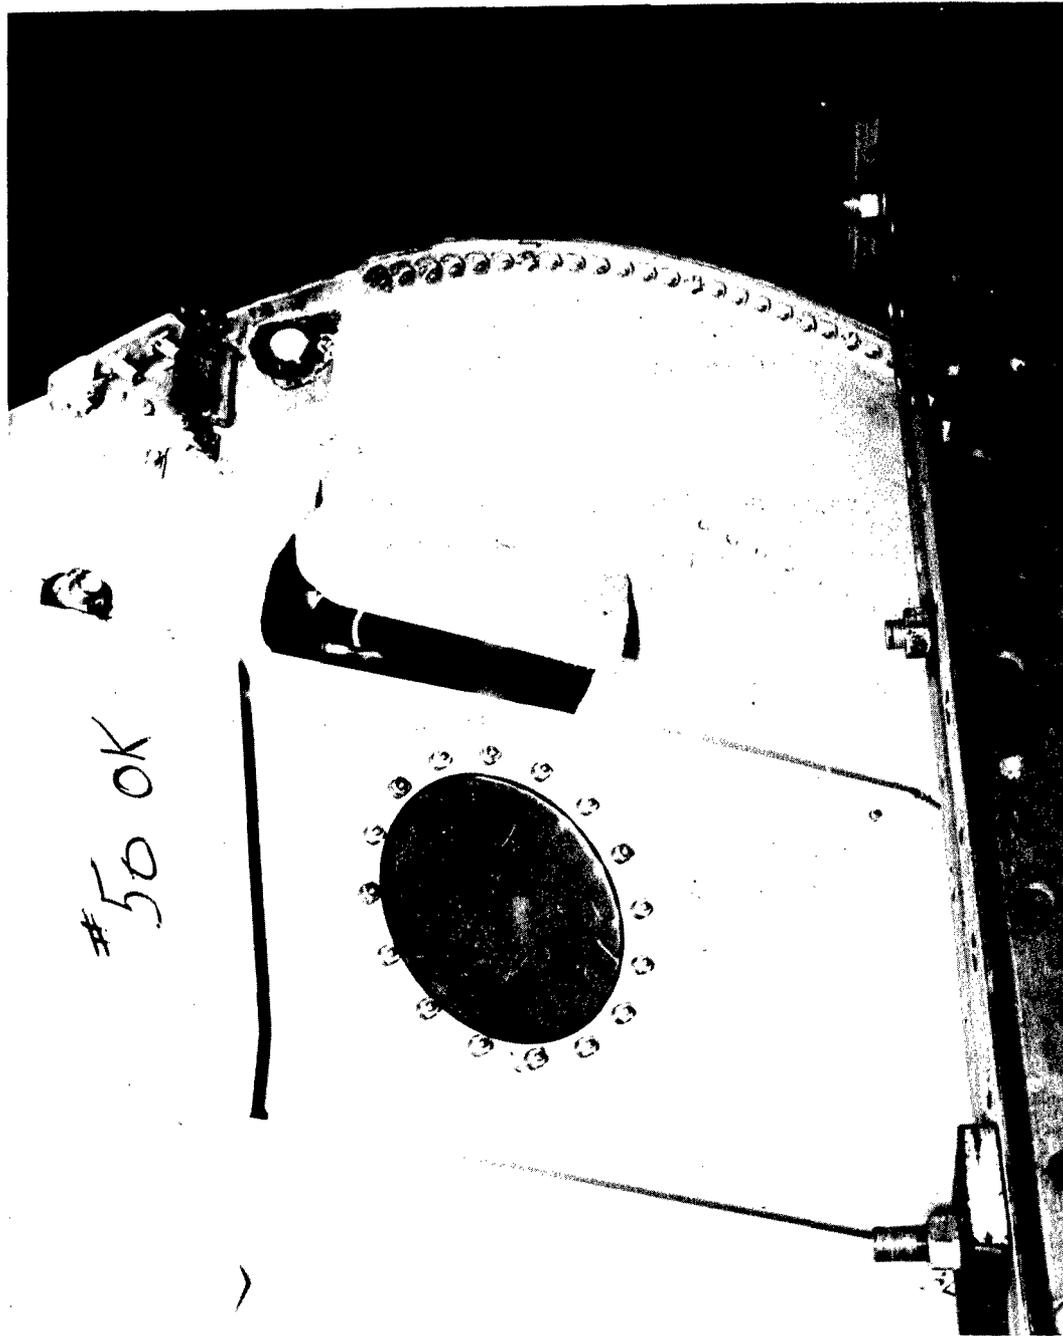
A static pressure test for both positive and negative pressure was conducted to determine the residual strength after the fatigue test. The escape module was pumped down to -13.5 psig (the limit of the test system) and returned to ambient pressure. The module was then tested hydrostatically to +20 psig, at which point the forward bulkhead failed. This is shown in Figure 31.

Figure 31. Hydrostatic Failure of the Forward Bulkhead of the Crew Module
