DOUGHTY POND UPPER

PHASE I INSPECTION REPORT NATIONAL DAM SAFETY PROGRAM

NJ 00081

MAY 1978

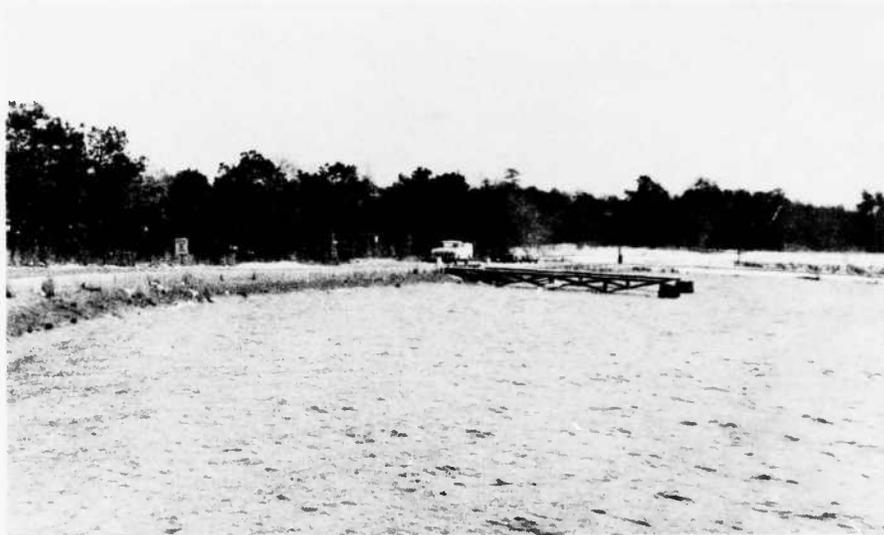
OVERALL VIEW OF DAM

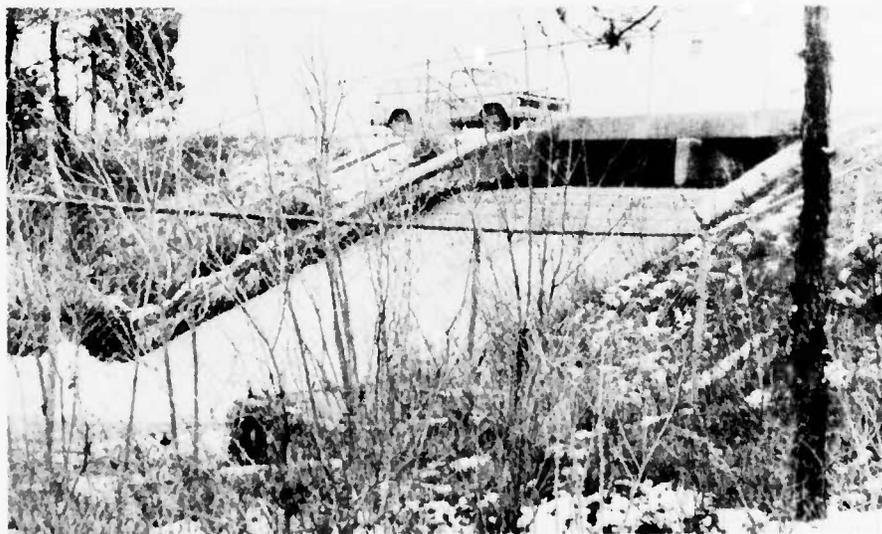
SPILLWAY

The spillway is a concrete weir 25 feet wide with a pier in the center supporting a bridge constructed over the spillway. The spillway abutments are cracked and spalled. Differential settlement of up to 3 inches was observed at the abutments. The channel directly downstream of the spillway is about 60 feet wide and conveys flow under the Garden State Parkway bridges. The bridge openings are approximately 80 feet wide and about 20 feet high.

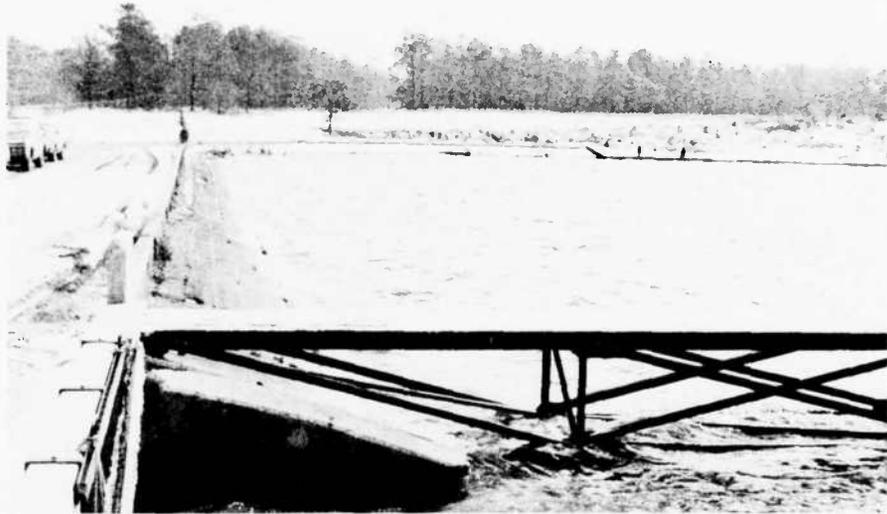
UPSTREAM FACE OF DAM

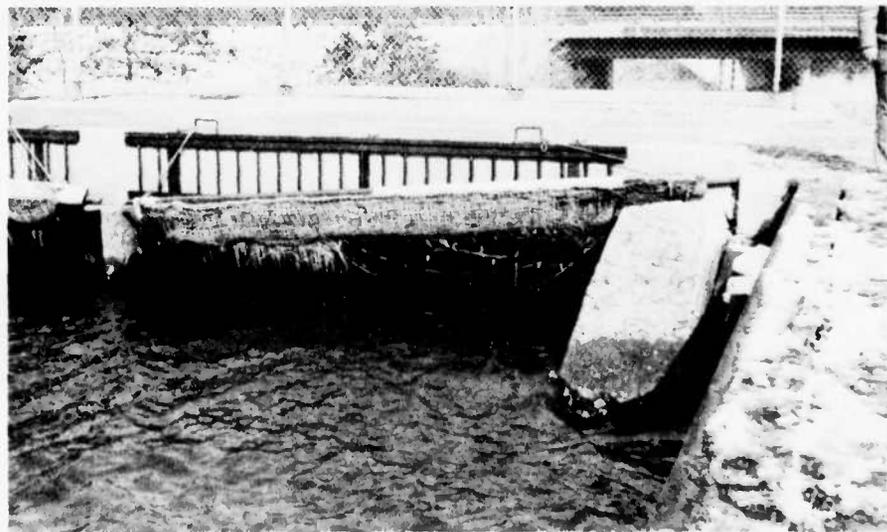
CRACKING AND DIFFERENTIAL SETTLEMENT OF
CONCRETE ALONG THE SPILLWAY

Differential settlement of up to 3 inches was noted at the junction of the spillway and embankment at both the left and the right sides.

(1) Investigate and determine the cause of the settlement in the embankment adjacent to the spillway.

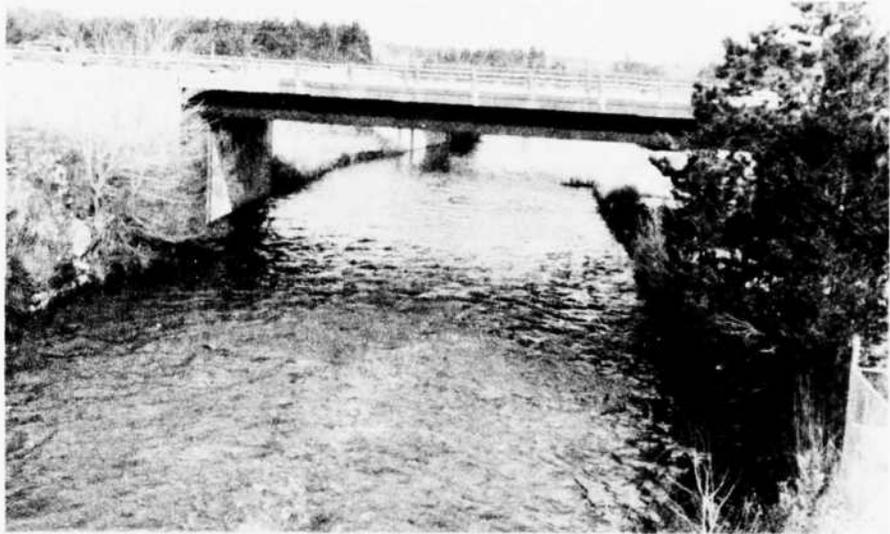
CHANNEL DOWNSTREAM OF SPILLWAY

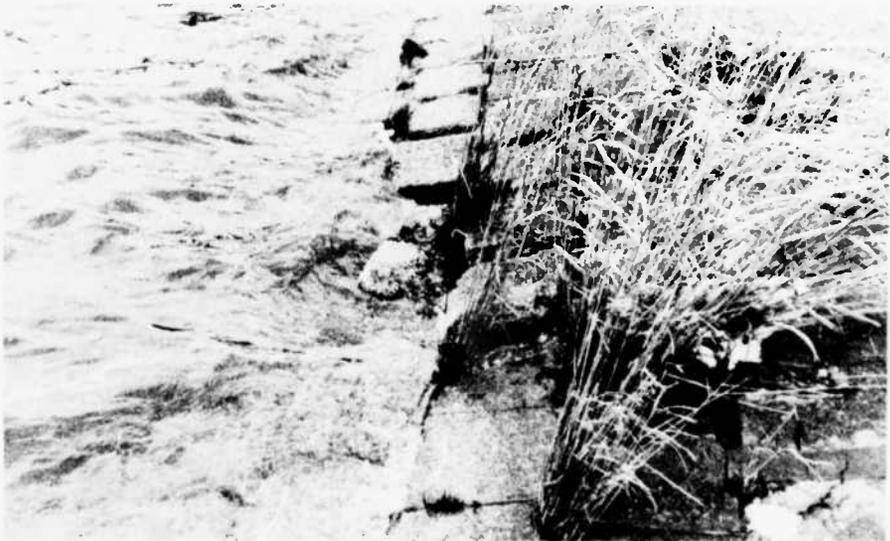
SLOPE PROTECTION ALONG UPSTREAM FACE

One foot square concrete blocks mortared
into place. Some displacement and minor
spalling has occurred.

The spalling appears to be
superficial.
