6 CHARACTERIZATION OF ELECTRICALLY ACTIVE DEFECTS IN Si USING CCD IMAGE SENSORS.

Texas Instruments Incorporated

11 Feb 1978

9 Final Technical Report,
30 Jul 1976 - 31 Jan 1978

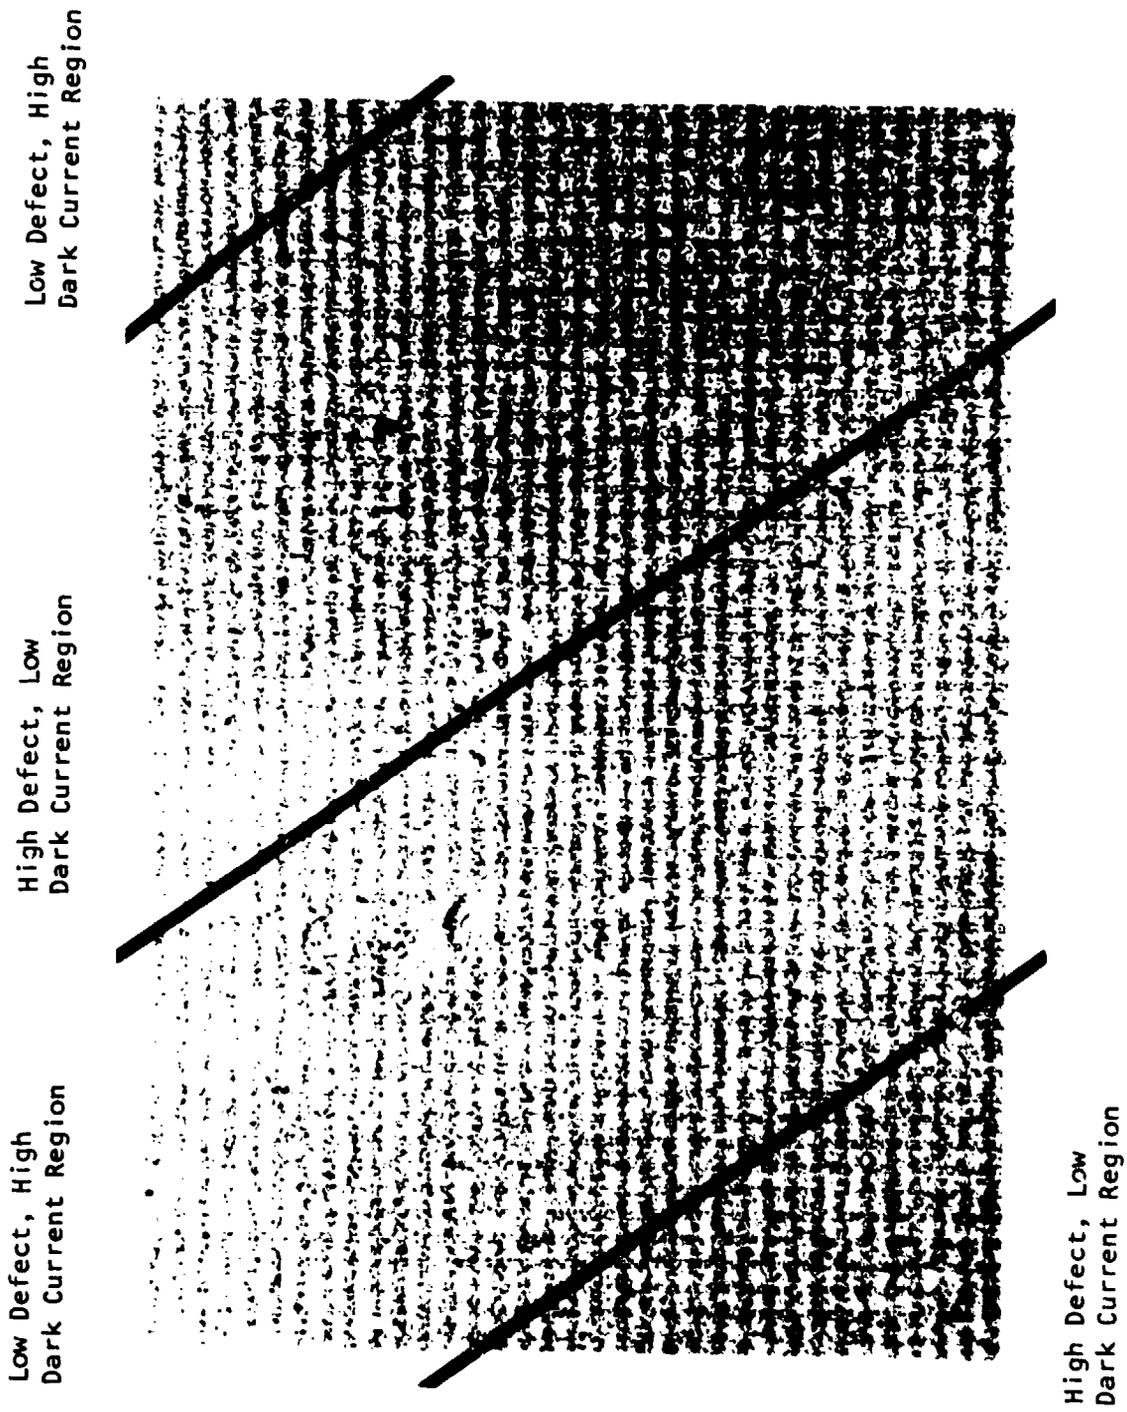
Figure 3 Portion of a 422 Reflection Topograph of Device Exhibiting Banded Swirl Pattern of Dark Current

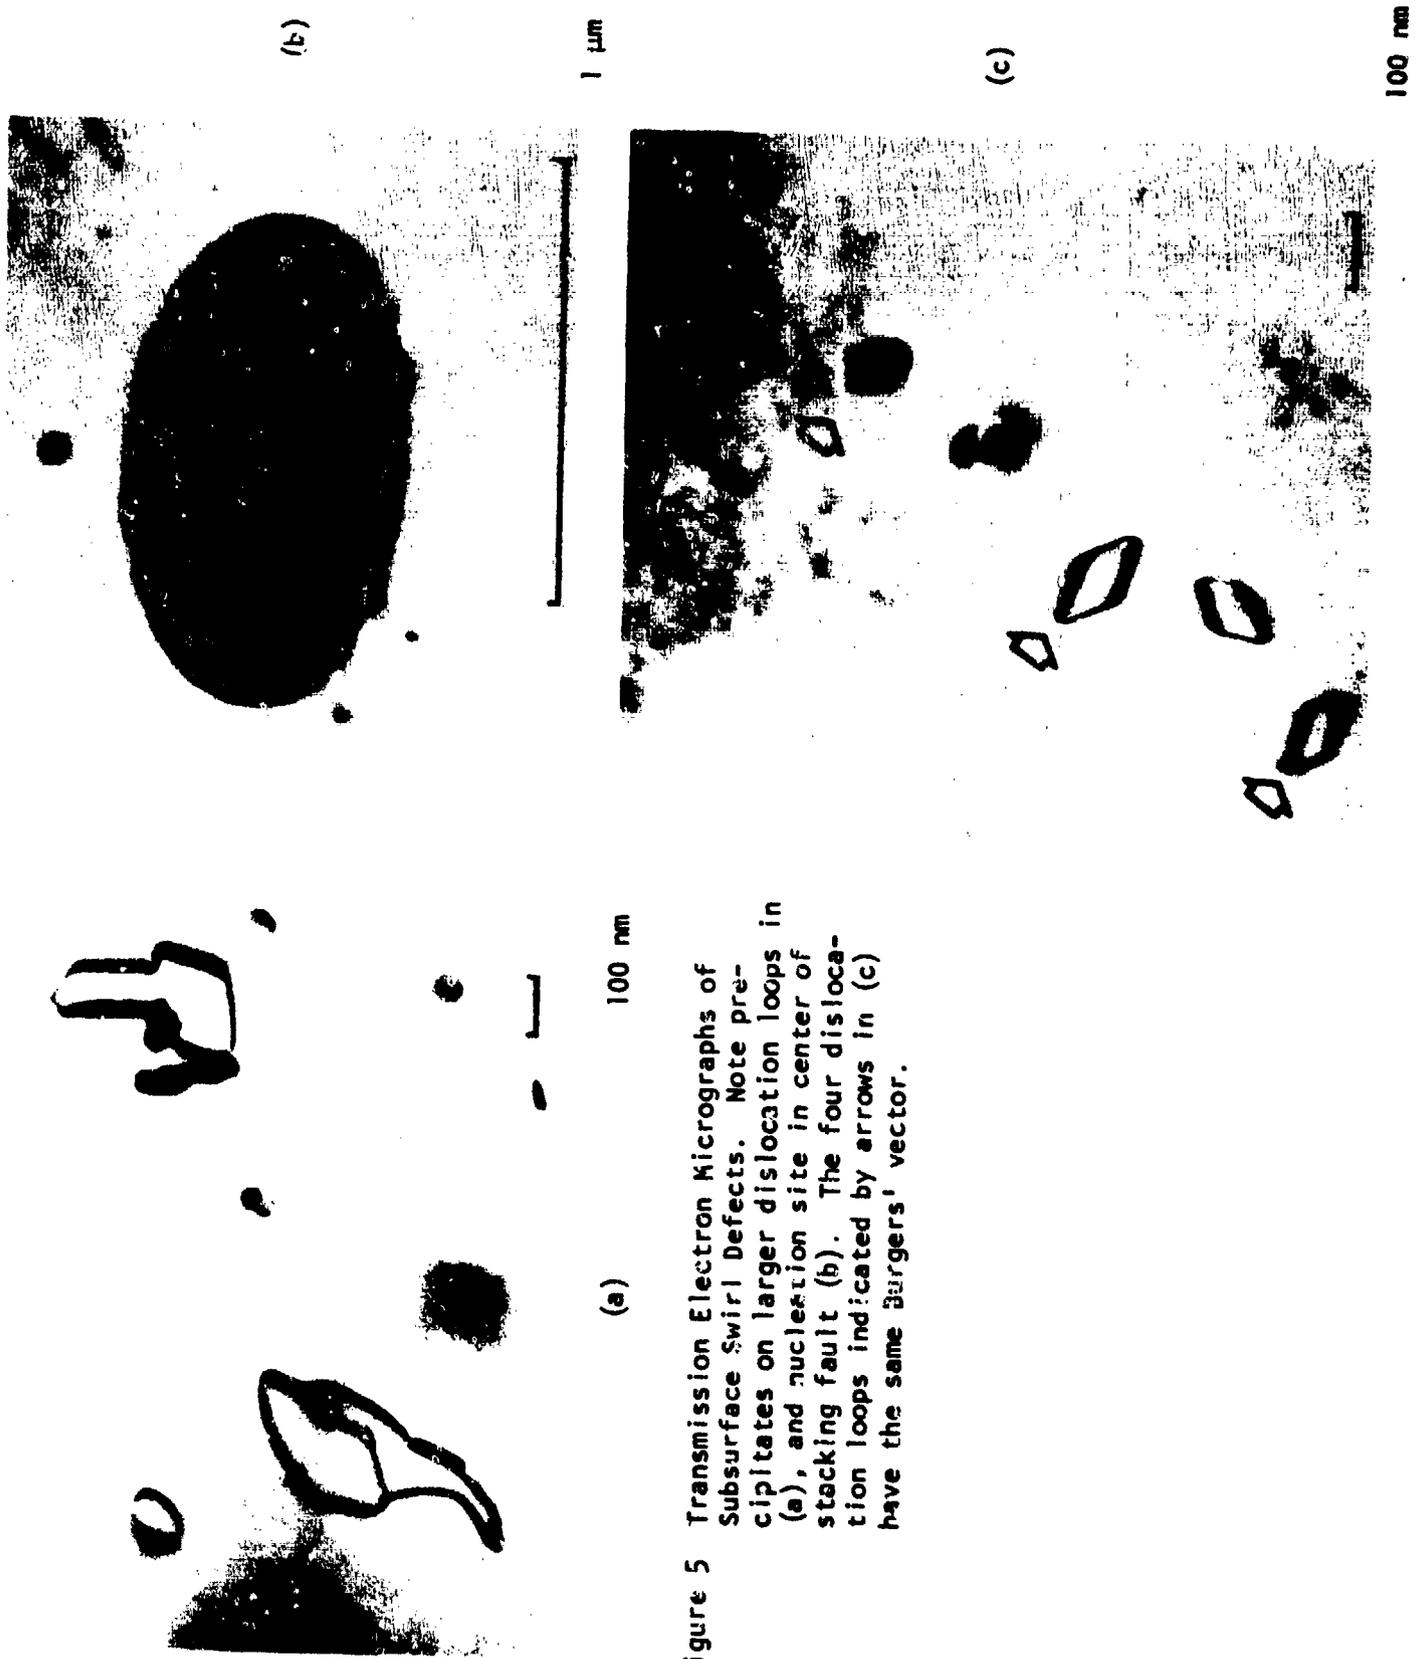
Figure 5 Transmission Electron Micrographs of Subsurface Swirl Defects. Note precipitates on larger dislocation loops in (a), and nucleation site in center of stacking fault (b). The four dislocation loops indicated by arrows in (c) have the same Burgers' vector.

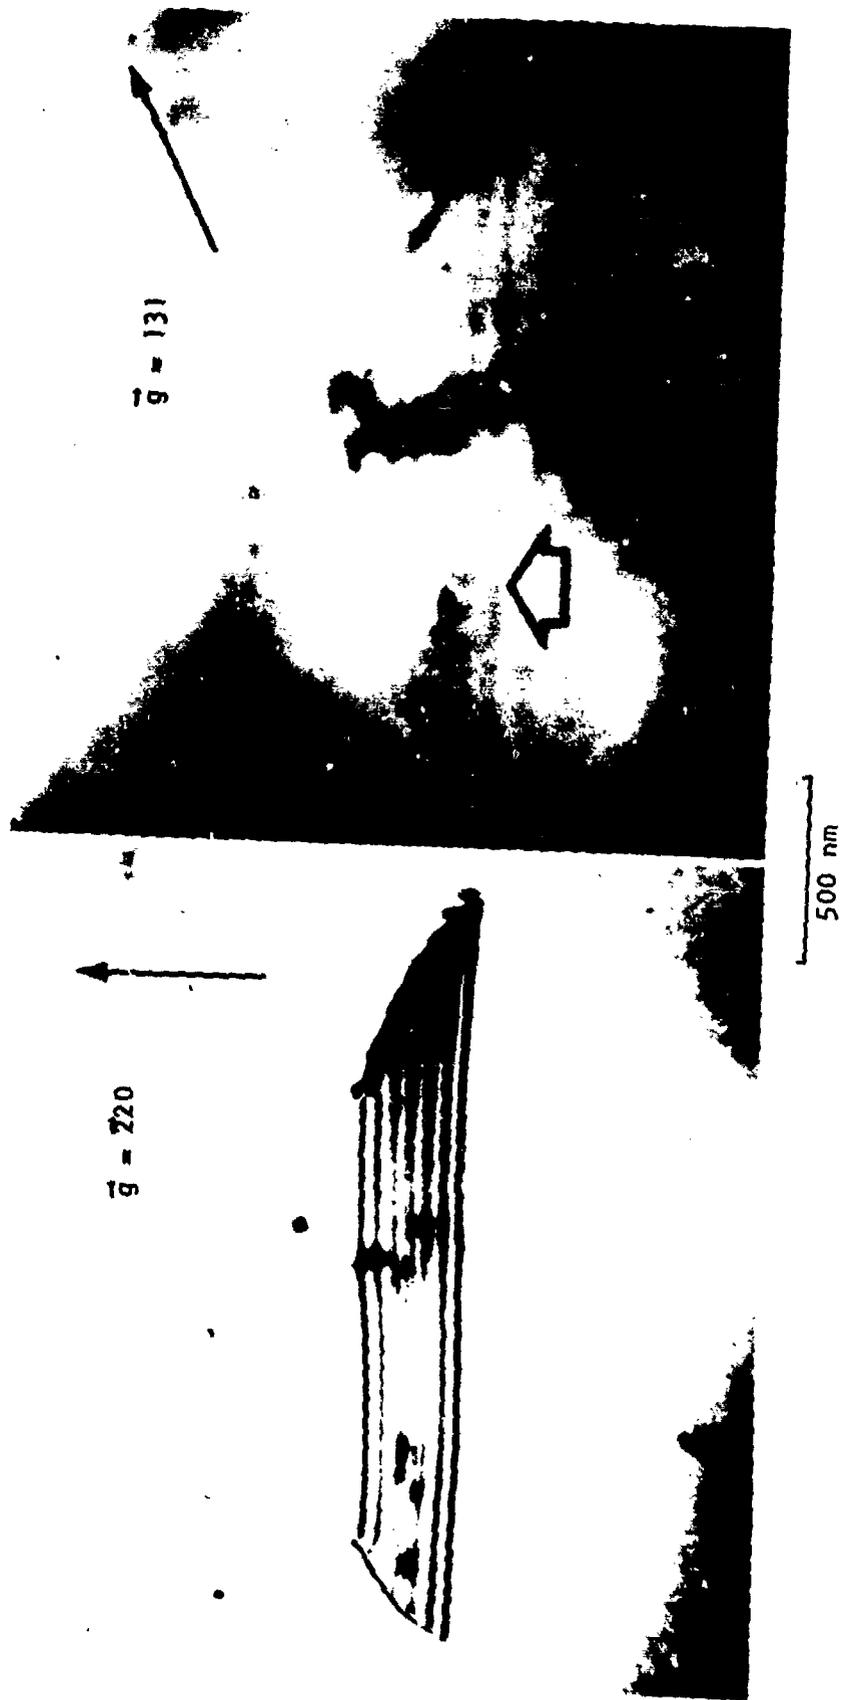
Figure 6 Stacking Fault Underneath a Channel. Residual contrast (open arrow) when $\vec{g} = 131$ shows stacking fault has an adsorbed impurity.

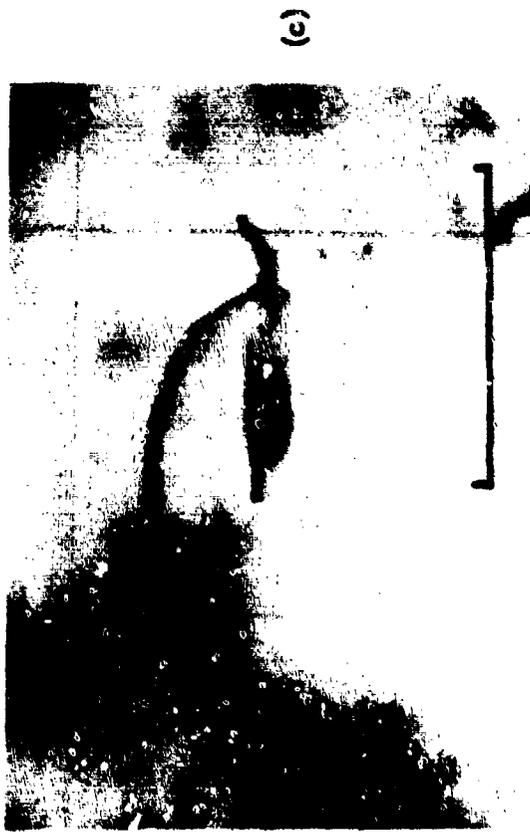
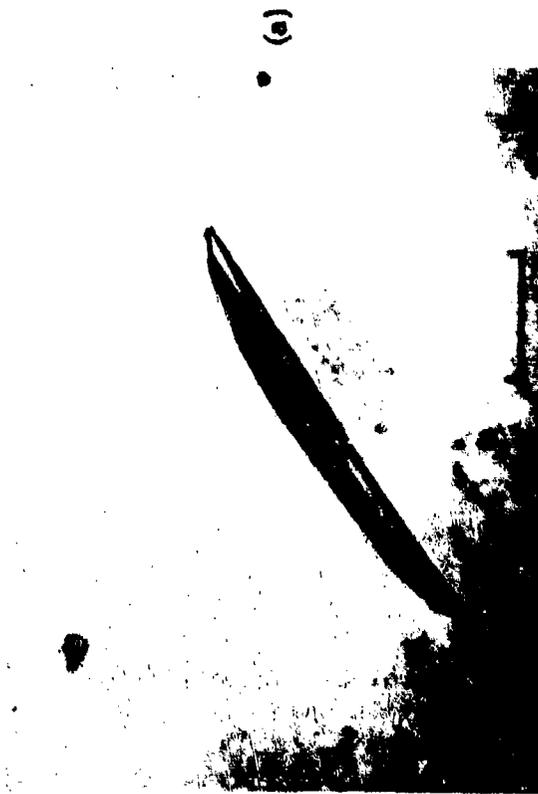
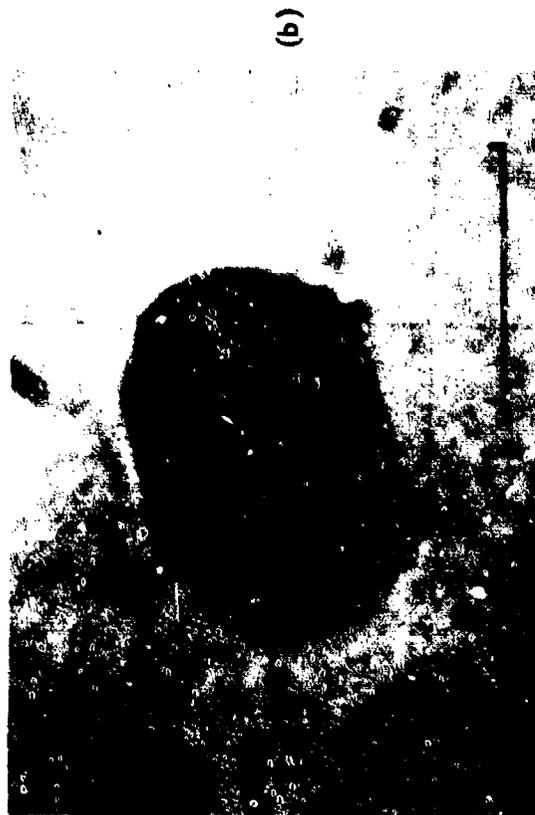
Figure 9 TEM Micrographs of Defects in Czochralski - Control Group Devices. (a) and (b), stacking faults in channel stops; (c) and (d), dislocations in channels. All markers = 0.5 μm .

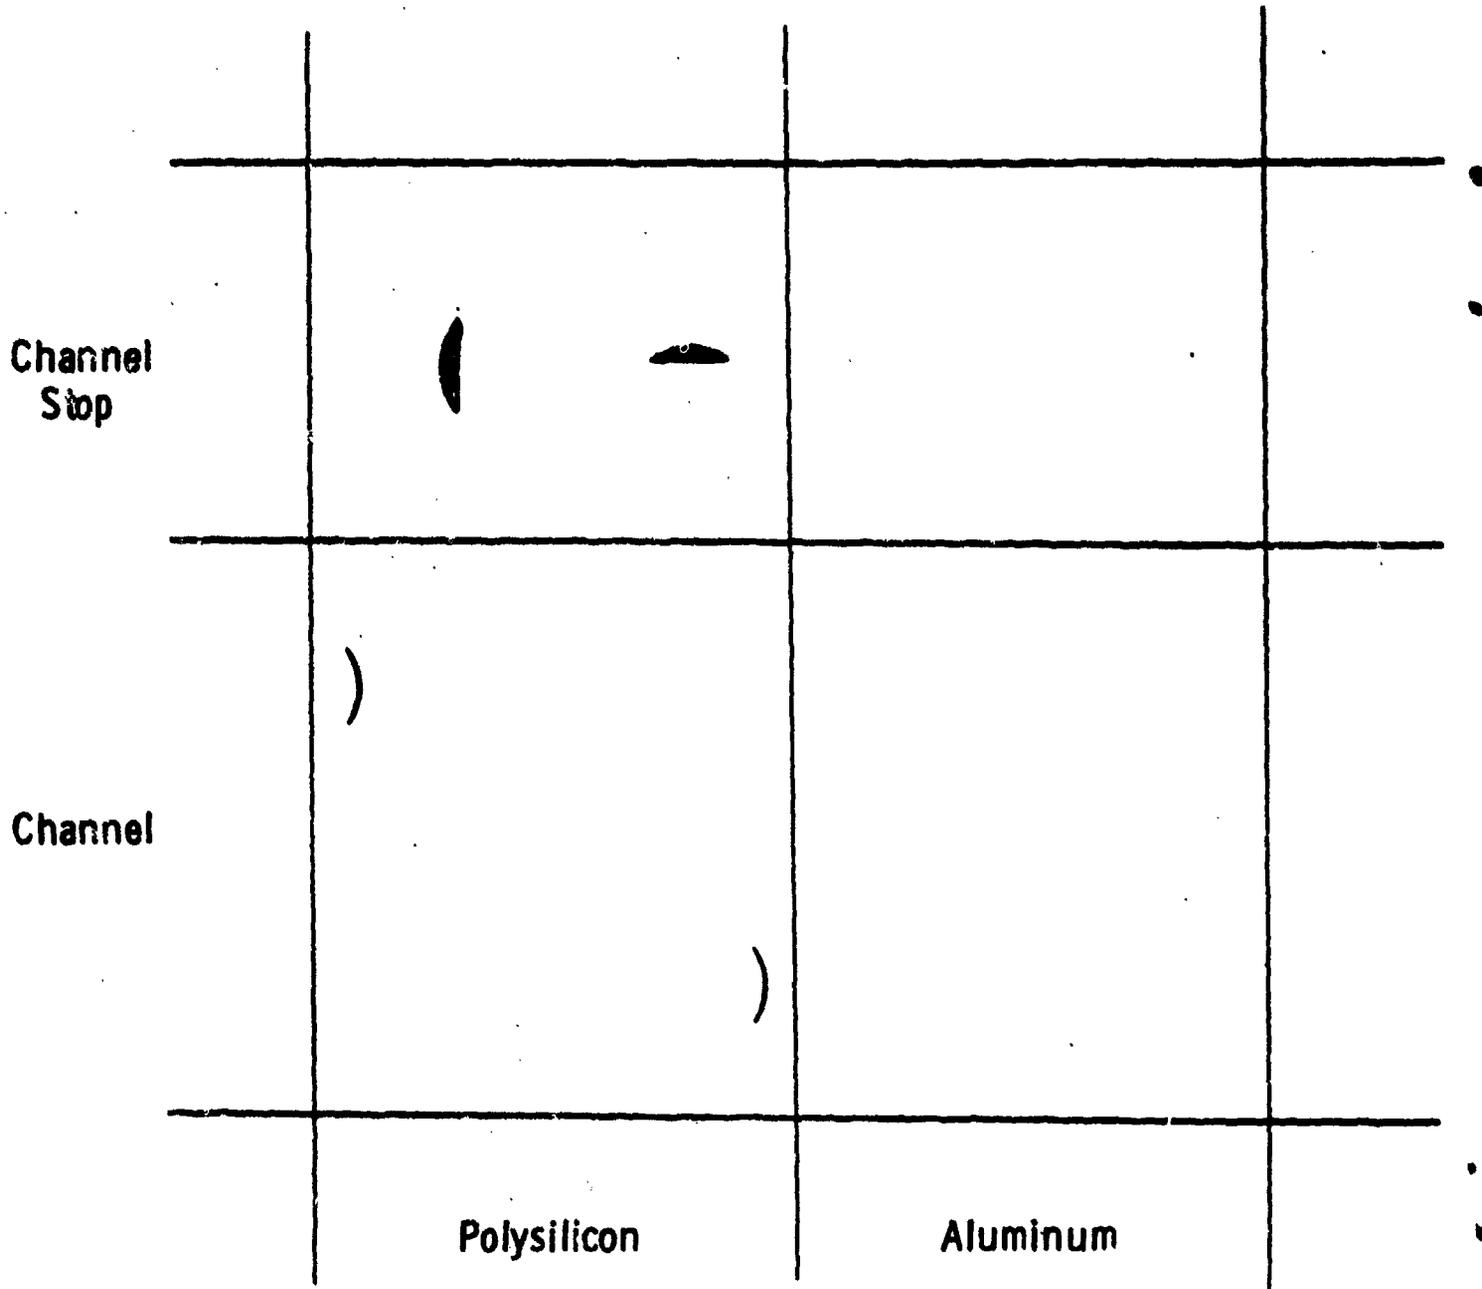
Figure 10 Distribution of Defects in Czochralski - Control Group. Stacking faults in channel stops, and dislocation loops in channels, both predominantly under the polysilicon electrode.

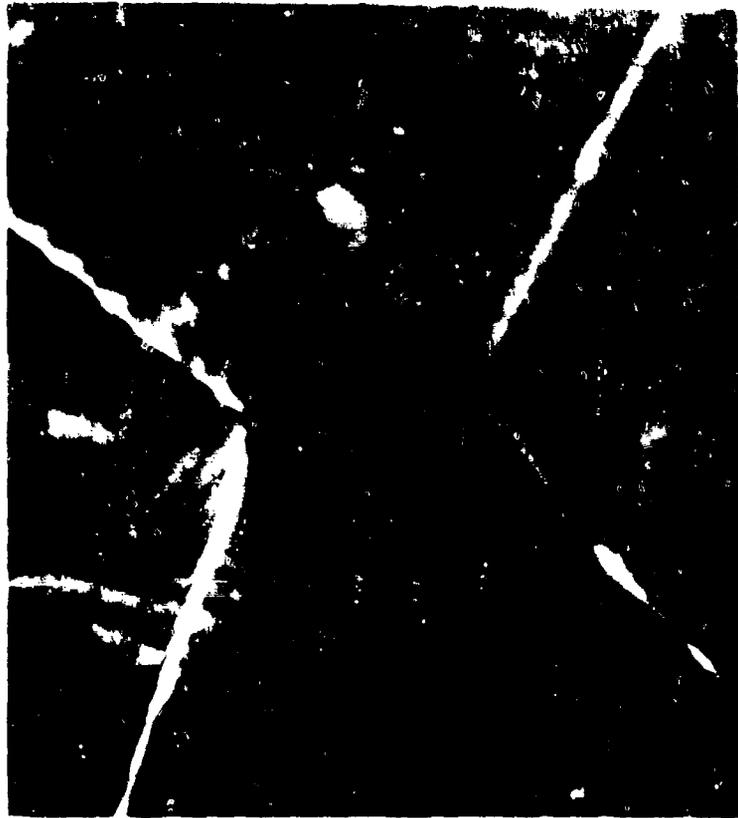
Occasionally, we find that a dislocation reaction has occurred. Figure 18 illustrates an example where two dislocations having the same Burgers vector, but lying on two different (111) planes (the traces of which are perpendicular in this figure), intersect.

Figure 18 Dark Field Transmission Electron Micrograph of Float-Zoned Wafer Showing Dislocation Reaction. Two perpendicular 60° dislocations moving on two different slip planes, but with the same Burgers vectors, have reacted to form nearly right angle configuration.

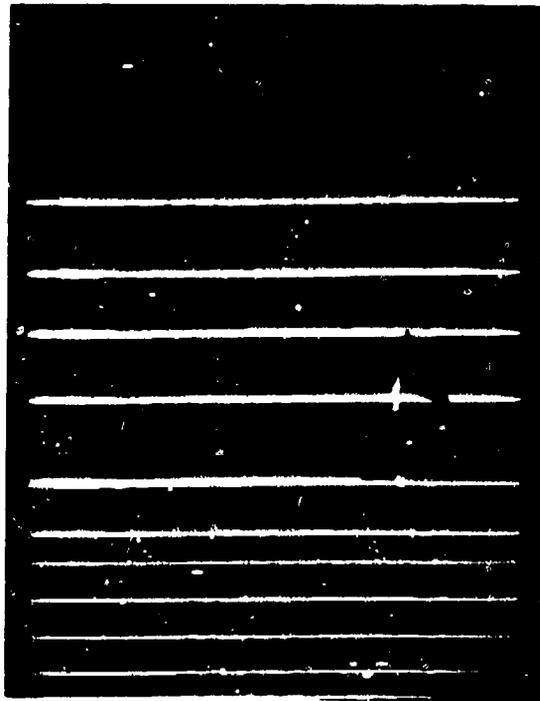
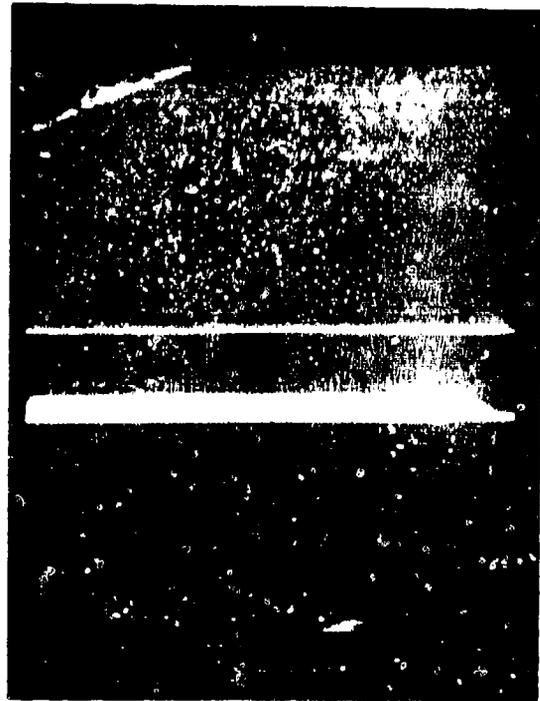
Figure 22 Dark Current Patterns - Czochralski Group 1. Defect at arrow in (b) is shown in topograph, Figure 23(a).

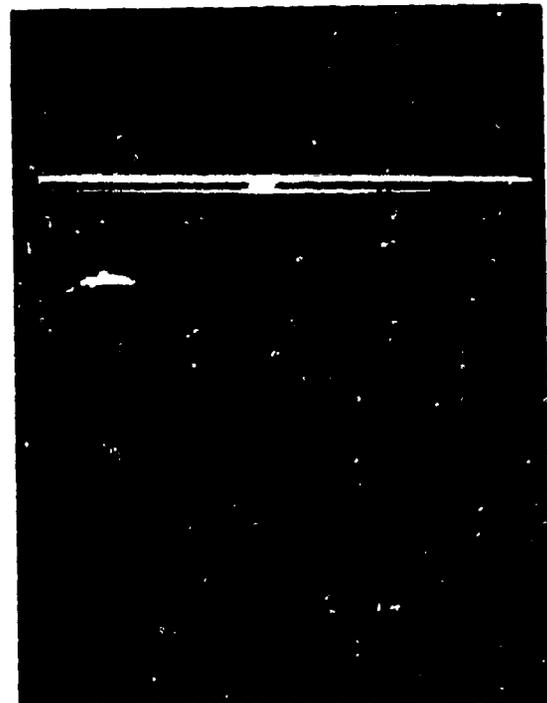
Figure 24 Dark Current Patterns of Three Adjacent Devices, Czochralski Group 2. Defect at arrow in device 3 is shown in topograph, Figure 25.

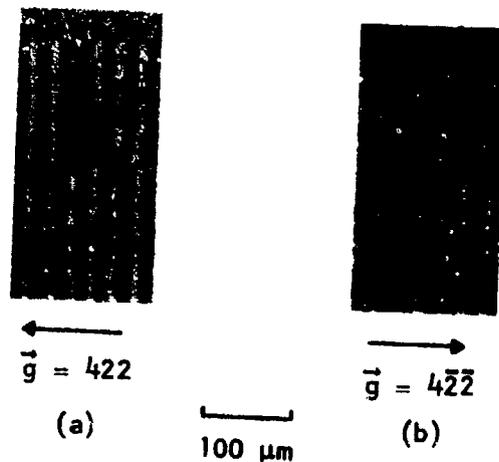
Figure 30 Reflection Topographs of Channel Stop Dislocations That are Dark Current Sources

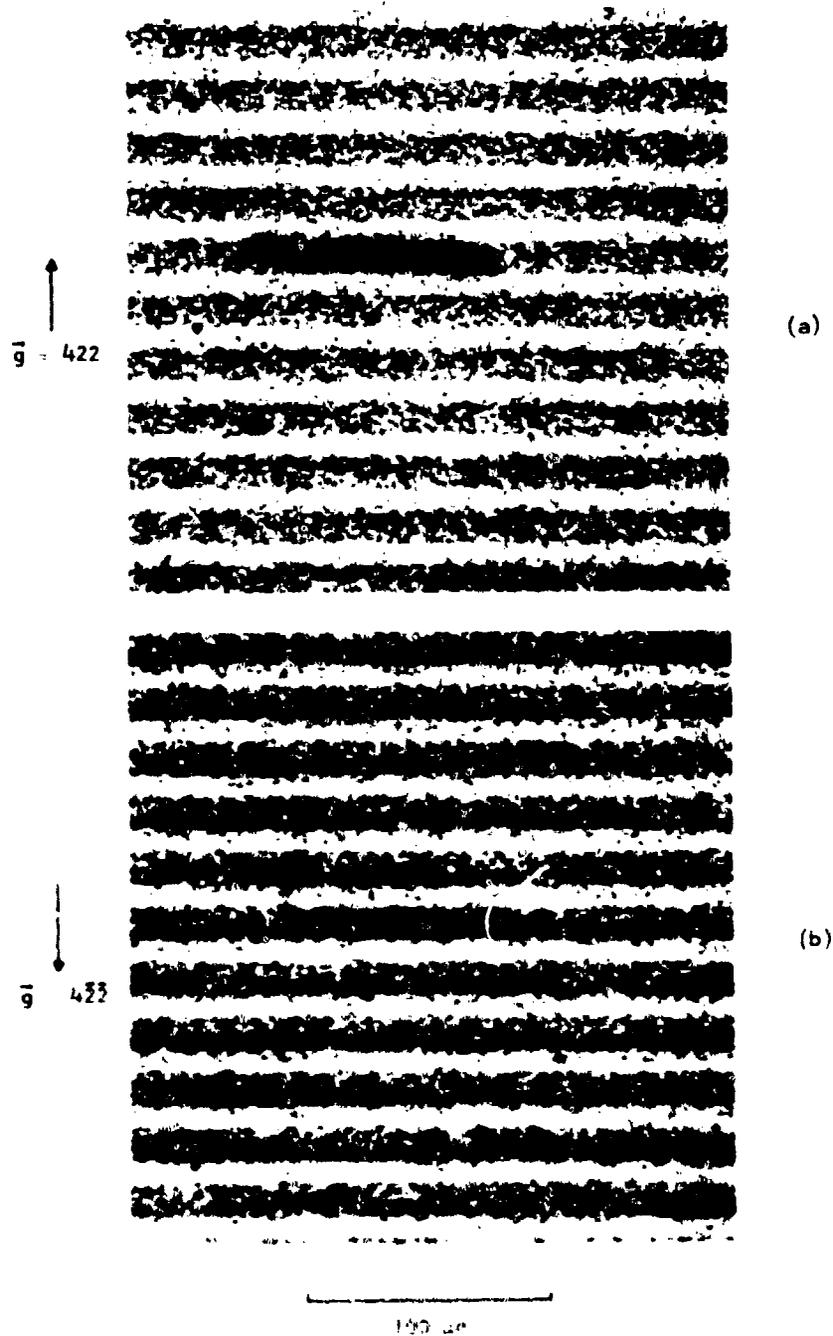
Figure 32 Electrically Inactive Dislocation in CCD Imager

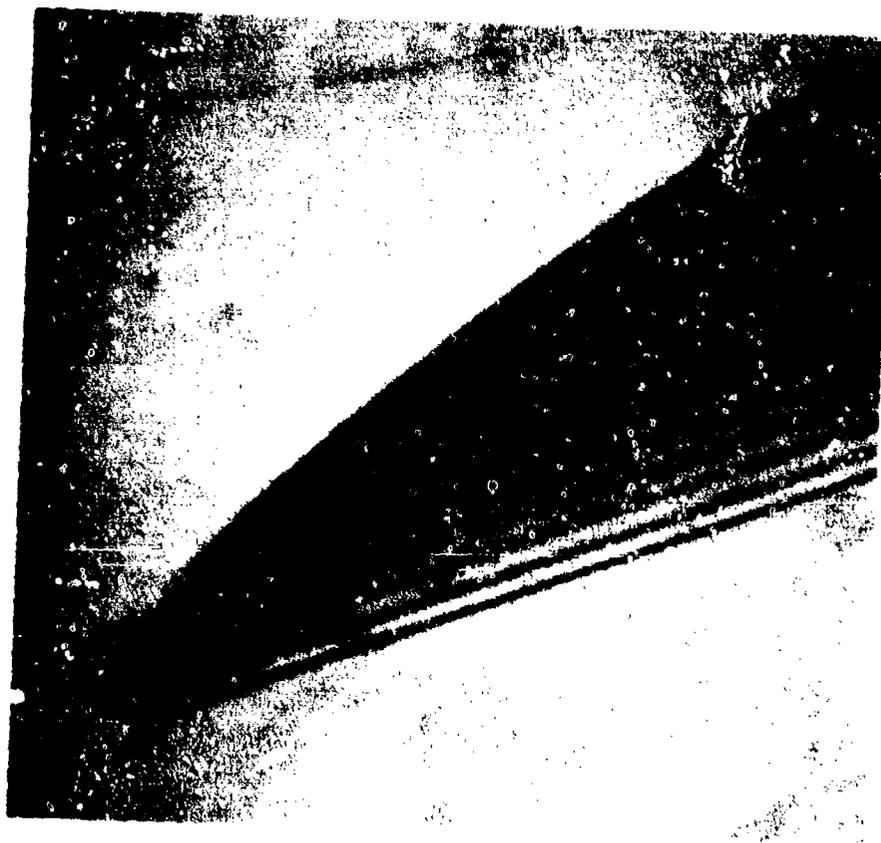
Figure 68 Stacking Fault with Precipitate Colony at Edge

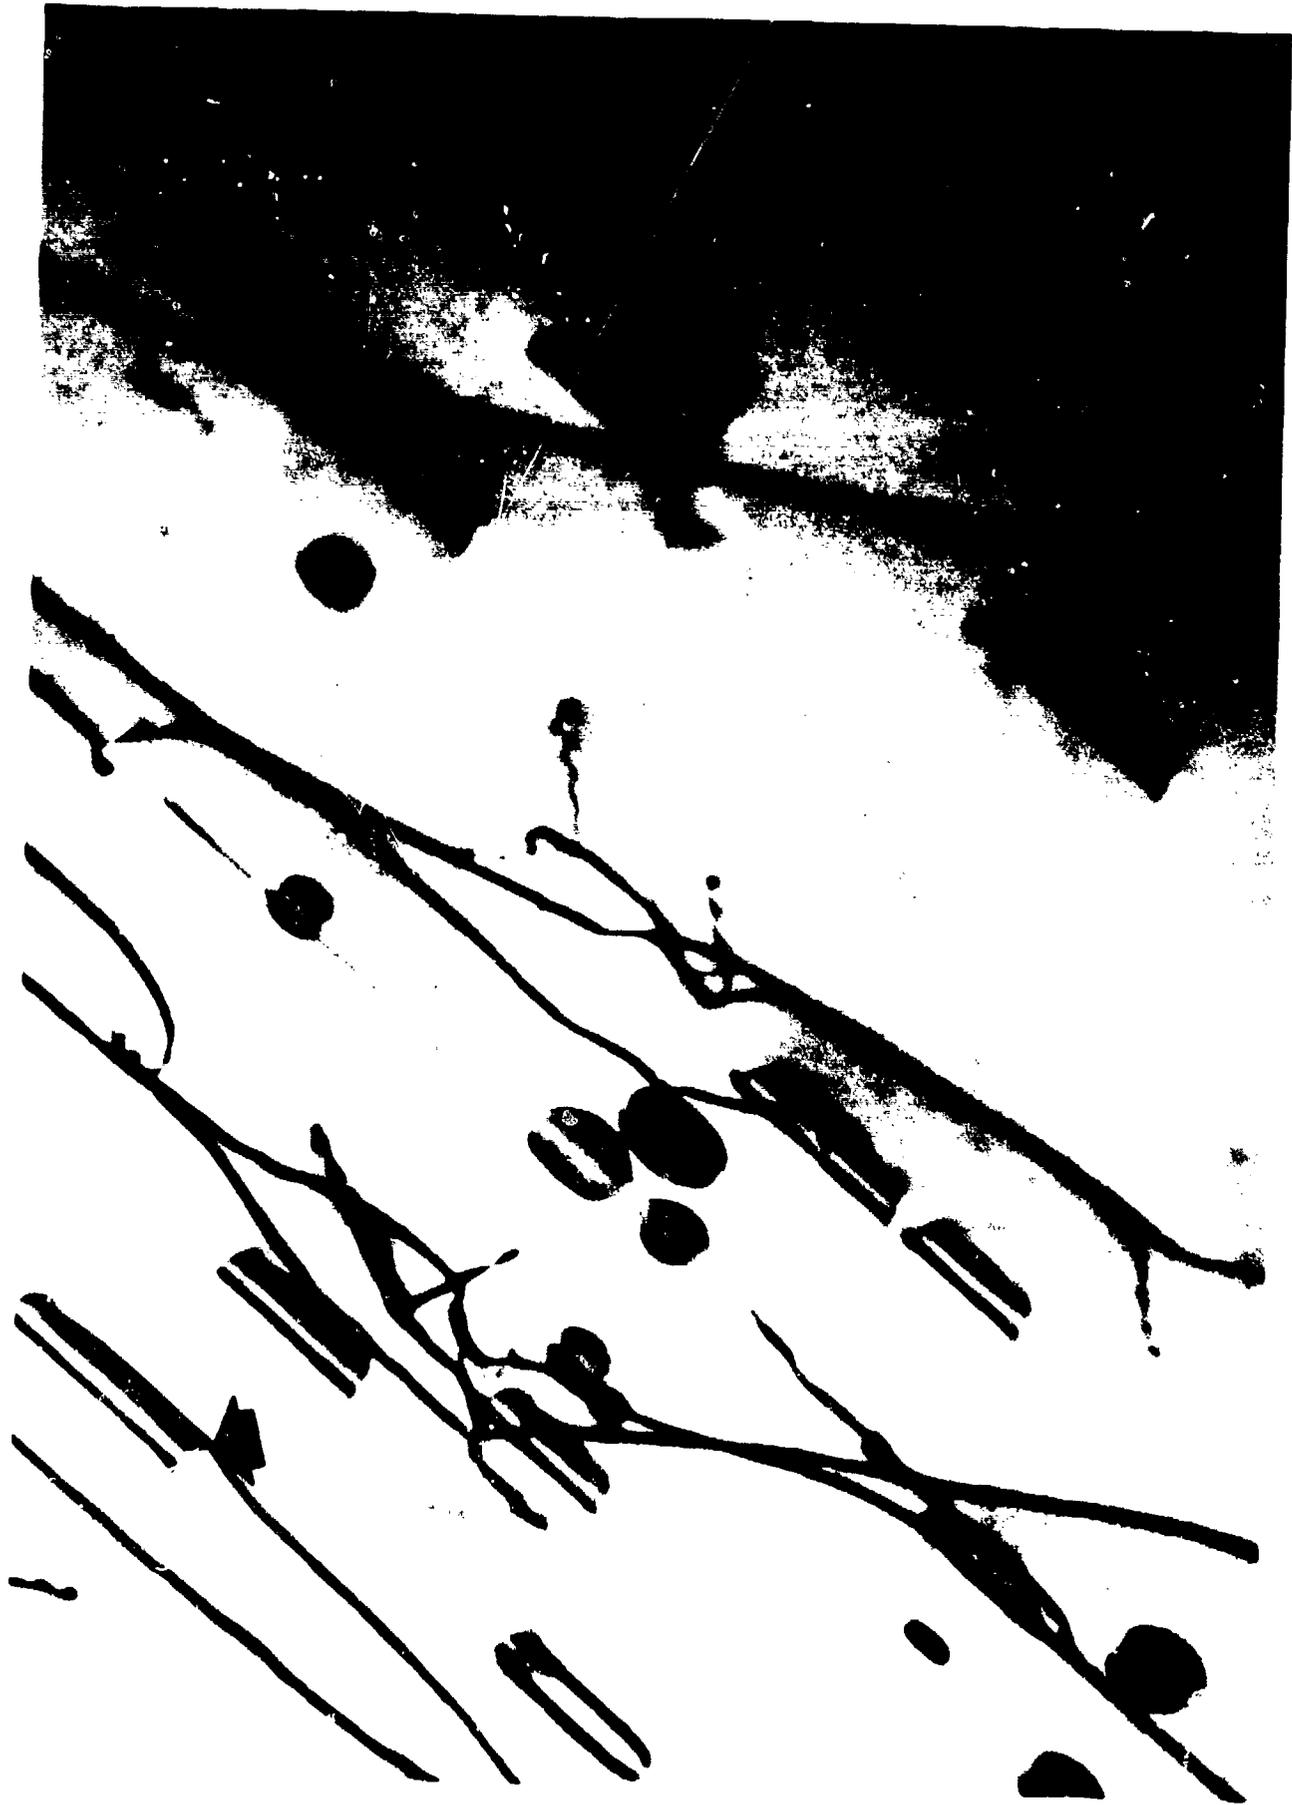
Figure 69 Subsurface Nucleation of Stacking Faults. Arrow indicates stacking fault in process of unfauling.

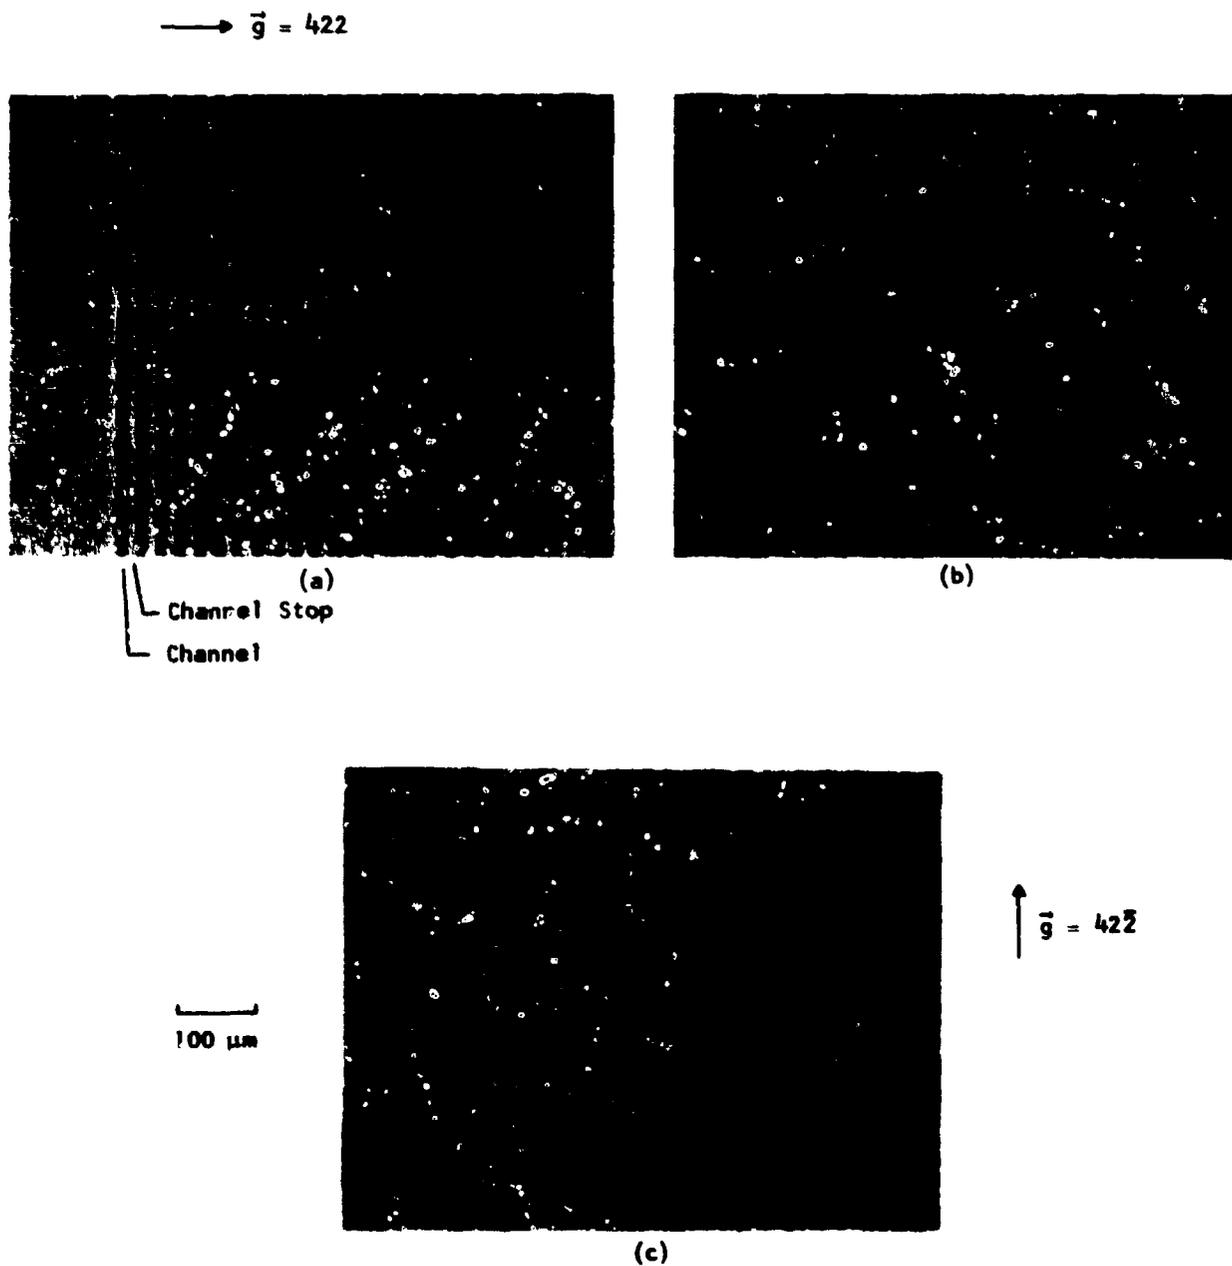
Figure D-3(a) is a $\lambda/22$ reflection topograph of an imager that contains a surface scratch applied after device fabrication. The same scratch is visible in an optical micrograph of the imager in Figure D-3(b). The channels in the optical micrograph can be readily identified since they contain additional surface relief arising from the oxidation of the polysilicon. This relief is not found on the channel stops. The scratch, therefore, is seen to lie entirely on the higher channels.

Figure D-3 Postprocessing Scratch in CCD Imager. (a) 422 reflection topograph. (b) optical photograph, (c) 422 reflection topograph. (a) and (c) are mirror images of (b).

The same scratch, imaged in a $42\bar{2}$ reflection, is shown in Figure D-3(c). The faint black bands running from left to right arise from the same type of contrast mechanism as the bands in Figure D-3(a), but the surface relief is substantially less. The horizontal dark band corresponds to the silicon under the polysilicon gate, while the light band is under the aluminum gate. This surface relief results from the process step where the polysilicon is oxidized, causing additional oxidation of the silicon substrate that is not covered by the polysilicon. The channels and channel stops, which are very faint, may be seen by viewing the image at a glancing angle from the bottom of the page. By correlating Figures D-3(b) and D-3(c), it will be seen that the channels appear light, while the channel stops are darker. This contrast arises from the strain field of the doping in the channel stop.

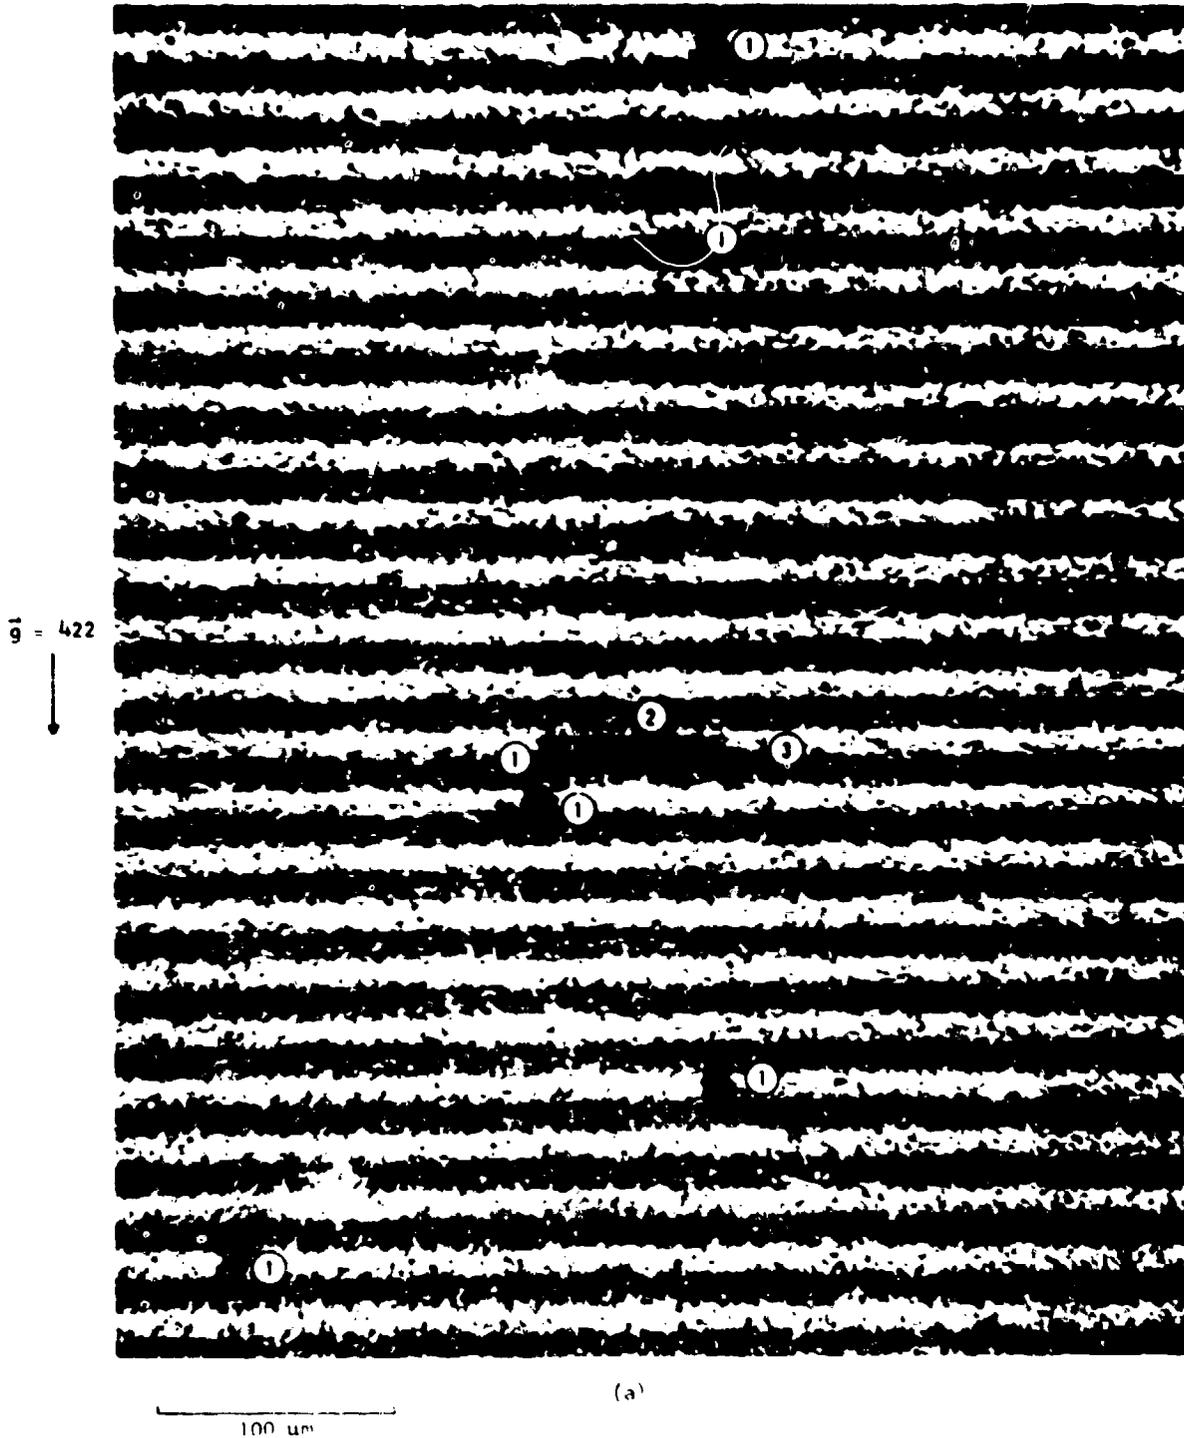
Figure D-5 Topograph of Dislocations in Device on Float-Zoned Material
