1. REPORT NUMBER		2. GOVT ACCESSION NO. 10	3. RECIPIENT'S CATALOG NUMBER
4. TITLE (and Subtitle) Phase I Inspection Report Owasco Lake Outlet Dam Oswego River Basin, Cayuga County, New York Inventory No. NY 776		5. TYPE OF REPORT & PERIOD COVERED Phase I Inspection Report National Dam Safety Program

OSWEGO RIVER BASIN

OWASCO LAKE OUTLET DAM

INVENTORY No. NY 776

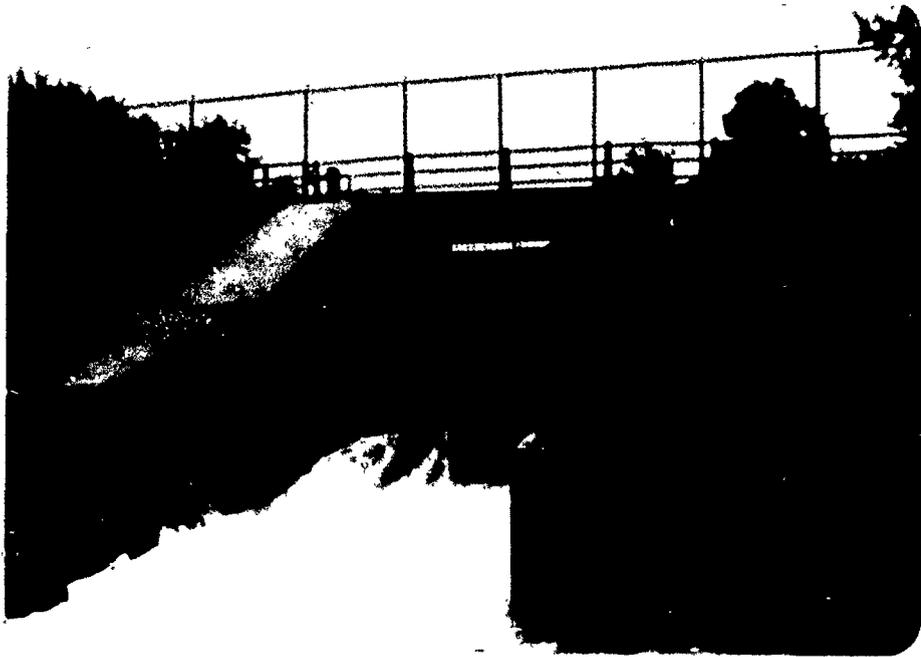
The downstream channel was in satisfactory condition. There was a wingwall and riprap extending well downstream of the dam on the east bank. The west bank was an earthfill on a steep slope with several gullies caused by surface runoff.

Principal Spillway, Note Gully at Right

- a. After the structural stability analysis has been completed, appropriate remedial work should be performed.
- b. Joints between blocks of masonry which are missing mortar should be repointed.
- c. Small gullies and erosion on the downstream slope of the abutments and on the west bank of the downstream channel should be regraded.
