XM587E2/XM724 Electronic Time Fuses

Developmental Test/Operational Test (DT/OT) II

by W. L. Aschenbeck

November 1979

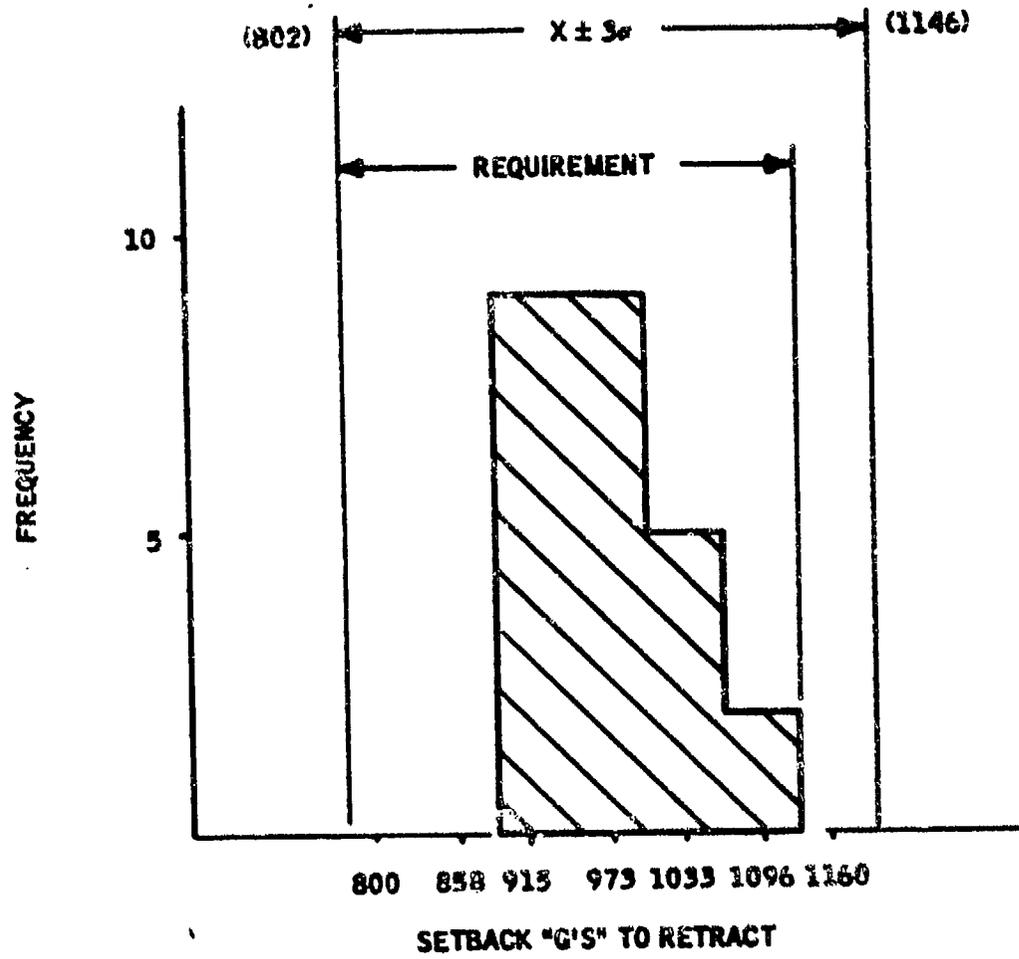
Figure 13. Setback pin operational test results.

A minor problem was experienced during the fabrication and testing of the second lot of S&A modules. The problem involved the specified setback pin operation test, M-106 (Reference Drawing 11720300). Five units from the 125 unit sample failed when the setback pin did not retract and lock-out at the specified 1,100 G's. Each unit from that lot was then subjected to this test to eliminate all of the defects. Eight additional defects were found as a result of this 100 percent screening operation.

- A) Three units from the first five failures were disassembled and examined. No apparent reason for failures was found.
- B) The 10 remaining failures were tested to determine the G level required to retract and lock-out the setback pin. The results of this test were as follows:
 - 7 units functioned at 1,160 G's
 - 2 units functioned at 1,430 G's
 - 1 unit did not function at 1,800 G's.

- 1 unit - no obvious failure mode
- 1 unit - damaged setback spring
- 1 unit - damaged setback pin

The above data was reviewed with HDL. Two corrections for this problem were recommended: A) revise the bias level of the setback spring and B) revise the upper limit of the requirements.

ECP-724-MHR-039, recommended changing the upper limit of the requirement from 1,100 G's to 1,200 G's.

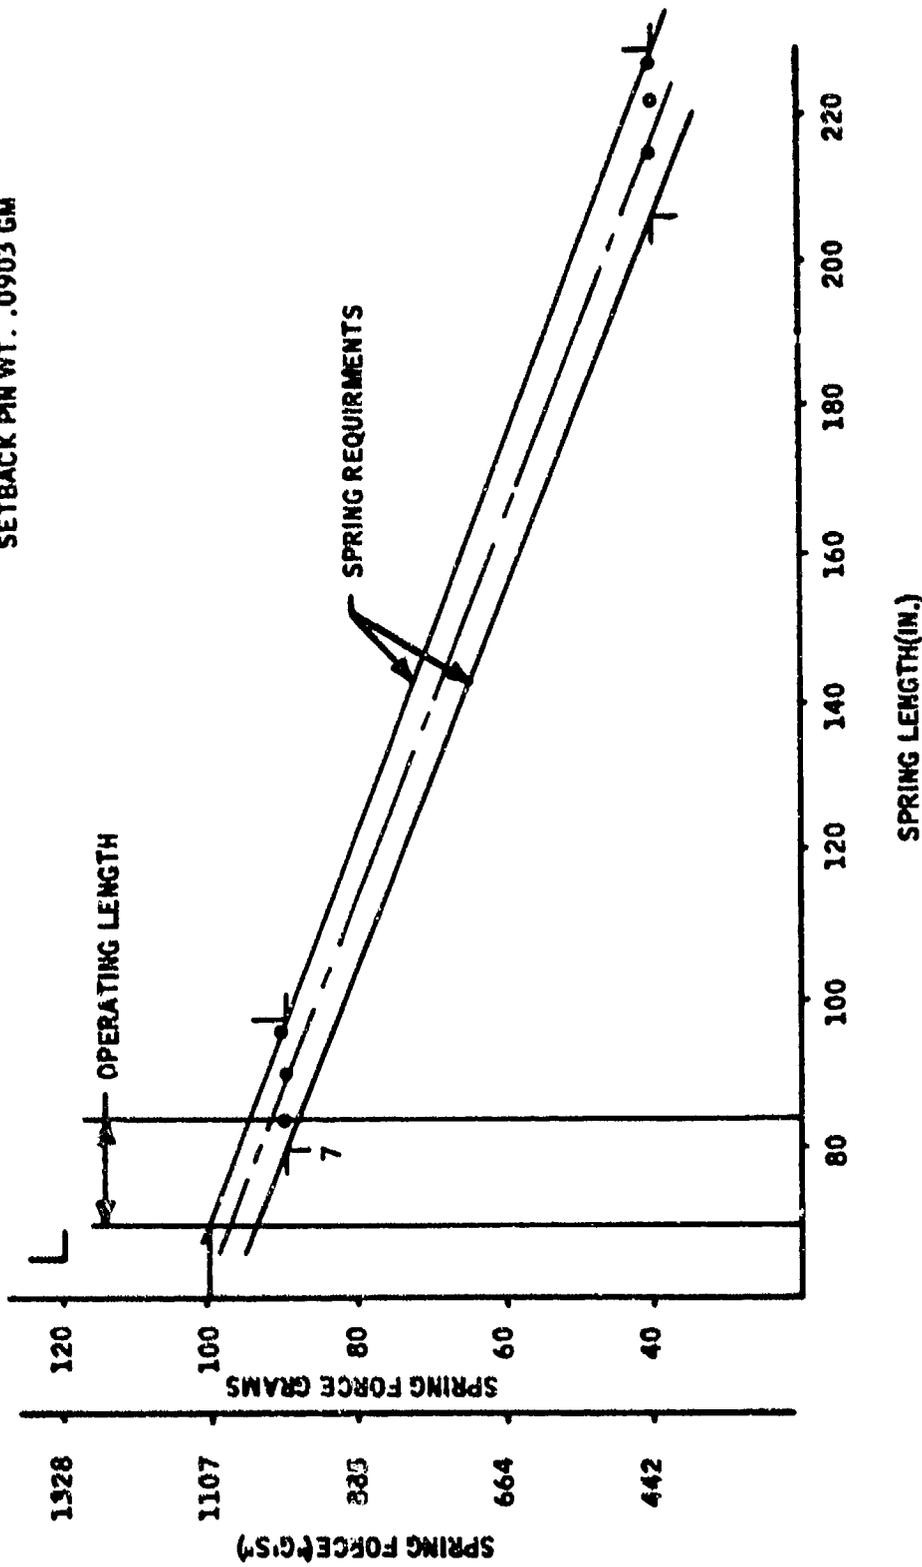
Figure 14. Setback pin operational analysis.

The units which did not function at 1,160 G's were disassembled and analyzed to determine the cause of failure with the following results:

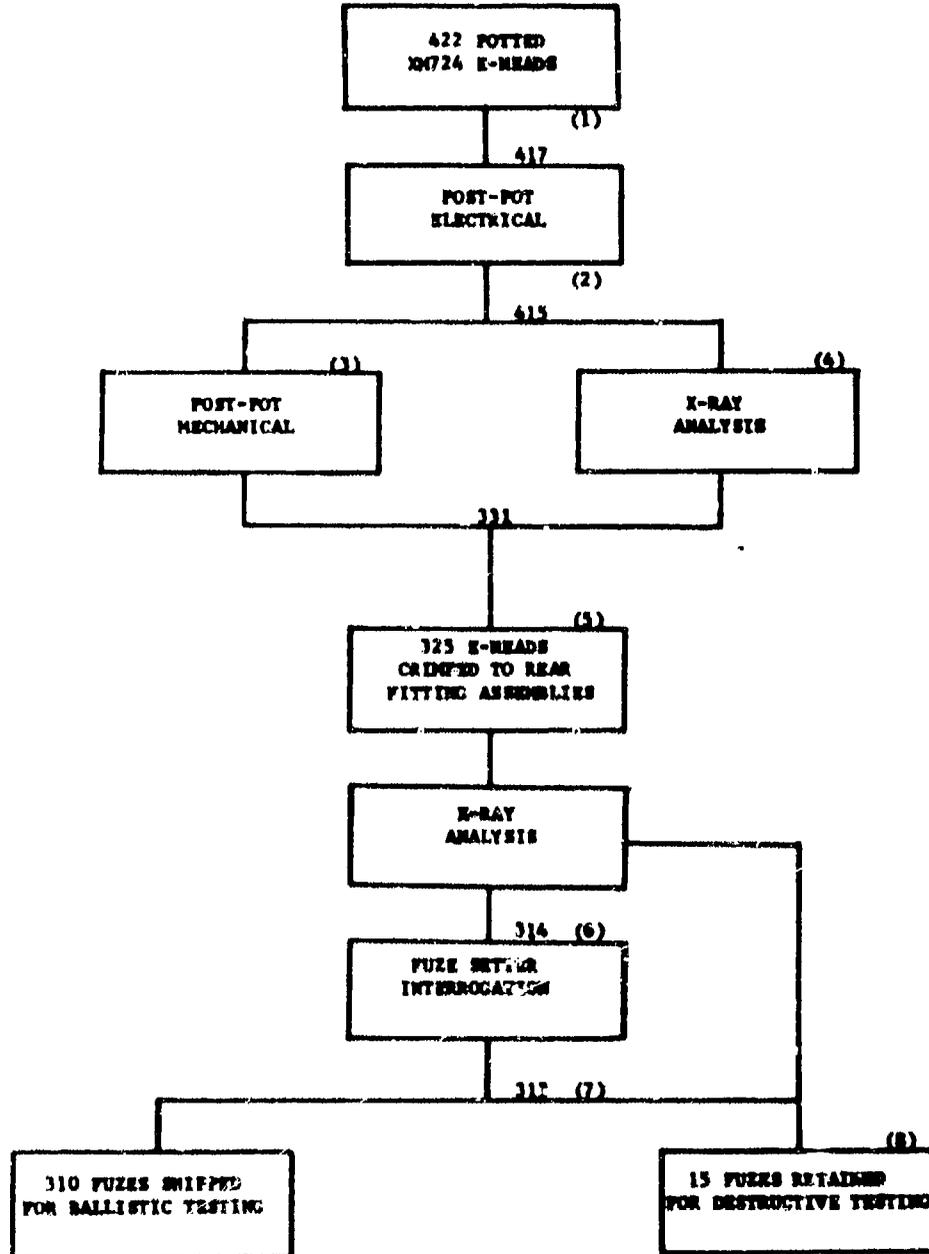
- (1) Five E-heads lost during potting process, four of which exhibited damaged O-rings and one of which was over potted.
- (2) Two E-heads were rejected by the automatic fuse test station.

- (3) A total of 32 E-heads were rejected for various mechanical reasons:
 - a) Five E-heads had nose plugs below .012 or .018 above ogive.
 - b) One E-head traveler was missing.

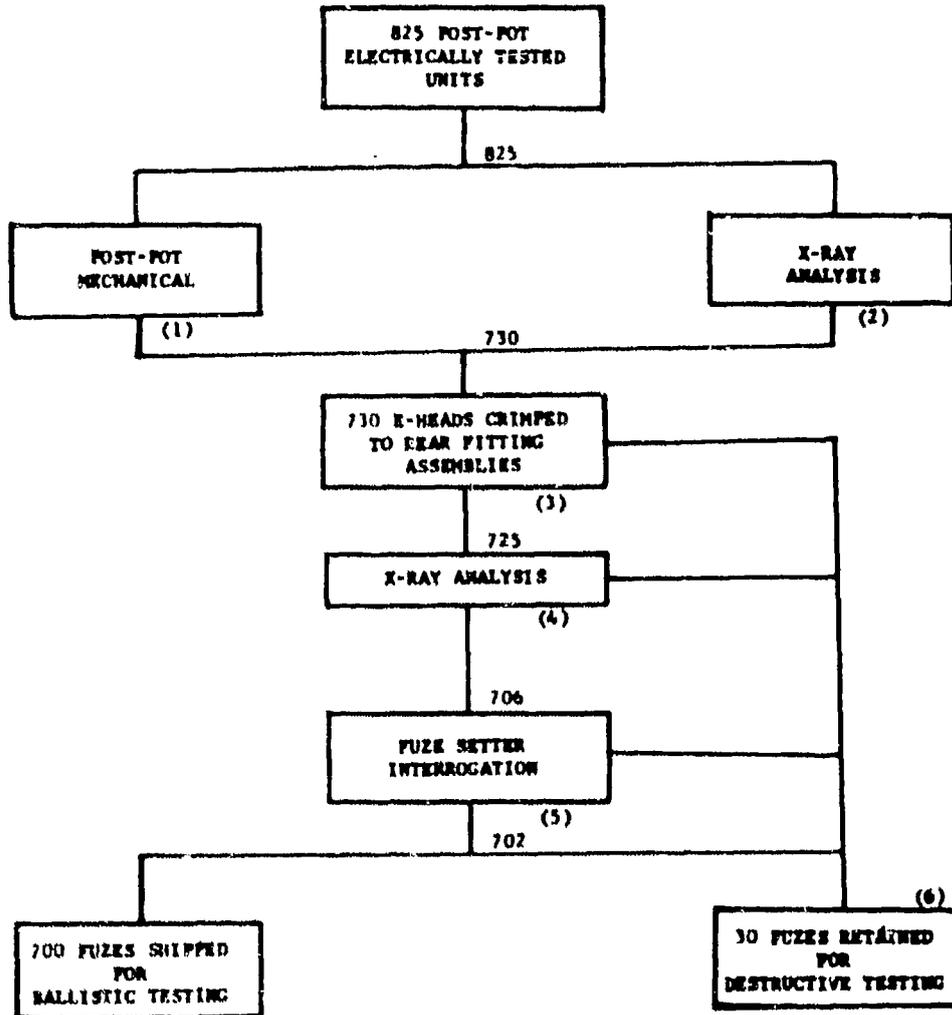
- (1) TOTAL OF SEVEN (7) E-HEADS WERE REJECTED DURING THE MECHANICAL POST-POT INSPECTION. ALL SEVEN (7) E-HEADS COULD NOT BE MATCHED WITH THEIR UNIQUE TRAVELER.

- (2) A TOTAL OF 88 E-HEADS WERE SORTED FROM THE LOT FOR EXHIBITING CRACKED TRANSFORMER CORES.
- (3) FIVE (5) FUZZES WERE REJECTED AFTER BEING CRIMPED BECAUSE OF THE FOLLOWING REASONS:
