National Dam Inspection Program

TODD SPRING RESERVOIR

(NDI ID # PA-00241)

Susquehanna River Basin,
Unnamed Tributary of Raystown Branch
Juniata River, Bedford County, Pennsylvania.
PHASE I INSPECTION REPORT

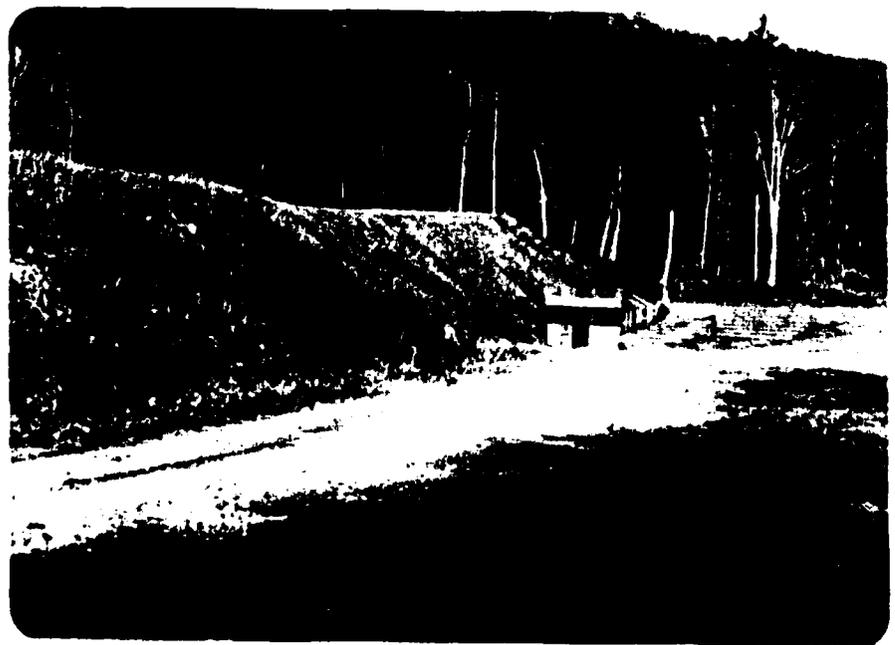
Downstream Face

VISUAL EXAMINATION OF	OBSERVATIONS	REMARKS OR RECOMMENDATIONS
SURFACE CRACKS	None	
UNUSUAL MOVEMENT OR CRACKING AT OR BEYOND THE TOE	None	
SLOUCHING OR EROSION OF EMBANKMENT AND ABUTMENT SLOPES	Minor erosion rills on the downstream slope near the right abutment.	
VERTICAL AND HORIZONTAL ALIGNMENT OF THE CREST	Middle one third of the embankment was found to be approximately 1.5 feet lower than the abutments. See Plate 4 for the dam crest profile.	
RIPRAP FAILURES	There is no erosion protection on the upstream side of the dam.	The owner should evaluate the need for providing erosion protection.

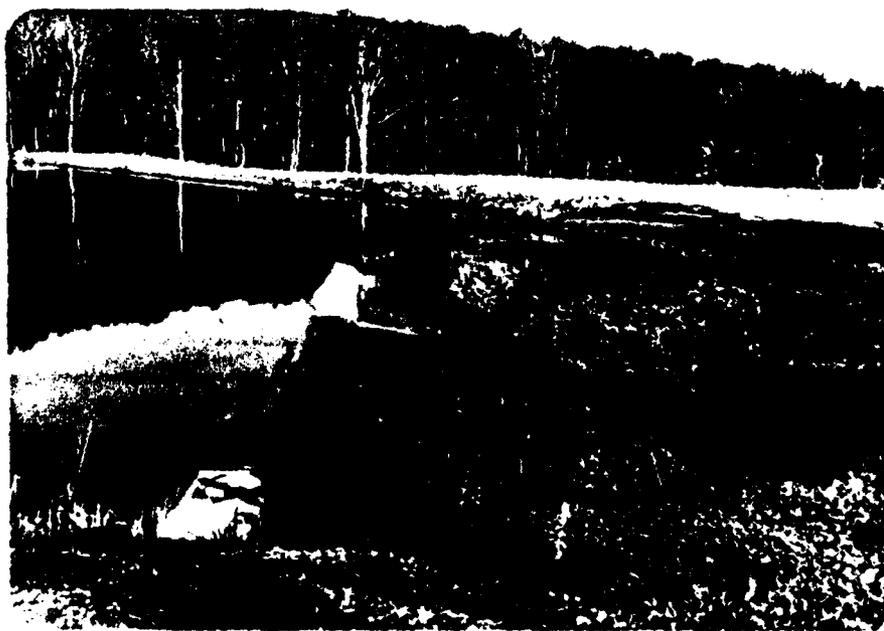
Photograph No. 2

Spillway crest.
