SHAWNEE DAM

NDI ID NO. PA-00629  
DER ID NO. 45-115

PHASE I INSPECTION REPORT  
NATIONAL DAM INSPECTION PROGRAM

JANUARY 1980

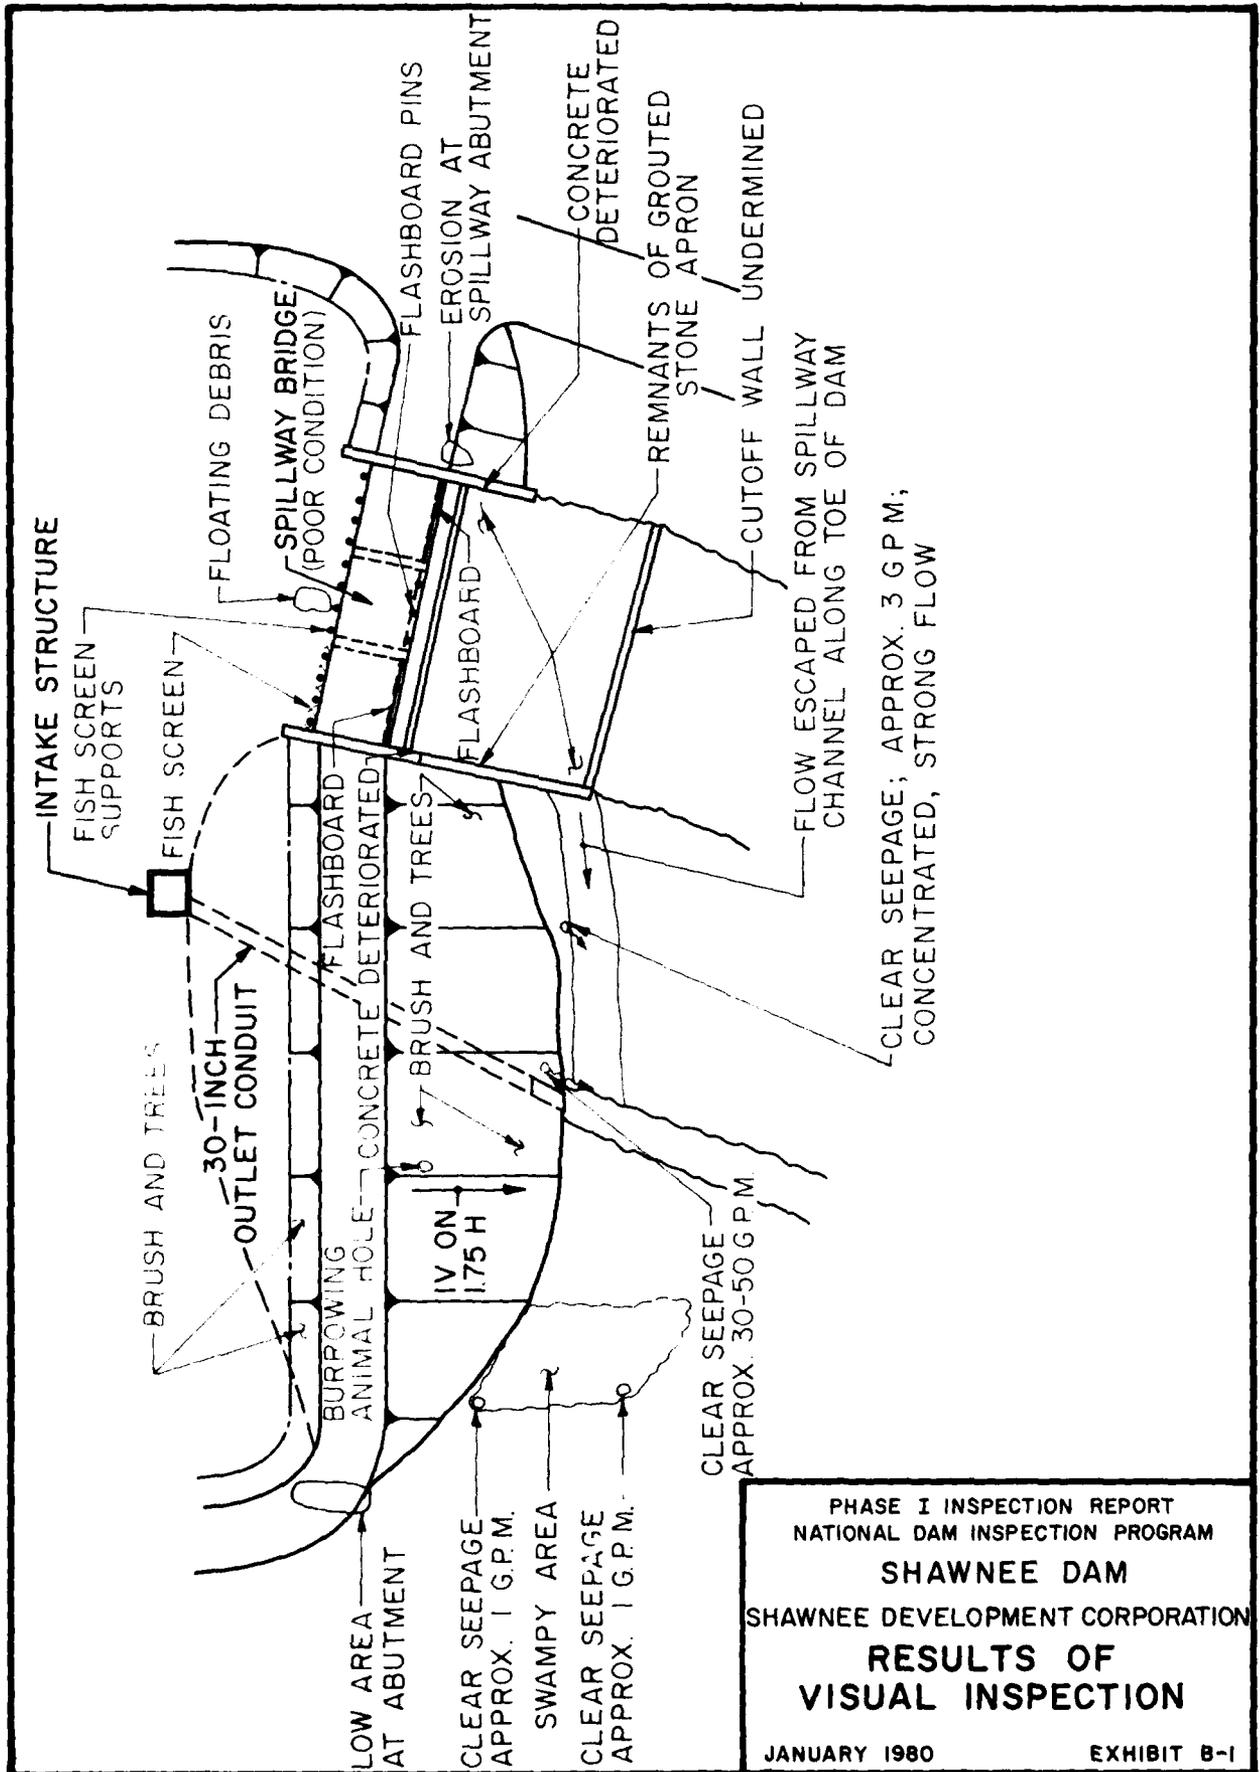
PHASE I INSPECTION REPORT  
 NATIONAL DAM INSPECTION PROGRAM  
**SHAWNEE DAM**  
 SHAWNEE DEVELOPMENT CORPORATION  
**RESULTS OF VISUAL INSPECTION**  
 JANUARY 1980 EXHIBIT B-1

a. General. The overall appearance of the dam is poor. Deficiencies were observed as noted below. A sketch of the dam with the locations of deficiencies is presented on Exhibit B-1 in Appendix B. Survey information acquired for this report is summarized in Appendix B. On the day of the inspection, the pool was 0.1 foot above spillway crest.

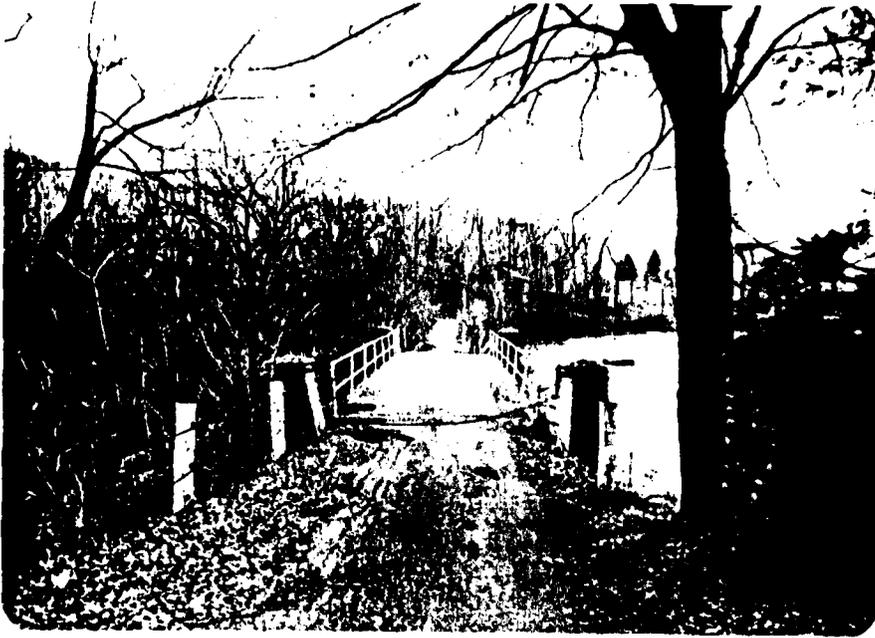
b. Embankment. The top of the dam is paved and used as an access road (Photograph A). The measured average topwidth is 10.5 feet. A low area, 0.3 foot below design level for top of dam, is located at the right abutment. All other portions of the embankment are at or above the design elevation. One area was observed on the top of the dam that has undergone erosion (Photograph B). It is on the downstream side of the dam adjacent to the left abutment of the spillway.

A. Top of Dam. View from Left Abutment.

(7) Fill low area at top of dam, repair eroded area at top of dam, fill burrowing animal hole, and make repairs to spillway bridge.

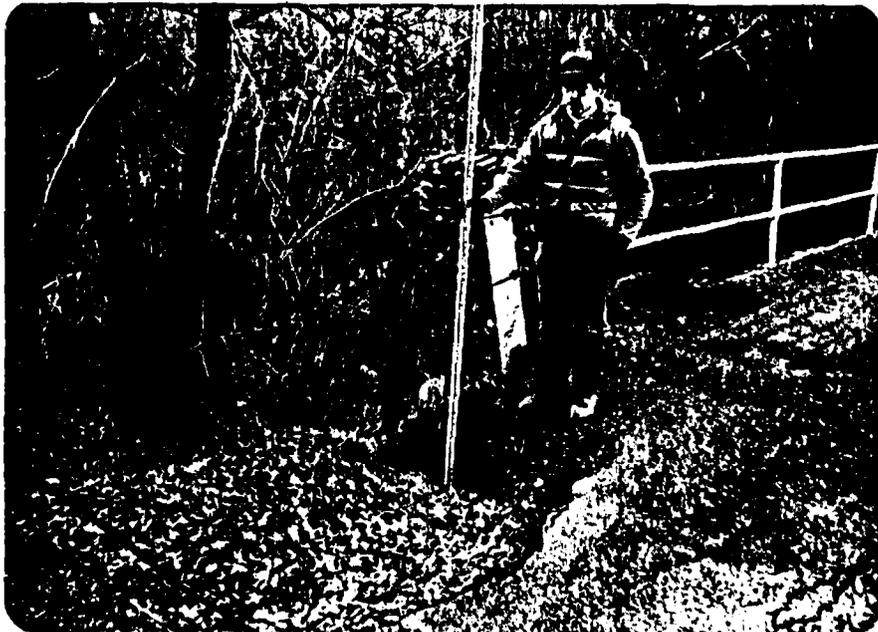
(2) Embankment. The eroded area on the downstream side of the top of the dam was not a serious hazard at the time of the inspection, but continued erosion is likely. As shown on the surveyed section in Appendix B, a portion of the upstream slope above the normal pool level is very steep (2V on 1H). Although it could not be verified by survey, records indicate that the submerged portion of the slope was constructed to the approved design slope of 1V on 2H. Provided that the record data are accurate, the small section of steep slope would not cause serious hazard to the safety of the embankment. Any failure that might occur would probably be a shallow slough that would not extend across the top of the dam. No evidence of sloughing or cracking along the upstream slope was apparent during the visual inspection. Although riprap does not extend to the top of the dam, there were no areas of wave erosion. Vegetation above the riprap has apparently provided adequate slope protection.

B. Eroded Area Adjacent to Spillway.

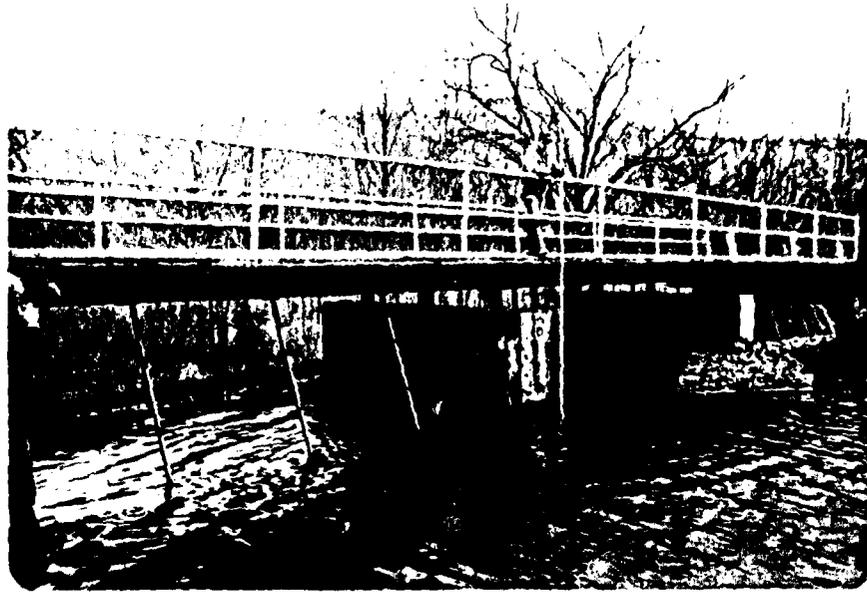
c. Appurtenant Structures. The spillway approach channel was obstructed by a fish screen and by the supports for the fish screen (Photograph E). Some floating debris was present. Flashboard pins were in place in all three bays of the spillway. A 6-inch high flashboard was in place in the right bay, and a partially displaced flashboard was in the left bay (Photographs E and F). The concrete of the spillway structures is in fair condition, with local areas of cracking and disintegration at the ends of the piers and sidewalls (Photographs F and G). The concrete weir is in good condition. The wood decking of the spillway bridge is rotted at various locations. The underside of the spillway bridge was determined to be at Elevation 439.2, which is 0.1 foot above the existing top of the dam and 0.2 foot below the design top of the dam. Only remnants of the grouted stone apron are visible (Photographs G and H). Erosion at the toe of the spillway weir is severe (Photographs F and G). The apron, which was once grouted, consists now of mostly large, loose rock. A cutoff wall located at the downstream end of the apron is badly undermined.

(3) Appurtenant Structures. The fish screens and fish screen supports are serious obstructions that could catch debris and significantly reduce spillway capacity. The flashboards serve no useful purpose, and they obstruct the spillway. The underside of the spillway bridge was found to be lower than the design elevation, which might cause pressure flow. Discharges under pressure flow would be less than under a free overfall condition. In computing the existing spillway capacity and in evaluating the spillway adequacy, none of the effects of the above deficiencies were included. The spillway capacity computed and used in this Report assumes that all flashboards, fish screens, and fish screen supports were removed.

E. Spillway Approach Channel.

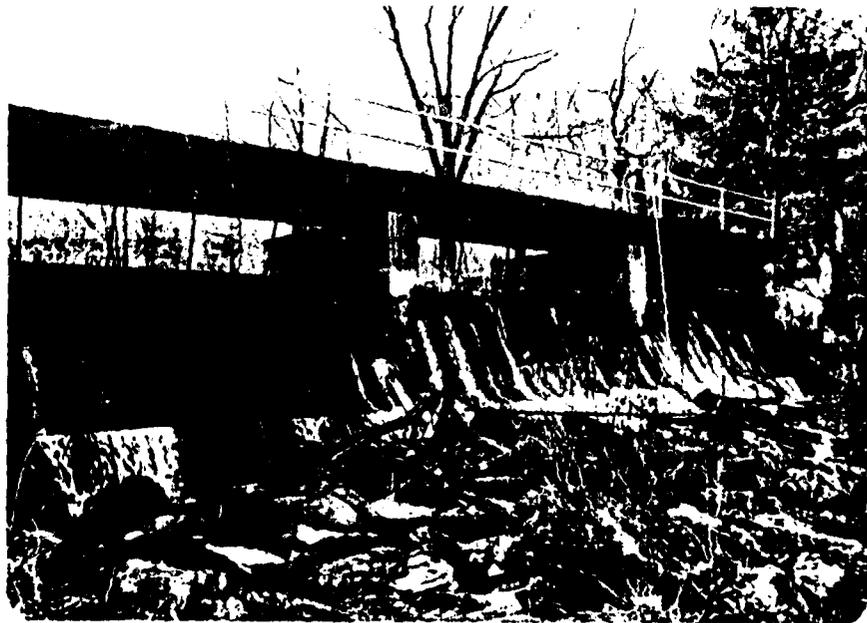
(3) Appurtenant Structures. Erosion of the grouted stone apron downstream from the spillway weir apparently began shortly after the dam was completed. There are no records of repairs. The existing condition is probably the result of progressive deterioration and

erosion over the last 52 years. The existing condition is potentially hazardous. The loss of material at the downstream toe of the weir adversely affects the stability of that structure. The spillway outlet channel does not adequately confine even small spillway discharge. Flow that escapes and flows along the toe of the embankment obscures seepage and creates an erosion hazard.

F. Spillway Weir and Apron.

(3) Perform additional studies to more accurately ascertain the spillway capacity required for Shawnee Dam as well as the nature and extent of measures required to provide adequate spillway capacity. The study should also address the deficiencies of the spillway apron and outlet channel. Take appropriate action as required.

(4) Perform additional investigations and studies to more accurately ascertain the structural stability of the spillway weir as well as the nature and extent of measures required to provide adequate factors of safety for structural stability under all loading conditions. Take appropriate action as required.

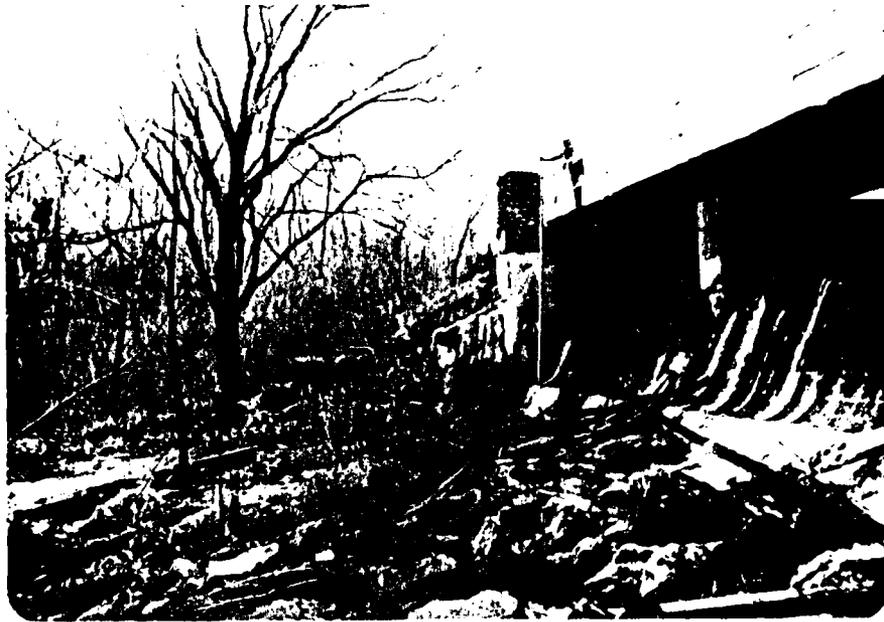
G. Spillway Weir and Apron.

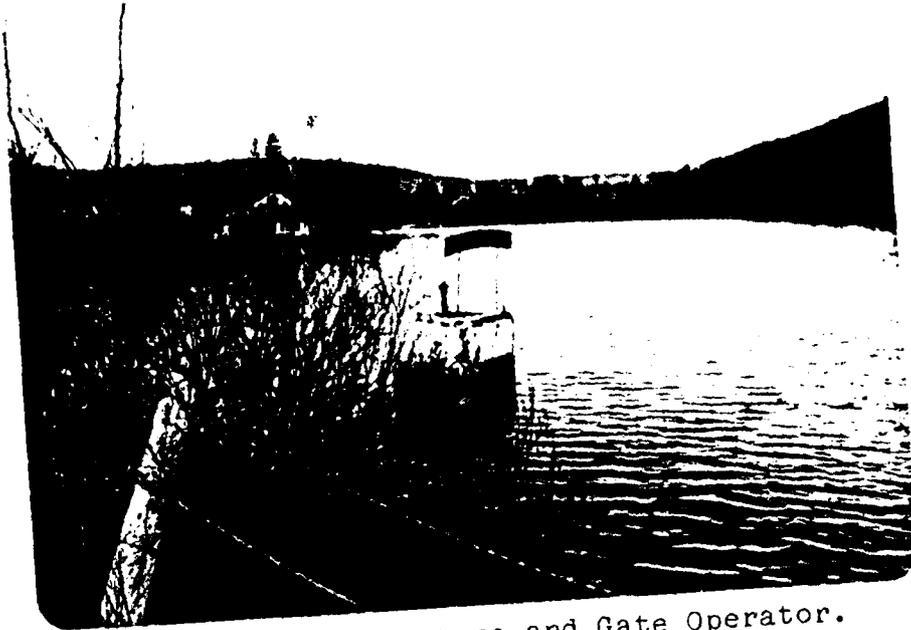
I. Intake Structure and Gate Operator.
