RAILROAD CREEK DAM
~~BUCKS COUNTY, PENNSYLVANIA~~

(NDS I D NO. PA 01062,
DER I D NO. 9-175,
SCS NO. PA 615)

PHASE I INSPECTION REPORT
NATIONAL DAM INSPECTION PROGRAM

JANUARY 1980

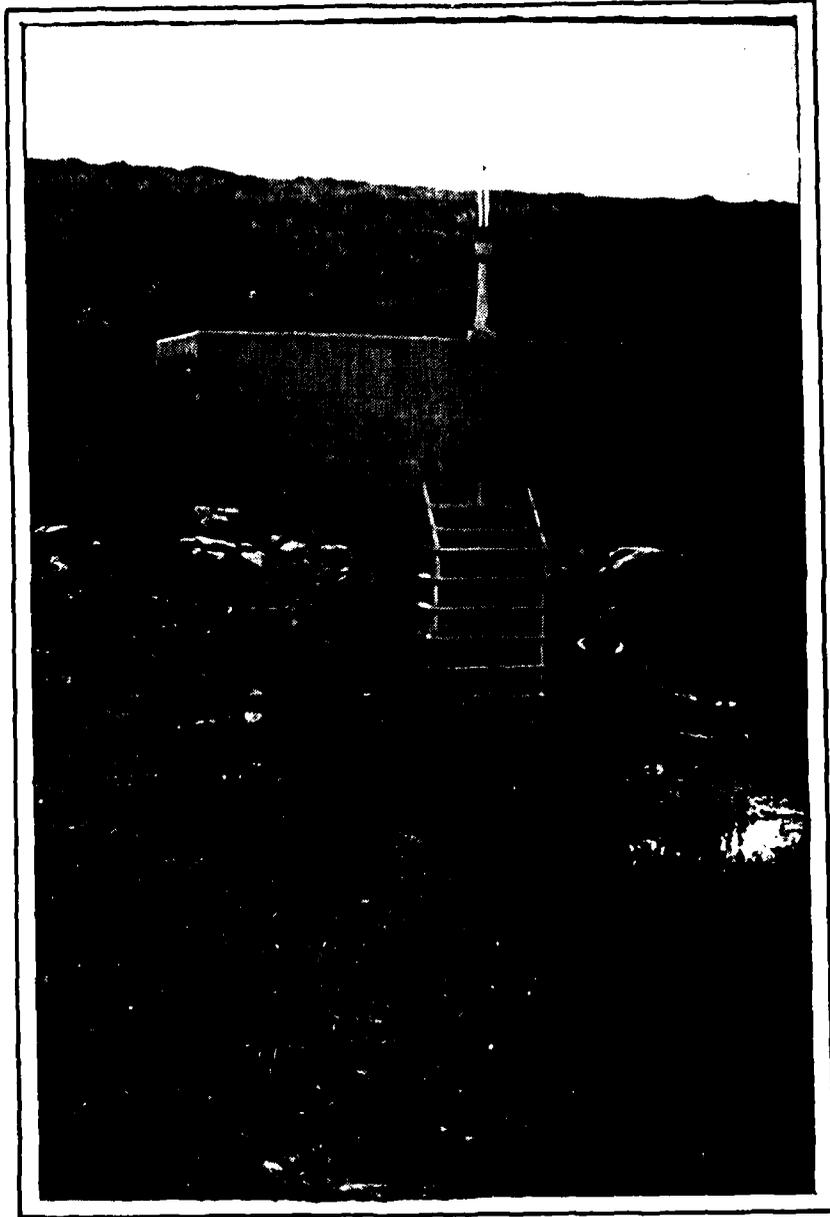
PHOTOGRAPH NO. 1

PRINCIPAL SPILLWAY RISER
WITH OPEN POND DRAIN GATE.

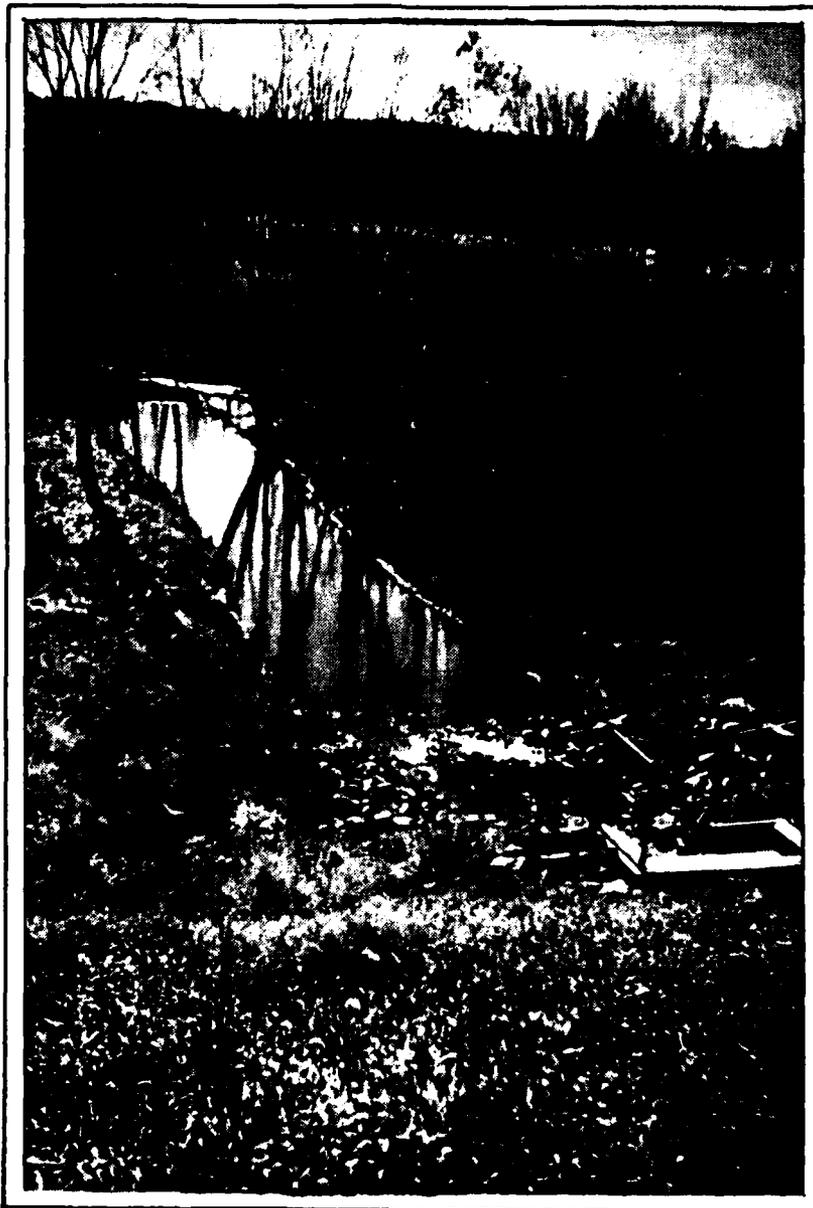
PHOTOGRAPH NO. 3

VIEW FROM TOP OF DAM SHOWING
IMPACT BASIN AND DOWNSTREAM
CHANNEL.

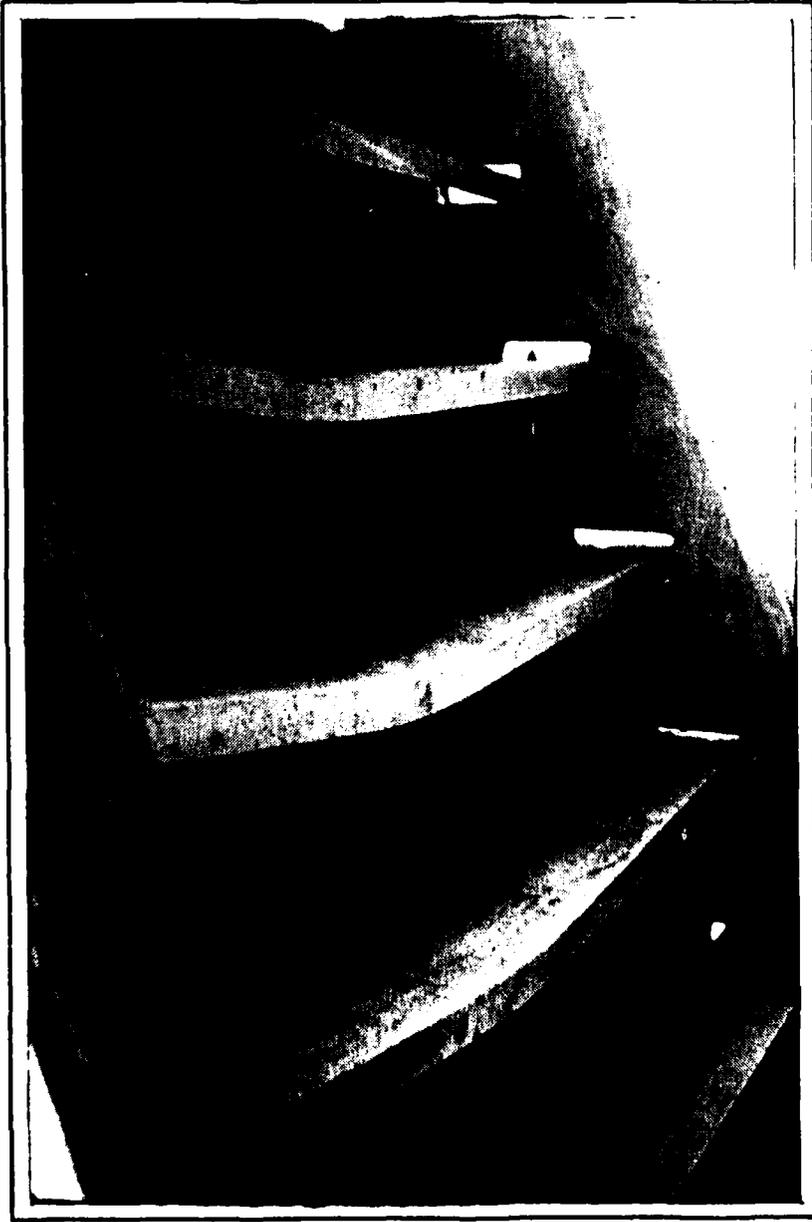
PHOTOGRAPH NO. 8

SCS is investigating replacement of aluminum trash rack channels with steel channels. The channels were bent by ice during the first winter when the reservoir level was high during a rapid freeze.

1. Principal Spillway. As shown on the plates, the riser is located at the upstream toe of the embankment. The exposed portions of the riser were inspected and evaluated to be in good condition with no signs of excessive concrete deterioration, spalling or other structural deficiency or defects. As shown in Photograph 9, an angle is missing from the pond drain trash rack. Photograph 8 shows that aluminum channels forming the upper stage trash rack are bent. The

channels were bent by ice during the winter of 1977-78. At the time of inspection, the low stage trash rack was clear of debris, although some debris was noted at the stream edge. By December, this debris had collected in the trash rack. The pond drain gate was exercised and was observed to seal completely. The impact basin at the downstream toe was inspected and found to be in good condition with no significant cracking or spalling of the concrete or erosion adjacent to the structure. The embankment drains outlet through walls of the impact basin. The bolts used as small animal guards were missing and should be replaced. The downstream channel was also inspected and found to be in good condition with no significant erosion or deterioration.

TRASH RACK CHANNELS, REPORTEDLY
DAMAGED BY ICE.

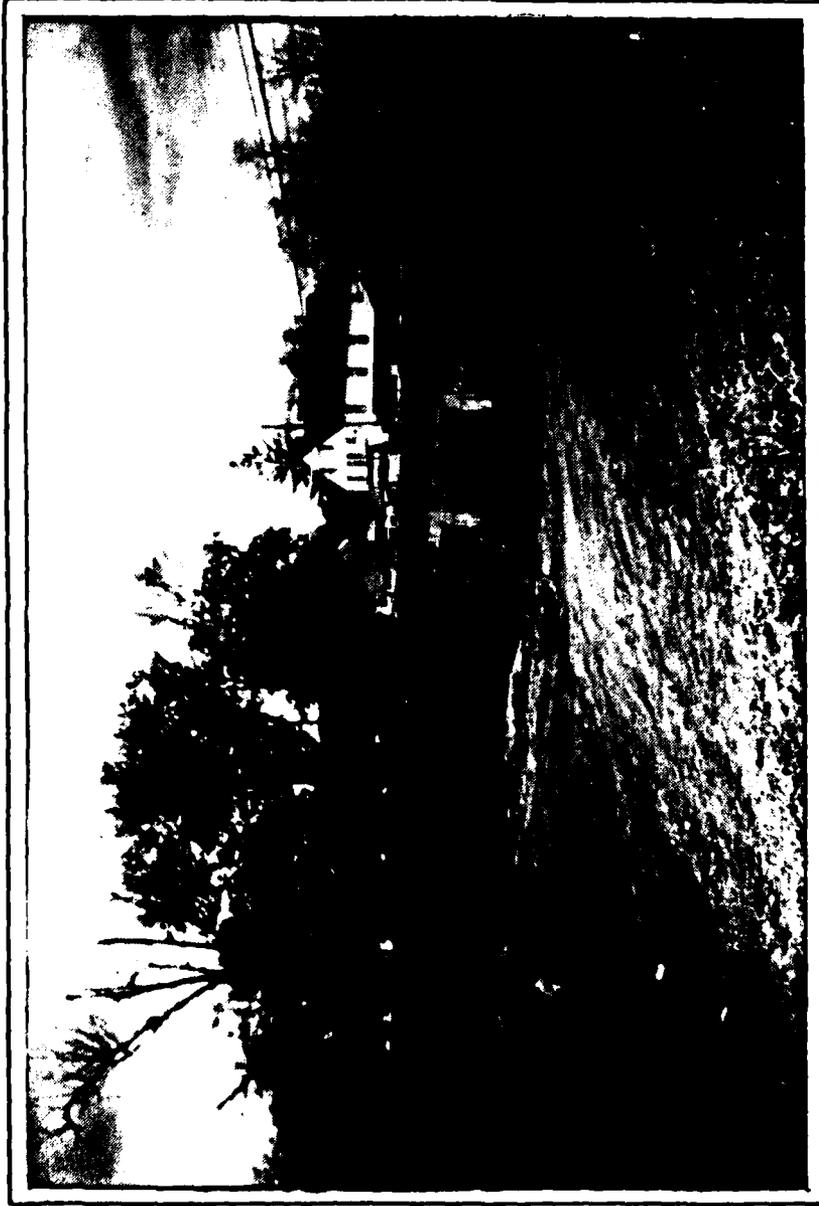
PHOTOGRAPH NO. 11

SECOND DOWNSTREAM HIGHWAY BRIDGE
AND DAMAGE CENTER. PICTURE TAKEN
FROM DIKE PROTECTING GASOLINE
STATION TO THE RIGHT OF THE PICTURE.
