*National Dam Inspection Program
Shirts Run Dam*

PHASE I INSPECTION REPORT,
NATIONAL DAM INSPECTION PROGRAM

NAME OF DAM: Shirf's Run Dam
STATE LOCATED: Pennsylvania
COUNTY LOCATED: Cambria
STREAM: Unnamed Tributary of the North Branch of Black Lick Creek
SIZE CLASSIFICATION: Small
HAZARD CLASSIFICATION: High
OWNER: Spangler Municipal Water Authority
DATE OF INSPECTION: November 27 and December 28, 1979

PHASE I REPORT
NATIONAL DAM INSPECTION PROGRAM
SHIRF'S RUN DAM
NDI I.D. PA-438
DER I.D. 11-71

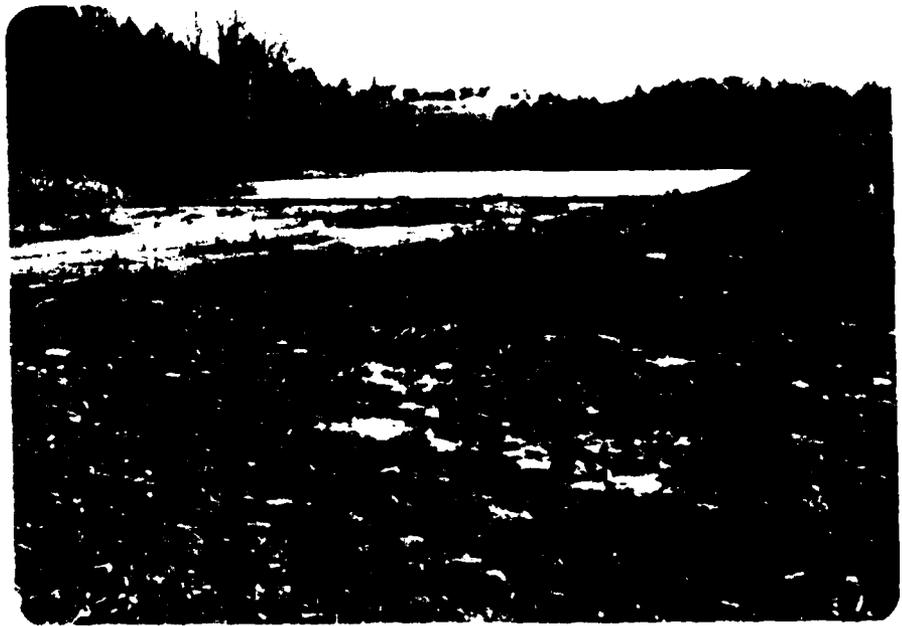
Photograph No. 3
Spillway crest and approach channel.

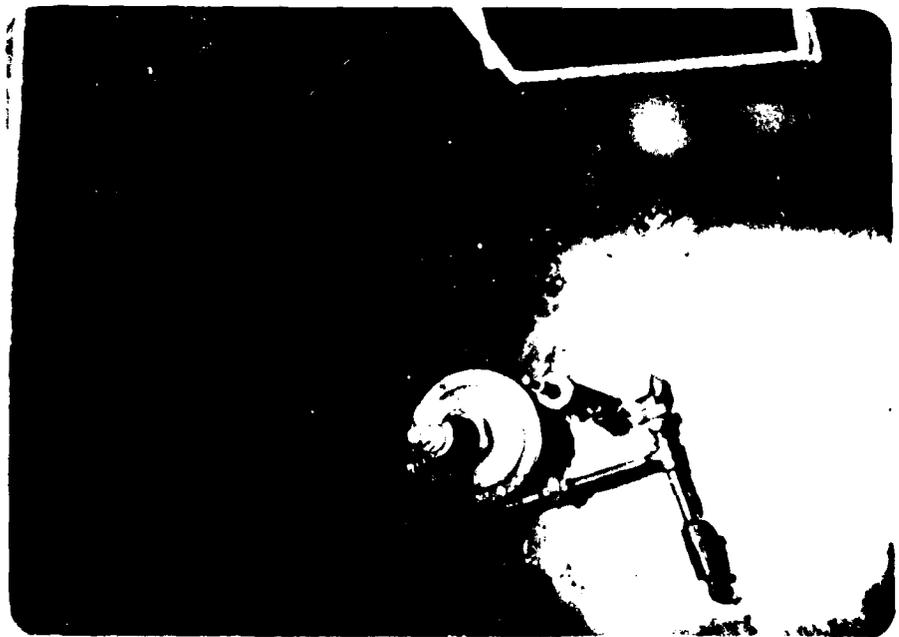
4.3 Maintenance of Operating Facilities. The only visible operating facility was the automatic valve located at the downstream end of the outlet pipe. This valve was found to be in good condition.

Photograph No. 6
Outlet pipe valve (automatic altitude valve).

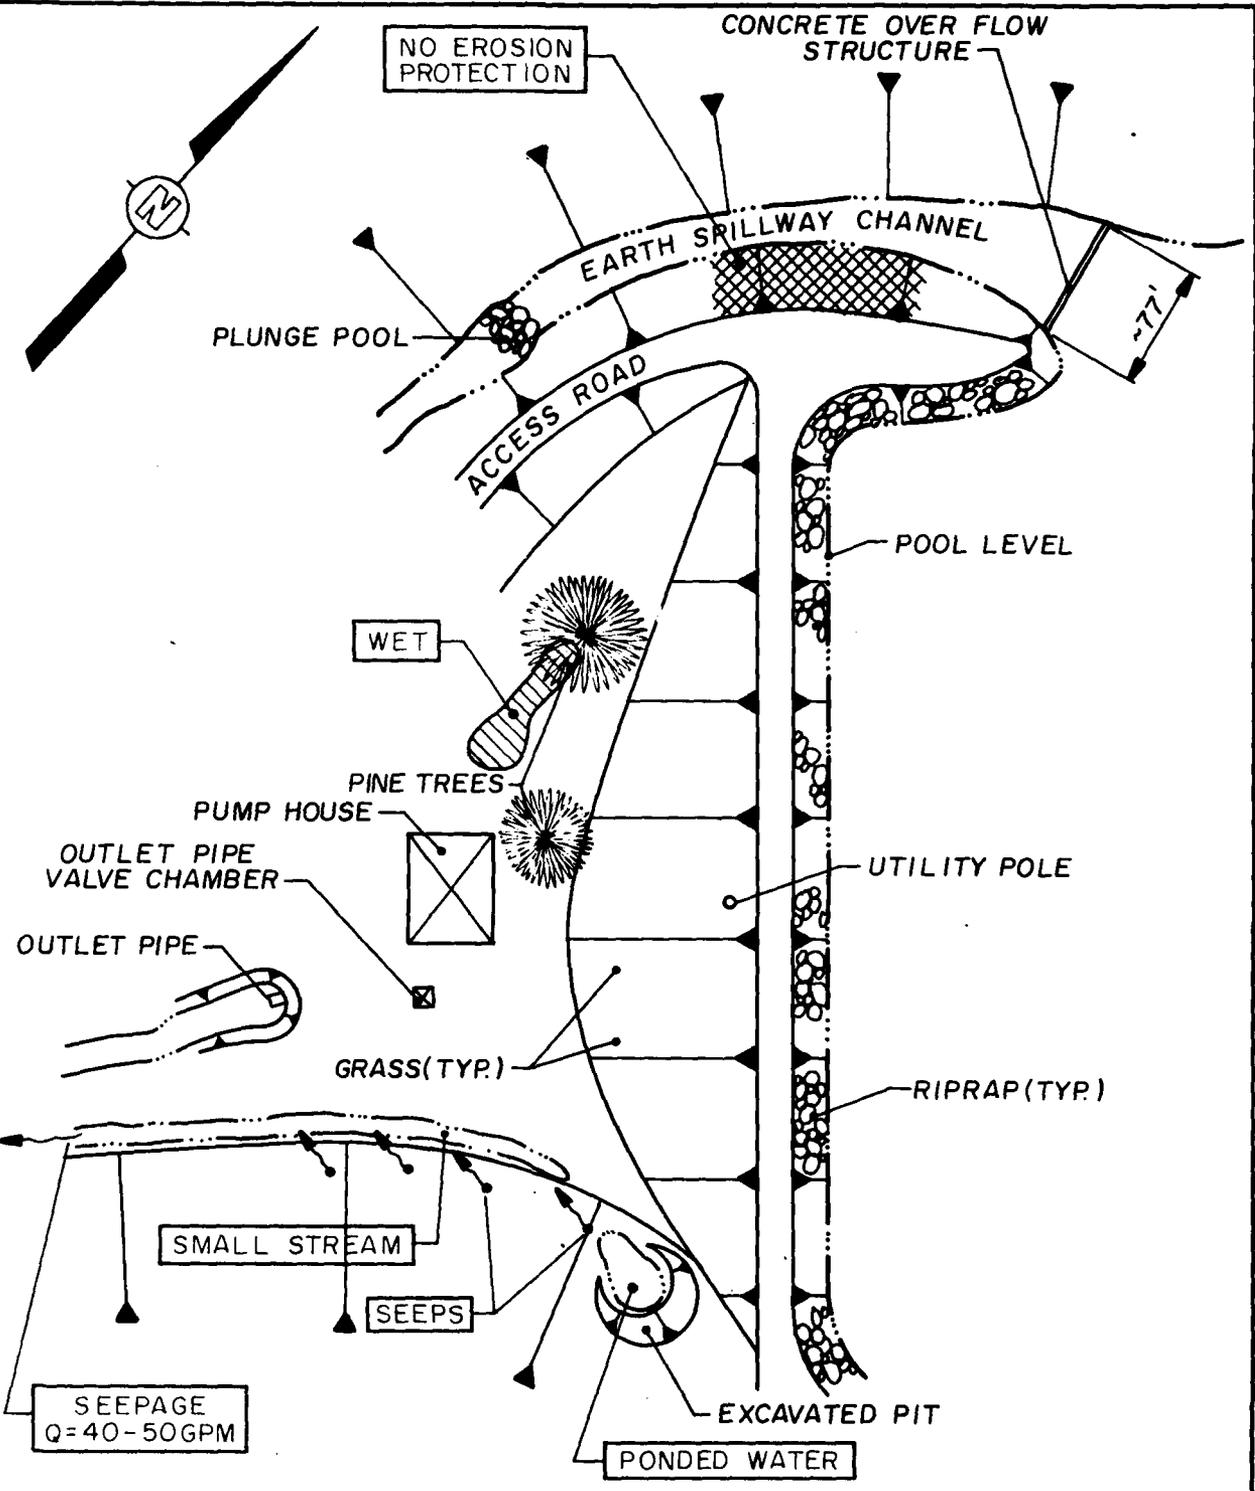
In general, the condition of the embankment is considered to be good. Other than a seepage condition on the left abutment, which was reported to have existed in the past, no other seepage locations were found. Seepage from the left abutment, which flows into a small stream along the left side of the valley over a distance of 100 feet, was estimated to be on the order of 40 to 50 gallons per minute.

1. POOL LEVEL DATE OF INSPECTION:
1.0 FT. ABOVE SPILLWAY
STRUCTURE CREST.

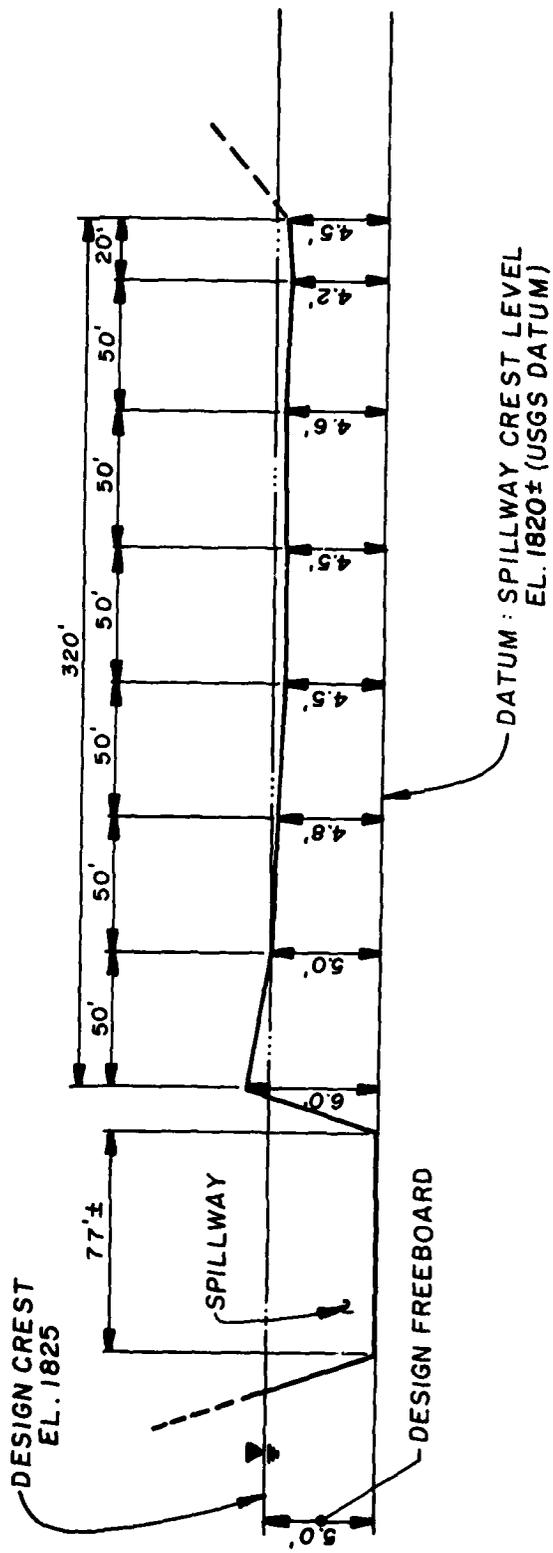
DAM CREST PROFILE
(LOOKING DOWNSTREAM)

The crest of the dam was surveyed relative to the spillway crest elevation and it was found to be on the order of four to six inches below the design elevation. The dam crest profile is illustrated in Plate 5. Field measurements indicate that the downstream face of the dam is on a 2 horizontal to 1 vertical slope.
