GROUP CAMP DAM

NDI No. PA 00259

PHASE I INSPECTION REPORT  
NATIONAL DAM INSPECTION PROGRAM

Group Camp Dam, Beaver County, Pennsylvania  
NDI No. PA 00259, PennDER No. 4-31  
Traverse Creek  
Inspected 19 November 1979

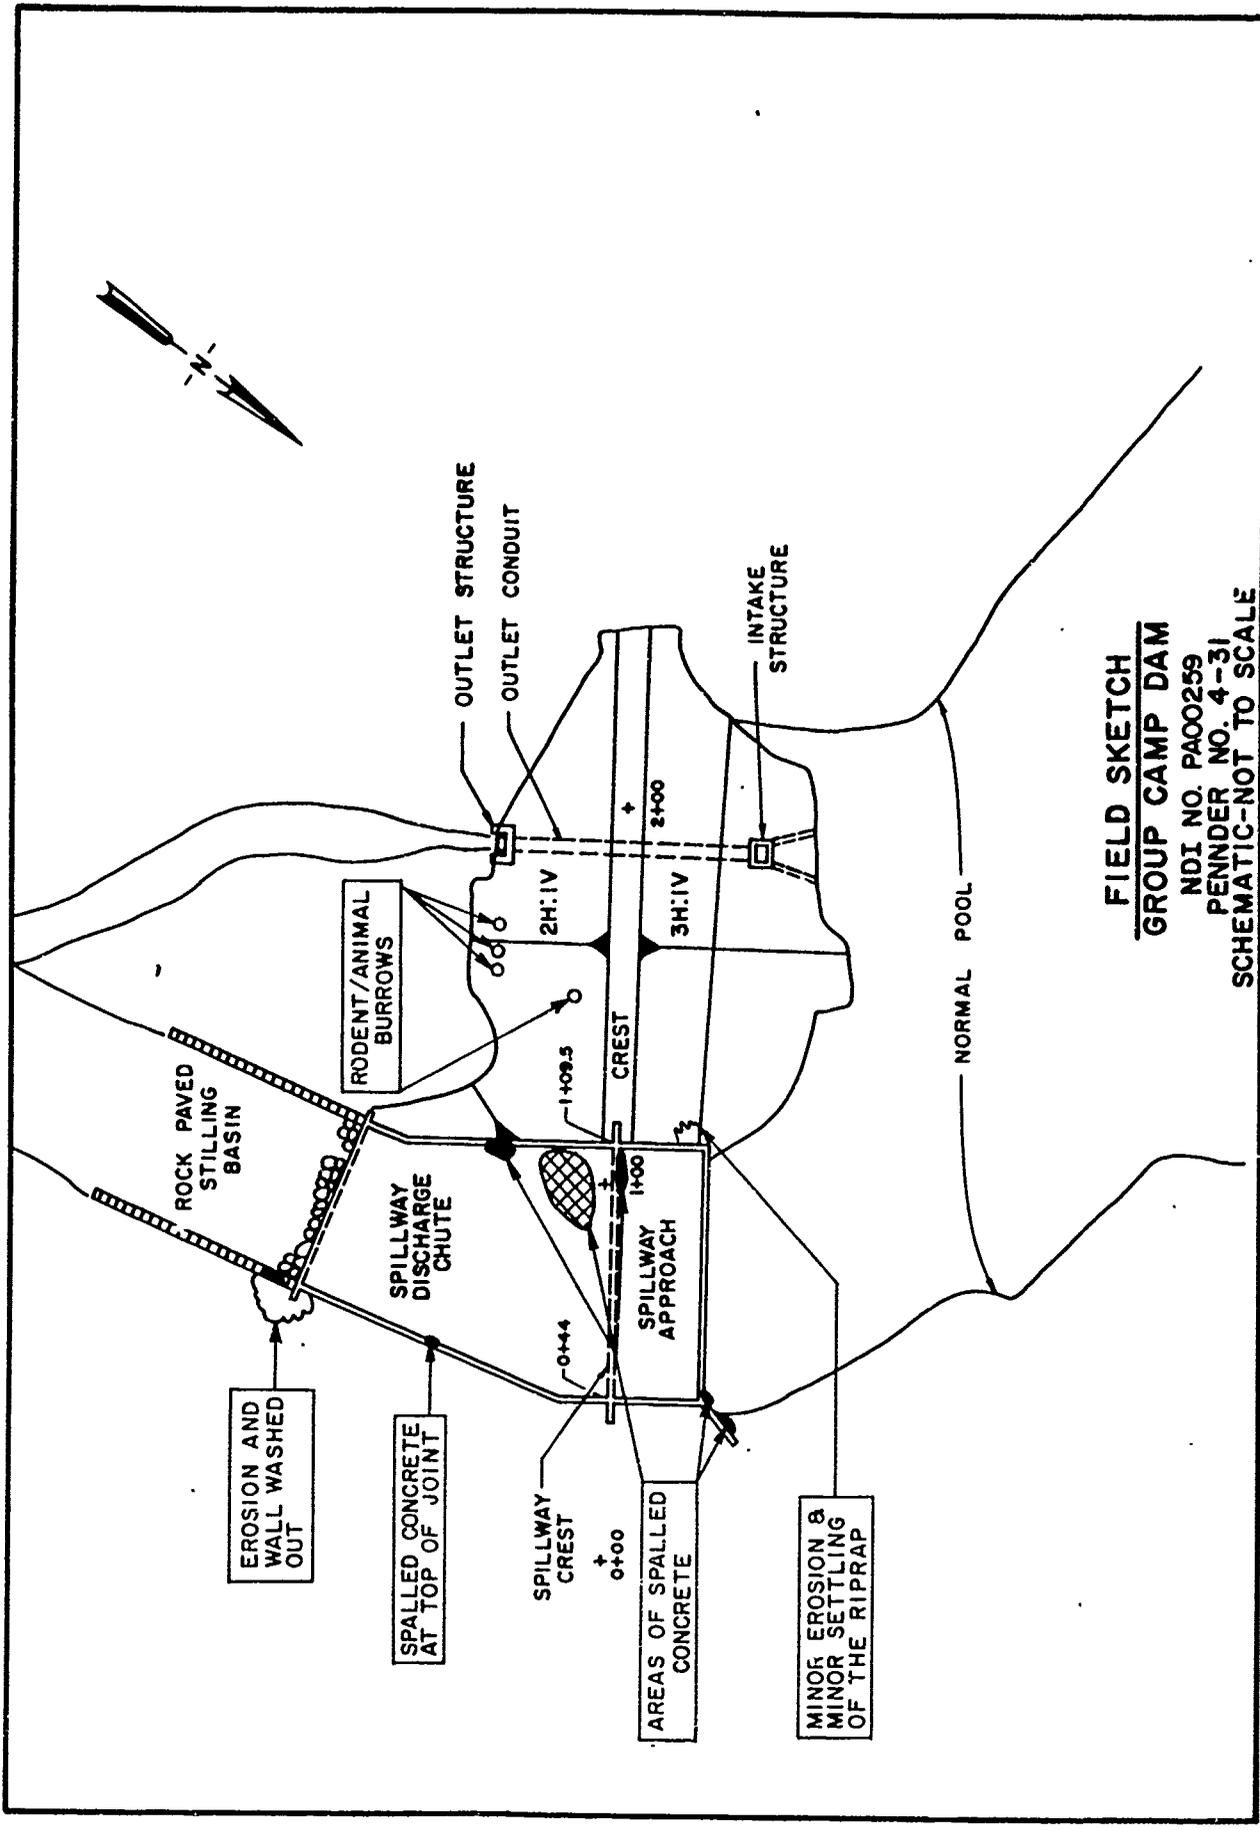
**FIELD SKETCH**  
**GROUP CAMP DAM**

Several rodent holes were observed in the embankment. (See Field Sketch for approximate location).

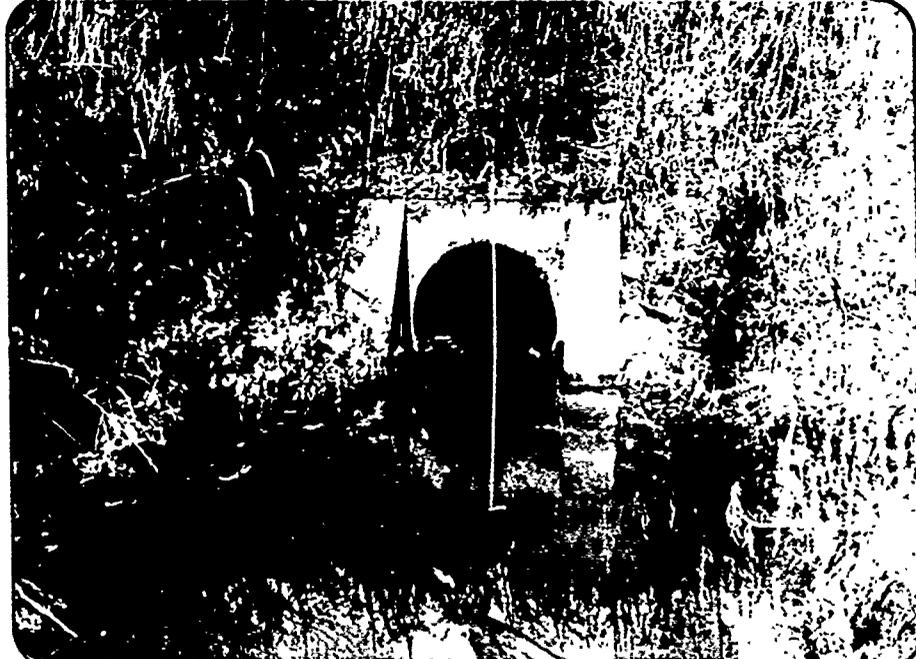
6. The condition of the conduit at the outlet works showed some corrosion of the 36 inch corrugated metal pipe. There was also erosion around the head wall and some debris and sediment in the discharge channel.

PHOTO 6. View of Outlet Conduit and Outlet Head Wall
