Special Report 80-13

EXTENDING THE USEFUL LIFE OF DYE-2 TO 1986

PART II: 1979 FINDINGS AND FINAL RECOMMENDATIONS

Wayne Tobiasson and Philip Tilton

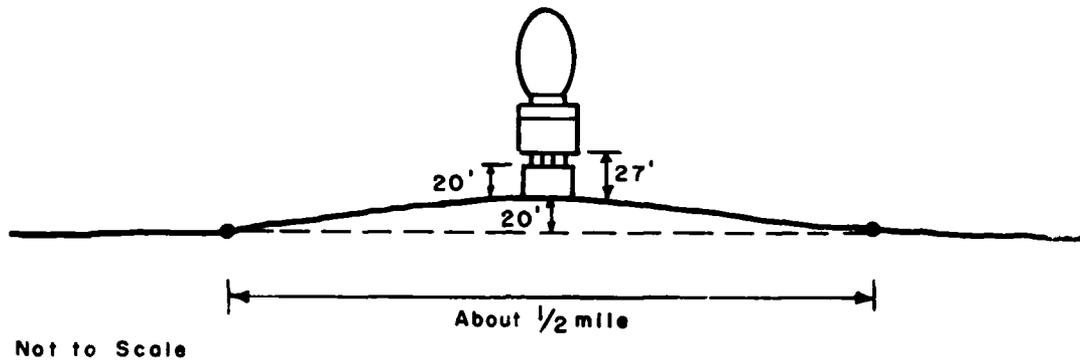
Figure 2. 1979 snow profile of mound at DYE-2.

The footings were 32 ft below the snow surface when DYE-2 was built in 1959. In 1979 they were about 102 ft below the snow surface in the immediate vicinity of the building, a change of 70 ft in 20 years or 3.5 ft/yr. Between 1973 and 1979 the footing depth increased from 78 ft to 102 ft, indicating an increase in the net build-up rate to 4 ft/yr. The reason for the increase to 4 ft/yr in recent years is that backfilling under the building has been progressing at a faster rate than the snow build-up in the vicinity. As a result, the building is located on a mound that is about 20 ft higher than the "natural" snow surface in the area (see Fig. 2).

As shown in Figure 2 the top of the truss enclosure will be slightly below the snow surface in 1986. Although this may create some minor problems, it is probably better than raising the roof of the truss enclosure 8 ft in conjunction with the life extension operation. If raised, the protruding portion of the truss enclosure will act as a snow fence and somewhat increase snow accumulation around the building.

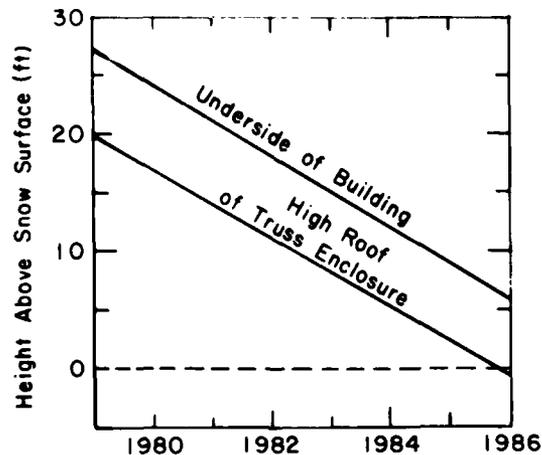
Figure 3. Building and truss enclosure clearances with time.

be maintained 15 ft or more above the snow surface. Using this criterion the building should be raised no later than 1983.

With the existing structural designs and systems it is most convenient to lift the building either 15 ft or 27 ft. If the building is lifted 15 ft in 1982 or 1983, the clearance in 1986 will be about 21 ft. Since this is adequate for snow control purposes, a 15-ft lift is all that will be needed to extend the useful life of DYE-2 to 1986.

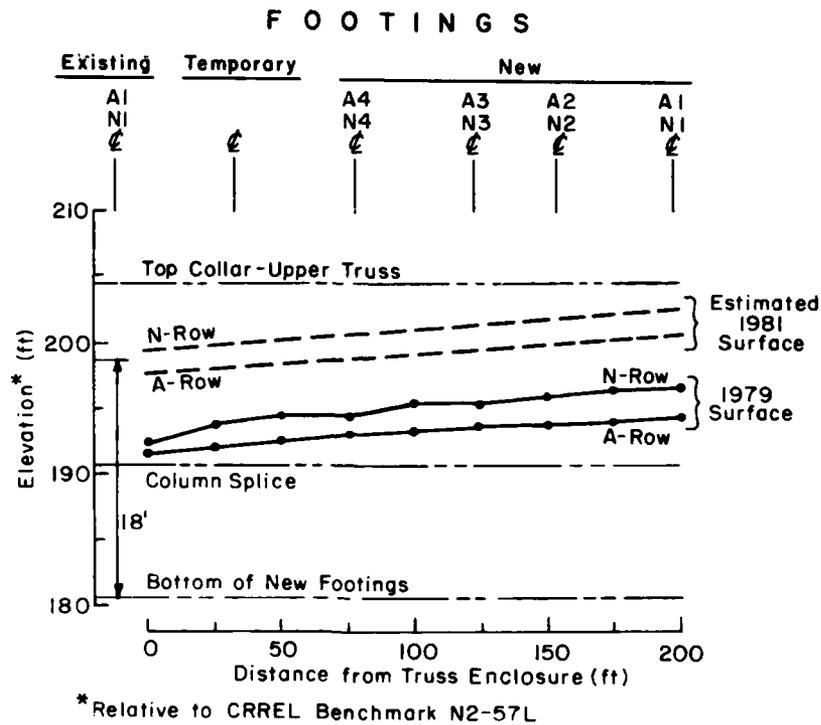
Figure 4. Elevations along the track of a sideways move.

The position of the snow surface is also an important consideration if the building is to be moved sideways in 1981 or 1982. Figure 4 shows snow surface elevations along the track of a sideways move, the estimated 1981 snow surface along the tracks, and the elevation of the column splice that corresponds to the splice separated for the DYE-3 move. If the snow surface permits, DYE-2 should be separated at this splice since the DYE-3 design could then be reused without much modification. Figure 4 also shows the elevation of the footings based on the footing-girder geometry used for the DYE-3 move. At this elevation the new footings would be at least 17 ft below the 1981 snow surface. Since a depth of at least 15 ft is desired for load bearing and thermal protection and a depth of less than 20 ft is desired to minimize costs, the DYE-3 sideways move geometry is appropriate to reuse at DYE-2. If the move is delayed until 1982, 3 to 3 1/2 ft of additional excavation will be necessary for the footings. This would be acceptable and would add little to the cost of the move.

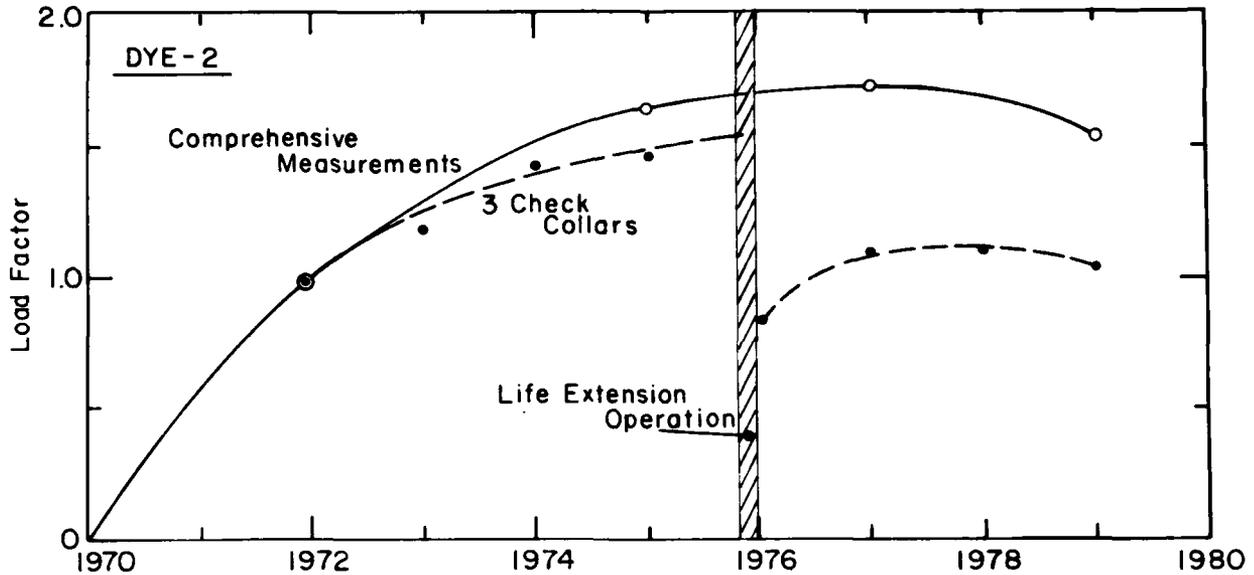
Figure 8. Load factor vs time.

the level of secondary stress in the structural frame. That load, normalized by dividing it by the load measured at all sway bolts in 1972, is presented as a load factor in Figure 8. Since all sway bolts were loosened and the trusses were leveled during the 1970 life-extension operation, it has been assumed that the sway bolts were free of load at that time. The variation in load factor for the three checked collars monitored on more frequent occasions over the past eight years is also presented in Figure 8. It is evident that the level of secondary stress in the structural frame has decreased slightly since 1977. This is fortunate.

The expected benefits of a sway bolt adjustment program prior to an ice backfill operation and the slight decrease in the total sway bolt loads from 1977 to 1979 (see Fig. 8) indicate that there should be no need to sever the DYE-2 columns just above an ice backfill to relieve secondary stresses as would have been necessary at DYE-3. This will greatly simplify the ice backfill alternative for DYE-2.

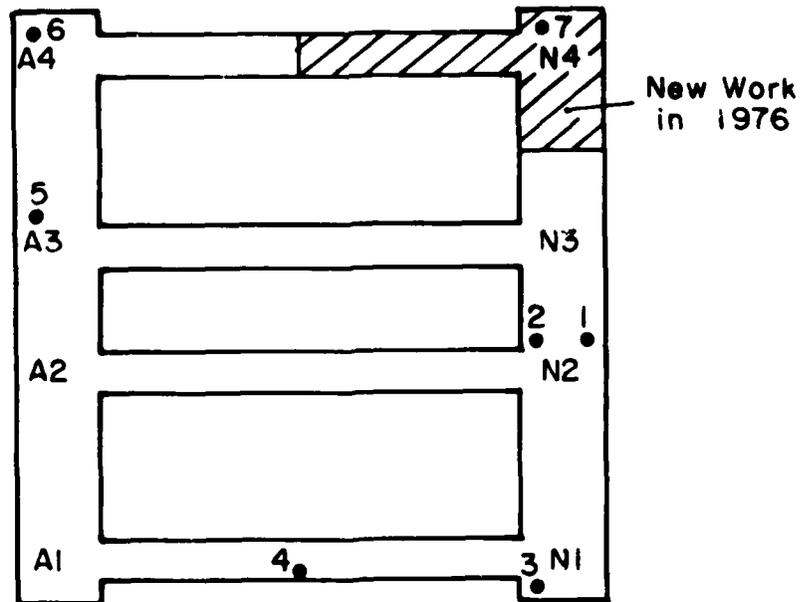
Figure 11. Location of dial extensometers.

As part of the 1979 truss enclosure inspection, seven dial extensometers were installed between the columns and the truss enclosure to measure the rate of downward movement of the truss enclosure. Figure 11 shows the location of each extensometer; Figure 12 shows a typical installation. A set of readings we took in late July and another set taken by station personnel on 1 September were used to establish the rates of downward movement presented in Table 5.

<u>Dial extensometer no.</u>	<u>Rate (in./yr)</u>
1	3 1/2
2	2 1/2
3	4
4	2 1/2
5	3 1/2
6	6
7	1 1/4

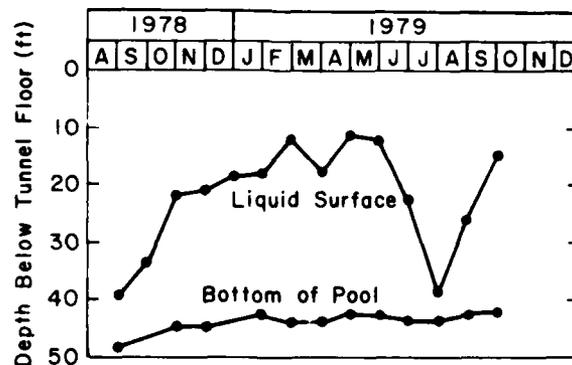
Because large discontinuous ice lenses and layers of very permeable granular depth hoar occur naturally in the snow at DYE-2, the DYE-2 wastewater disposal sumps behave more irregularly than do those at DYE-3. The wastewater disposal sump in use during our site visit had been used since August 1978. In May 1979 the liquid had risen until only 12 ft of freeboard existed below the sewer tunnel floor. In the past when such a limited amount of freeboard existed, wastewater was diverted to another disposal point. However, measurements taken in July and August 1979 indicated that the water level in the sump had dropped significantly. In August, 39 ft of freeboard was present. Since August, the water level has risen rapidly; in October, only 15 ft of freeboard was present. Figure 14 shows the irregular growth of this sump.

Figure 14. Growth of wastewater disposal sump B-2.

Station personnel were advised that a new wastewater disposal point should be readied at the junction of the main and branch tunnels but sewage should be discharged at the existing sump until the freeboard decreases to 10 ft.
