Name Of Dam: LEE HALL RESERVOIR  
Location: CITY OF NEWPORT NEWS  
Inventory Number: VA. 70001

PHASE I INSPECTION REPORT  
NATIONAL DAM SAFTY PROGRAM

Name of Dam: Lee Hall Reservoir  
State: Virginia  
Location: City of Newport News  
USGS Quad Sheet: Yorktown  
Stream: Headwaters of Warwick River  
Date of Inspection: 28 November 1979

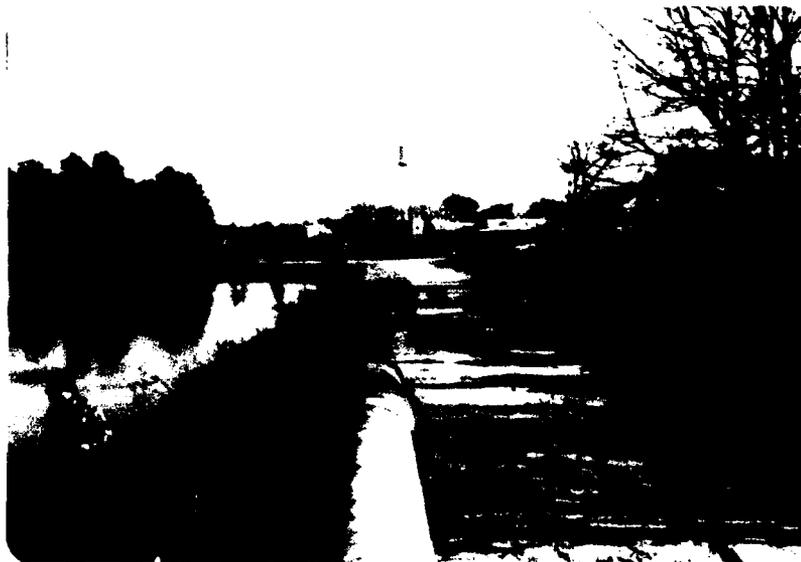
OVERALL VIEWS OF DAM  
28 NOVEMBER 1979

3.1.2 Embankment: The embankment is in good condition. A plan view and cross sections are provided on Plate VIII. Overall views of the dam are provided at the beginning of the report.

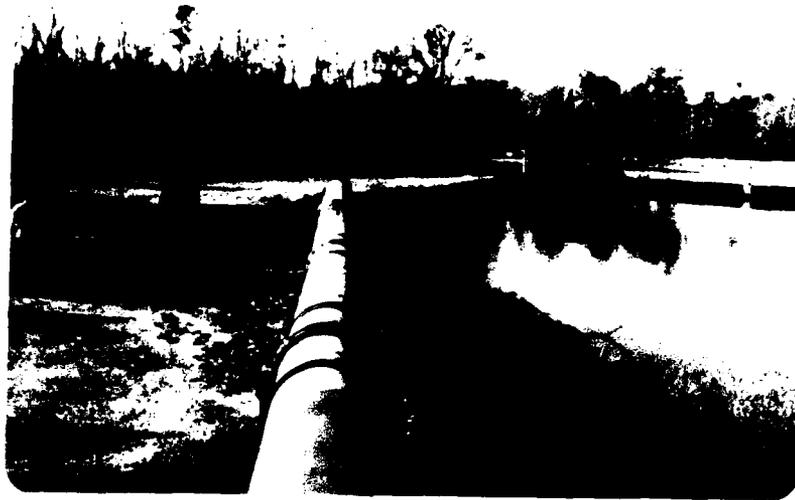
3.1.3 Gated Spillway: The spillway is fitted with a Bascule gate and is in good physical condition. The gate seals abutting the concrete wing wall have deteriorated. There is minor leakage. Also, the city is not satisfied with the past performance of the gate. The City can open the gate, but they are not sure the gate can be closed. Allis-Chalmers, the gate manufacturer, recently checked the gate, but the City is still dissatisfied with the performance of the gate. The approach channel is concrete lined, free from debris, and in good condition, except for a tree growing adjacent to the upstream right wingwall of the channel near the gate. The discharge channel is concrete lined, shallow, free from debris, and in good condition except for trees growing in downstream riprap. Photographs of the spillway are provided in Appendix II, Photos 1, 3, and 4.

PHOTO #1: PARTIAL VIEW OF DAM  
AND PRINCIPAL SPILLWAY

e. The city should attempt to reinstate the operability of the bascule gate to their satisfaction.
