4. TITLE (and Subtitle) Phase I Inspection Report National Dam Safety Program BEAR CREEK RESERVOIR DAM WISE COUNTY, VA		5. TYPE OF REPORT & PERIOD COVERED 9 Final Repts /

7. AUTHOR 10 Ray E. Martin Schnabel Engineering Associates 1 Cary Street Richmond VA 23220		6. PERFORMING ORG. REPORT NUMBER
9. PERFORMING ORGANIZATION NAME AND ADDRESS 12. 642		8. CONTRACT OR GRANT NUMBER(s) 15 DACW65-79-D-0004

PHASE I INSPECTION REPORT
NATIONAL DAM SAFETY PROGRAM
BEAR CREEK RESERVOIR DAM
VA. NO. 19511

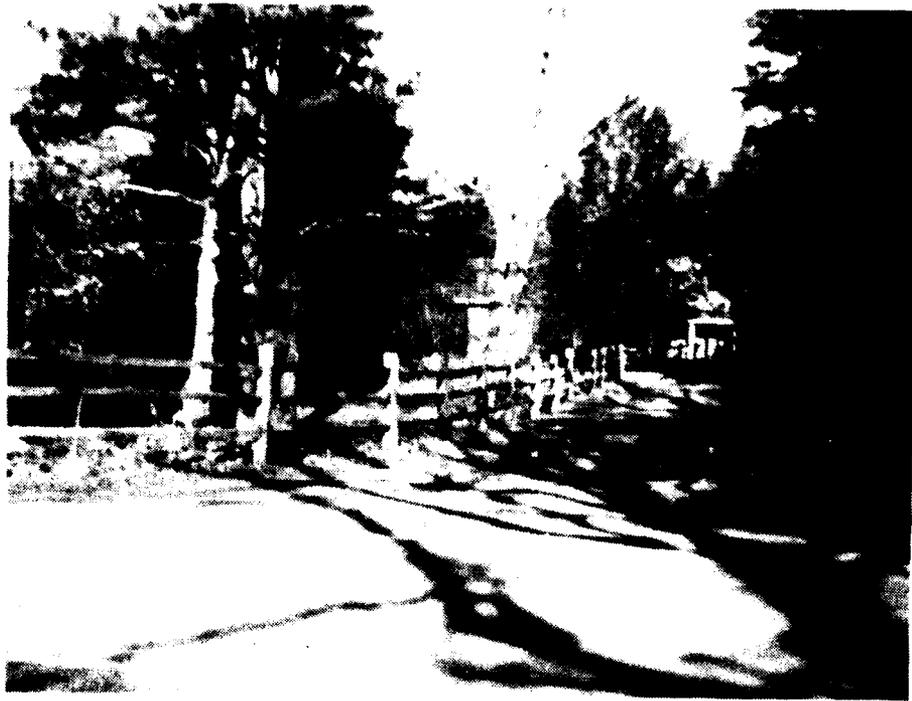
Photograph No. 1
Downstream flood plain at south end.
Stream bed is at left side about
6 feet below the yard level.

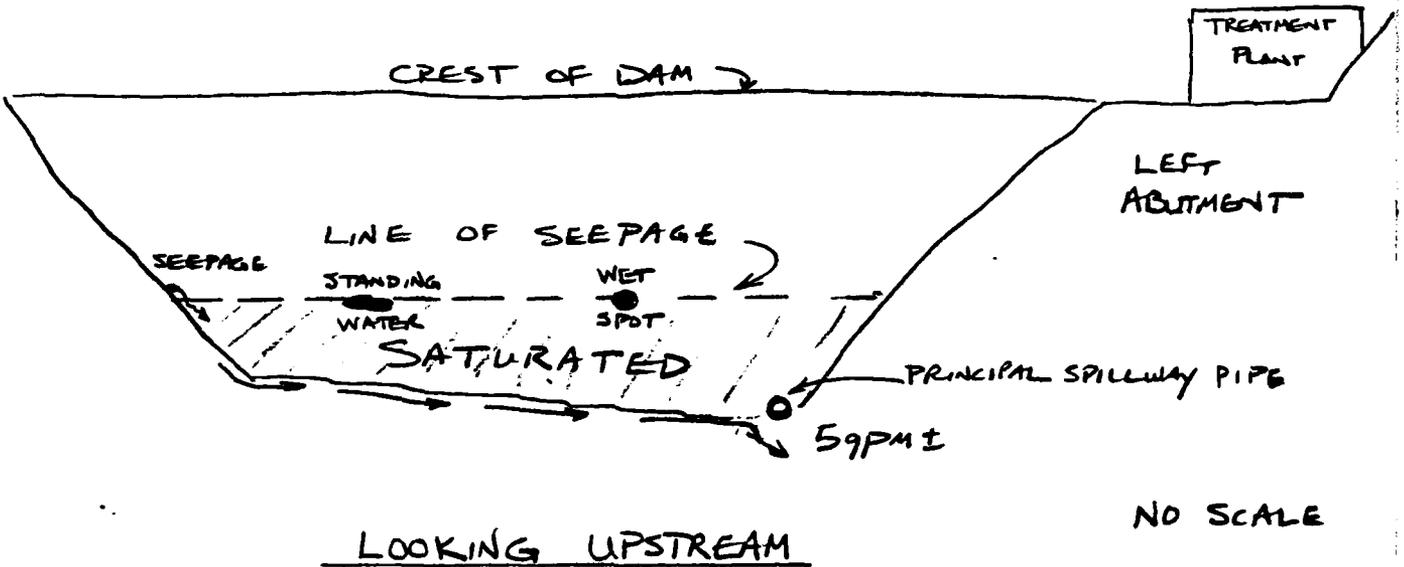
SUBJECT FIELD SKETCH
BEAR CREEK RESERVOIR DAM

6.3.2 Embankment: The iron-stained saturated areas located along the right downstream toe and the continuous saturated zone present along the basal third of the downstream slope are indicators of long-term seepage. The origin of the seepage could not be specifically

Scattered wet spots, standing water and iron-stained seepage were observed in a general line as shown on the accompanying field sketch. Essentially the entire basal 1/3 to 1/4 of the downstream slope is saturated and very spongy. This condition appears to be the result of long term seepage through the dam. Accumulated flow from the right side of the downstream slope was estimated at 5 gpm as the combined flow passed in front of the principal spillway pipe. Seepage observed during the site visit was clear and essentially free of turbidity.

- SEEPAGE - 2/3 WAY DOWN ON RIGHT ABUTMENT - DAM CONTACT
- STANDING WATER - 2/3 WAY DOWN - IRON STAINED SEEPAGE
- WET SPOT - 2/3 WAY DOWN - SMALL ZONE OF SEEPAGE WITH SWAMP GRASS. NO FLOW BUT SPONGY.

7.3.1 Seepage present along the downstream slope is of concern since it appears to indicate widespread seepage through the dam. The downstream slope should be monitored quarterly and after high pool levels in the reservoir to detect any increase in flow rates which may cause piping within the embankment. If increased flow rates should occur, a professional Geotechnical Engineer should be contacted to evaluate the problem and make recommendations for required corrective measures.
