4. TITLE (and Subtitle) Phase I Inspection Report National Dam Safety Program BIRDWOOD DAM ALBERMARLE COUNTY, VA	5. TYPE OF REPORT & PERIOD COVERED Final

PHASE I INSPECTION REPORT  
NATIONAL DAM SAFETY PROGRAM

NAME OF DAM: BIRDWOOD DAM

Name of Dam: Birdwood Dam  
State: Virginia  
County: Albemarle  
USGS 7.5 Minute Quadrangle: Charlottesville West, VA  
Stream: Morey Creek  
Date of Inspection: 13 November 1979

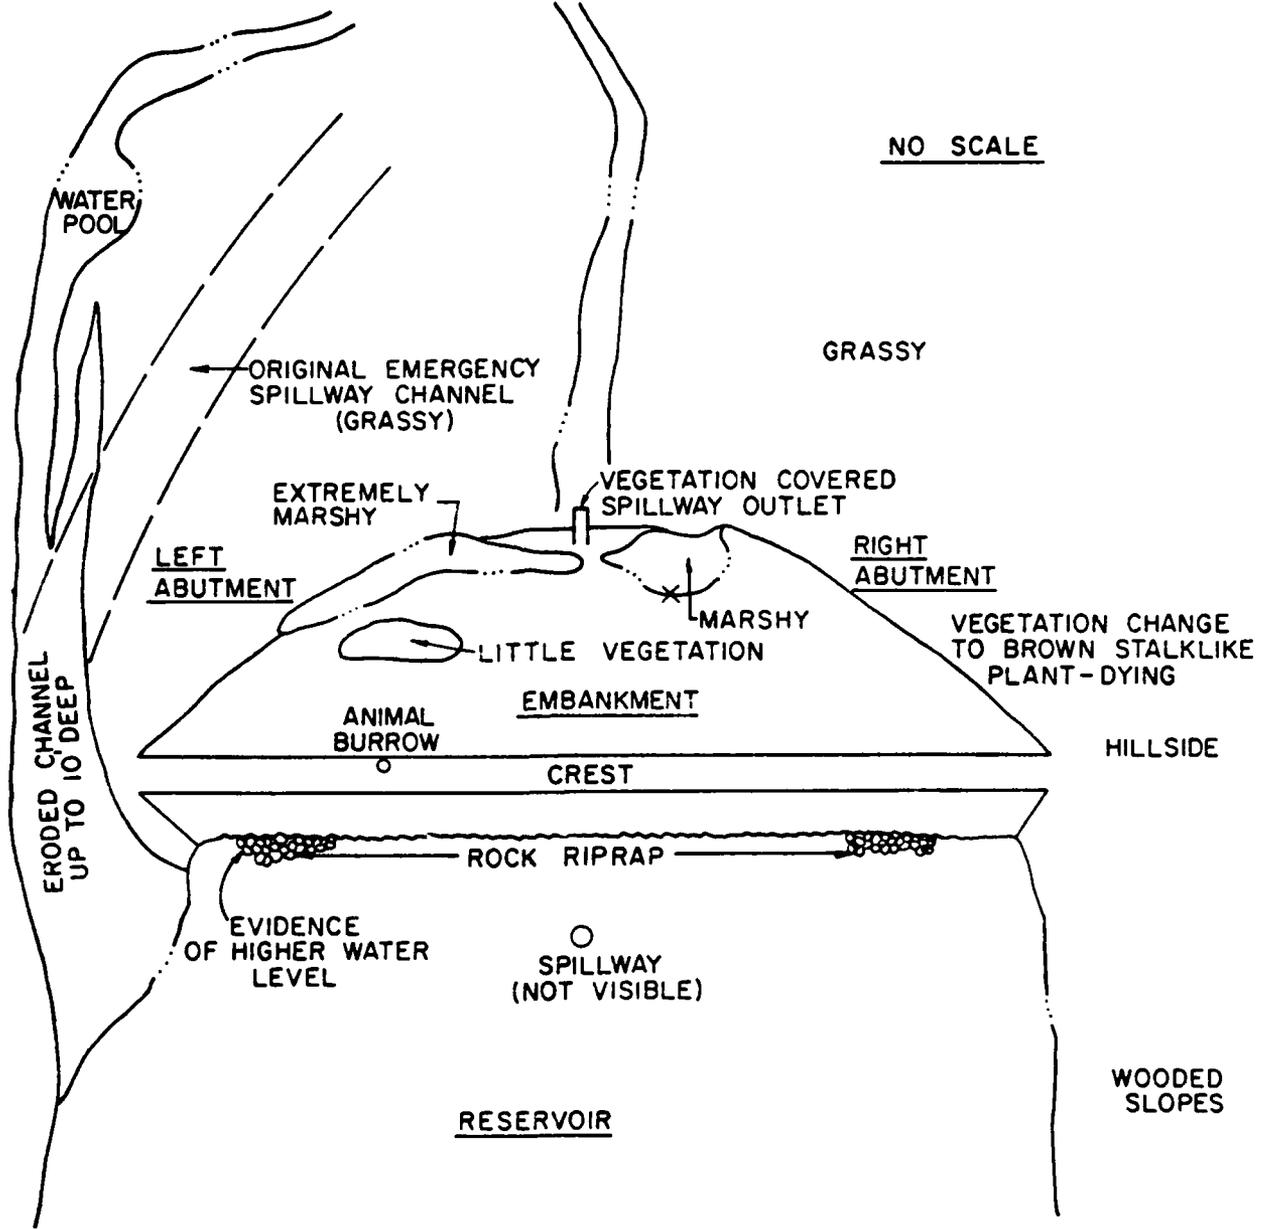
X - INDICATES VISIBLE WATER  
(SEEPAGE → <1 GAL./MIN.)

UPSTREAM AND DOWNSTREAM EMBANKMENT, ABUTMENTS, CREST, AND DOWNSTREAM CHANNEL ARE VERY OVERGROWN.  
DOWNSTREAM EMBANKMENT SURFACE SEEMED IRREGULAR - HOWEVER VEGETATION PREVENTED BETTER OBSERVATION.  
NO KNOWN TOE DRAINS.
