**INTERIM REPORT OF FIELD TEST
OF EXPEDIENT PAVEMENT REPAIRS
(TEST ITEMS 1-15).**

**RAYMOND S. ROLLINGS
ENGINEERING RESEARCH DIVISION**

MARCH 1980

INTERIM REPORT
JULY 1977 - JULY 1978

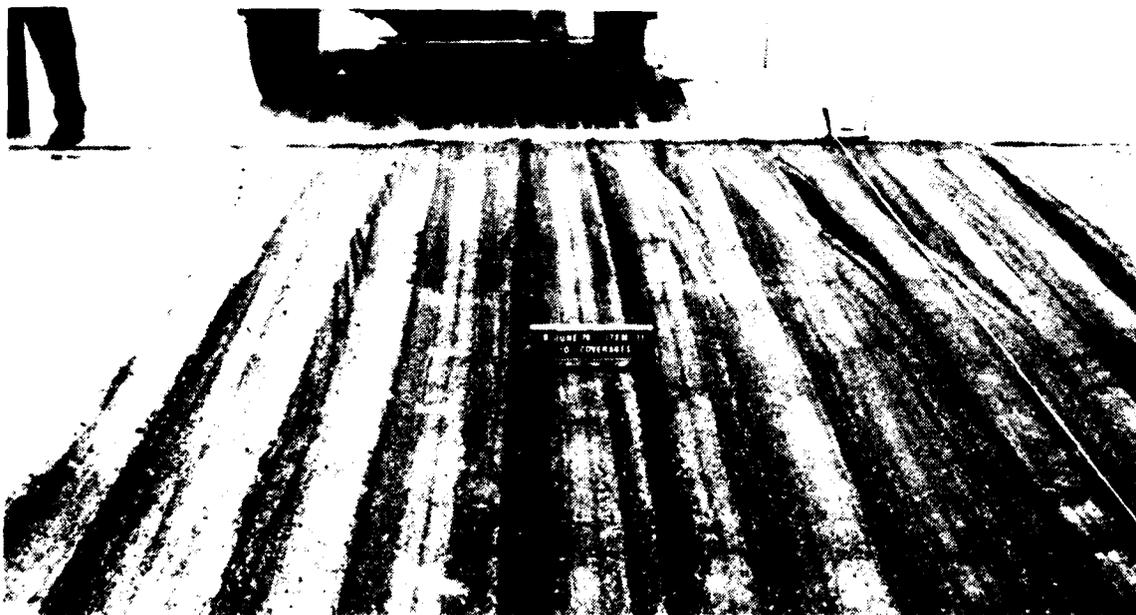
Figure 48. Rutting in Almalgapave® Surface, Item 11

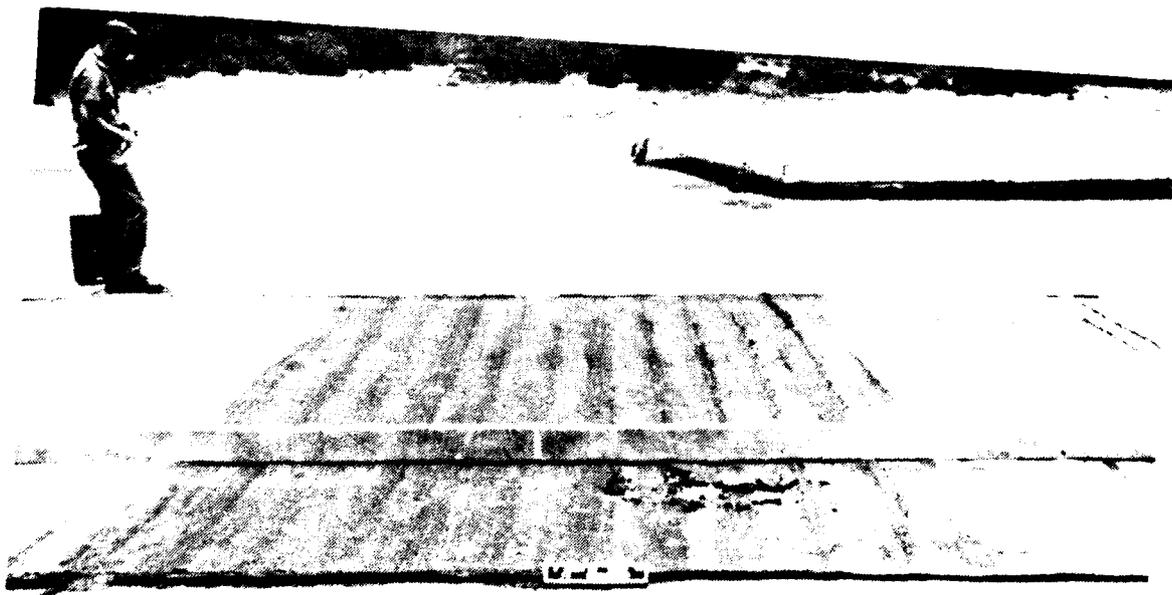
Figure 52. Zor-x[®] Surface After Traffic, Item 12

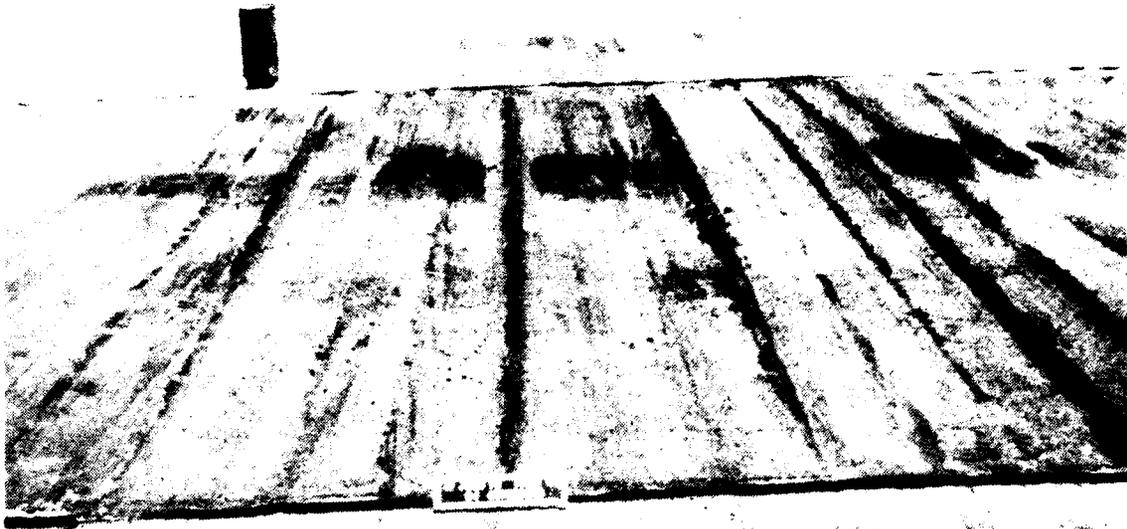
Figure 53. Almalgapave® Surface After 20 Coverages, Item 11A
