(6) NATIONAL DAM INSPECTION PROGRAM,  
BEAVER CREEK DAM  
(SCS PA 433).

~~CHESTER COUNTY DAM~~  
(NDS I.D. NUMBER PA 88903,  
DER I.D. NUMBER 15-301)

PHASE I INSPECTION REPORT,  
~~NATIONAL DAM INSPECTION PROGRAM~~

OVERVIEW  
BEAVER CREEK DAM (SCS PA 433), CHESTER COUNTY, PENNSYLVANIA

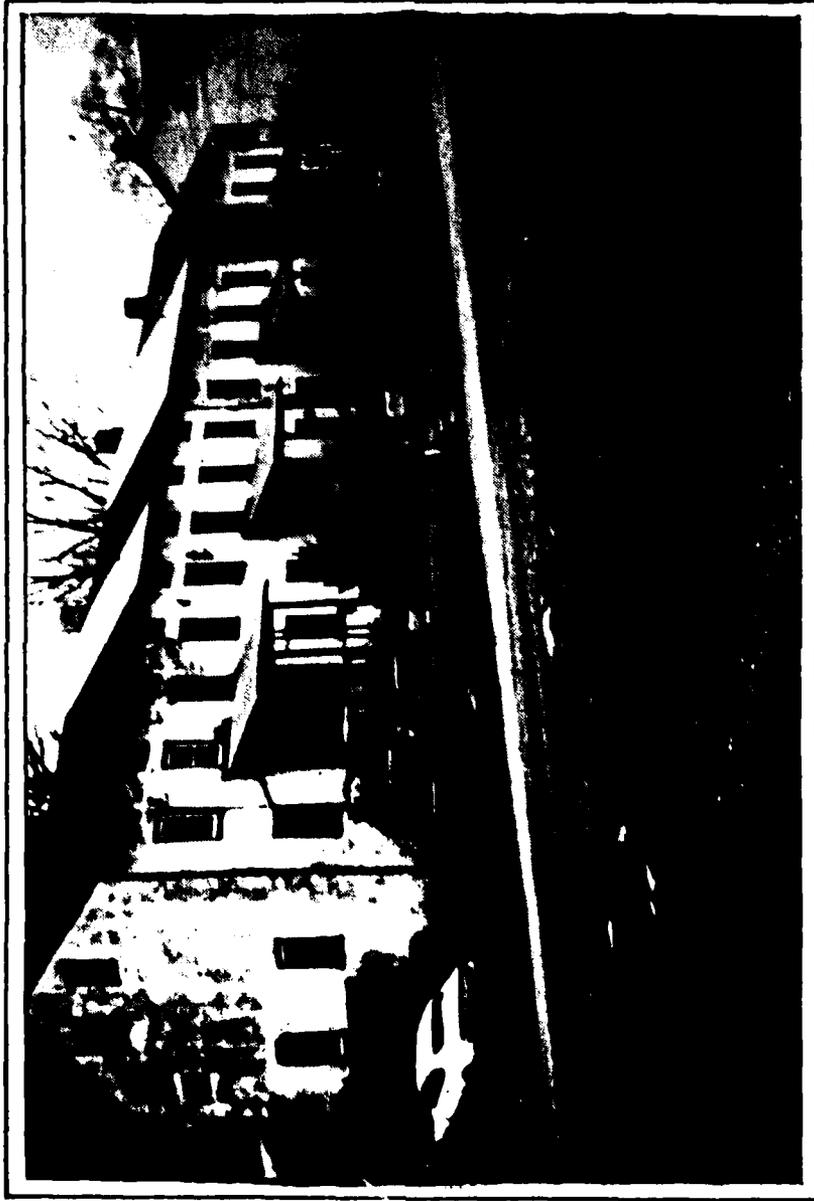
PHOTOGRAPH NO. 12

*In the first two river miles below the dam are 4 or 5 houses subject to damage in the event of failure of the dam. At Bondsville, 2 miles below the dam, additional homes and an unoccupied factory would be damaged.*

DOWNSTREAM HAZARD CENTER AT BONDSVILLE.
