6 NATIONAL DAM INSPECTION PROGRAM.
LAUREL RUN NO. 2 DAM.
NDI ID NO. PA-00550,
DER ID NO. 40-23,
~~BERNARD COUNTY AND LUZERNE COUNTY~~
PHASE I INSPECTION REPORT,
NATIONAL DAM INSPECTION PROGRAM

LAUREL RUN NO. 2 DAM

NDI ID No. PA-00550
 DER ID No. 40-23

PHASE I INSPECTION REPORT
 NATIONAL DAM INSPECTION PROGRAM

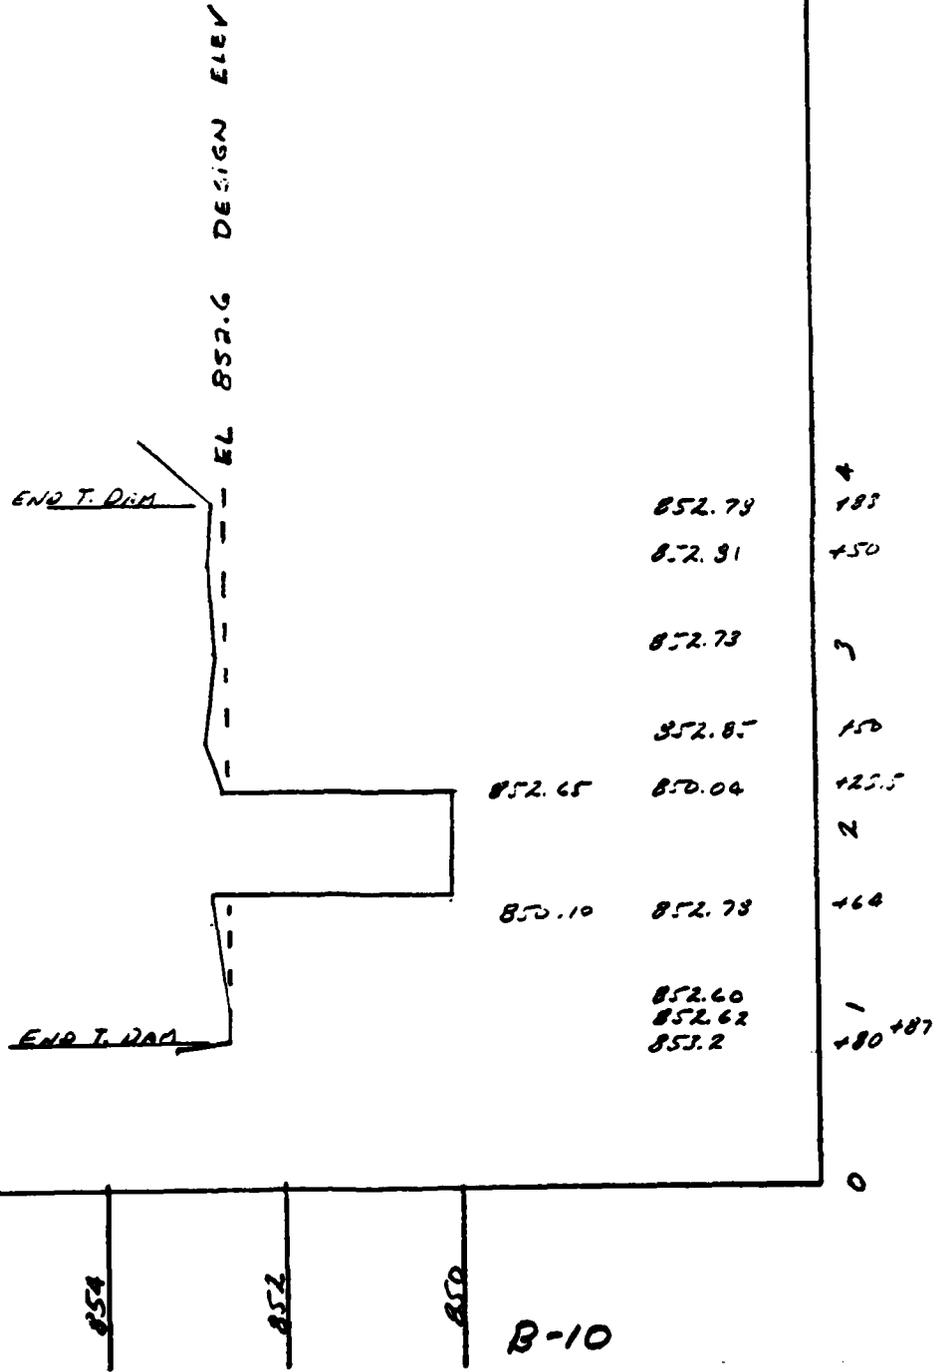
LAUREL RUN #2 DAM
 PROFILE - TOP OF DAM - LOOKING DOWNSTREAM

The survey performed for this inspection reveals that the top of the dam is above its design elevation. The minor variations shown on the profile are caused by the roughness of the capstones. The downstream face of the dam appeared to be in conformance with cross sections on the Plates in Appendix E.

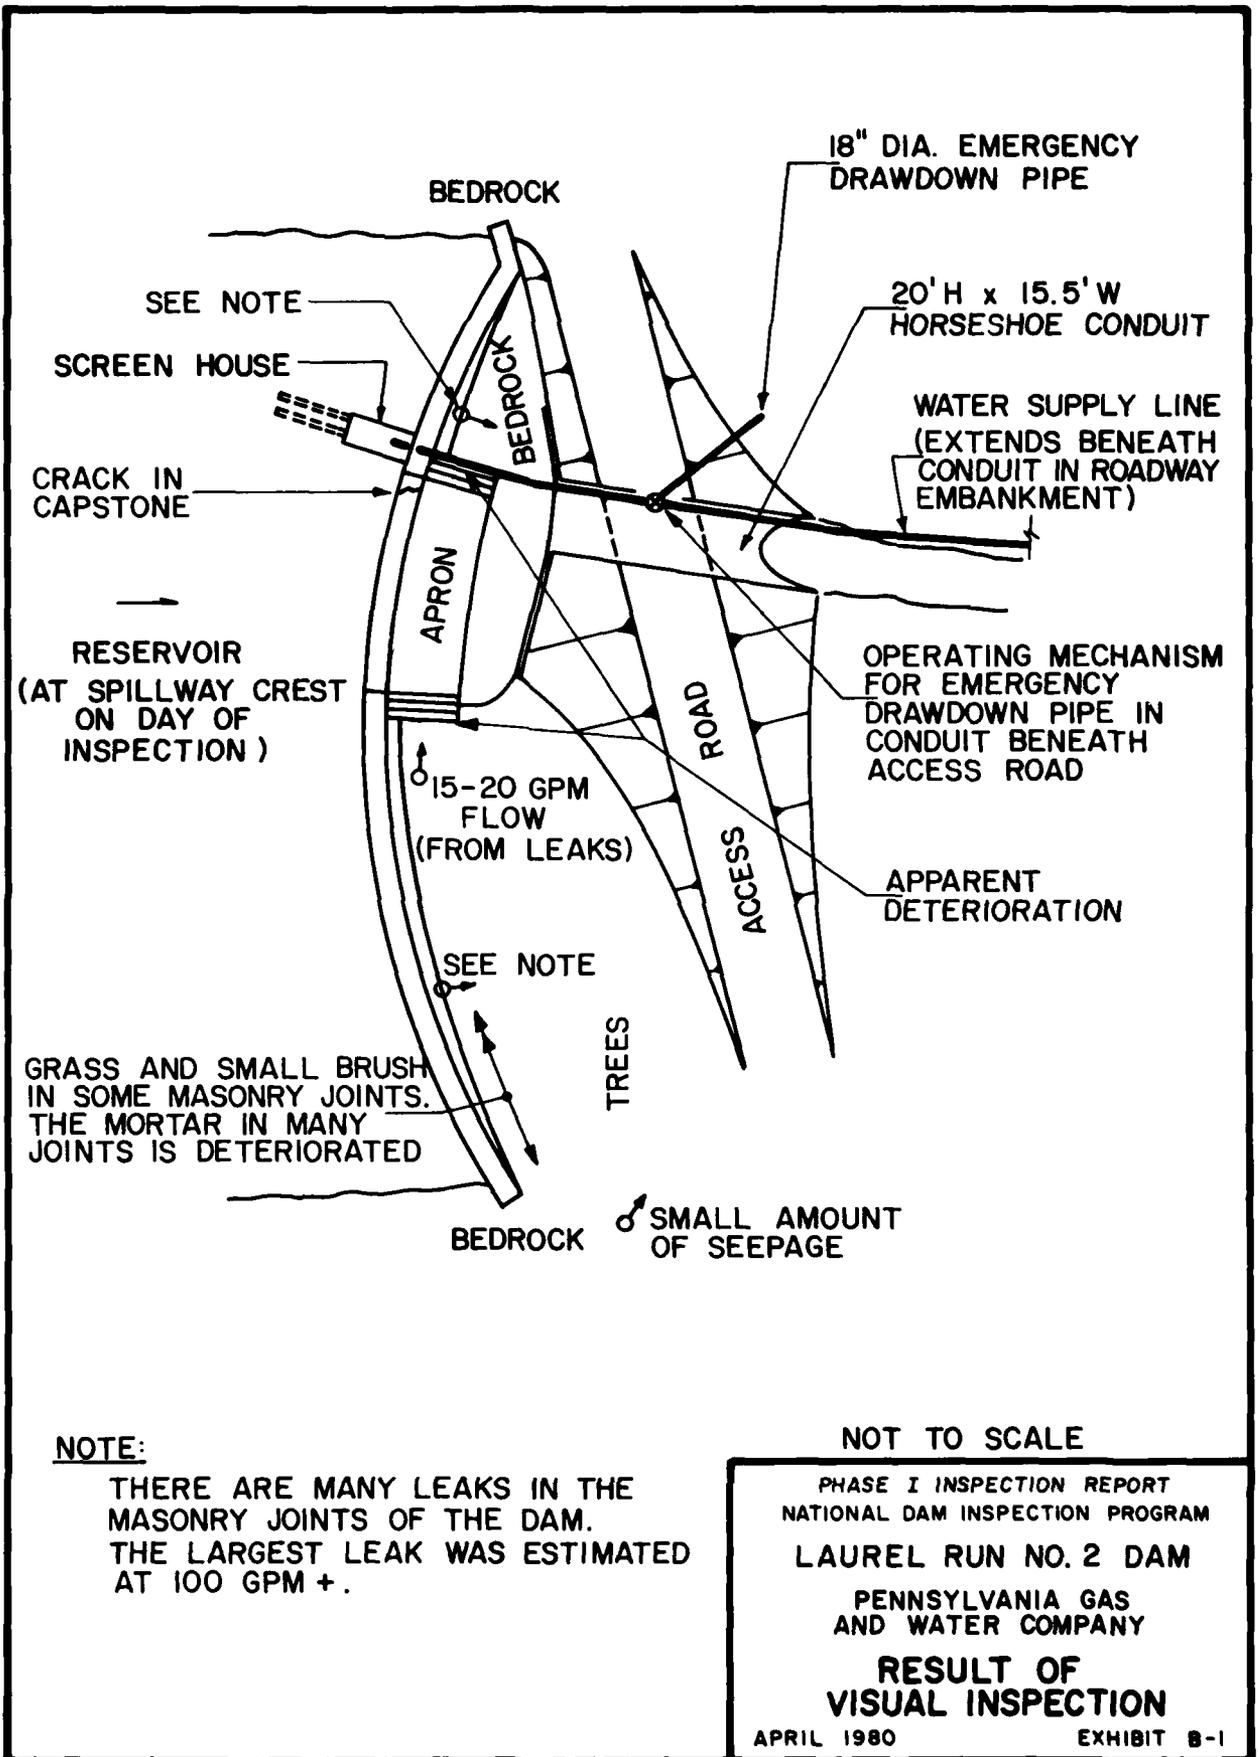
THERE ARE MANY LEAKS IN THE MASONRY JOINTS OF THE DAM. THE LARGEST LEAK WAS ESTIMATED AT 100 GPM + .
