CLAYSVILLE No. 1 DAM

NDI No. PA 00491
PennDER No. 63-35

PHASE I INSPECTION REPORT
NATIONAL DAM INSPECTION PROGRAM

March 1980

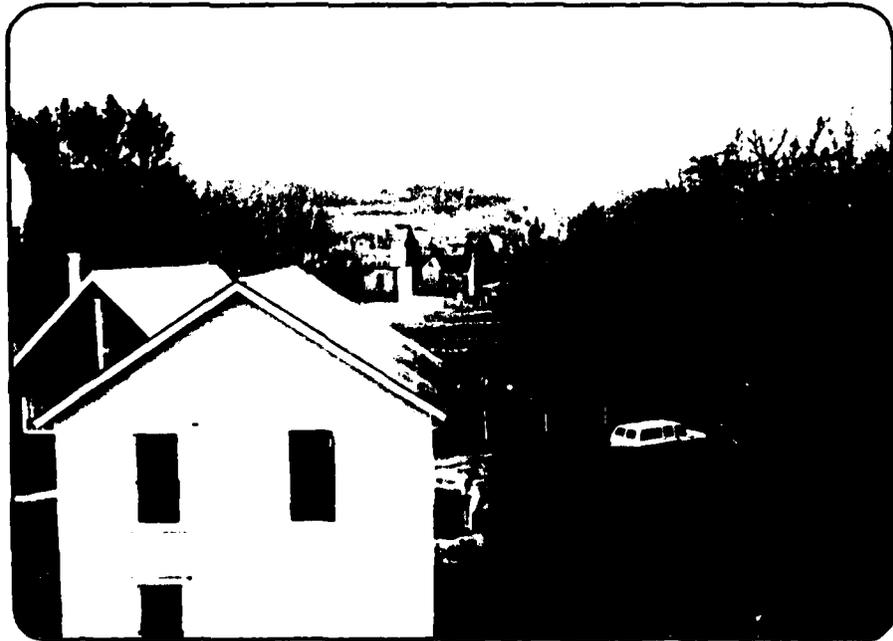
The water filtration plant is located immediately downstream of the left half of the dam. Several (four) storage facilities are also located immediately downstream of the right half of the dam. Approximately 900 ft. downstream is an elementary school and playground. Three residential structures are also located in the floodplain before the discharge would pass through a restrictive (approximately 4.5 ft. by 6 ft.) road (U.S. Route 40) culvert. An additional estimated 10 structures are located in the floodplain between U.S. 40 and a Baltimore and Ohio R.R. embankment and culvert. The amount of the flow that can be discharged by the R.R. culvert is also estimated to be low.

PHOTO 10. View from the Crest of the Embankment Looking Downstream at the School Located Within the Downstream Channel Floodplain
