POLK DAM

NDI No. PA 00253
PennDER No. 61-7

PHASE I INSPECTION REPORT
NATIONAL DAM INSPECTION PROGRAM

Polk Dam, Venango County, Pennsylvania
NDI No. PA 00253, PennDER No. 61-7
Piffer Run of Little Sandy Creek
Inspected 10 December 1979

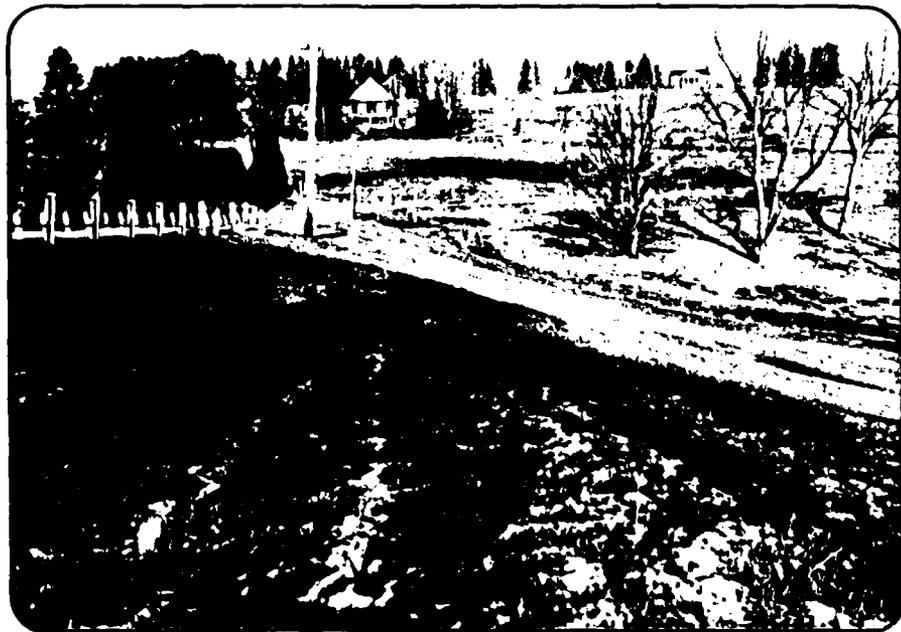
PHOTO 2. View of the Downstream Slope of Dam from the Right Abutment

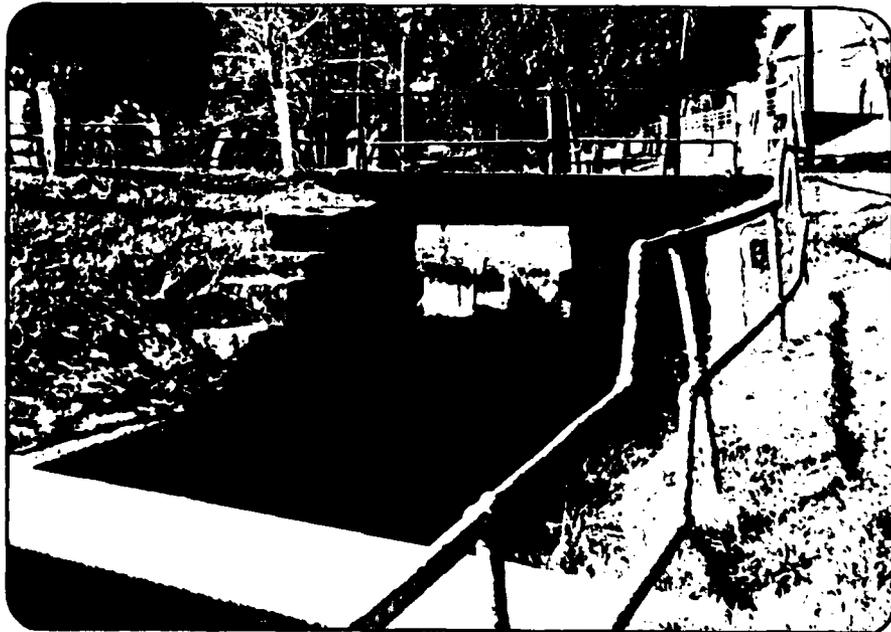
PHOTO 4. View of the Spillway and Bridge Looking Upstream

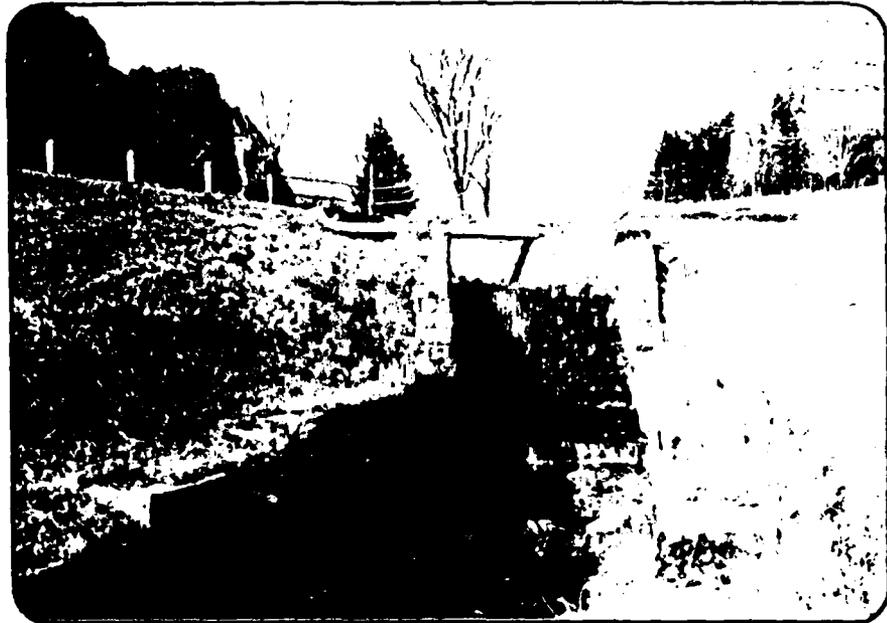
PHOTO 5. View of the Spillway Discharge Channel Looking Upstream

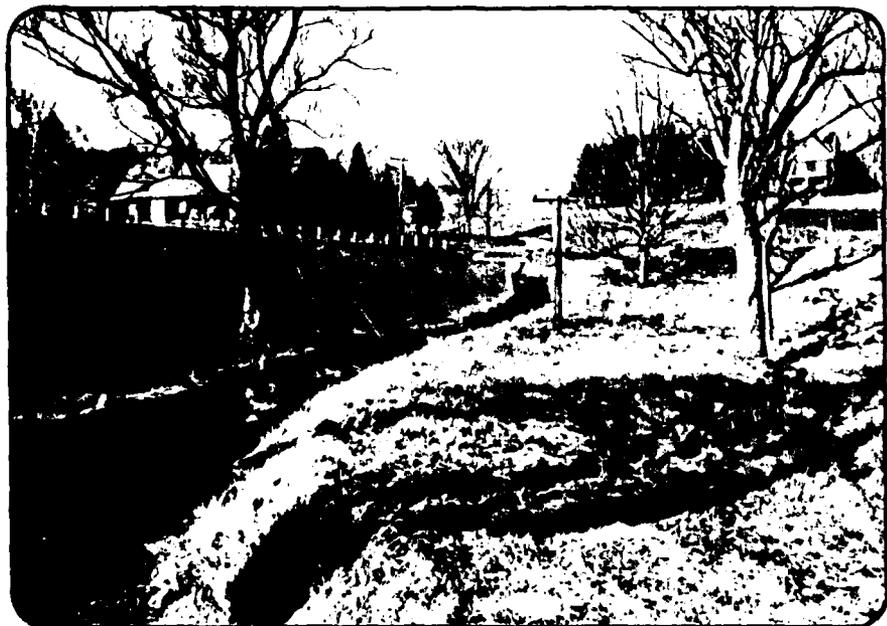
PHOTO 6. View of the Discharge Channel Looking Upstream

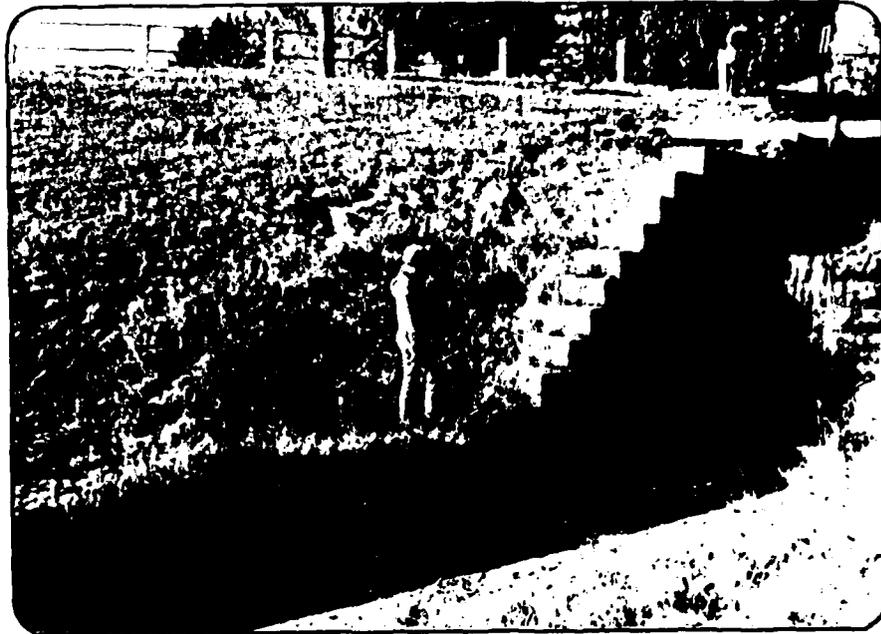
PHOTO 9. View of Eroded Area on the Right Downstream Side of the Spillway Structure

- 3) The sloughing and erosion of the downstream slope adjacent to the spillway structure should be repaired. It is recommended that the slope be partially cut back in this area so as to decrease or stop the sloughing and erosion.
