Detroit Diesel Allison
Division of General Motors Corporation
Indianapolis, Indiana

REPORT NO. 14 DDA-79D87

9 **ENGINEERING TEST REPORT.**

6 ENVIRONMENTAL AND COLD TESTS ON
MODEL 04045B03 GENERATOR SET SERIAL NUMBER
0000003 WITH IGT 404-4 ENGINE SERIAL NUMBER
TEST UNIT _____

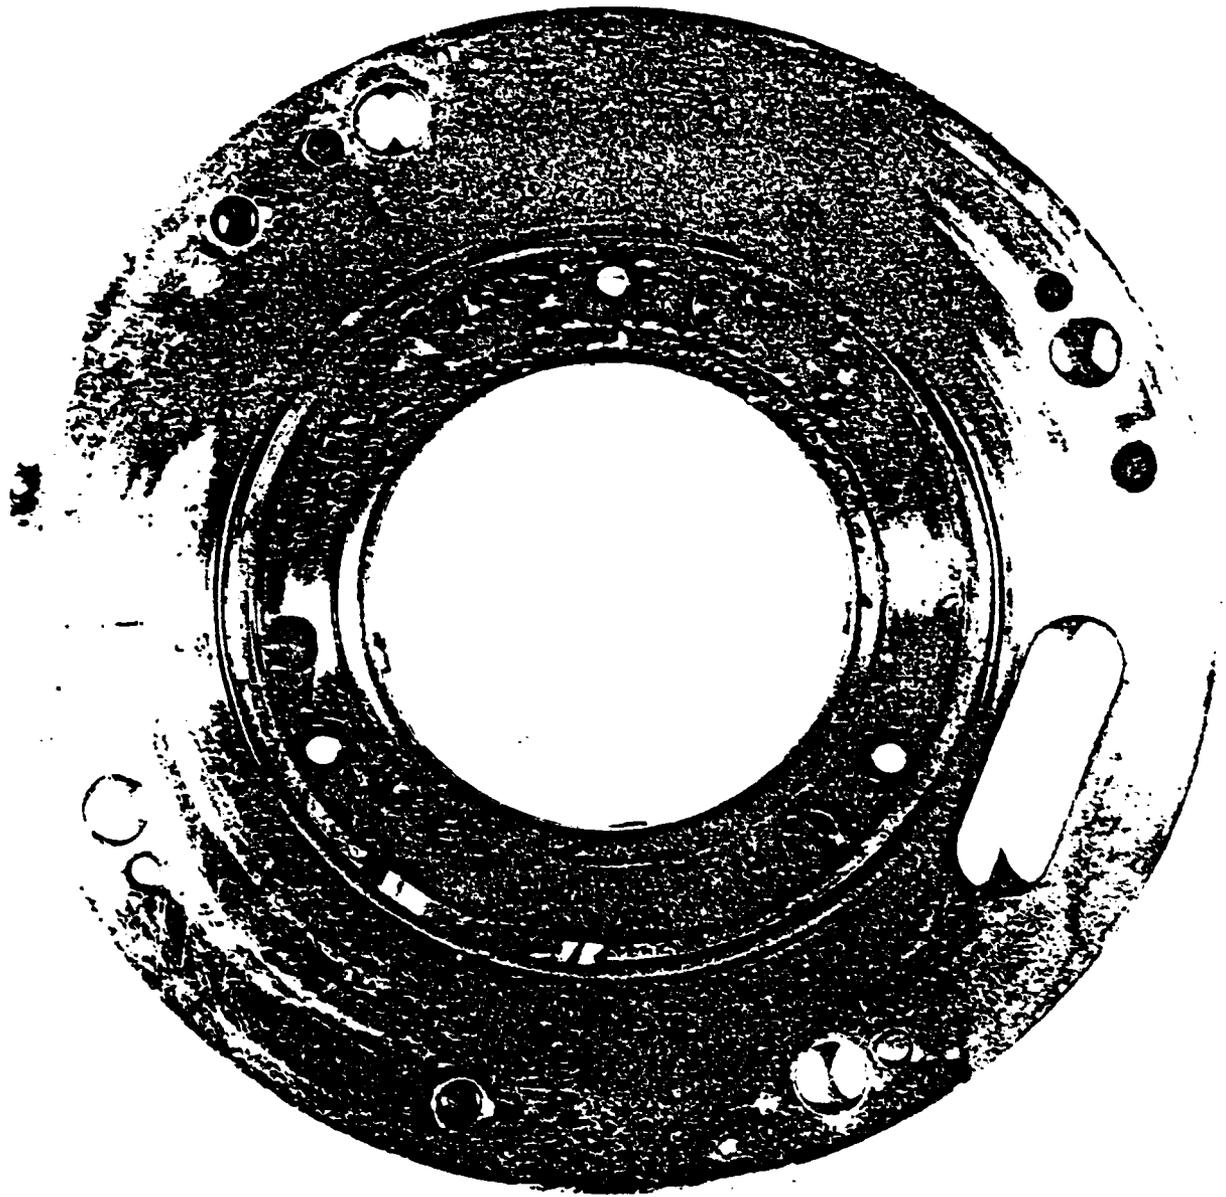
The generator set and engine were disassembled to assess the failure damage. The failure and secondary damage are shown on Photos 351421 through 351439 and 351525.

-50°F COLD TEST BRG. FAILURE, GEN. SET #3, ENG. T3, B.U. 7.

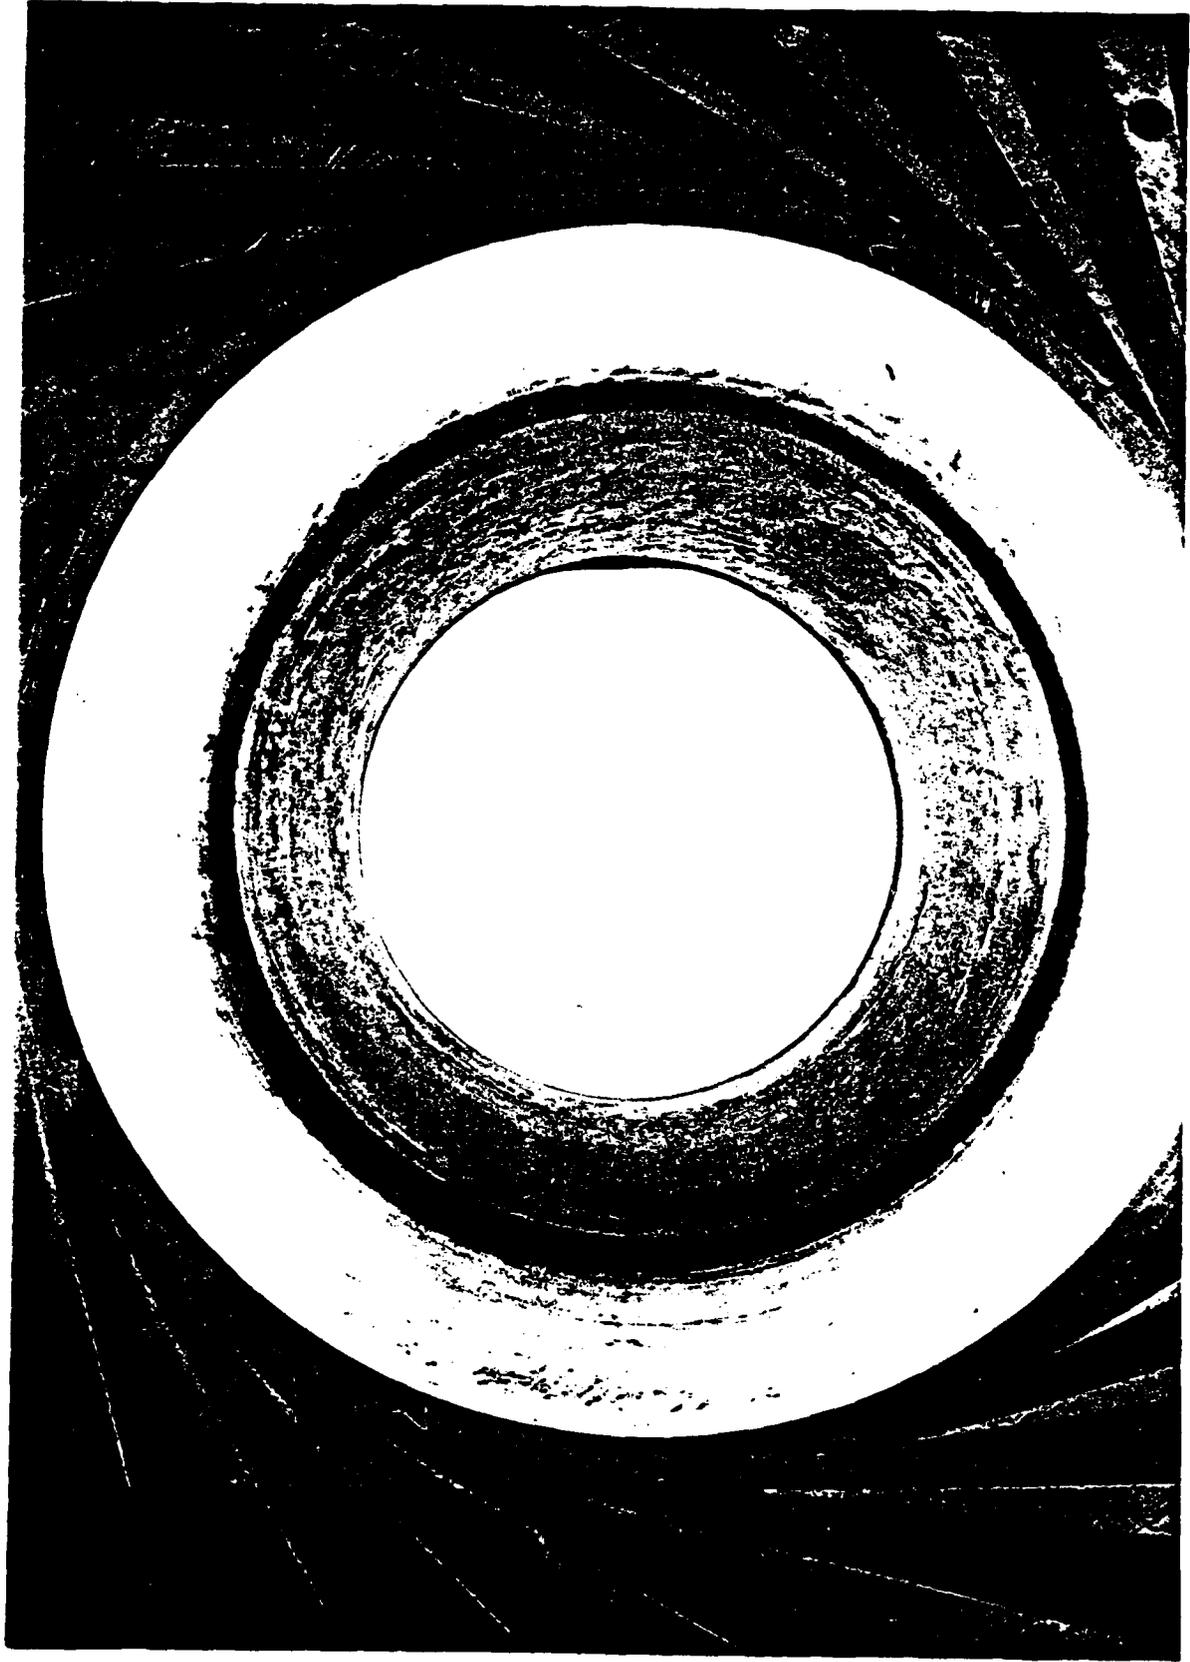
-50°F COLD TEST BRG. FAILURE, GEN. SET #3, ENG. T3, B.U. 7. 351422

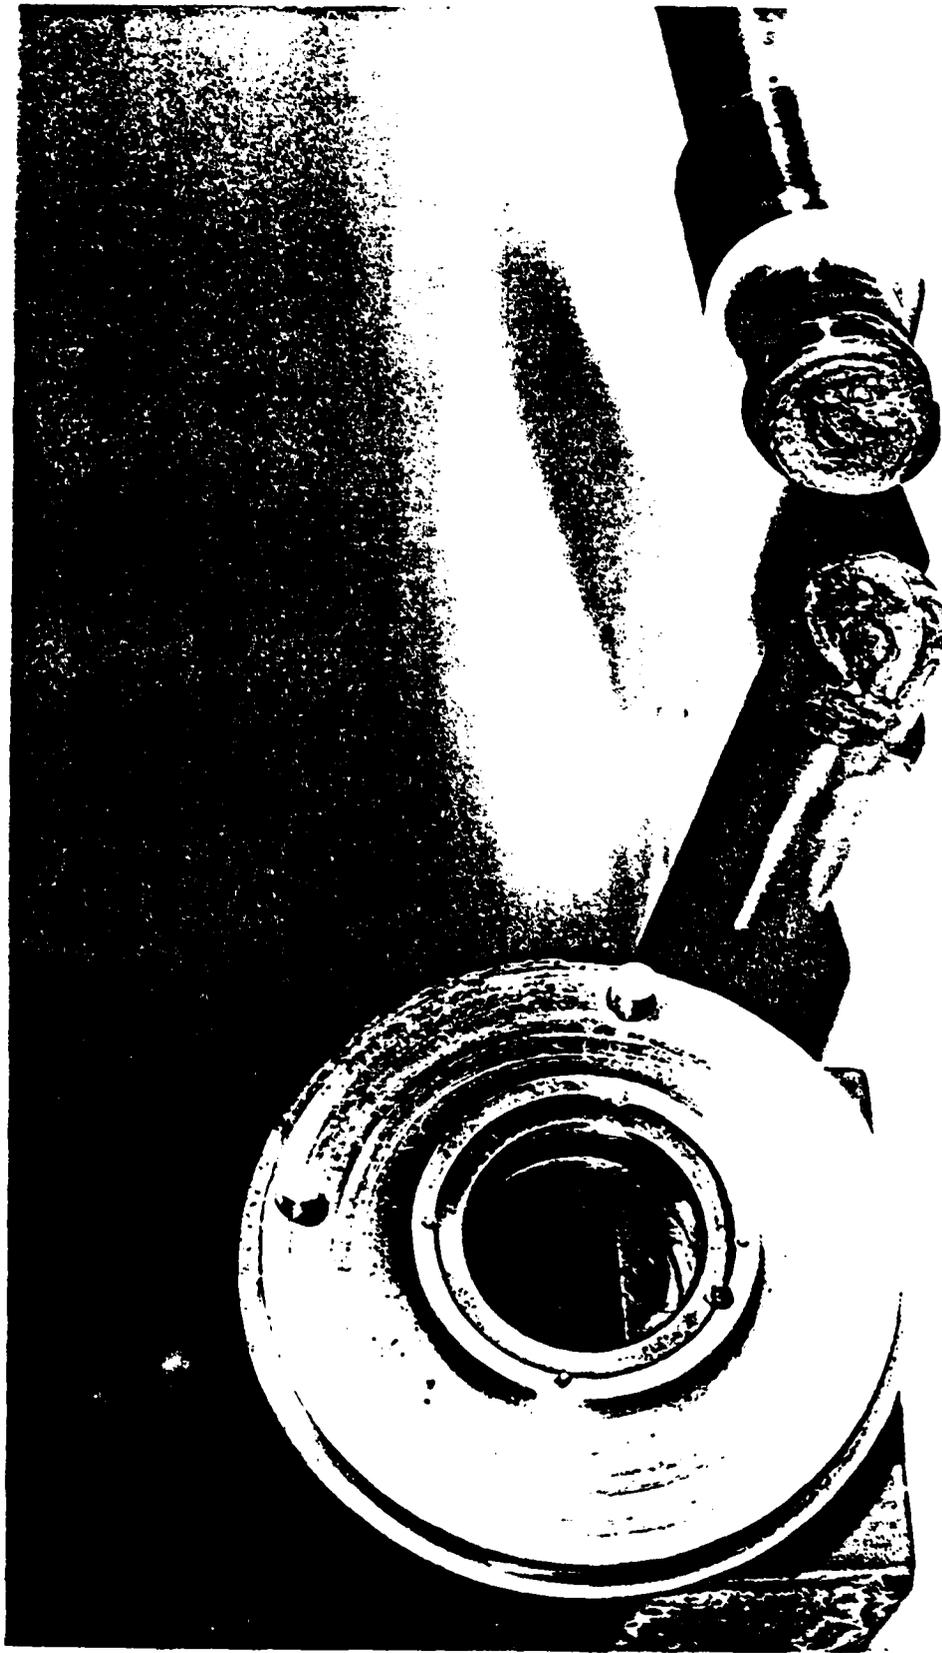
-50°F COLD TEST BRG. FAILURE, GEN. SET #3, ENG. T3, B.U. 7 351424

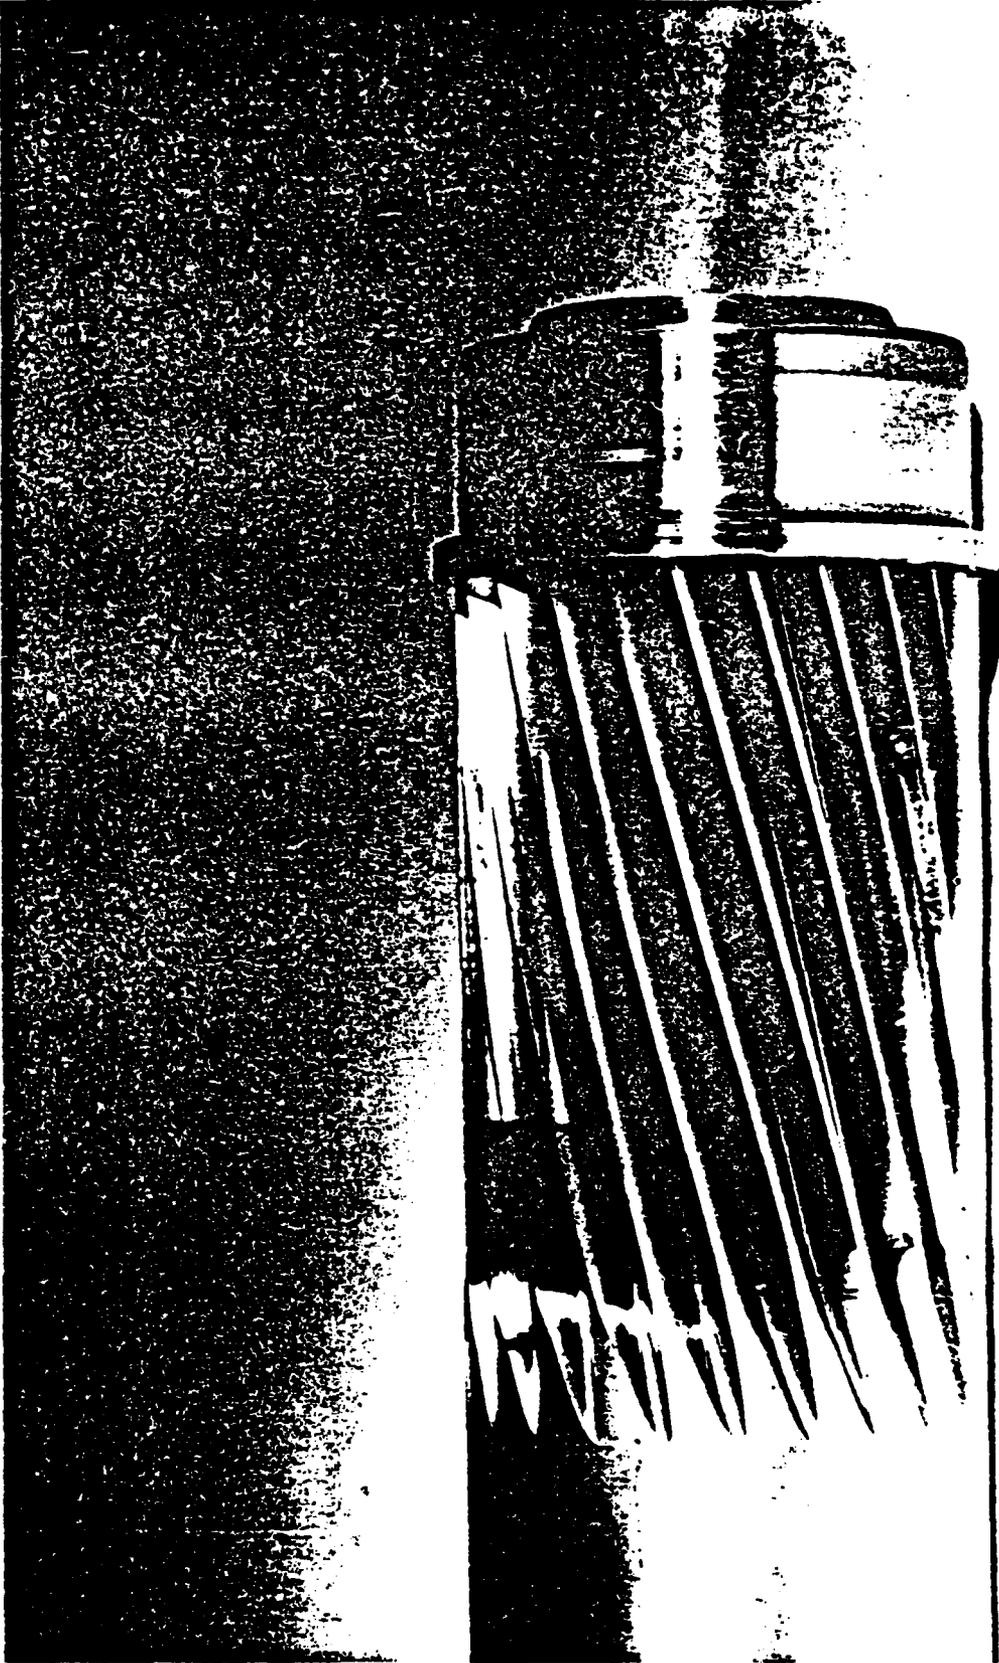
-50°F COLD TEST BRG. FAILURE. GEN. SET #3, ENG. T3, B.U. 7. 351425

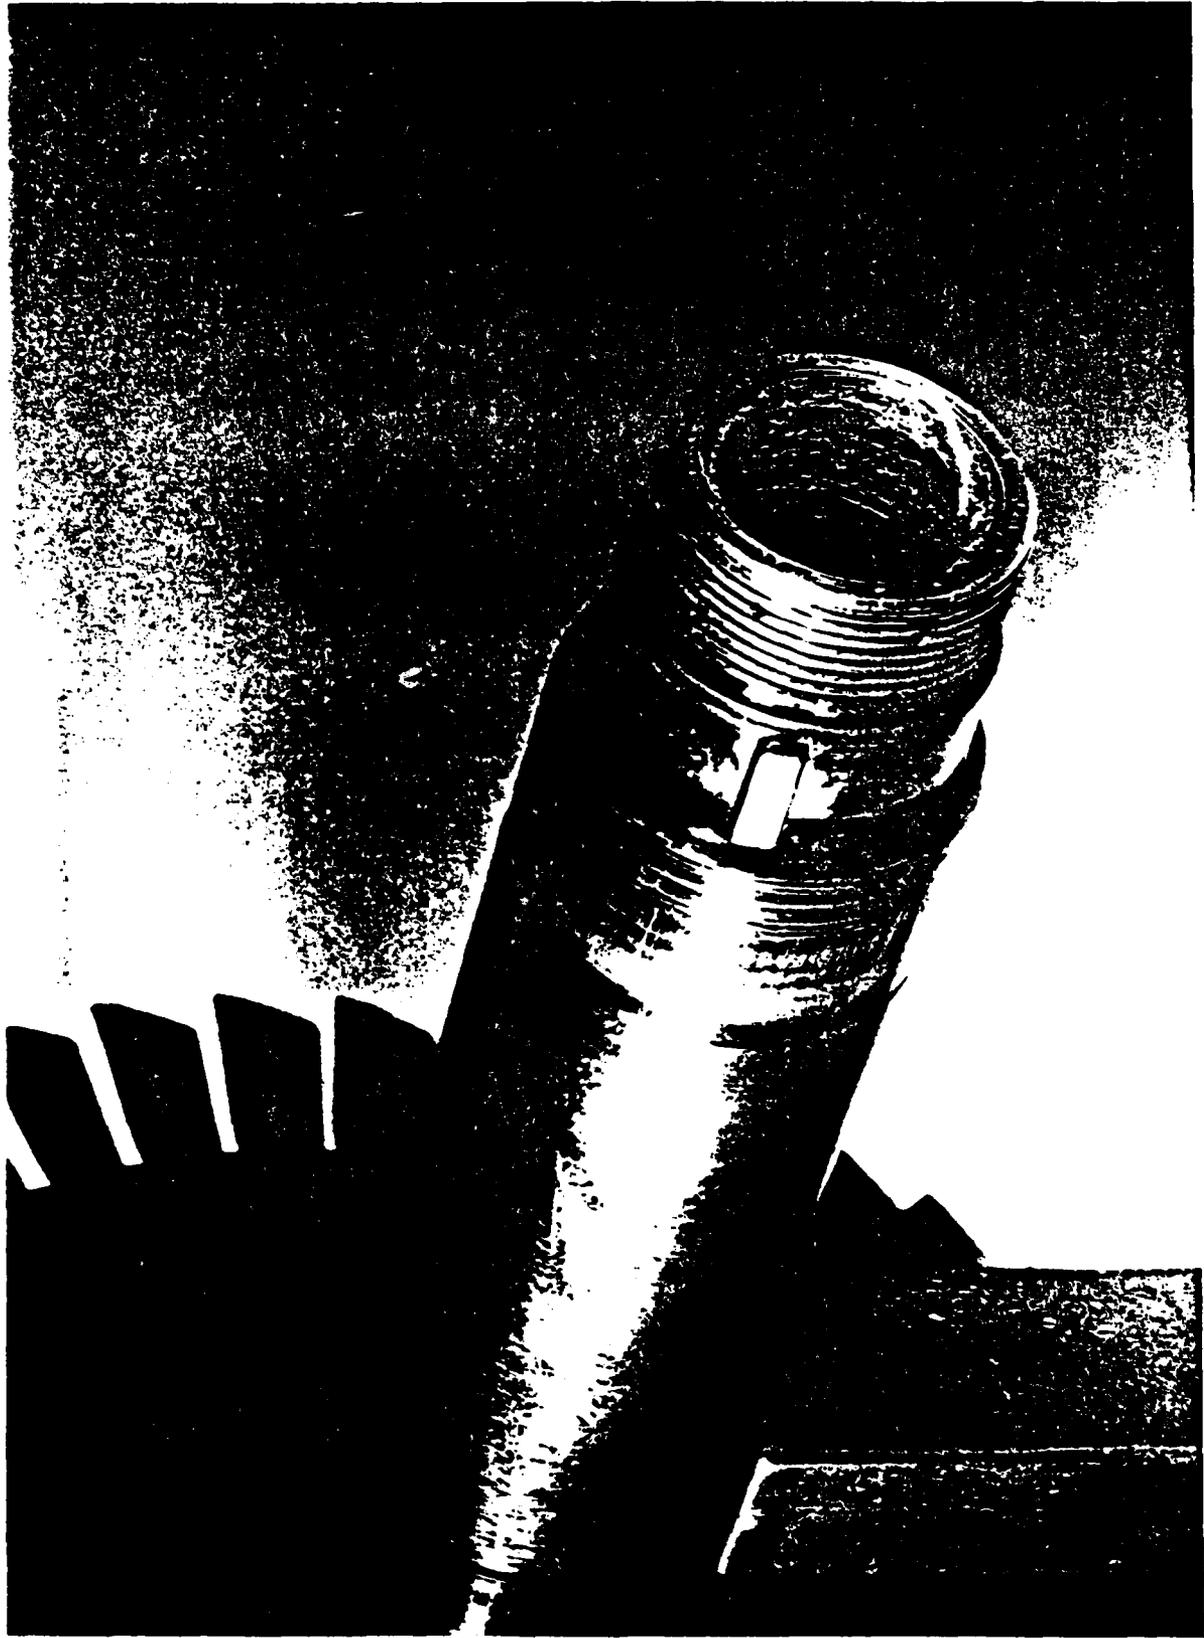
-50°F COLD TEST BRG. FAILURE, GEN. SET #3, ENG. T3, B.U. 7. 351426

Photographs 351430 and 351432 picture the failed power turbine roller bearing which was apparently the primary failure due to lack of lubrication. The other photographs depict secondary damage but special interest should be taken in the gasifier front (Photo 351429) and rear (Photo 351427) ball bearings which had extreme distress on one side due to the heavy activity at the quill shaft which finally failed at the seal (Photo 351424) which runs in the bushing located in the aft end of the power turbine (Photo 351426).

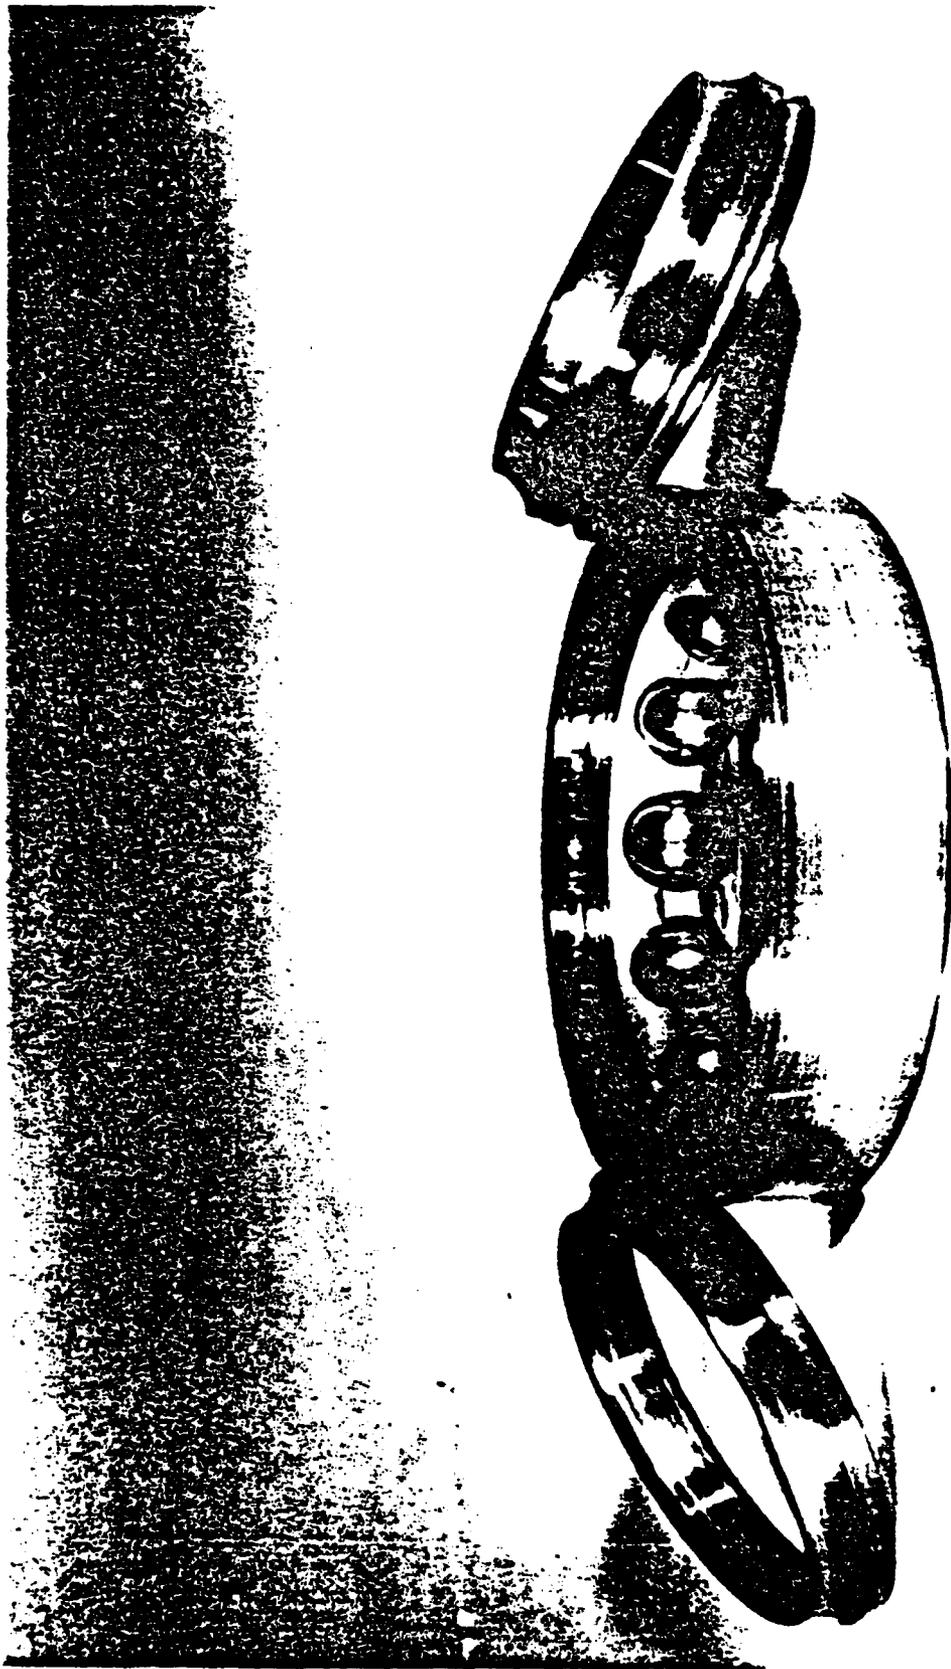
-50°F COLD TEST BRG. FAILURE, GEN. SET #3, ENG. T3, B. U. 7. 351429

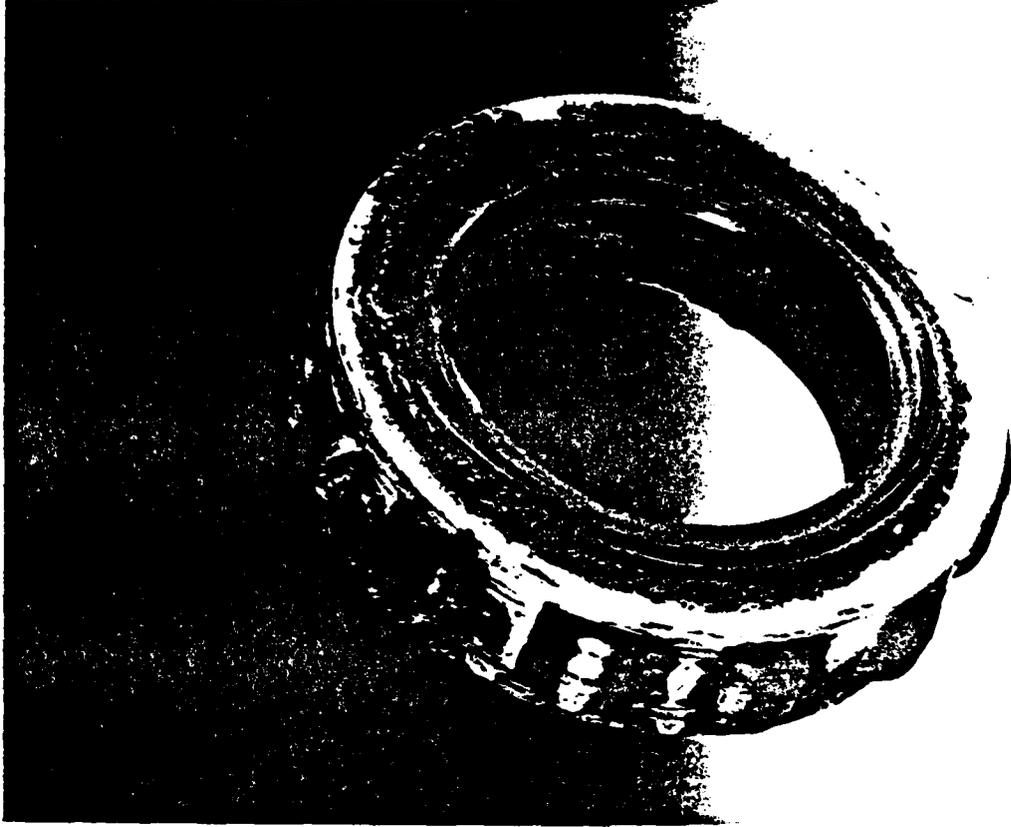
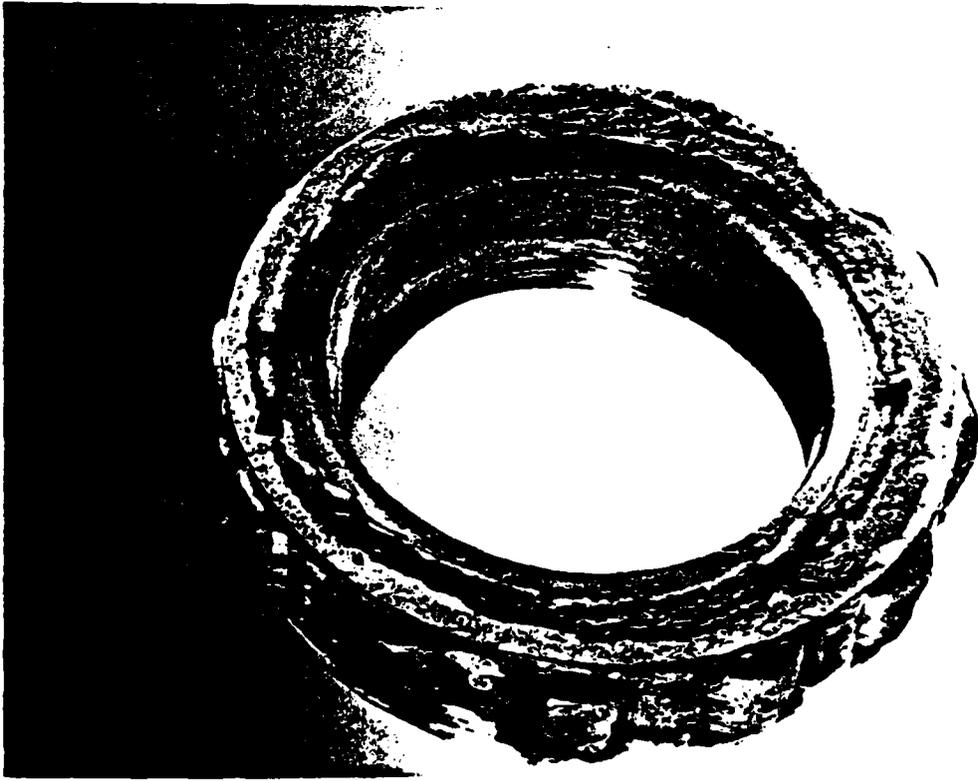
-50°F COLD TEST BRG. FAILURE, GEN. SET #3, ENG. T3, B. U. 7. 351430

After the normal preparations, the -50°F testing was initiated with a successful start and loading within one minute. However, soon after the loading occurred, the unit emitted two howls and a loud "pop." The pop was apparently due to the quill shaft failing as secondary damage when the power turbine roller bearing failed (lack of lubrication - cooling).

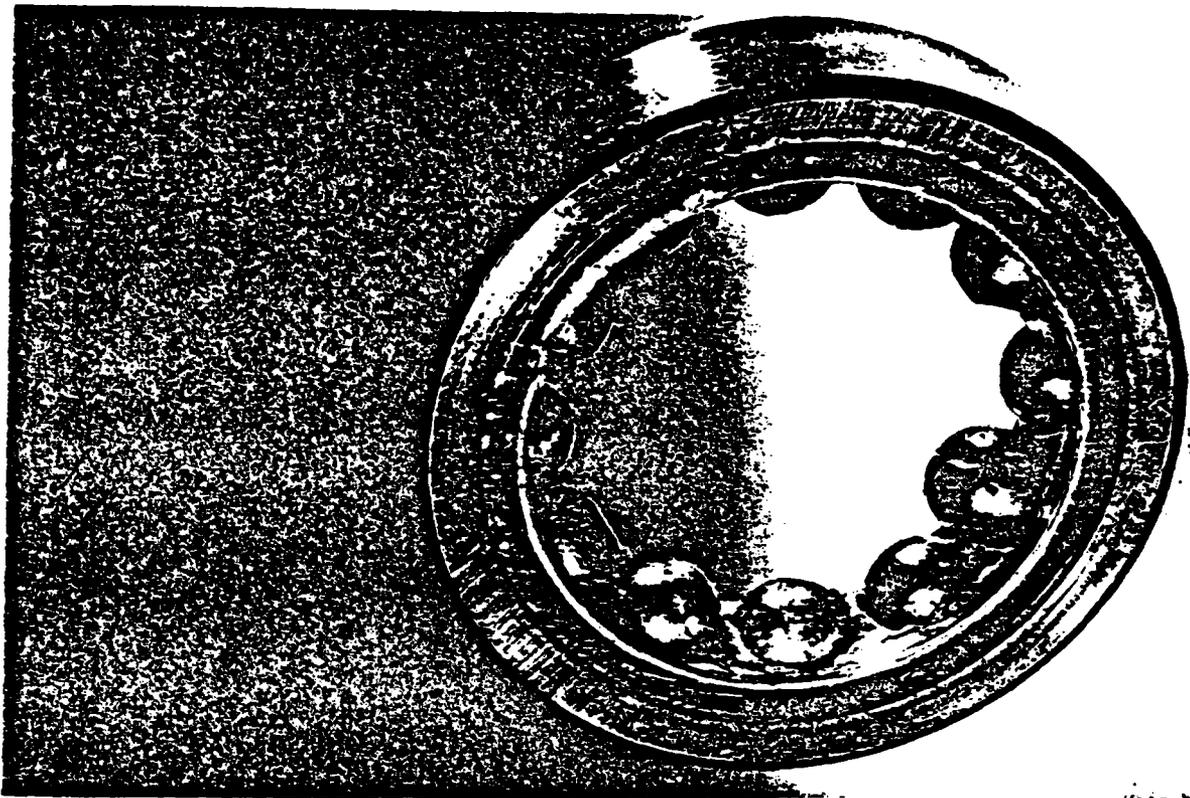
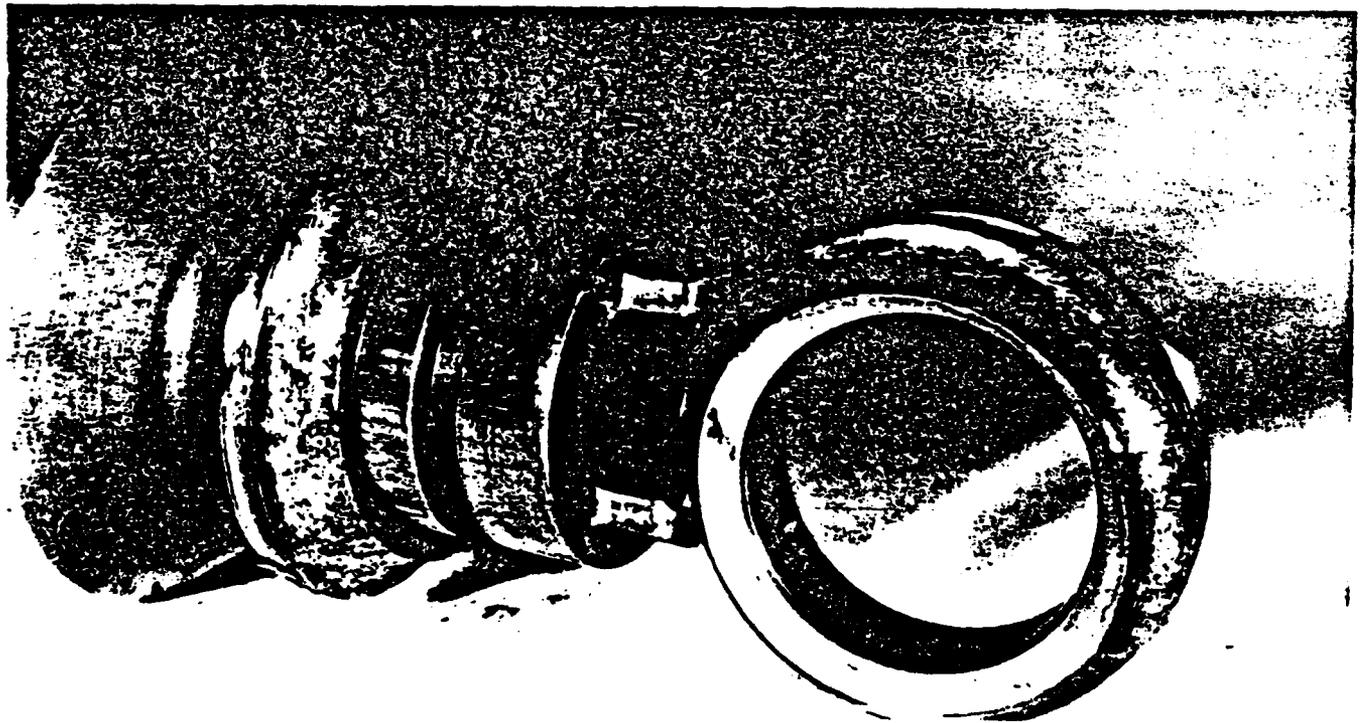
351431

-50°F COLD TEST BRG. FAILURE. GEN. SET #3, ENG. T3, B.U. 7.

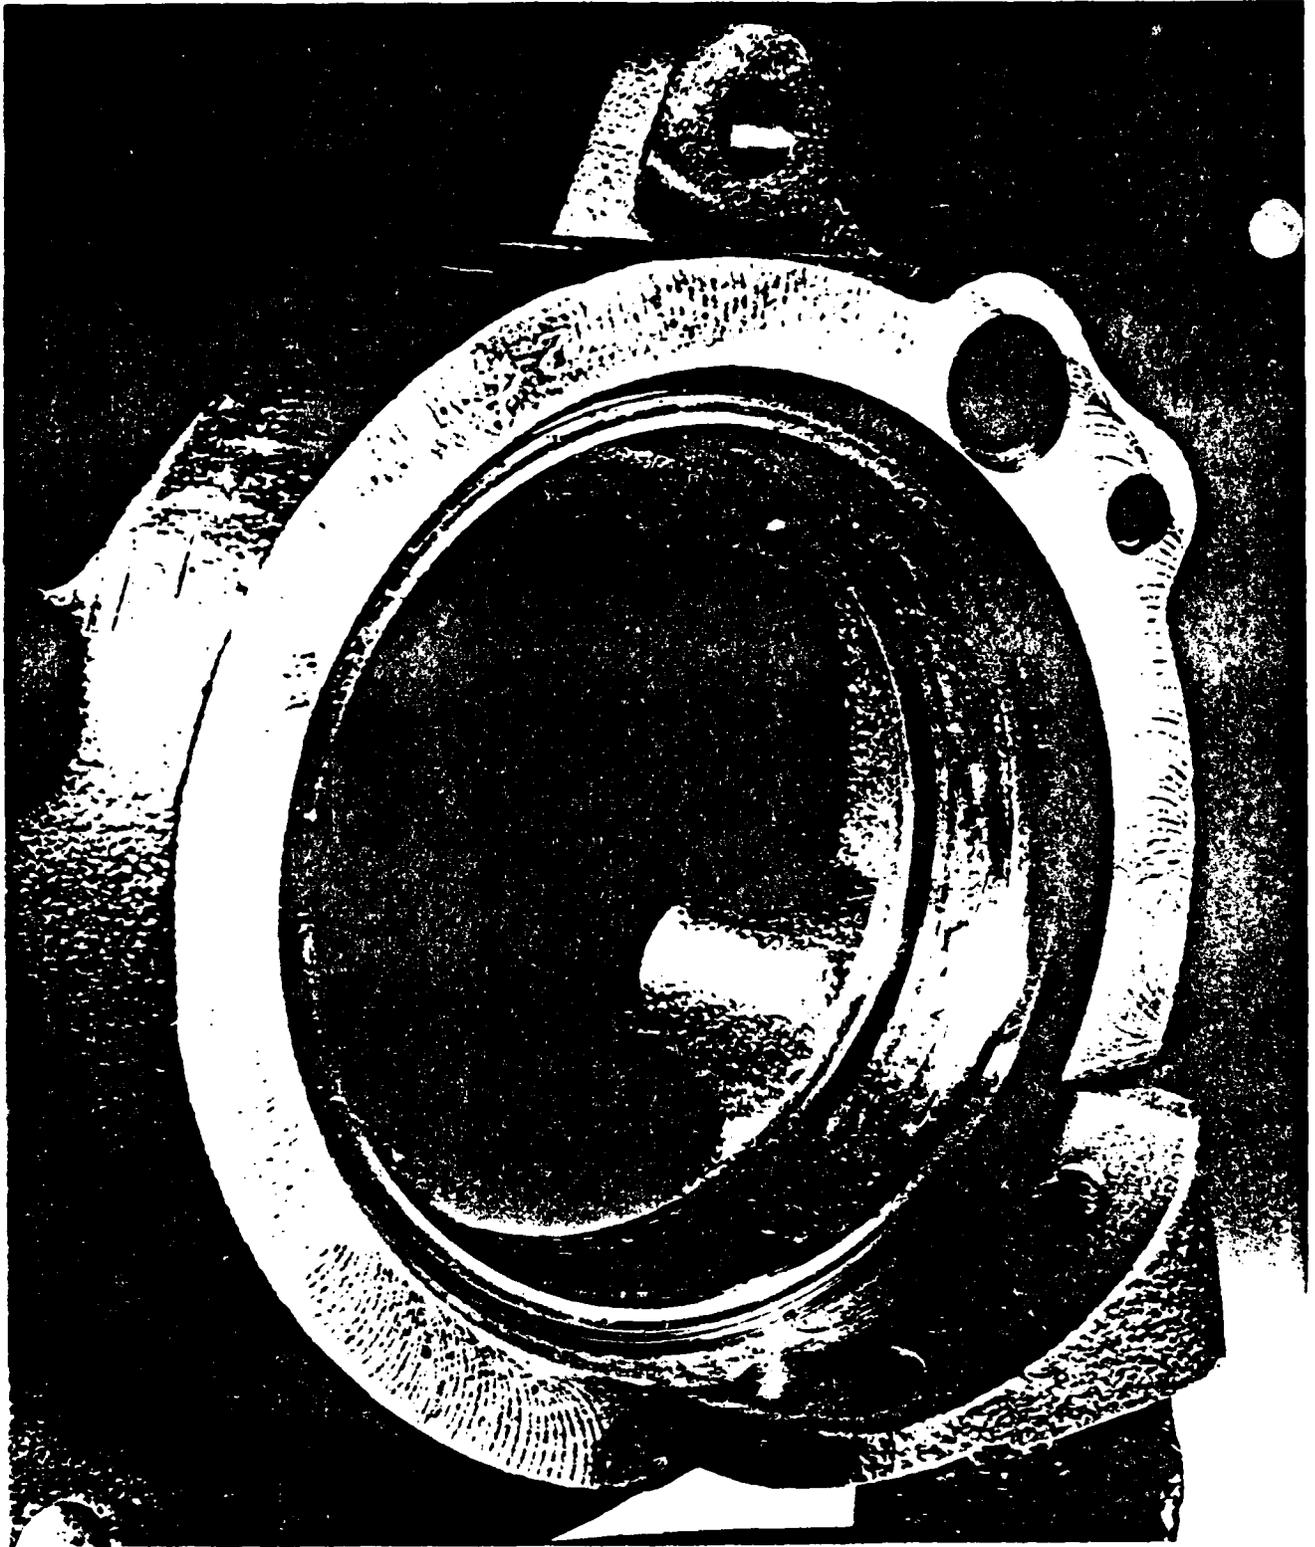
351432

-50°F COLD TEST BRG. FAILURE, GEN. SET #3, ENG. T3, B.U. 7.

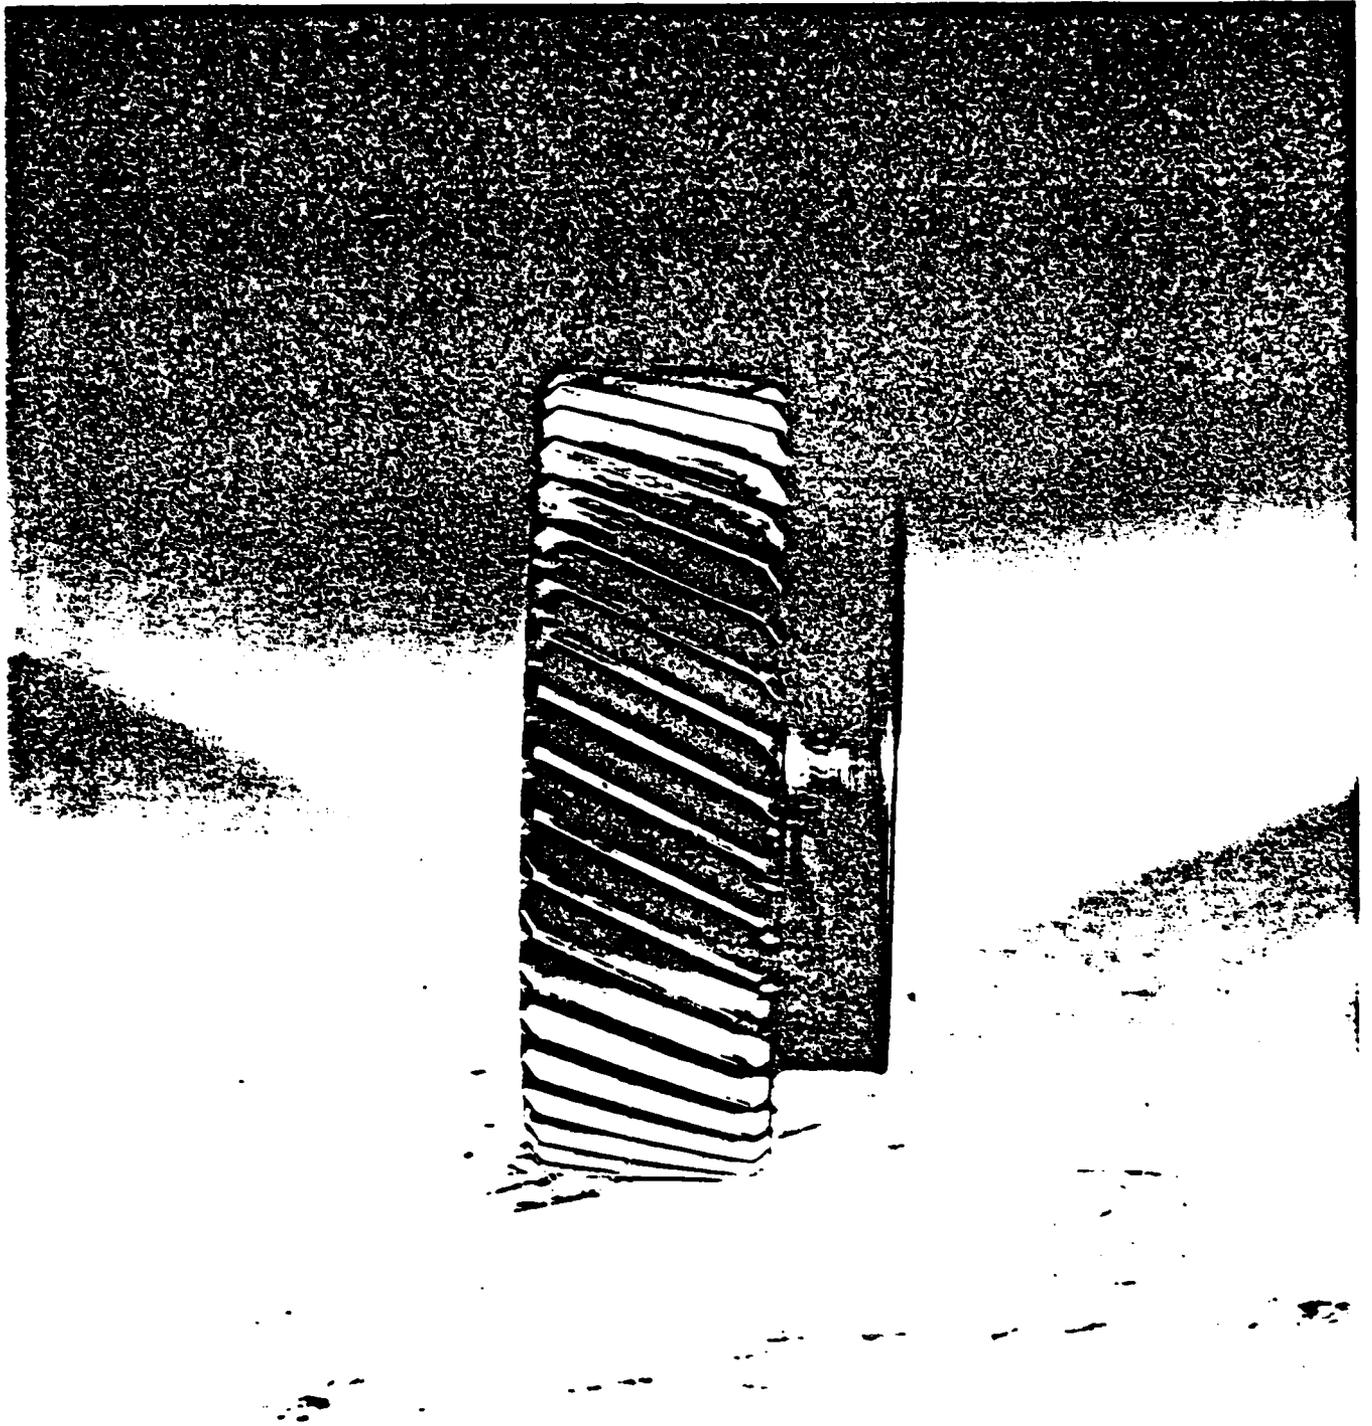
351433

-50°F COLD TEST BRG. FAILURE, GEN. SET #3, ENG. T3, B.U. 7.

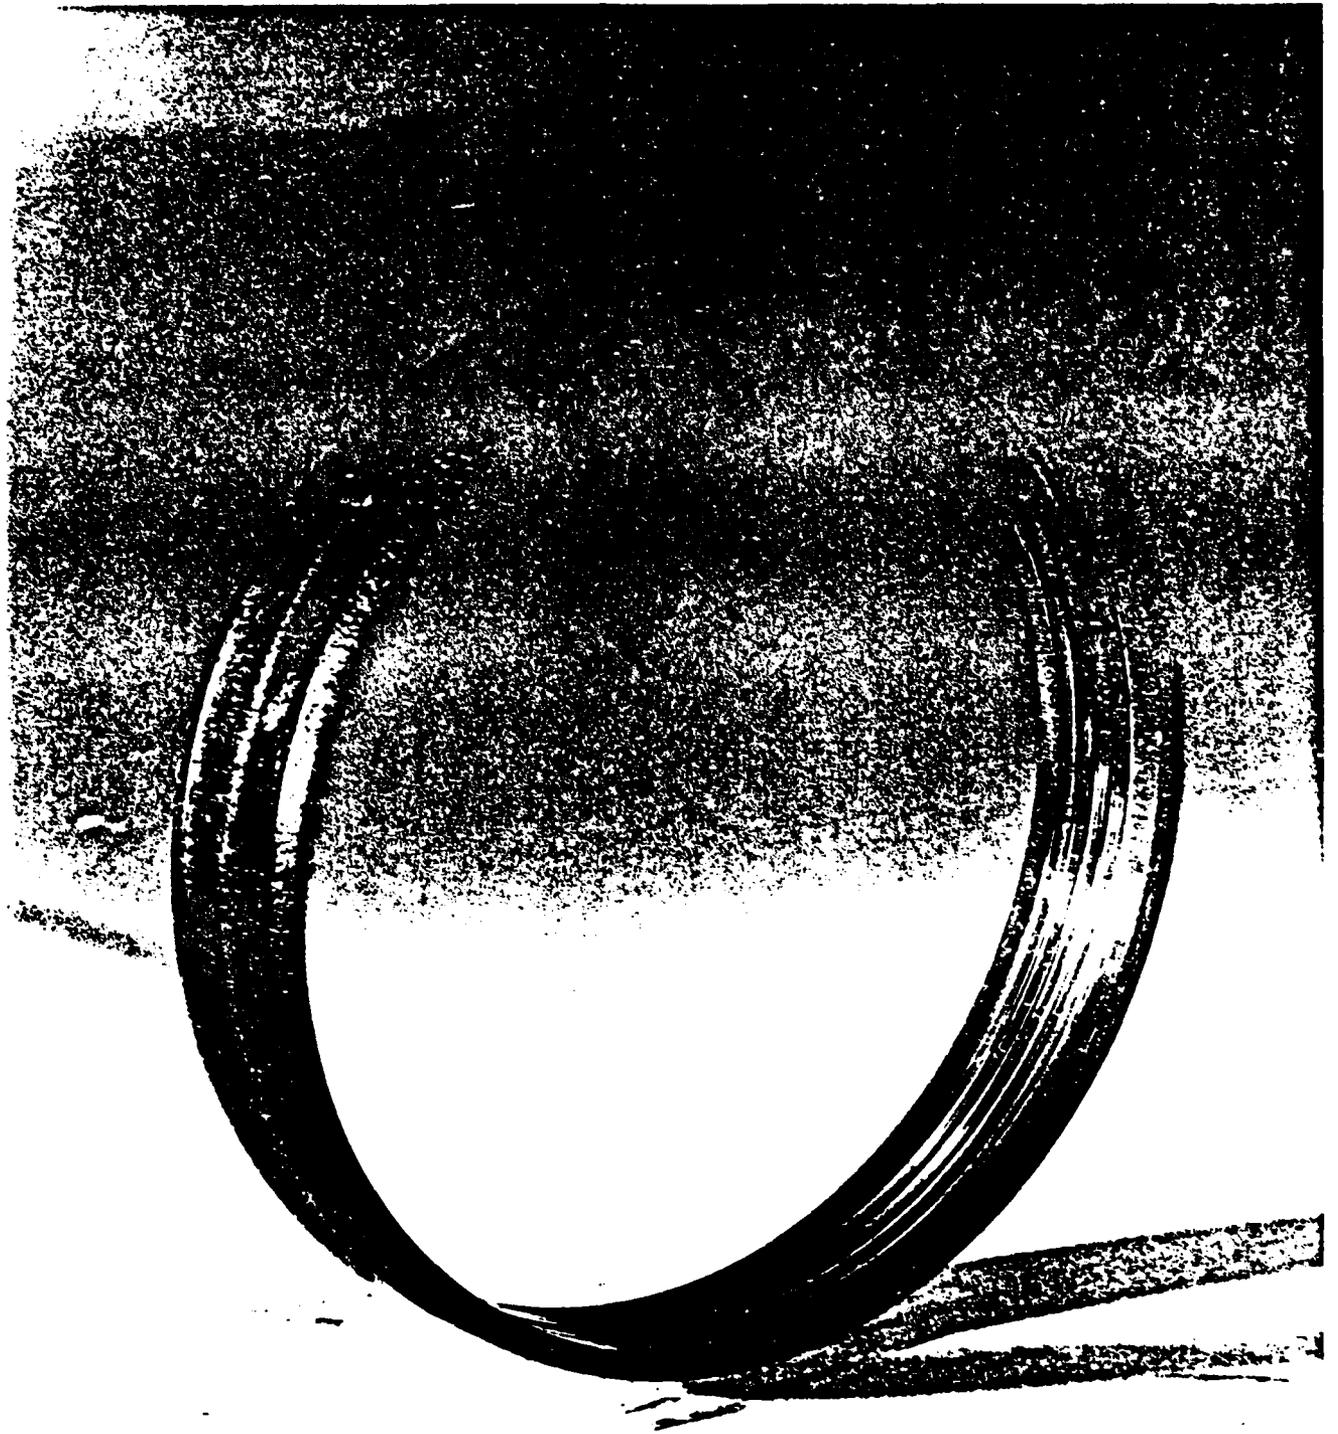
351434

-50°F COLD TEST BRG. FAILURE, GEN. SET #3, ENG. T3, B.U. 7.

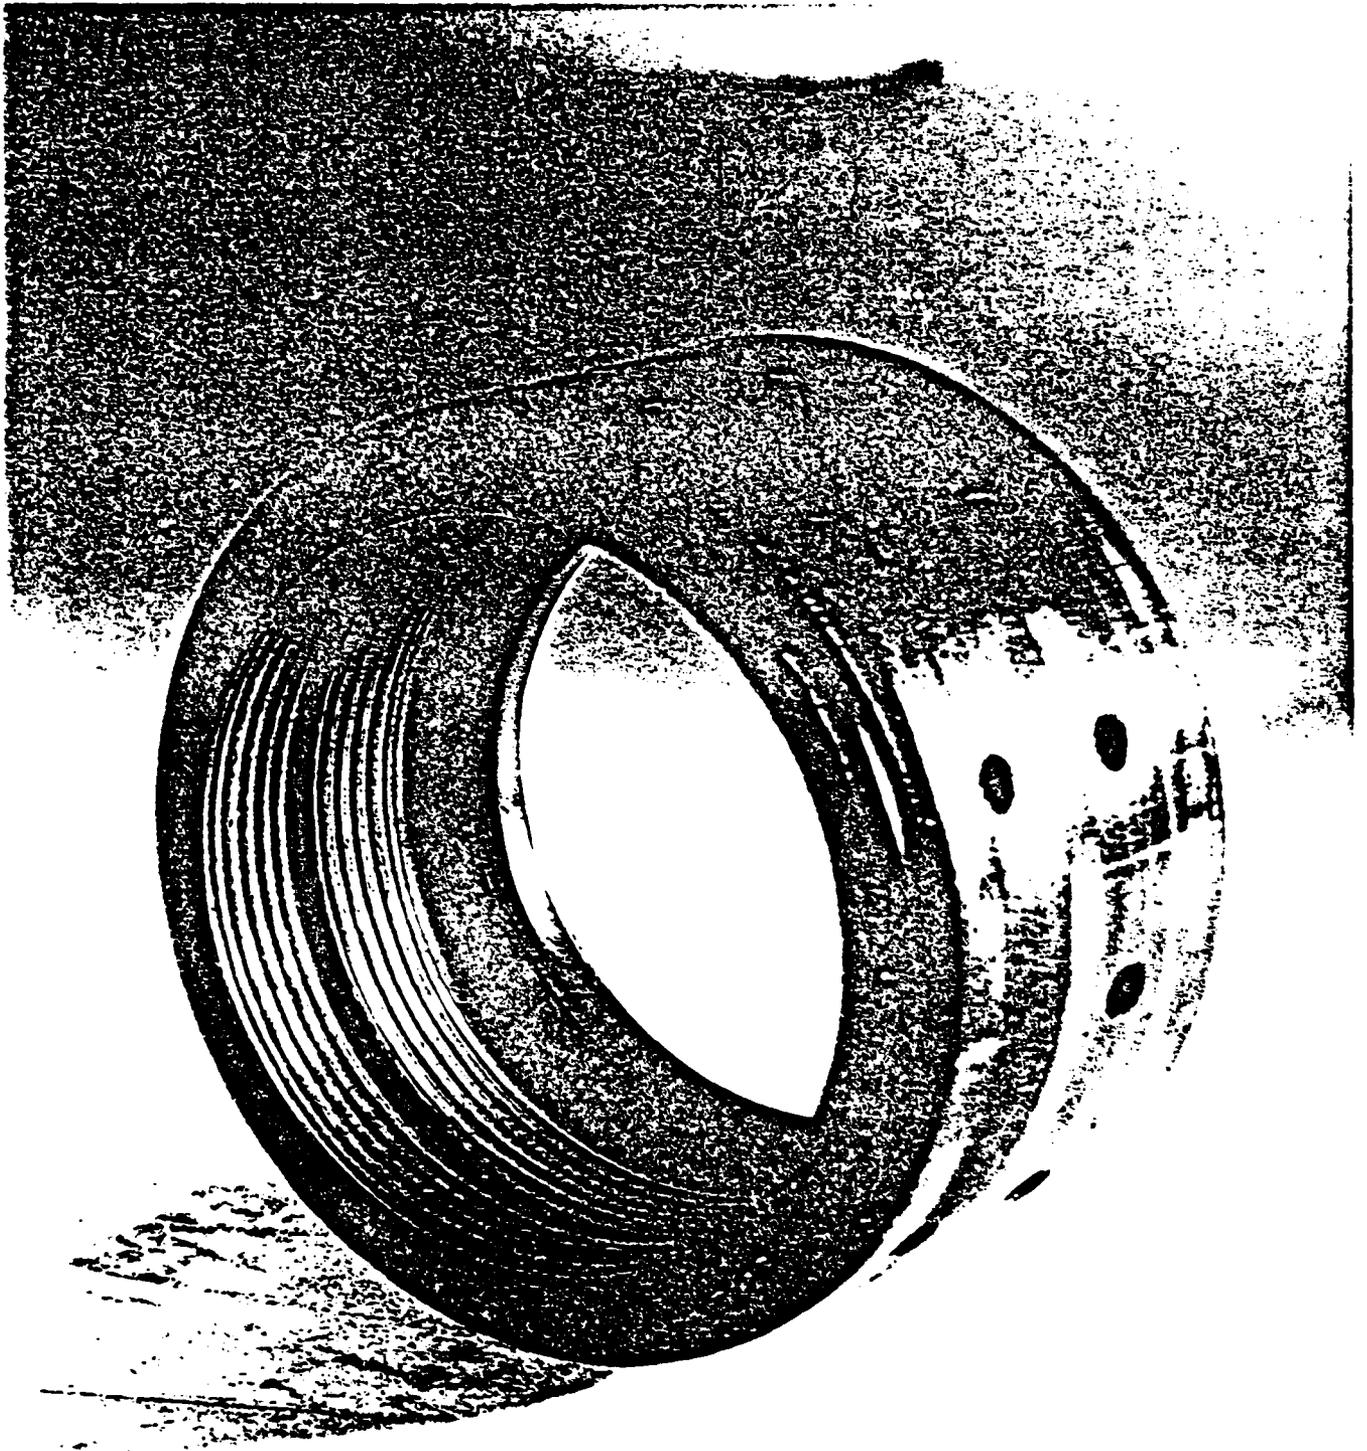
351435

-50°F COLD TEST BRG. FAILURE, GEN. SET #3, ENG. T3, B.U. 7.
