Detroit Diesel Allison
Division of General Motors Corporation
Indianapolis, Indiana

REPORT NO. 14 DDA-79D87

9 **ENGINEERING TEST REPORT.**

6 ENVIRONMENTAL AND COLD TESTS ON
MODEL 04045B03 GENERATOR SET SERIAL NUMBER
0000003 WITH IGT 404-4 ENGINE SERIAL NUMBER
TEST UNIT _____

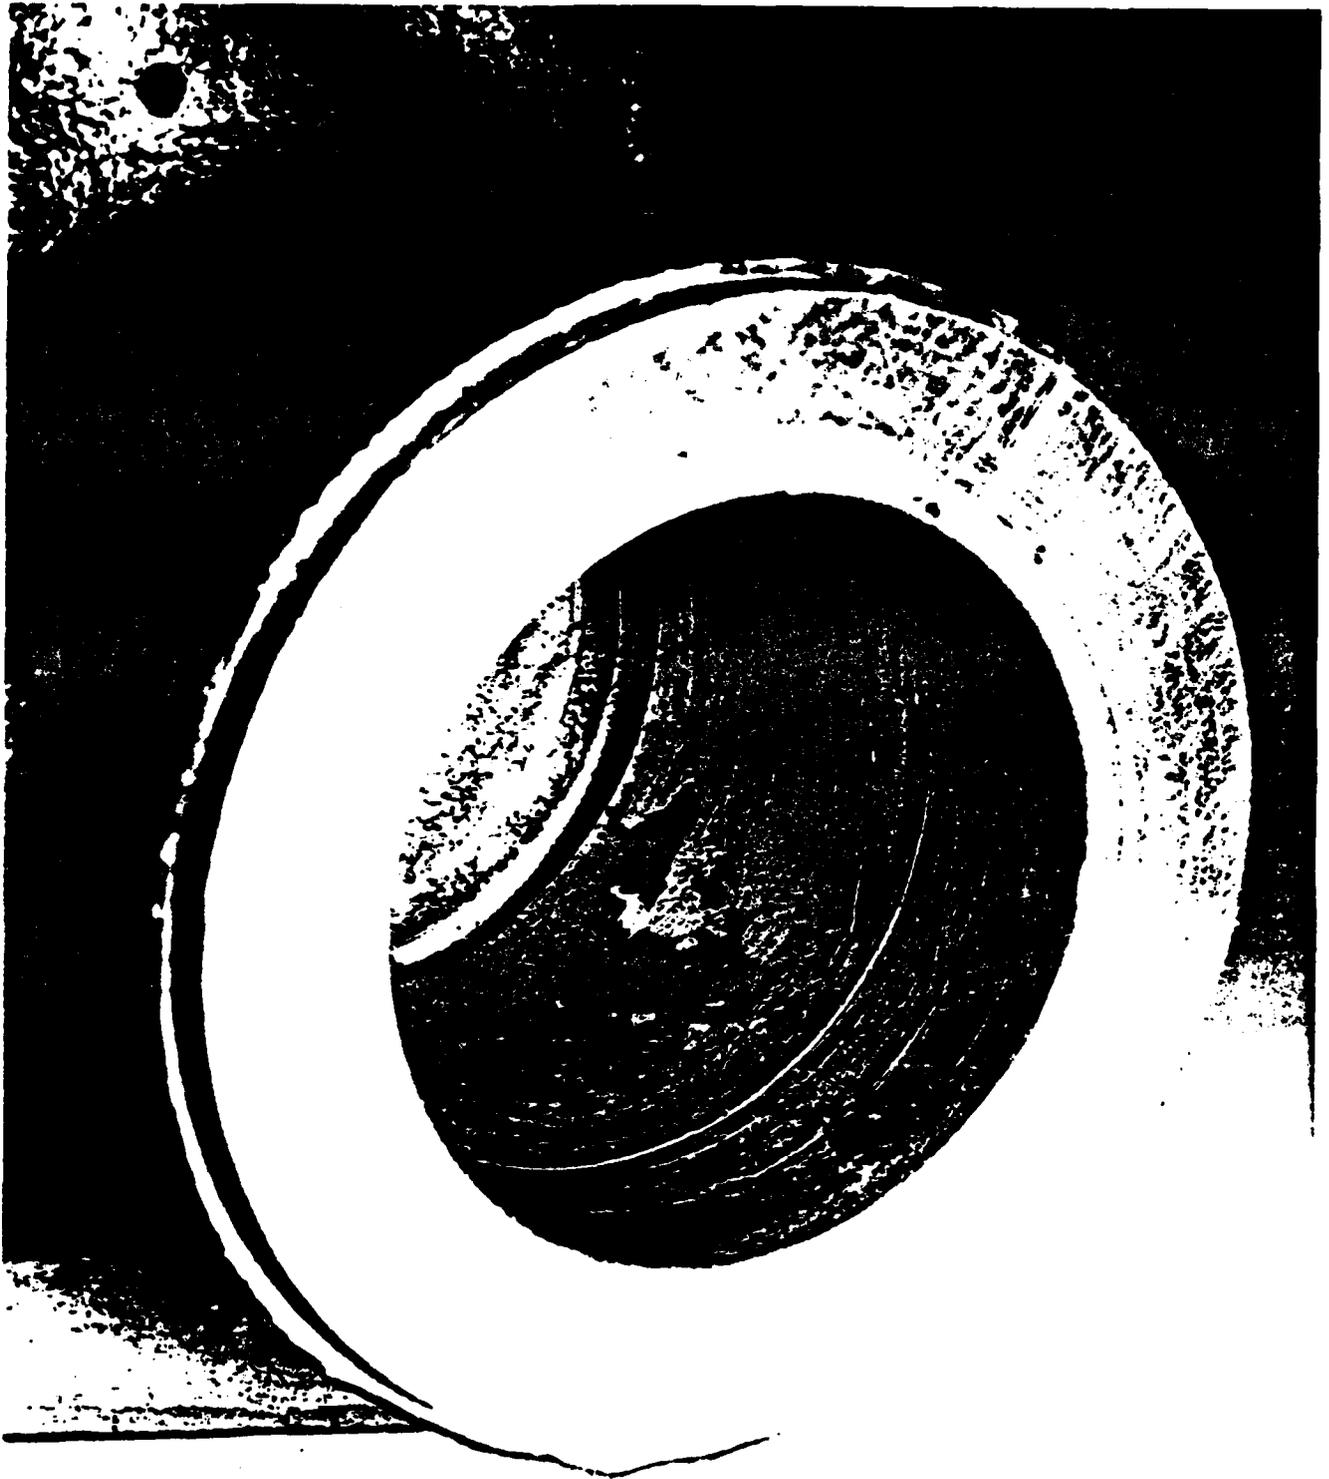
351436

The generator set and engine were disassembled to assess the failure damage. The failure and secondary damage are shown on Photos 351421 through 351439 and 351525.

-50°F COLD TEST BRG. FAILURE, GEN. SET #3, ENG. T3, B.U. 7.

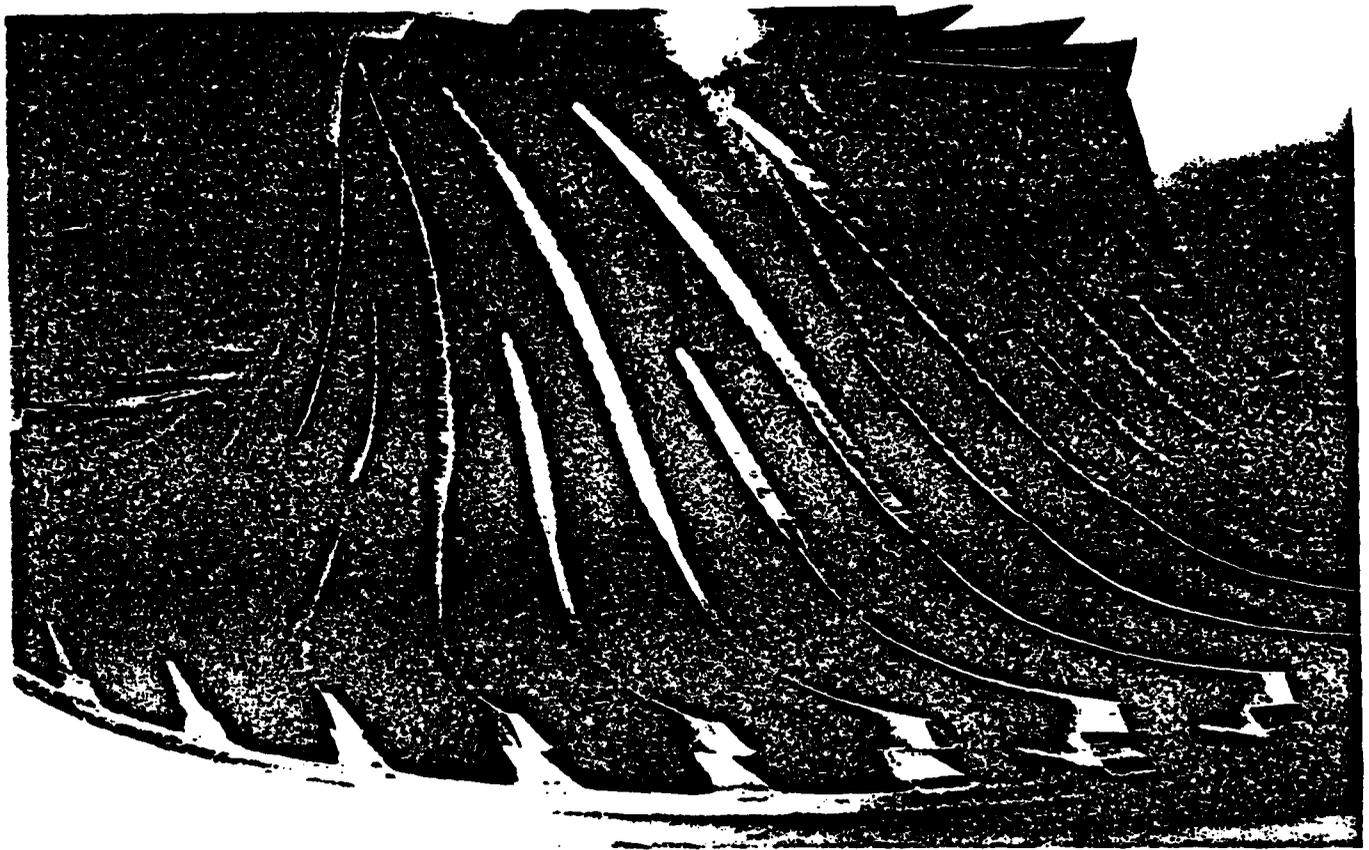
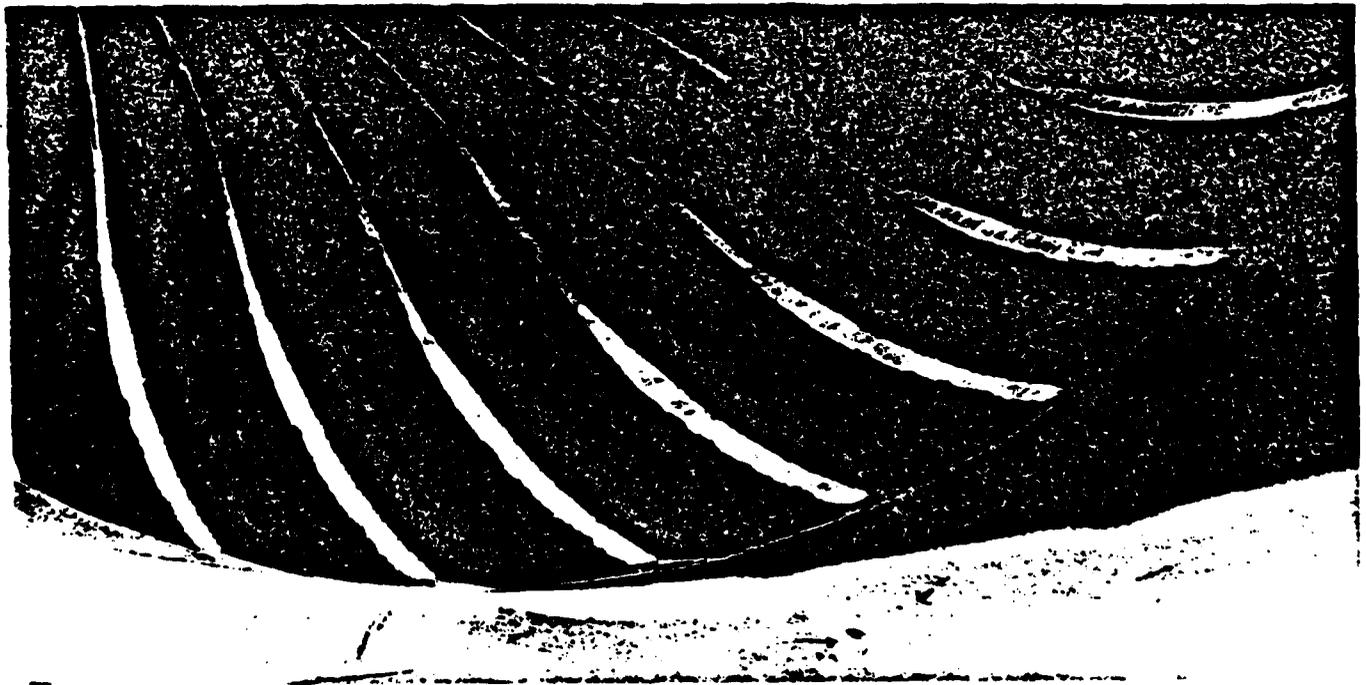
351437

-50°F COLD TEST BRG. FAILURE, GEN. SET #3, ENG. T3, B.U. 7.

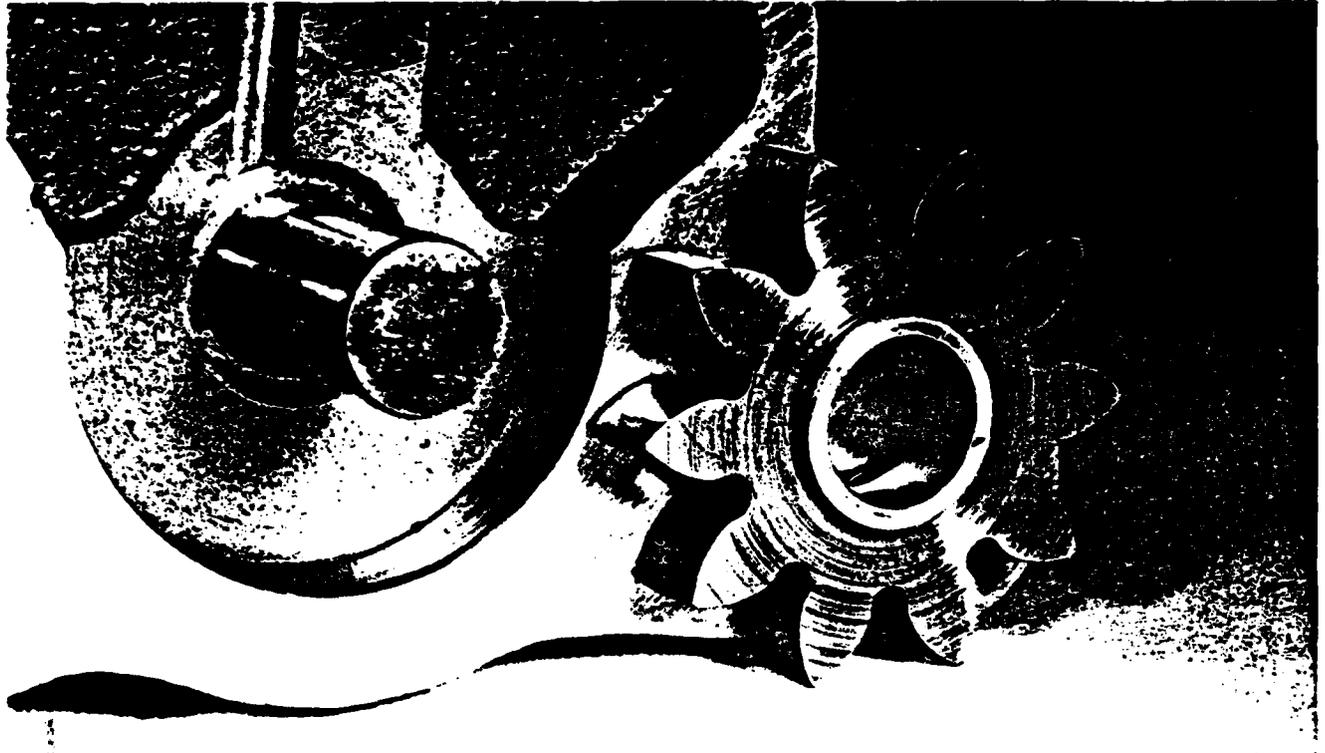
351438

-50°F COLD TEST BRG. FAILURE, GEN. SET #3, ENG. T3, B.U. 7.

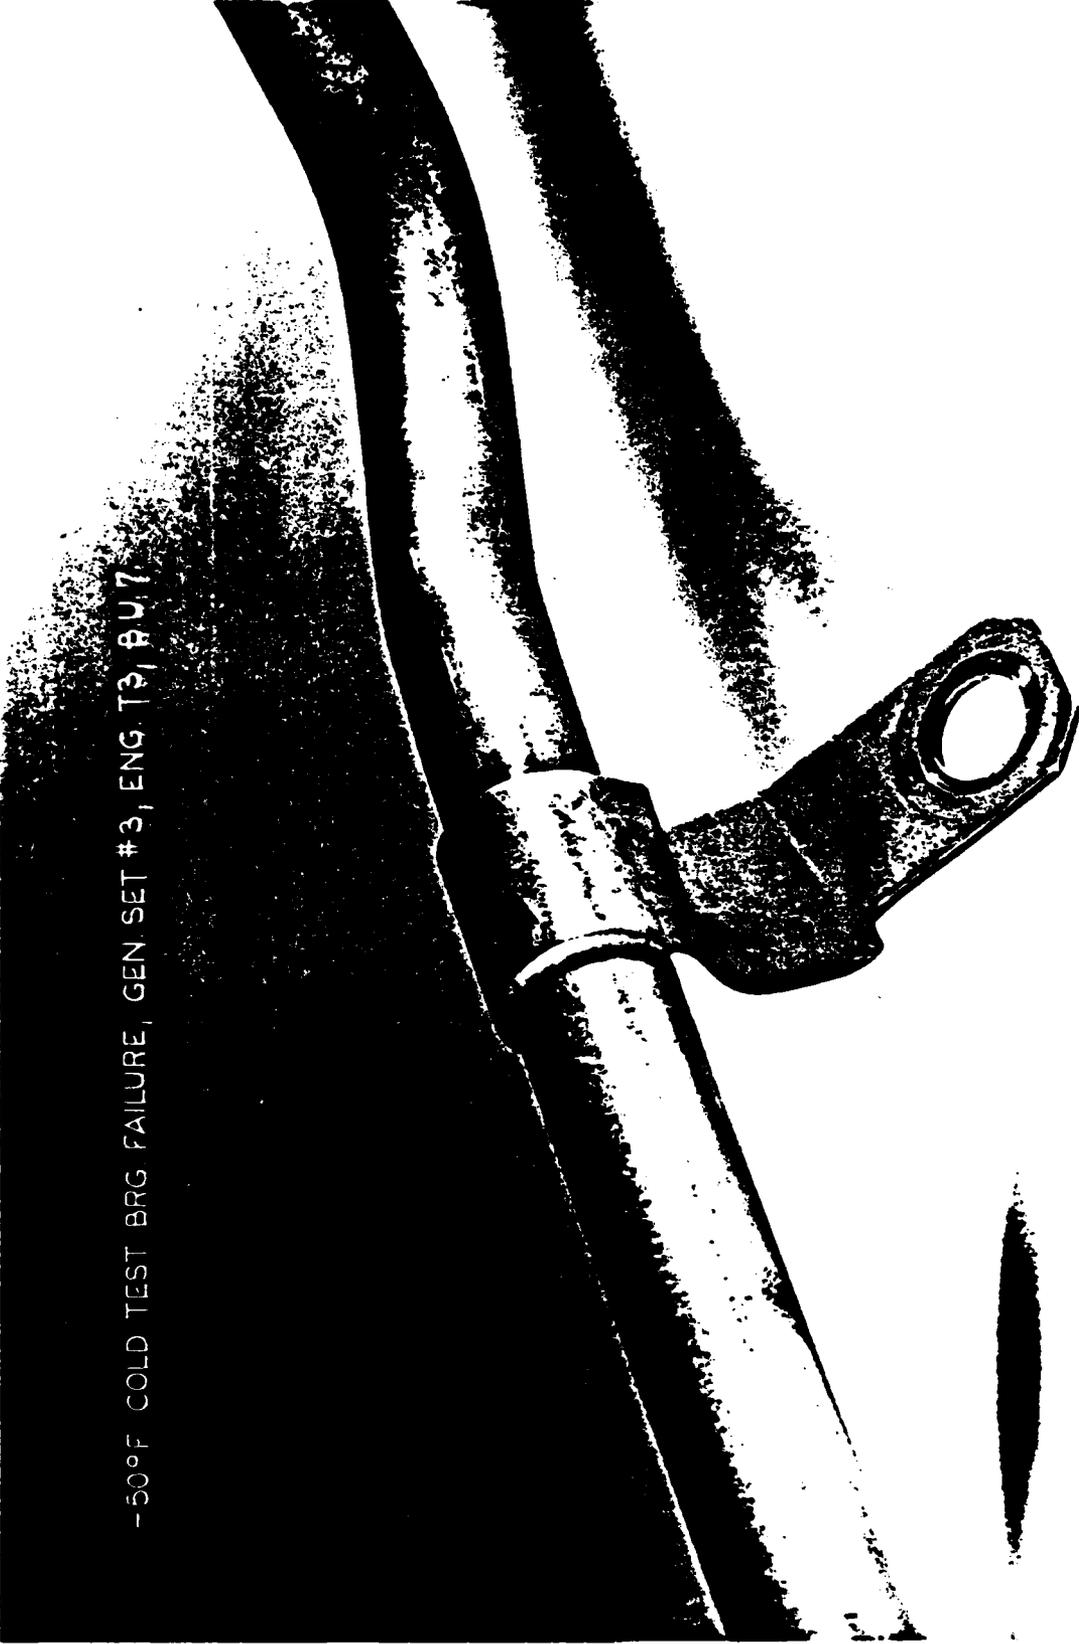
351525

-50°F COLD TEST BRG FAILURE, GEN SET #3, ENG T3, BU7
