MISCELLANEOUS PAPER S-73-43

**CONDITION SURVEY, DYESS AIR
FORCE BASE, TEXAS**

R. D. Jackson

June 1973

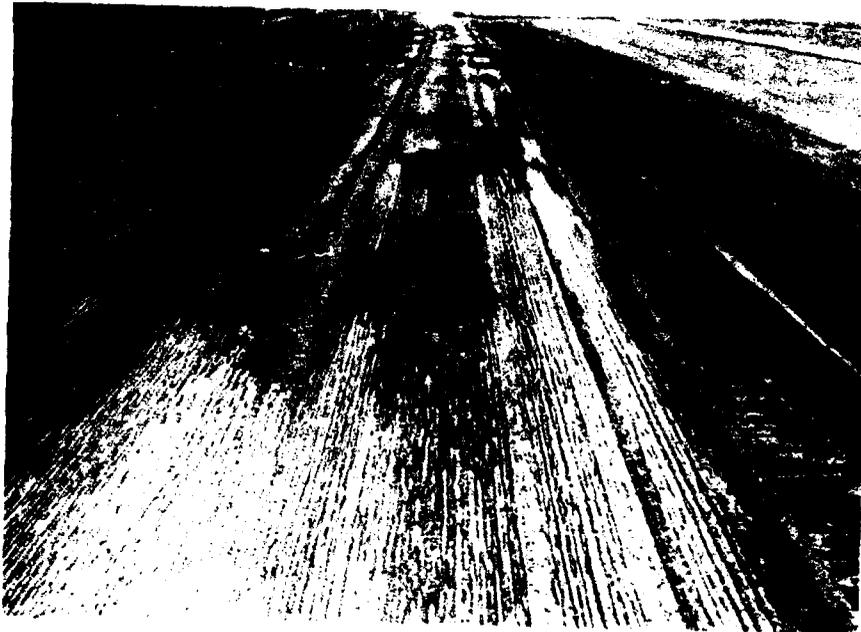
13. The PCC pavement features of the runway were in good to excellent condition based on the percentages of slabs containing no major defects. The predominate major defects on the runway were longitudinal cracks. The asphaltic concrete (AC) outside edges of the runway interior were in fair to good condition (see photos 1-5).

Photo 3. AC portion of runway, 5000 ft from north end,
east side

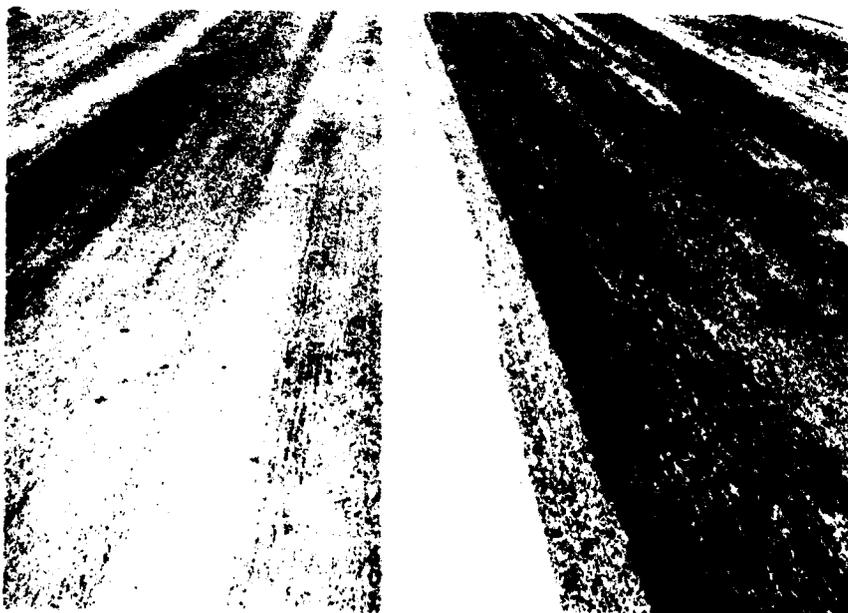
14. The primary taxiways, 1, 5, and 7 (features T1A, T2A, T3B, T7A, T8A, T10B, and T11B), were in conditions ranging from good to excellent based on the percentages of the slabs containing major defects. The taxi lane on taxiway 7 had been moved and a 26-in. inlay constructed at the present location of the taxi lane. Using only the 75 ft at the present location for the condition rating of this feature would have resulted in a rating of very good to excellent; however, using the 150-ft width resulted in a condition rating of good. Taxiway 2, which is 16- and 18-in. PCC, was in very good condition. Taxiways 3 and 4, which are AC, were in only fair condition (see photos 6 and 7).

Photo 6. General view of taxiway 3

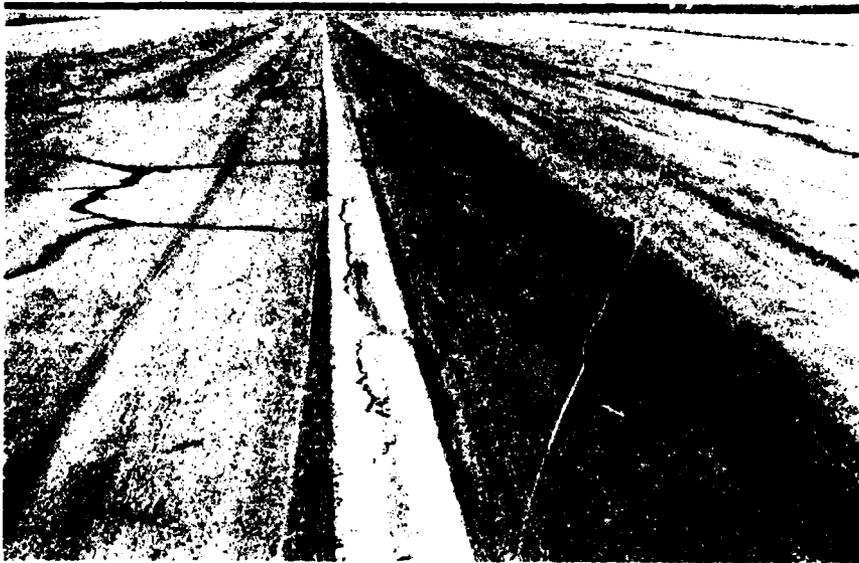
Photo 7. General view of taxiway 4
