LAKE JAMIE DAM

NDI ID NO. PA-00778  
DER ID NO. 45-220

PHASE I INSPECTION REPORT  
NATIONAL DAM INSPECTION PROGRAM

Prepared by  
GANNETT FLEMING CORDDRY AND CARPENTER, INC.  
Consulting Engineers  
Harrisburg, Pennsylvania 17105

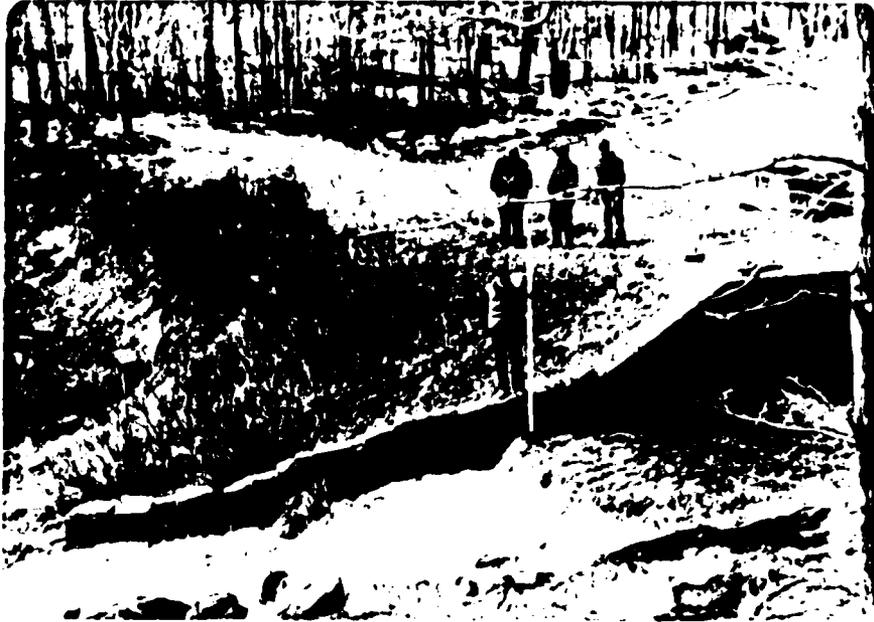
b. Embankment. The embankment is in fair condition. The upstream slope is protected by riprap, which is in good condition. Above normal pool elevation, the riprap is covered with grass (Photograph B). The top of the dam is covered with grass. The downstream slope is covered with grass and thick brush (Photograph A). A foot trail on the downstream slope just to the left of the outlet works is eroded. The erosion is very shallow. At the junction of the embankment and the right spillway wall, behind the stone masonry training wall, the downstream embankment slope is eroded severely (Photograph D). The erosion extends about half-way up the slope.

A. Downstream Slope

(1) Perform studies to determine the factor of safety for the embankment and to determine the potential of the seepage to cause piping. Take appropriate action as necessary. In lieu of the above, constructing the downstream slope to its design value and providing a properly designed toe drain to control seepage would be acceptable.

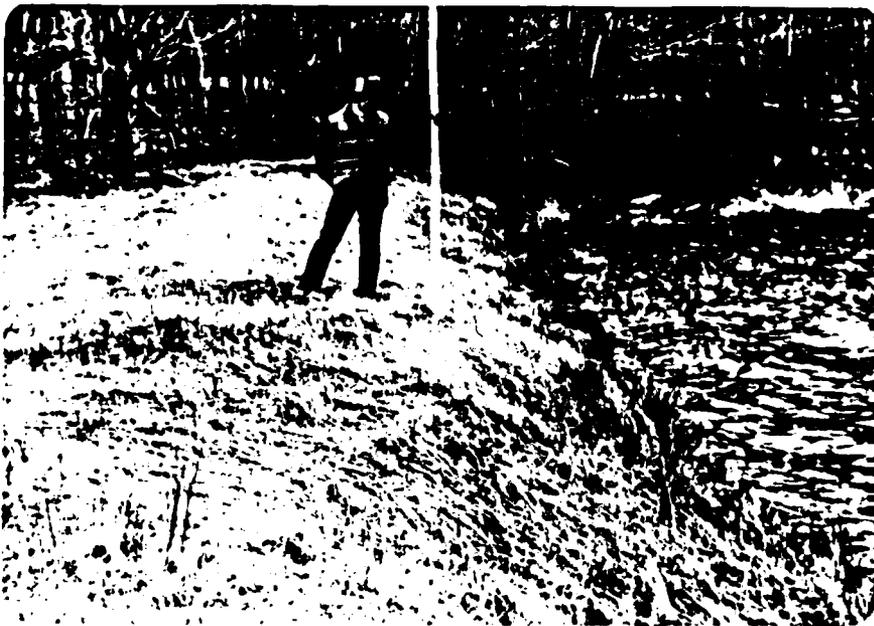
B. Upstream Slope

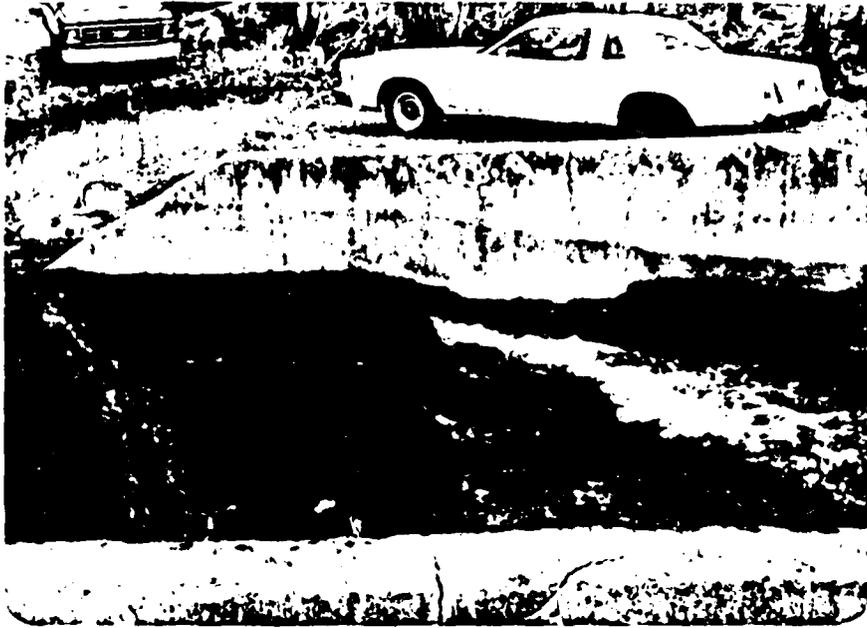
c. Appurtenant Structures. The spillway is in fair condition. A massive log, larger than a telephone pole and about the length of the weir, was floating in the approach channel just upstream of the weir (Photograph C). The weir itself is in good condition but the length of its crest measures 0.4 foot less than the design drawings indicate. The spillway sidewalls are slightly bowed. Cracks about 1/8-inch wide extend vertically through the walls just downstream of the weir (Photograph C). The spillway apron is in good condition. There is evidence of concrete patching on the apron and on the lower part of the cracks in the sidewalls. The patching appears to be rough but effective. The stone masonry training wall, which was added downstream of the right spillway wall after the dam was constructed, is in poor condition. The mortar is very deteriorated and daylight is visible through much of the wall. With the flow conditions on the day of the inspection, a significant amount of water was flowing through the wall. The erosion behind the wall, which reportedly occurred shortly after the dam was constructed, has never been repaired (Photograph D).

C. Spillway

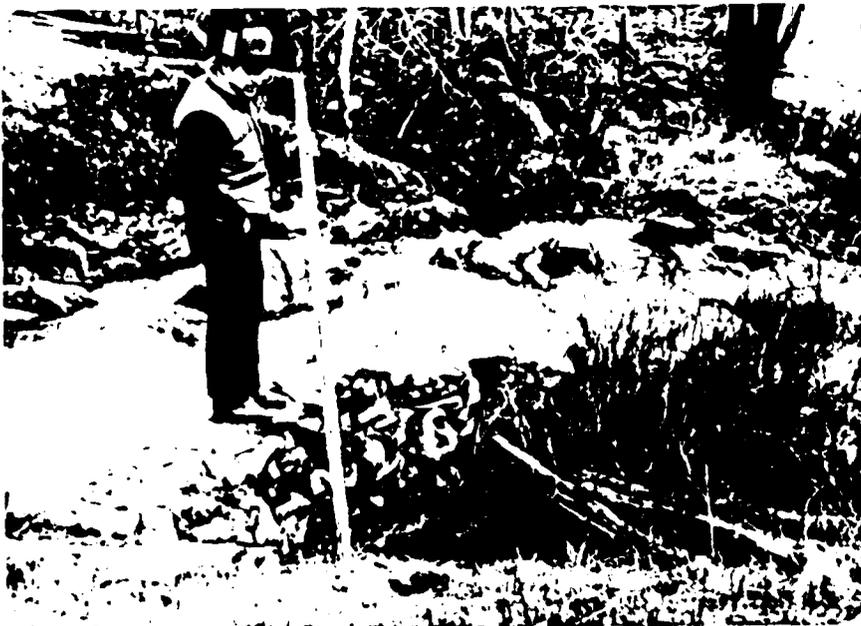
(3) Appurtenant Structures. Plate E-2 indicates that the spillway walls are founded on rock. The cracks in the walls are probably shrinkage cracks that have been widened slightly by freeze-thaw action. At present, the cracks prevent the walls from acting as an impervious barrier during periods of high pools. The concrete patching at the lower part of the cracks and on the apron is satisfactory.

The amount of water leaking through the wall on the day of the inspection was almost sufficient to cause erosion. Because of the poor condition of the wall, larger spillway discharges would cause significantly more flow through the wall and, therefore, increase the erosion hazard. Other conditions at the spillway are assessed in Paragraph 6.1b.

D. Spillway. The concrete wall

(3) Repair the spillway training wall so that it acts as an impervious barrier and repair the eroded area behind the wall.

(6) Repair the cracks in the spillway walls. Visually monitor the cracks. If the cracks enlarge or if other cracks appear, have the condition assessed by a professional engineer.

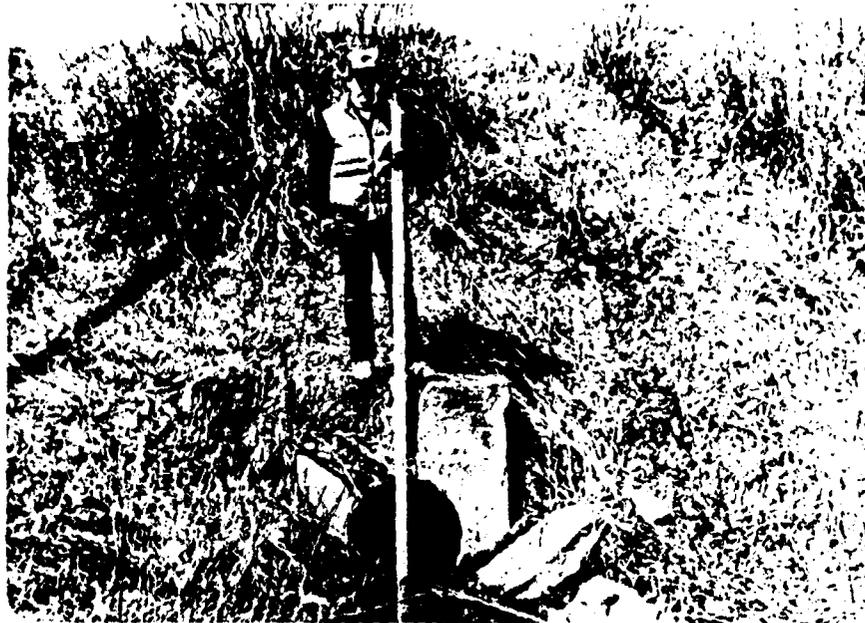
The outlet works is in fair condition. Minor spalling was observed on the endwall and intake structure (Photographs E and F). The intake structure tilts toward the dam (Photograph F). The gate operating mechanism on the intake structure is rusty. The Owner stated that it has not been operated since the dam was constructed; he reported that he had been instructed shortly after the dam was built by a representative of the Commonwealth to never operate the gate. He felt that the intake structure was partially silted, which would hinder the gate operation. Therefore, he declined to attempt to operate it for the inspection team.

The spalling at the endwall and intake structure of the outlet works is minor and of no concern at present. Other conditions at the outlet works are assessed in Paragraph 6.1.b.

E. Outlet Works Endwall

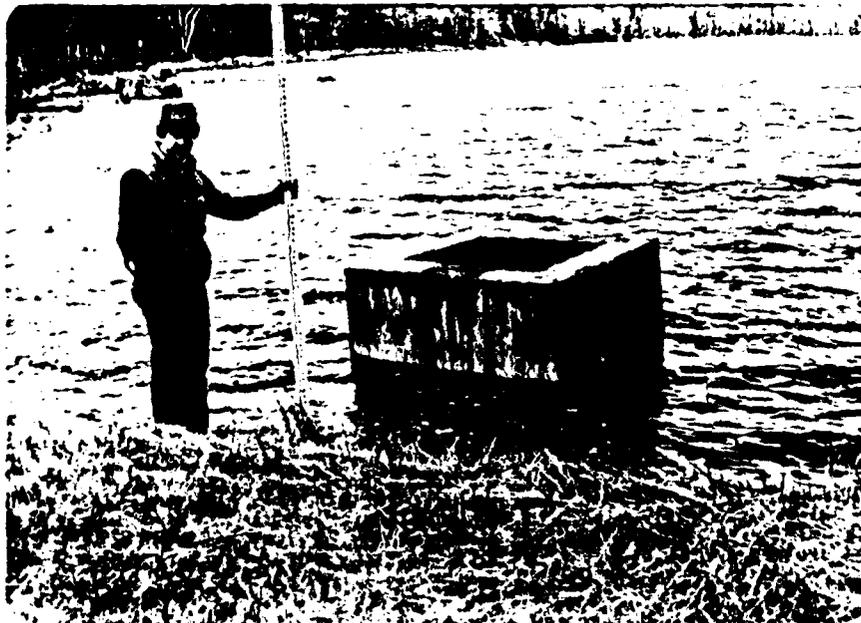
If the intake structure was constructed out-of-plumb, there would be no concern for its integrity. However, if the tilting is caused by differential settlement, there would be serious concern for the structure because Plate E-2 indicates it is founded on rock, which should allow for no settlement. The Owner confirmed that the cutoff wall is founded on rock. There would also be concern for the junction of the pipe and the intake structure.

F. Outlet Works Intake Structure

(4) Perform studies to determine the cause of the tilting of the intake structure. Take appropriate action as necessary.
