JOHNSON'S POND

NDI ID NO. MD-11

PHASE I INSPECTION REPORT  
NATIONAL DAM INSPECTION PROGRAM

JULY 1980

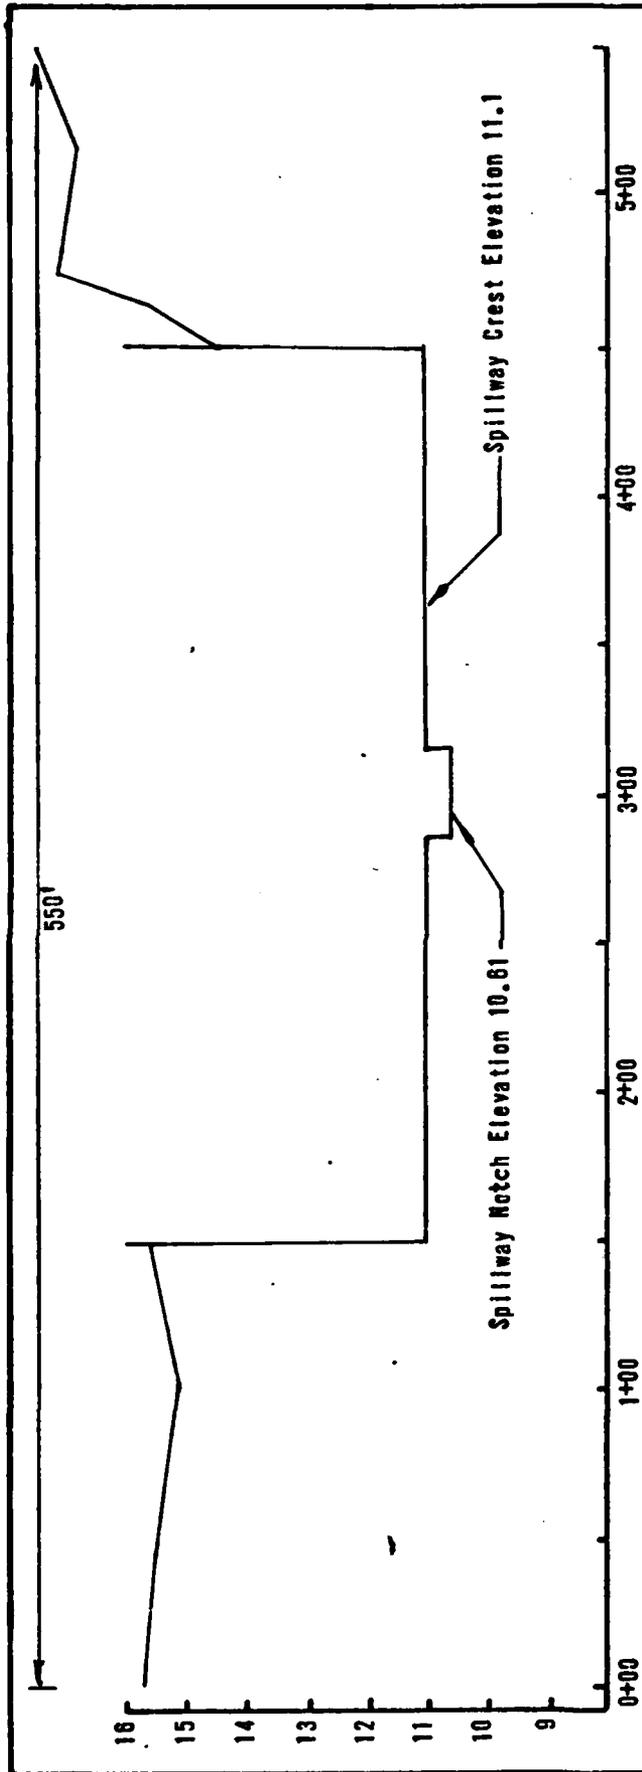
**DAM CREST PROFILE**  
(LOOKING DOWNSTREAM)

The crest of the clay fill embankment was surveyed and the variance in elevation was 10 inches between the high and low point on the left side, and was 36 inches between the high and low point on the right side. It should be noted that the contract drawings show that the clay fill on both sides of the ogee spillway was to be constructed even with the top of the wingwalls, or to elevation 16. The low point of the fill was elevation 14.5 noted adjacent to the right wingwall. The crest elevations measured on the left side of the dam ranged from 15.1 to 15.8. Since there is no evidence that any fill was removed from the crest by natural processes, it is presumed that either the fill was not constructed in accordance with the contract drawings, or regrading of the fill has been accomplished since construction of the dam.

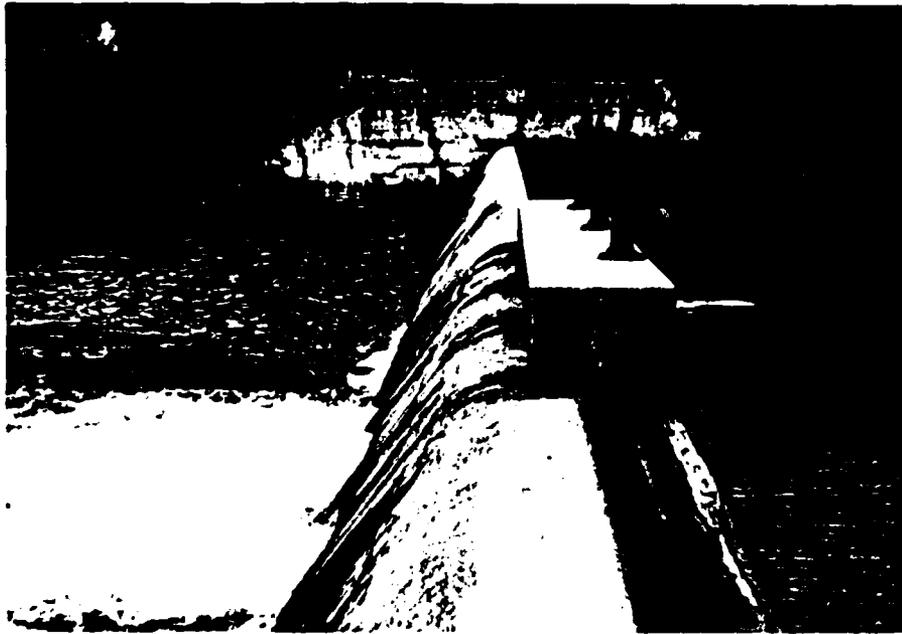
A. Dam with sluice gates open

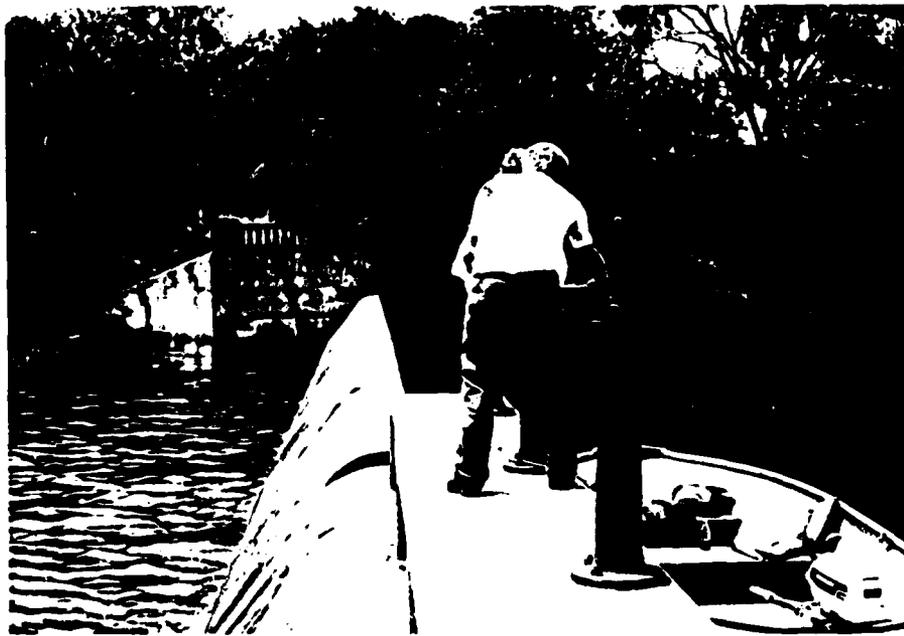
B. City of Salisbury personnel closing sluice gates

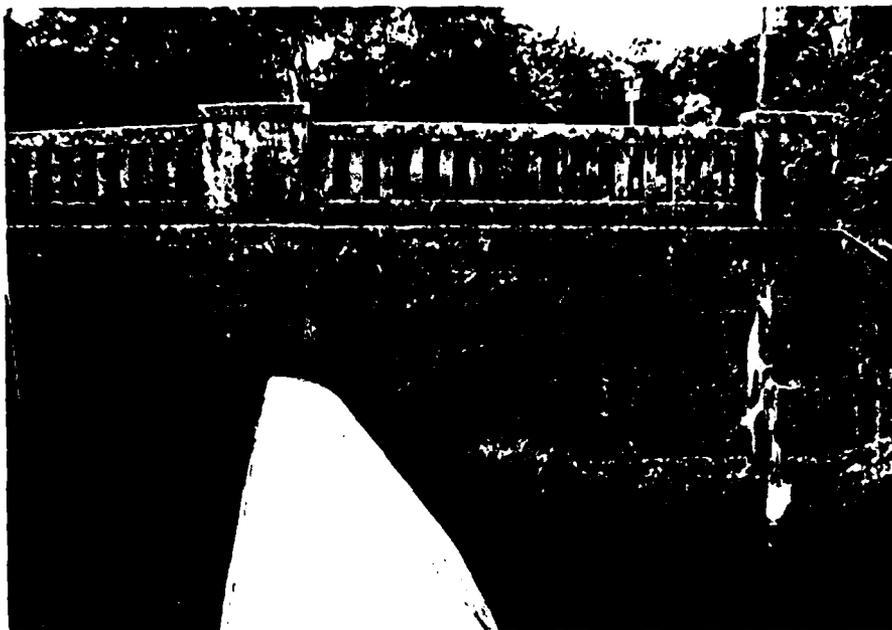
walls from the spillway crest to the top of the wingwall. The crack in the left wingwall is approximately 0.25 inch wide and the crack in the right wingwall is approximately 0.5 inch wide. Cracking is responsible for a piece of concrete being displaced on the upstream side of the spillway along a joint located 20+' left of the spillway notch. No displacement was noted along any other cracks in the spillway, and no water was noted seeping through the cracks on the downstream side of the spillway. Minor spalling of the concrete was noted on the crest of spillway near the left wingwall.

VISUAL EXAMINATION OF	OBSERVATIONS	REMARKS OR RECOMMENDATIONS
JUNCTION OF EMBANKMENT AND ABUTMENT, SPILLWAY AND DAM	A crack was noted through both left and right wingwalls extending from spillway crest to top of wingwall	Patch the cracks
ANY NOTICEABLE SEEPAGE	None	
STAFF GAGE AND RECORDER	None	
DRAINS	None

E. Structural crack in retaining wall  
above dam crest at left end of dam

- b. Repair the cracks which extend through the right and left wingwalls from the crest of the ogee spillway to the top of each wingwall.
- c. Repair the cracks noted in the ogee spillway before the cracks enlarge.
- d. Raise the embankment to the design elevation.
- e. Carefully inspect the ogee spillway for additional cracks, seepage through cracks, or displacement of concrete along the cracks at least once a year while the water level is down.
- f. Develop a formal warning system to alert downstream residents in the event of emergencies.

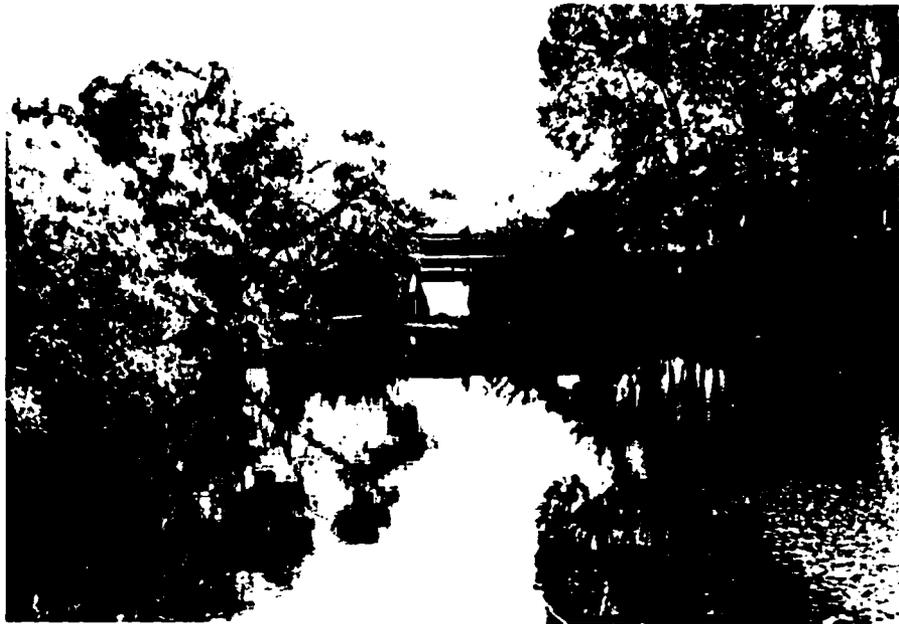
Downstream channel routings of outflow hydrographs generated by the above reservoir routings indicate that the barrier caused by the approaches to the Isabella Street bridge will produce backwater conditions extending upstream to the Johnson's Pond spillway. In addition these analyses indicate that these approaches will be overtopped if the flood event exceeds 10 percent of the PMF. If these bridge approaches fail upon overtopping, the results from the initial reservoir routing analyses for Johnson's Pond can be considered valid since backwater conditions caused by the bridge embankment would not materialize for the 50 and 100 percent PMF events. If it is assumed that the bridge approaches do not fail, this affect or resultant backwater conditions upon the spillway discharge must be considered.

G. Isabella Street Bridge crossing  
river downstream of dam

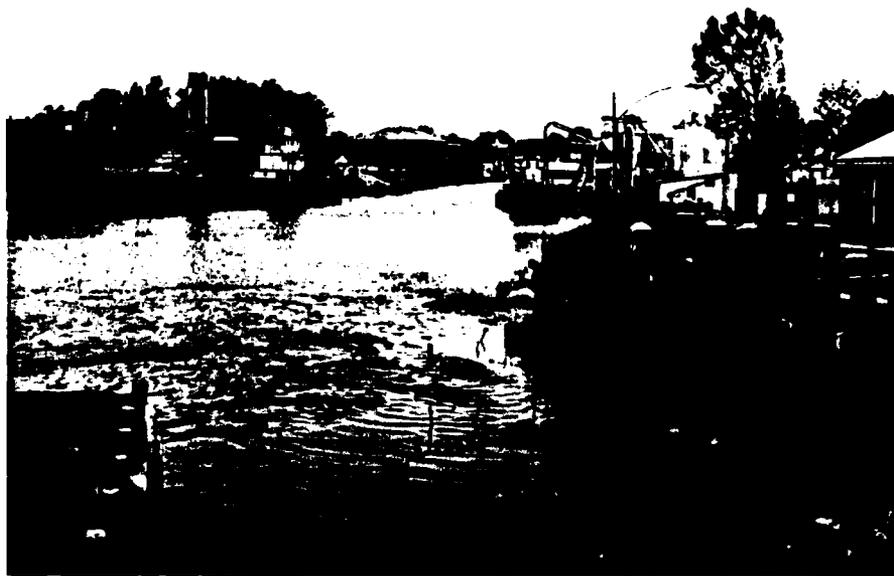
H. Downstream of Isabella Street Bridge
