LAKE HENRY DAM

Number
NDI ID No. PA-00154
DER ID No. 64-34
Name

PHASE I INSPECTION REPORT
NATIONAL DAM INSPECTION PROGRAM

11 JUL 1980

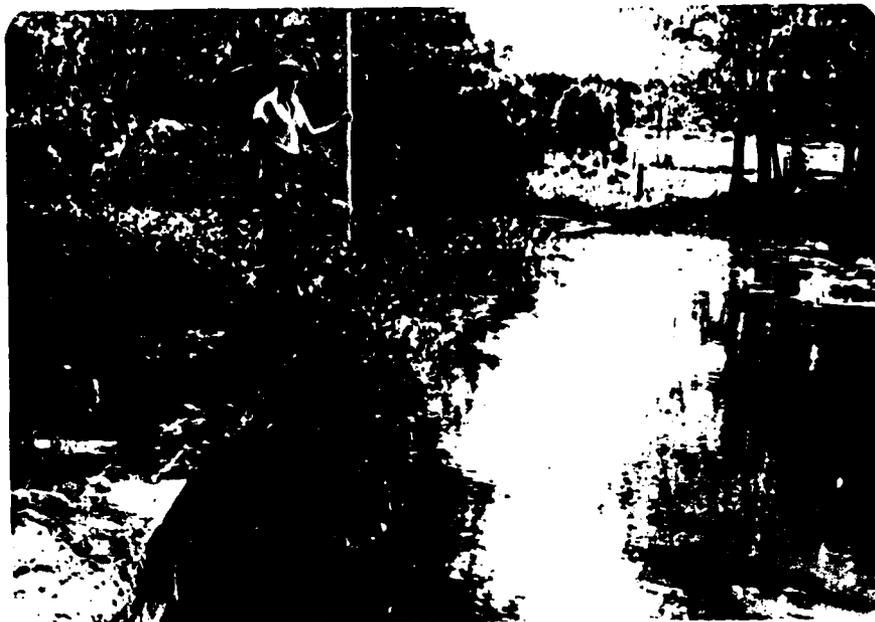
The upstream side of the dam has been recently filled with crusher waste. The LHCA reported that whirlpools developed in the lake near the dam in about 1976. One whirlpool was near the main spillway. The other was just to the right of the auxiliary spillway. The crusher waste was placed both to eliminate the whirlpools and to provide a submerged access road for construction equipment, as noted in Paragraph 1.2g. The crusher waste is not well compacted adjacent to the embankment.

A. Upstream Slope

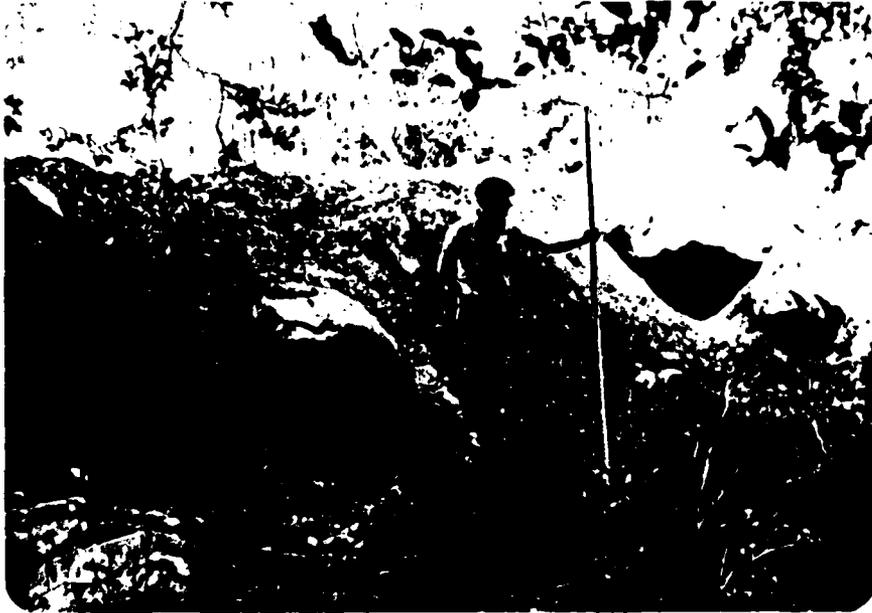
C. Downstream Slope at Auxiliary Spillway

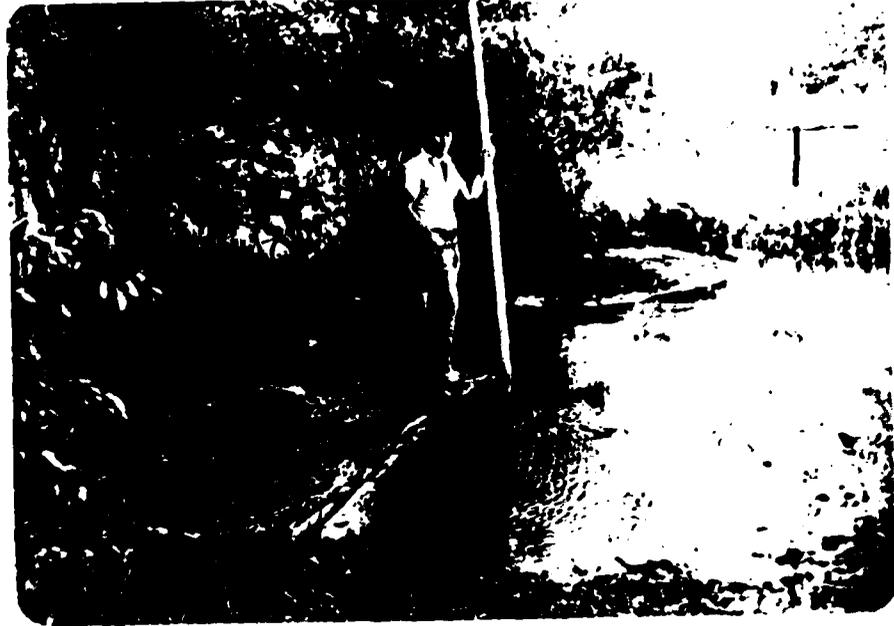
E. Main Spillway

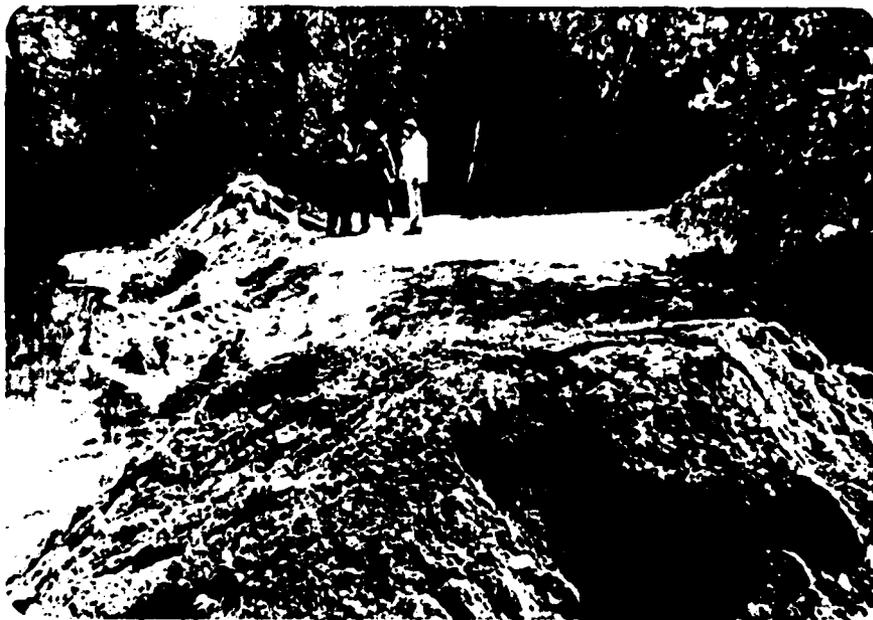
G. Auxiliary Spillway at Start of Inspection

PHOTOGRAPH G TAKEN
IN MORNING, PHOTOGRAPH
H TAKEN IN AFTERNOON.

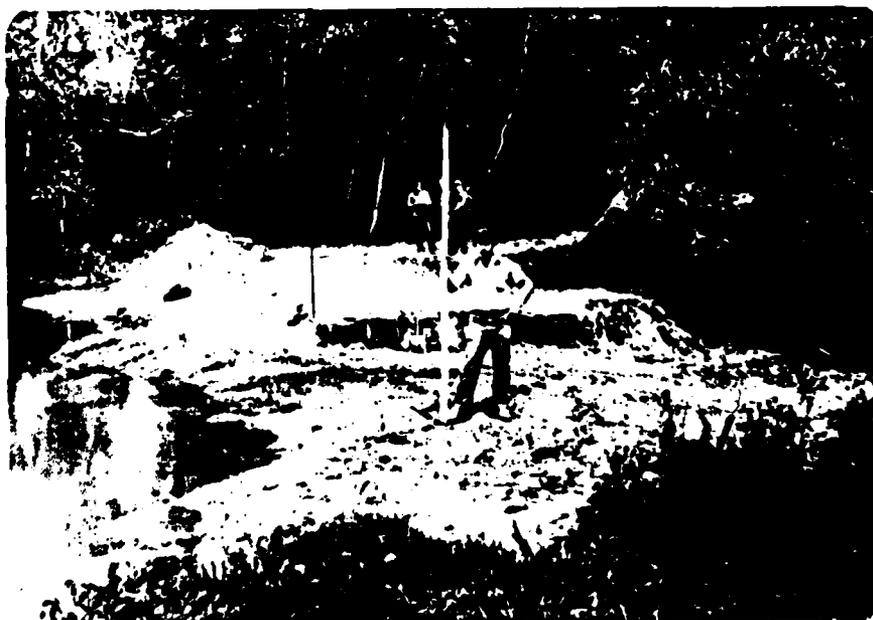
The PennDER representative asked the LHCA if they had a permit to perform the work. When the LHCA replied that they had no permit, the PennDER representative informed them that they were in violation of the Pennsylvania Dam Safety and Encroachments Act. He advised them to cease work. Further discussions with LHCA revealed that the fill in the auxiliary spillway was intended as a temporary measure to protect the auxiliary spillway structures from damage by hauling equipment. The PennDER representative then advised that since obtaining a permit could be a relatively lengthy process, removing the fill from the auxiliary spillway would enable it to pass its discharge capacity. When the PennDER representative and the inspection team returned from lunch, the temporary fill in the auxiliary spillway had been completely removed and all work had ceased (Photograph H).

The auxiliary spillway is located near the center of the dam. The auxiliary spillway was obscured by a thin layer of soil (Photograph H). Macadam was observed at two locations through the soil cover. To the right of the auxiliary spillway, a concrete wall extends to the main spillway, as shown on Plate E-2. Only the top of the wall is visible. It deflects at two locations. At the deflection point nearest the main spillway, the wall is cracked and offset vertically by 0.2 foot.

H. Auxiliary Spillway at End of Inspection

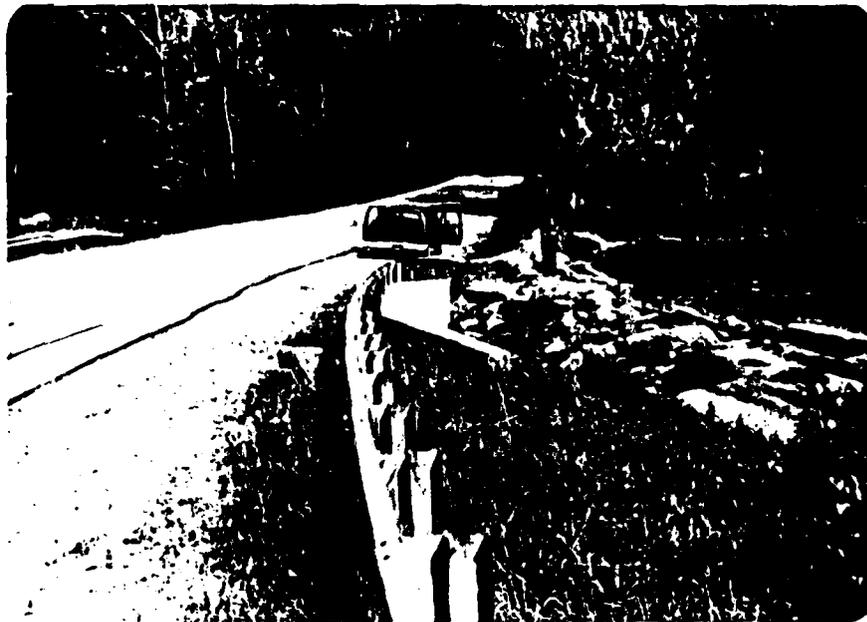
I. Kizer Pond Dam - Upstream of Lake Henry
