REPORT DOCUMENTATION PAGE		READ INSTRUCTIONS BEFORE COMPLETING FORM
1. REPORT NUMBER	2. GOVT ACCESSION NO.	3. RECIPIENT'S CATALOG NUMBER
4. PHASE (and Subphase) Lake Flower Dam Lake Champlain River Basin, Franklin County, NY Inventory No. 707		5. TYPE OF REPORT & PERIOD COVERED Phase I Inspection Report National Dam Safety Program

7. AUTHOR(s) John B. Stetson		6. PERFORMING ORG. REPORT NUMBER
9. PERFORMING ORGANIZATION NAME AND ADDRESS Stetson-Dale Engineering Company Bankers Trust Building Utica, NY 13501		8. CONTRACT OR GRANT NUMBER(s) DACW-51-79-C-0001

PHASE I INSPECTION REPORT
NATIONAL DAM SAFETY PROGRAM
NAME OF DAM - LAKE FLOWER DAM ID# - NY 707

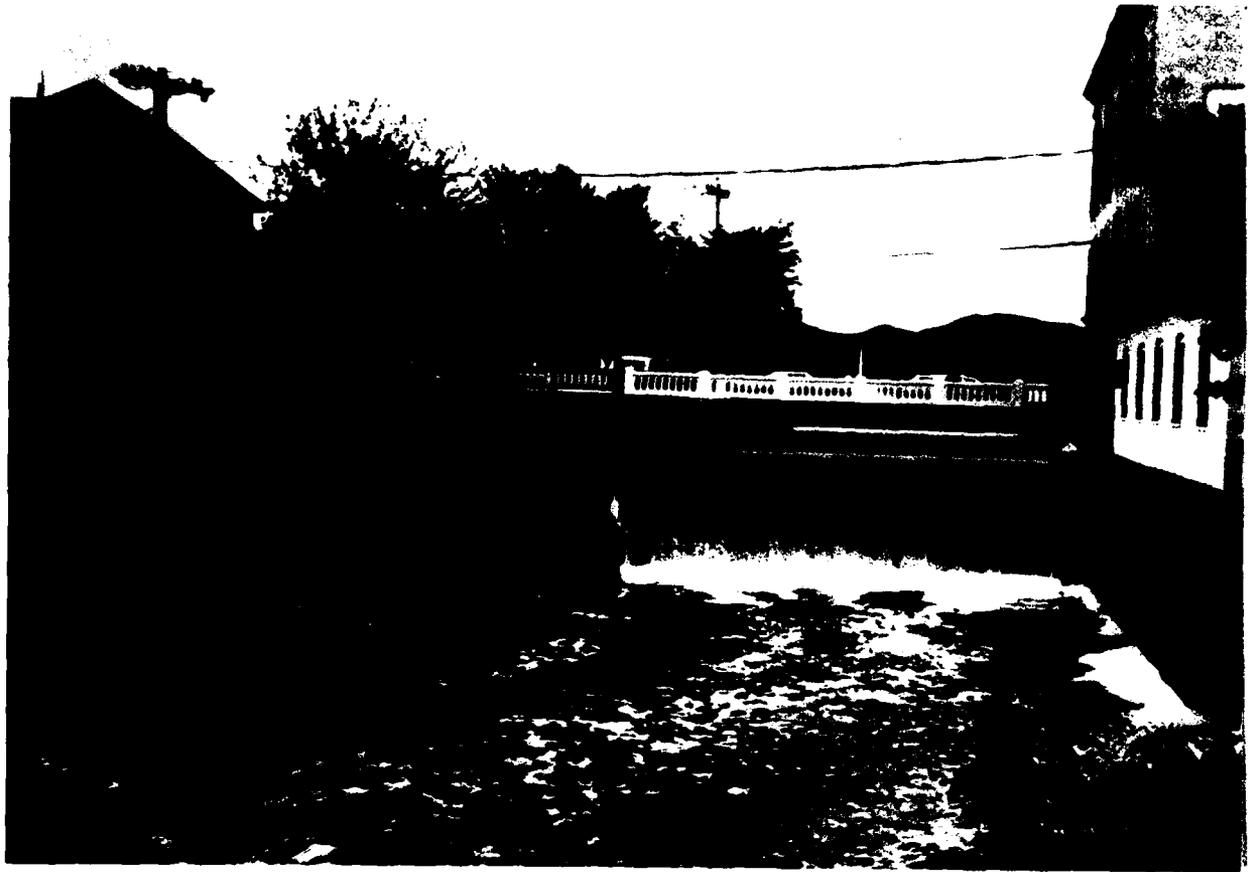
1. Overview of Lake Flower Dam

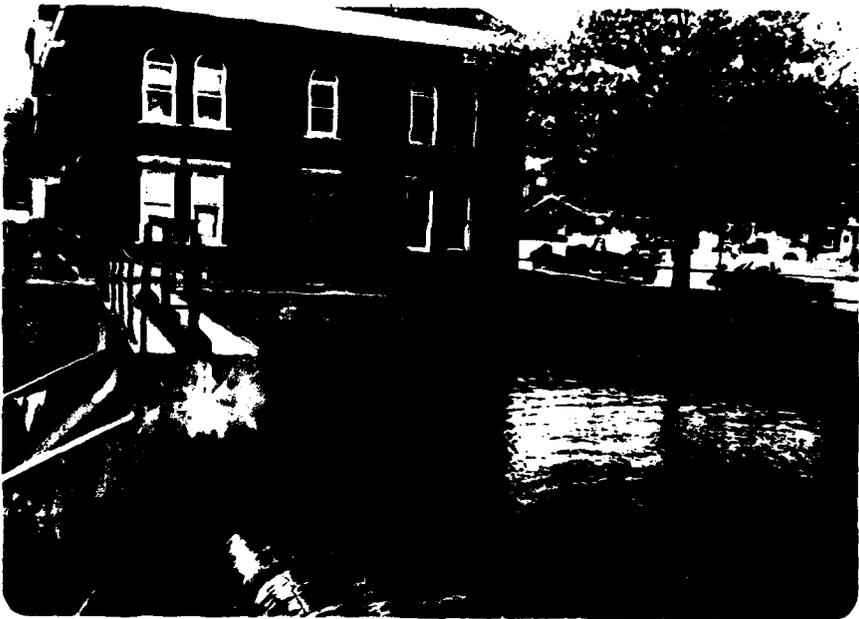
3. View of right abutment showing forebay control to hydro-mechanical equipment in basement of municipal building (red brick building). Beam on walkway is used to support hoist for removing stop planks.

The wall of the Municipal Building which forms the right abutment of the dam was viewed from the basement of this structure. Considerable seepage is taking place through the masonry wall of this structure. The Water Superintendent indicates that this condition has worsened in recent years and that the wall is covered by a layer of ice during the winter season.

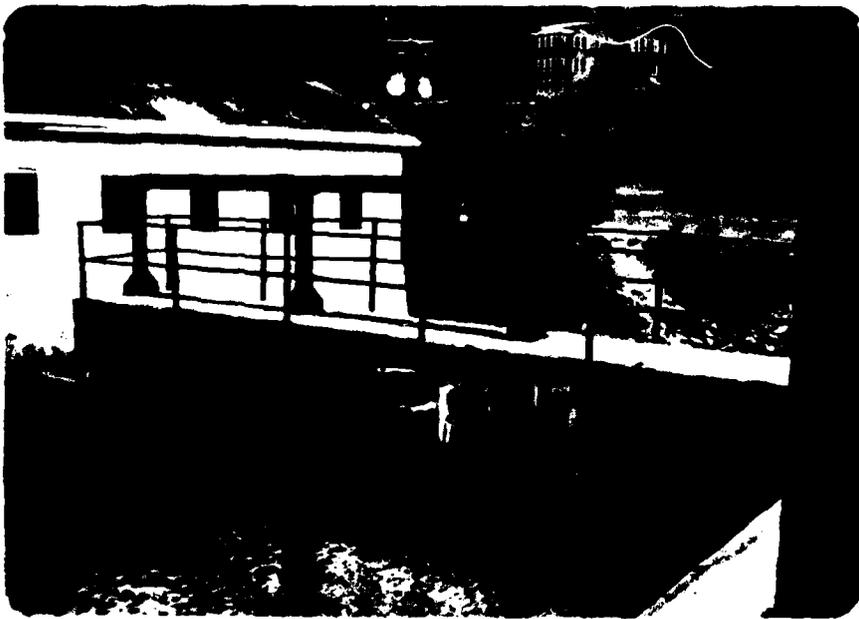
4. Stop plank structure from upstream.

The stop planks in the outlet structures have been replaced so that the conditions which caused an emergency during 1977 and 1978 have been remedied. However, the Water Superintendent indicates that it is sometimes quite difficult to remove and replace stop planks in the structure.

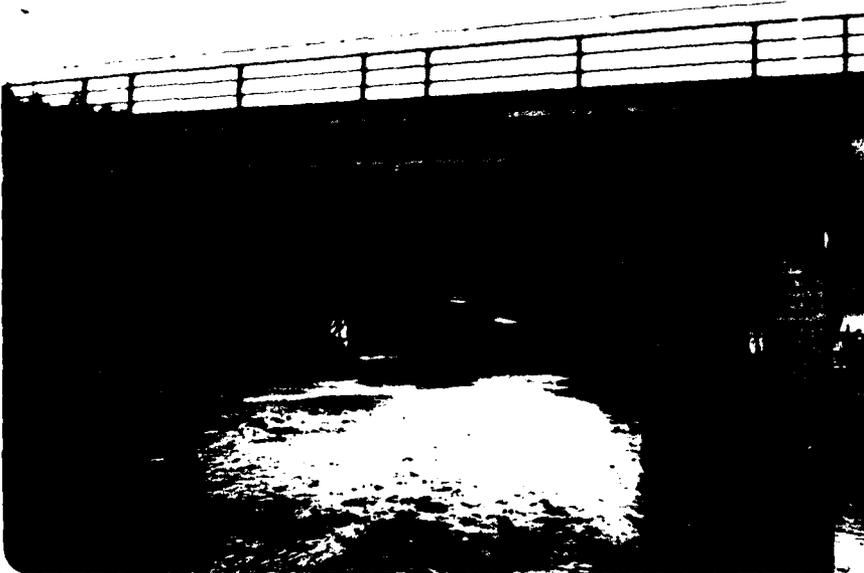
6. Receiving stream showing downstream hazard.

The Saranac River, the receiving stream from Lake Flower, flows through the Village of Saranac Lake. Several residences and commercial establishments are located close to the stream. Therefore, the dam is in the High Hazard Category as defined by the Recommended Guidelines for Safety Inspection of Dams.
