LAKE WHETSTONE

NDI ID NO. MD-53

PHASE I INSPECTION REPORT  
NATIONAL DAM INSPECTION PROGRAM

JULY 1980

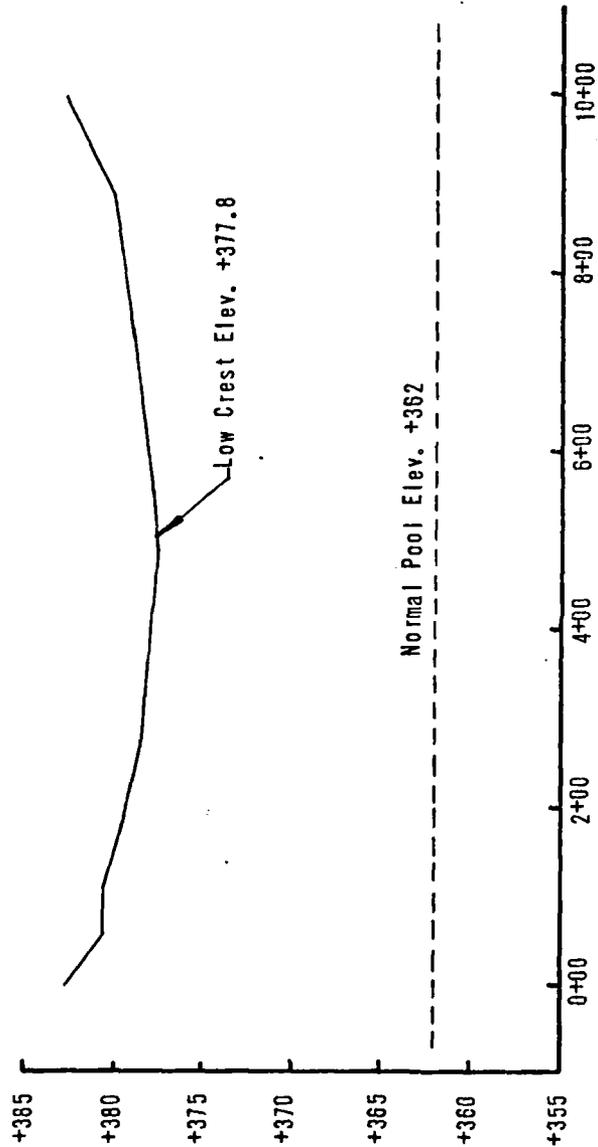
**DAM CREST PROFILE**  
(LOOKING DOWNSTREAM)

The crest of the dam was surveyed and the variance in elevation was 5 feet between the high and low point. This variance is due to the vertical curve of the roadway across the dam crest. The low point on the crest is approximately 8 inches below the design crest elevation of 378.5, and is located 50+ feet left of the intersection of the twin box culverts of the spillway and the embankment. Freeboard at the time of inspection was approximately 16 feet, and under maximum pool (i.e. design flood) conditions would be approximately 3.5 feet. The dam crest profile is included as Plate C-2.
