| REPORT DOCUMENTATION PAGE | | READ INSTRUCTIONS BEFORE COMPLETING FORM |
|---|---|--|
| 4. TITLE (and Subtitle) Phase I Inspection Report Wappingers Falls Hudson River Basin, Dutchess County, New York Inventory No. 003 | | 5. TYPE OF REPORT & PERIOD COVERED Phase I Inspection Report National Dam Safety Program |

HUDSON RIVER BASIN
WAPPINGERS FALLS

PHASE I INSPECTION REPORT
NATIONAL DAM SAFETY PROGRAM
WAPPINGERS FALLS DAM
I.D. NO. N.Y. 3
D.E.C. NO. 613A
HUDSON RIVER BASIN
DUTCHESS COUNTY, NEW YORK

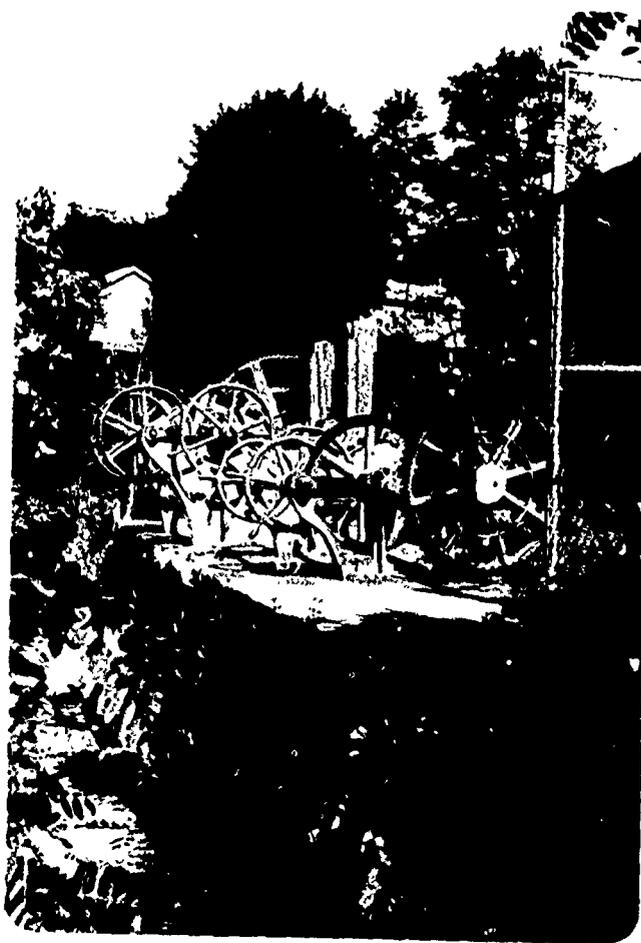
6. DOWNSTREAM VIEW
OF SLUICeway
GATE CONTROL
STRUCTURE.
