REPORT DOCUMENTATION PAGE		READ INSTRUCTIONS BEFORE COMPLETING FORM
1. REPORT NUMBER	2. GOVT ACCESSION NO. A092219	3. RECIPIENT'S CATALOG NUMBER
4. TITLE (and Subtitle) Phase I Inspection Report Tivoli Lake Dam Hudson River Basin, Rockland County, New York Inventory No. 052		5. TYPE OF REPORT & PERIOD COVERED Phase I Inspection Report National Dam Safety Program

1. OVERVIEW OF DAM

PHASE I INSPECTION REPORT
NATIONAL DAM SAFETY PROGRAM
TIVOLI LAKE DAM
I.D. NO. N.Y. 52
D.E.C. NO. 306
HUDSON RIVER BASIN
ROCKLAND COUNTY, NEW YORK

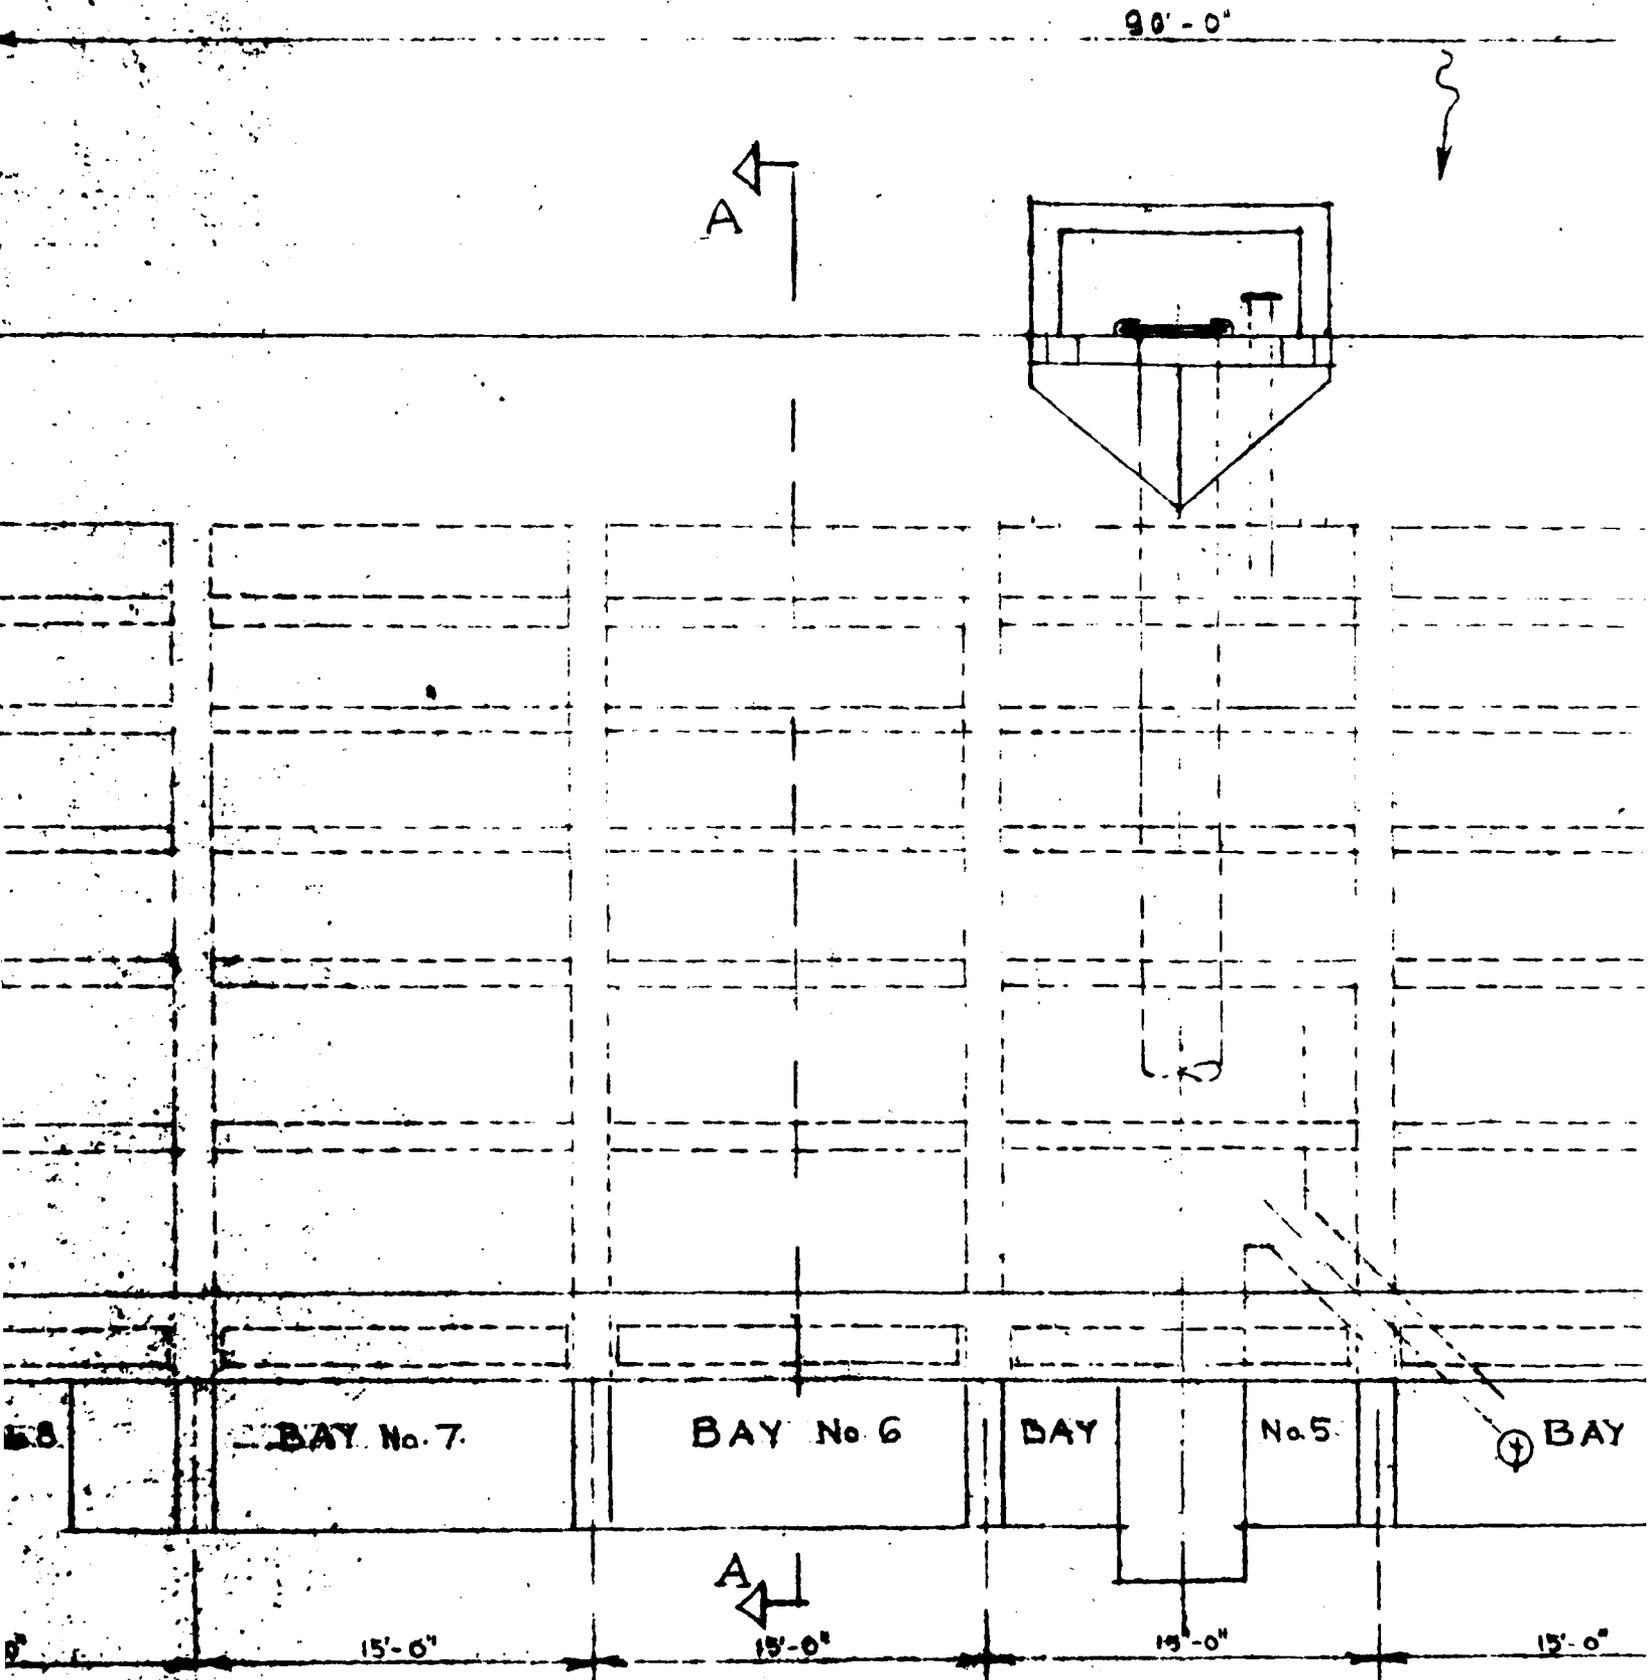
PLAN OF CRANBERRY DAM
(FORMER TIVOLI DAM)

LOCATION OF NECESSARY CONCRETE REPAIRS.

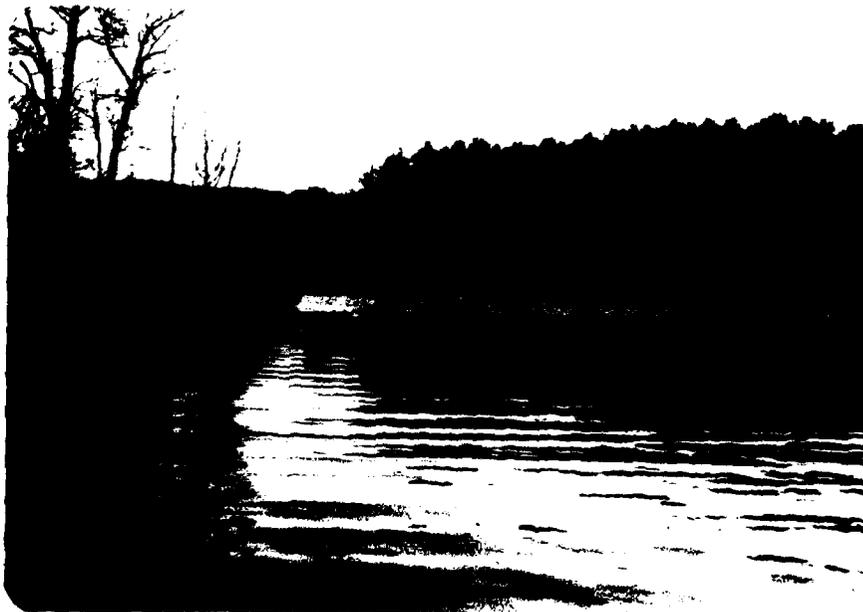
7. VIEW OF CAUSWAY ACROSS LAKE NEAR SPILLWAY.
