**DSCS II
SATELLITE 9444
TELEMETRY TRANSMITTER ANOMALY REPORT**

AUGUST 1980

**DEPARTMENT OF THE AIR FORCE HEADQUARTERS
SPACE DIVISION (AFSC)**

CDRL Sequence Number 009A2
Contract F04701-80-C-0022
Report No. 36060-AR-022-01

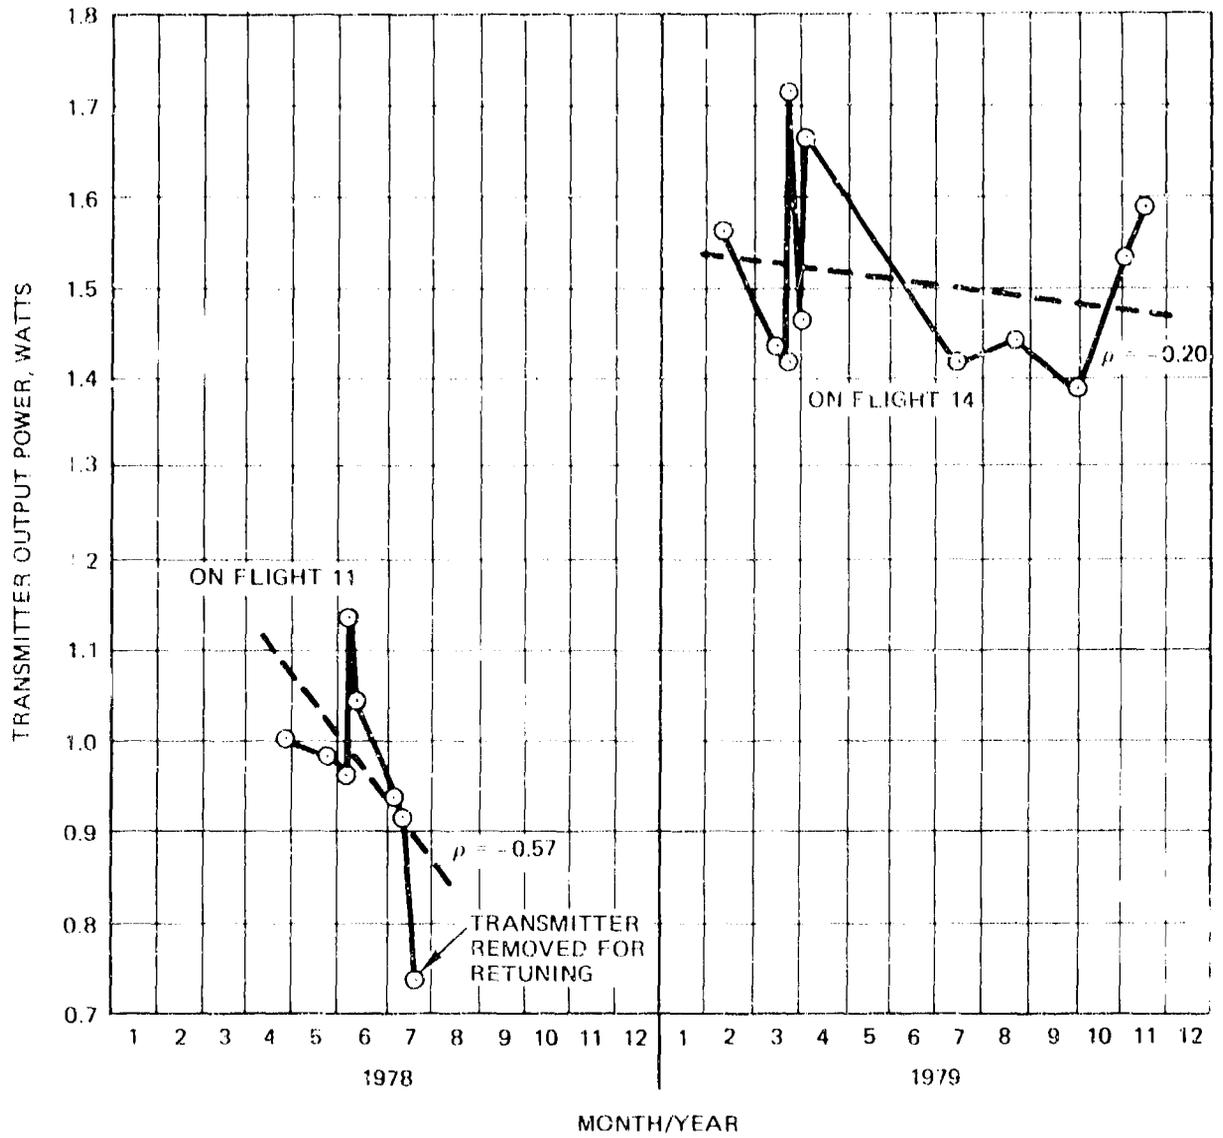
Figure 2-3. Transmitter S/N 3-25 Output Power During Integration and Test

No anomalies were observed during reacceptance testing, subsequent integration testing or prelaunch checkout at Cape Kennedy. The results of integration testing on both F-11 and F-14 are shown in Table 2-1. Transmitter output power versus calendar time are shown plotted in Figure 2-3 together with least squares trend lines. Note the significant improvement in output power after retuning. The effect of temperature on output power is shown in Figure 2-4. There was very little correlation on Flight 11; somewhat more on Flight 14, but not enough to be considered significant.

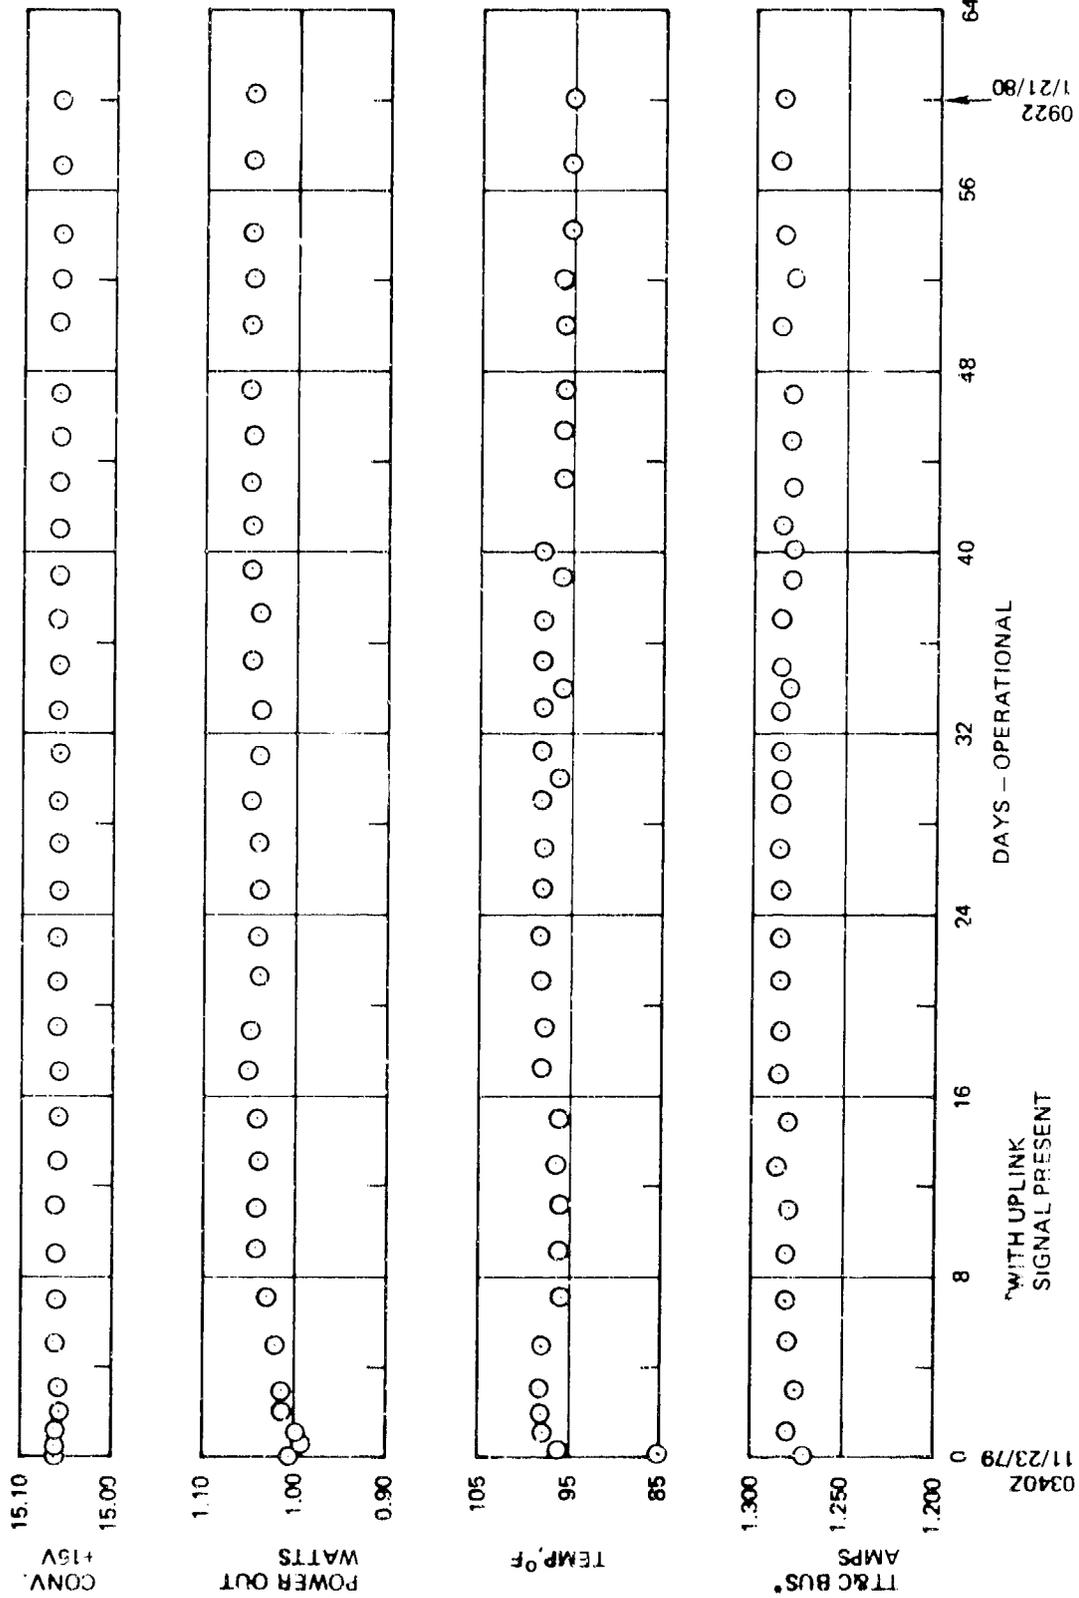
Figure 2-5. 9444 XMTR 1 Orbital Parameters

During its two months of orbital operation, transmitter 3-25 performed normally. A graph of several operating parameters is shown in Figure 2-5. Converter output voltage was steady at 15.06 V. Transmitter output power increased slightly during the first few days of operation and became steady at 1.05 W, a nominal value. Transmitter internal temperature increased initially when the transmitter was turned-on, then stabilized at a normal value, varying by only 2 to 3 degrees. TT&C bus current also was steady and normal. Thus, there was no evidence of degradation or anomalous behavior of the transmitter prior to the failure.

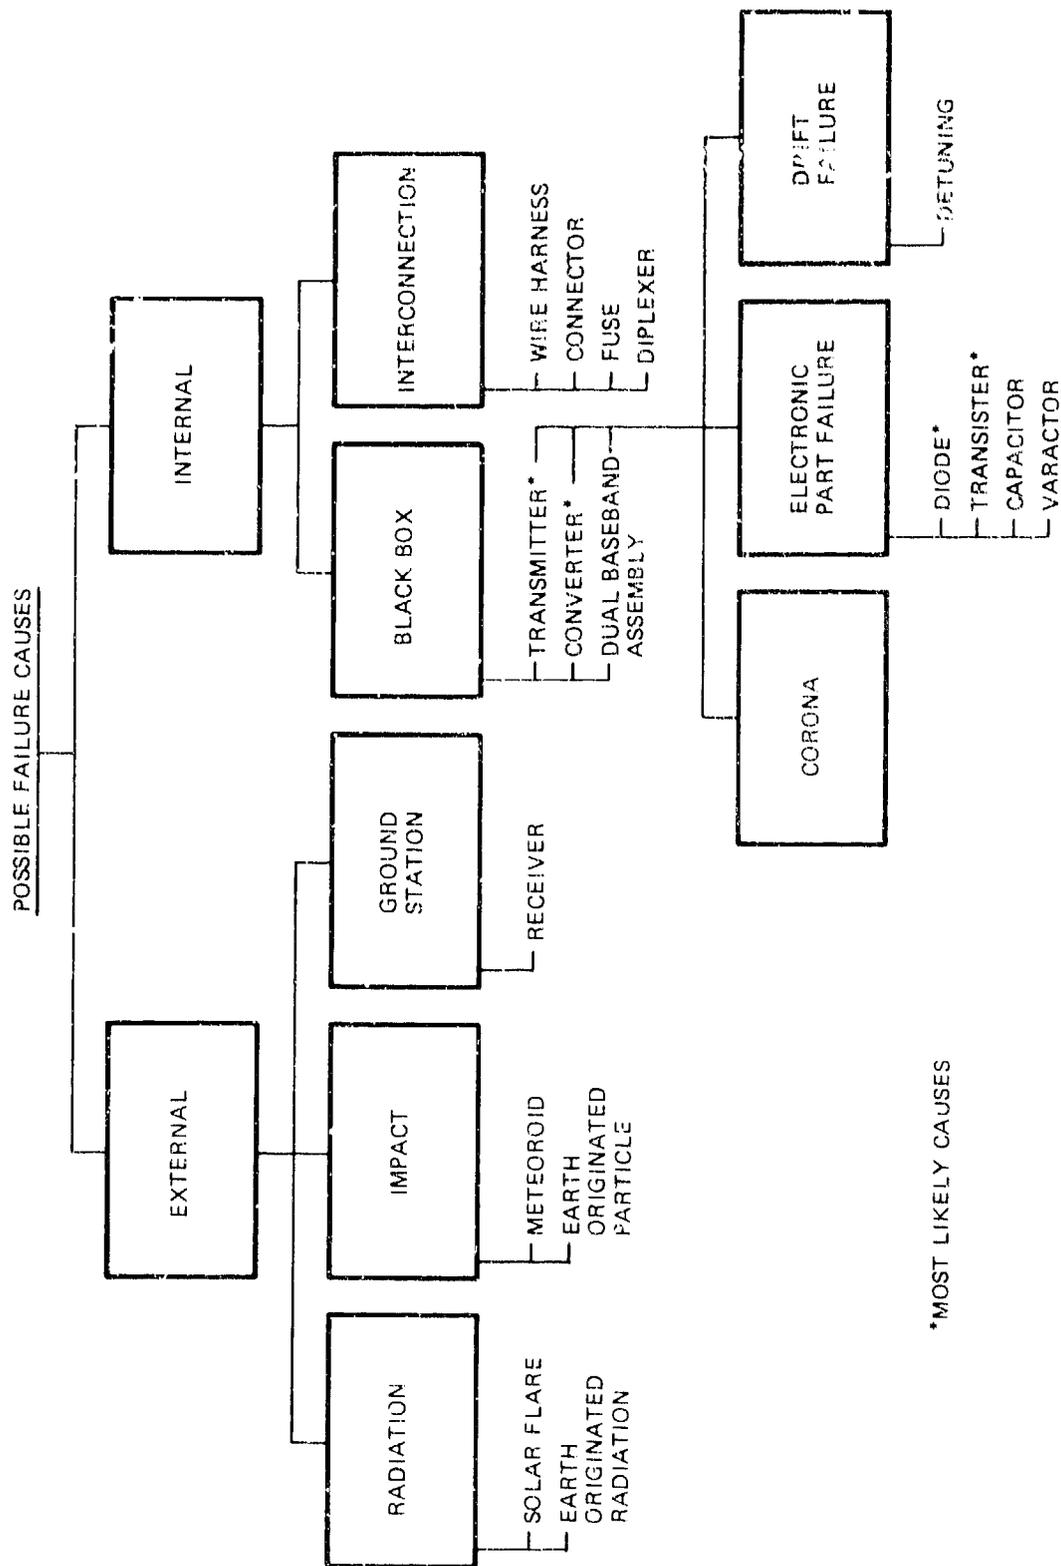
Figure 3-1. Diagram of Possible Failure Causes

Two general categories of possible failure causes exist: external and internal. These are diagrammed in Figure 3-1. Although there is no evidence to suggest any particular external failure cause, they were considered by the anomaly investigation team and are shown here for completeness. Radiation and particle impact were ruled out early as failure causes because they are remote and shielding is provided by the satellite structure and unit housings. The possibility of ground station failure was eliminated because the loss signal from the satellite was verified by a second ground station.

Based on past experience with electronic assemblies, it is more likely that the failure cause is internal. Of these, the transmitter itself, or its power converter, have the highest likelihood. Hence, efforts of the investigation team were concentrated in this area. Drift failure was ruled out quickly because, as seen in Figure 2-5, there was no indication of drift in any of the transmitter parameters. Drift from 1.05 W output power to less than 0.1 W would have had to occur in the 20.5 hours between telemetry samples.

An interconnection failure, such as a broken wire, open printed circuit board trace or improperly mating connector, would fit the observed sudden loss of signal; however, it is highly unlikely that these would not have been detected during ground testing if they existed prior to launch, and are unlikely to occur while the spacecraft is operating normally under relatively benign orbital conditions. Fuse failure is unlikely as there was no indication of any unusual power consumption in the TT&C subsystem. The possibility of corona, as was observed during F-15 thermal-vac testing, was discussed but considered unlikely since the transmitter would have vented completely long before two months in orbit. A diplexer failure is considered unlikely as this would be reflected on the redundant downlink.

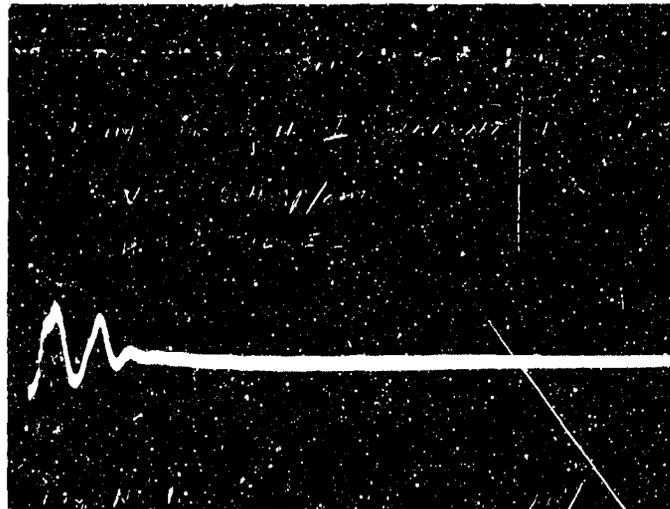
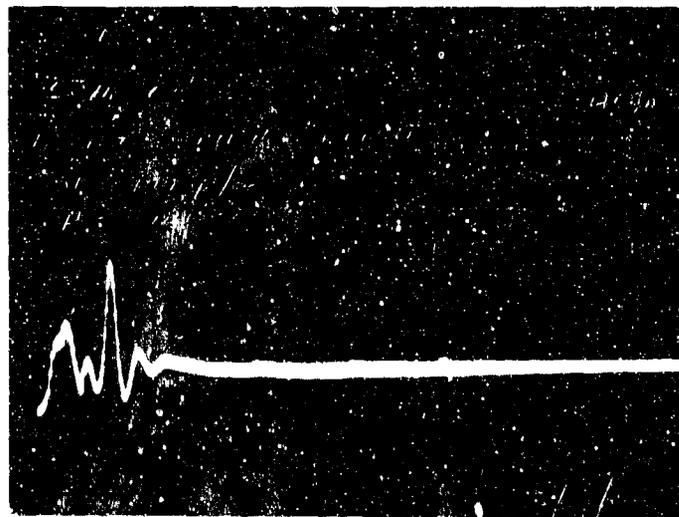
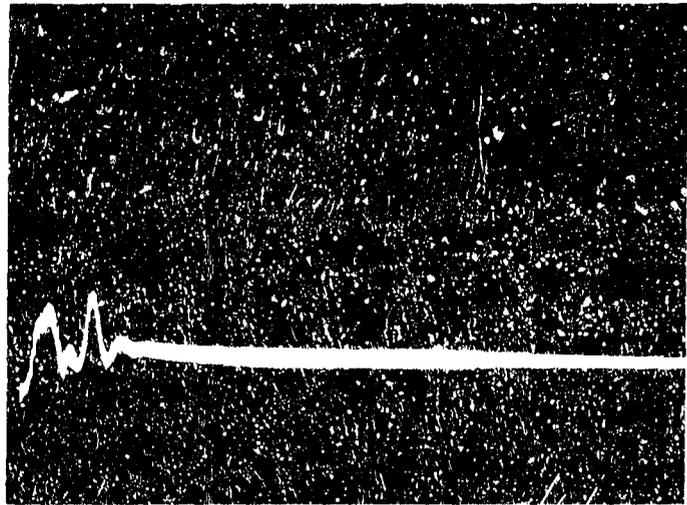
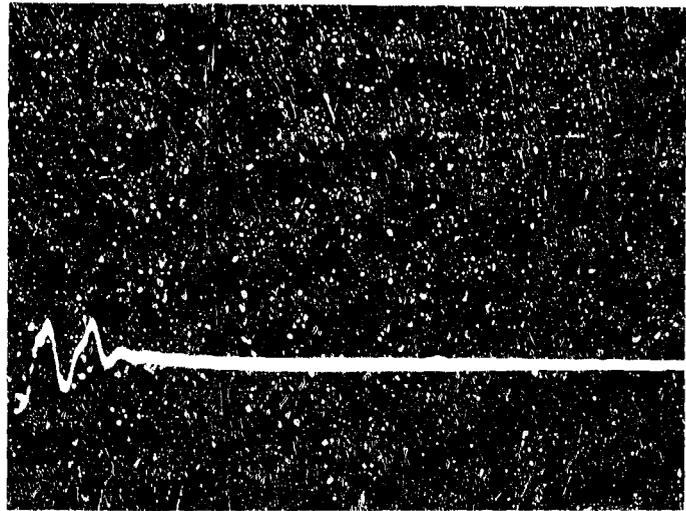
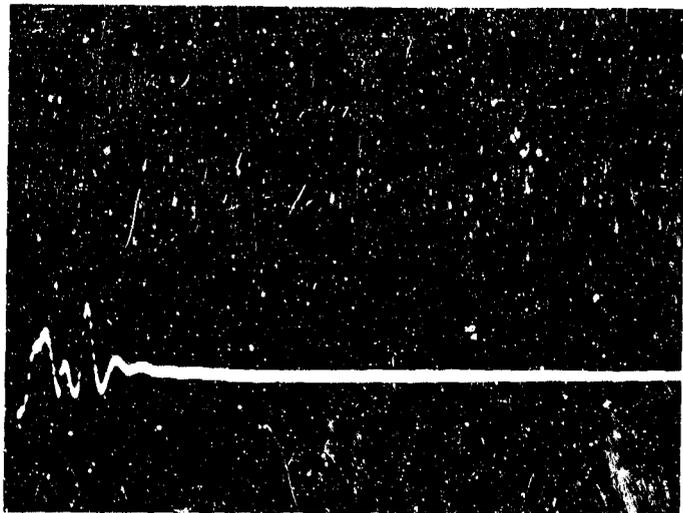
Figure 3-2. Output Oscilloscope Traces From Converter Overload Tests

It was concluded that as the output load is increased, the input current increases until the input bus fuse blows, thus precluding damage to the transmitter or dual baseband unit.

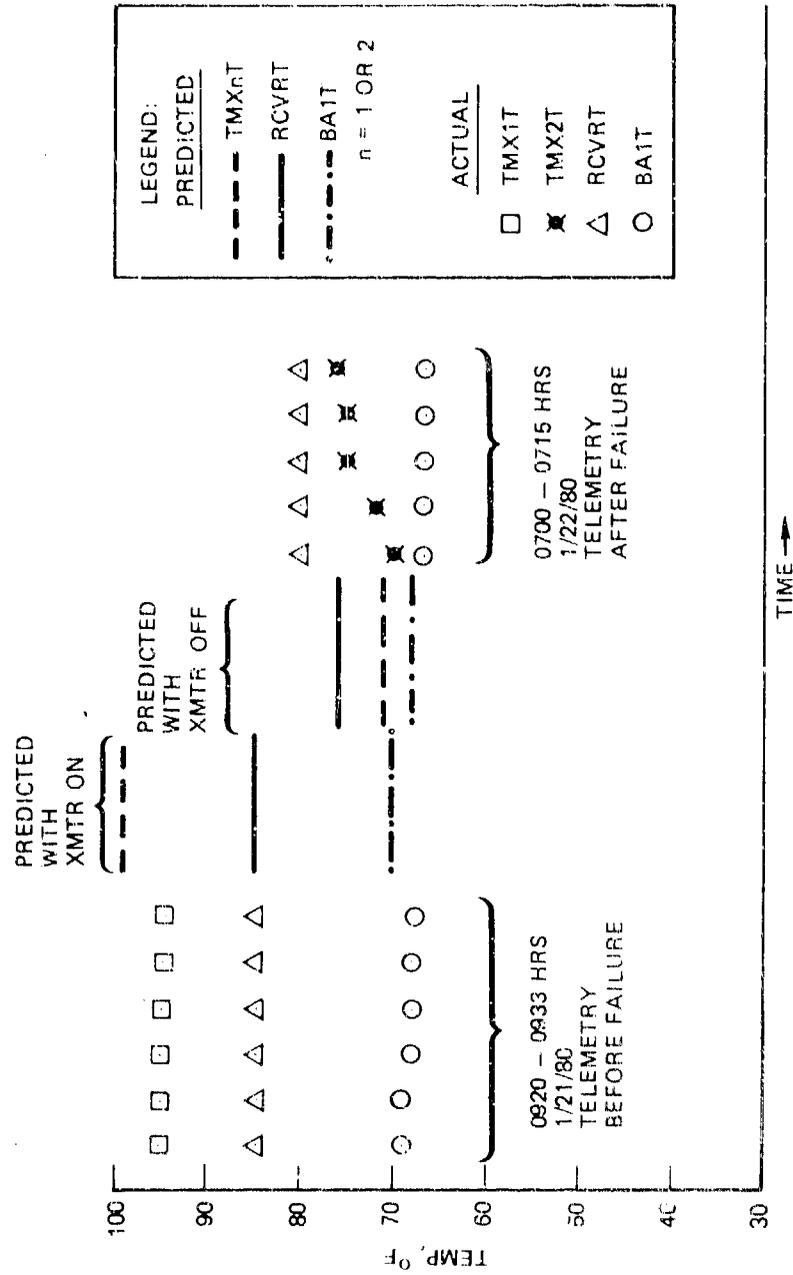
Figure 3-3. 9444 XMTR 1 Failure - Related Temperature Data

Telemetered temperature measurements for transmitters No. 1 and 2, the receiver and battery No. 1 are shown plotted in Figure 3-3 for several minutes before and after the failure. This figure clearly shows the warm-up of transmitter No. 2.

Before the failure, transmitter No. 1 was operating at 95°F, 4°F below the predicted 99°F. This was not considered significant since it is within the accuracy of the measurements and analytical predictions. The receiver and battery were operating very close to the predicted values.

After the failure, transmitter No. 2 temperature was very close (within 1°F) to its predicted value in the off condition. This indicated that neither the transmitter nor its converter was dissipating power. However, this does not necessarily infer that the converter failed causing loss of power to the transmitter, because failure of the transmitter could also reduce power output of the converter causing it to cool down. The receiver temperature dropped to within 4°F of predicted. Battery number one temperature changed only 1-2°F as predicted. Thus, nothing unusual could be inferred from this temperature data.

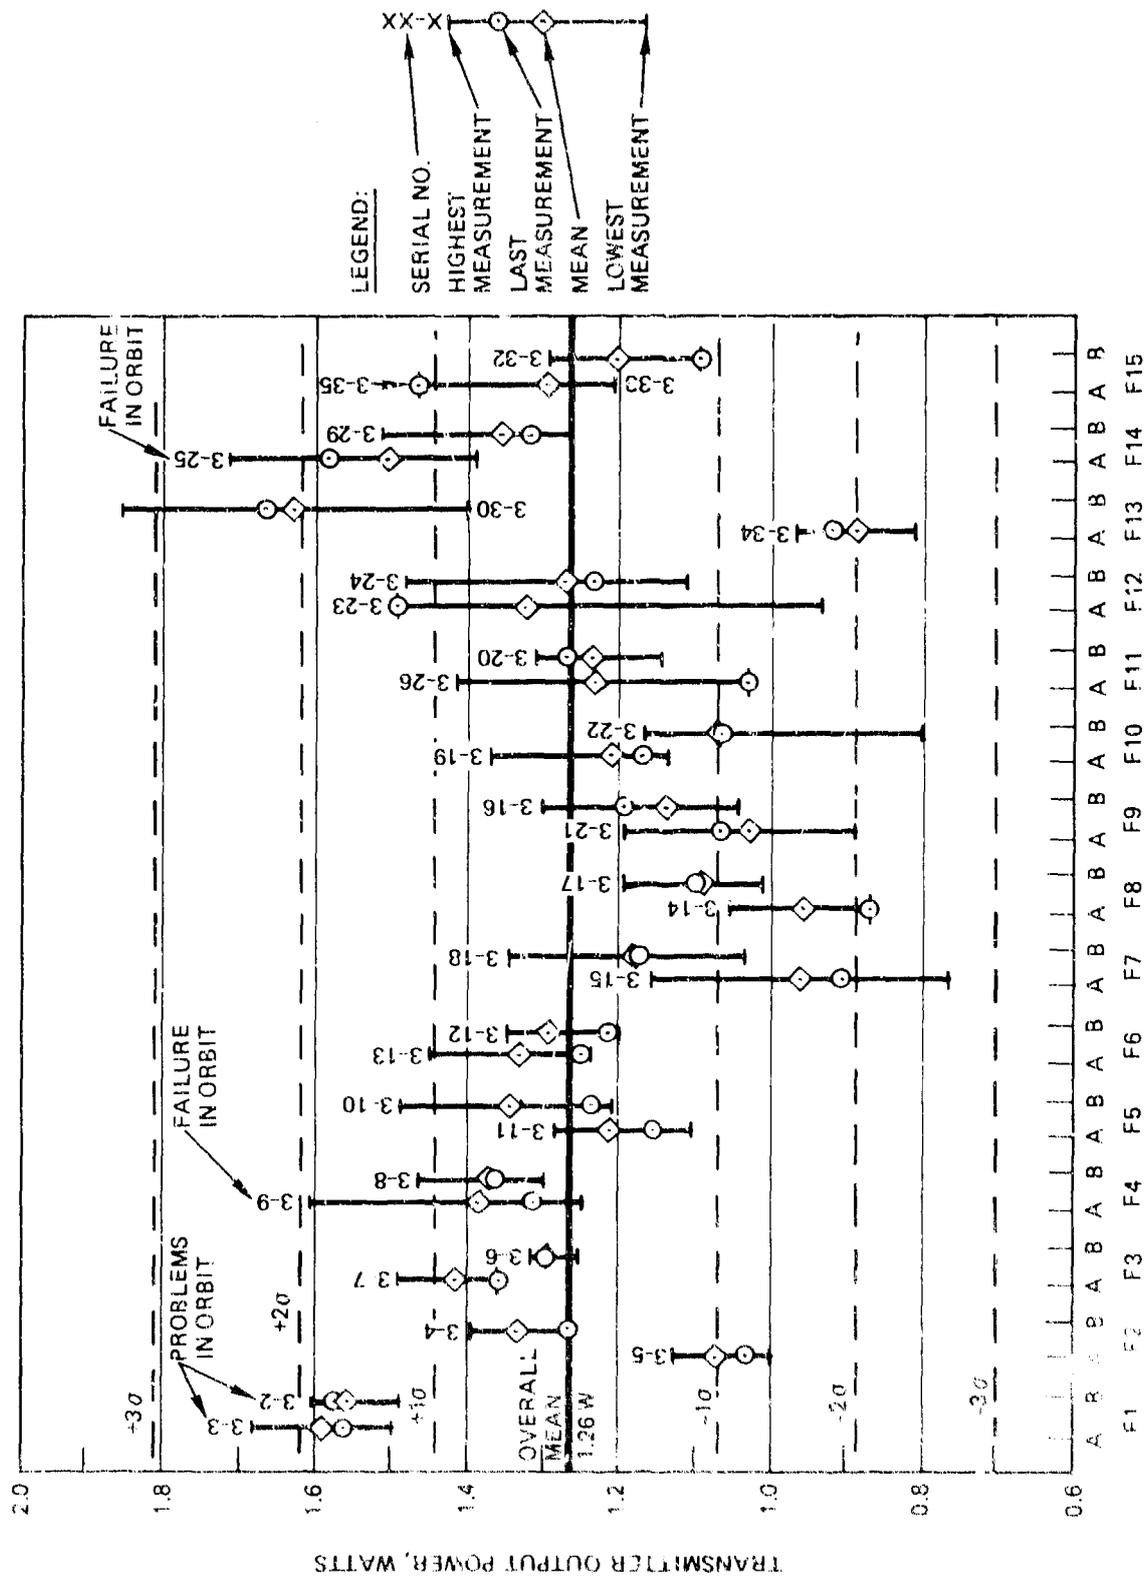
Figure 3-4. TTC Transmitter Output Power History During I&T

In general, Flights 1 through 5 tended to have transmitter powers above the mean, Flights 7 through 12 were generally below the mean and Flights 13 through 15 were above the mean. Flight 13 is a notable exception; the A-side transmitter (S/N 3-34) was one of the lowest power transmitters tested while the B-side transmitter (S/N 3-30) was the highest.

Of particular interest is that the mean output power of the failed transmitter on Flight 14 (S/N 3-25) during I&T was one of the highest ever measured. Only transmitter 3-30 on Flight 13 and the two transmitters on Flight 1 (which had problems in orbit) had higher average output. Transmitter 3-9 on Flight 4 (which failed in orbit) also had some relatively high power measurements, although the last measurement in I&T was near the overall mean. This raised the question of whether high transmitter output power was correlated with failure.

To assure that the transmitter power variations shown in Figure 3-4 are not just due to normal random variations, statistical significance tests were performed on the data in Appendix C. First an analysis of variance was conducted on the output power measurements made during I&T on the 30 transmitters. This analysis is summarized in Appendix D. As might be expected, the results show that the observed variation in output power is significant and it is highly unlikely that all transmitters come from the same statistical population. Although all transmitters are of the same design, their performance is highly dependent on their tuning.

A second statistical test was performed to determine if the two transmitters which failed abruptly in orbit (S/N 3-9 and S/N 3-25) had significantly higher output power than the average of non-failed transmitters (excluding Flight 1). This analysis is shown in Appendix E. The results indicate that the observed higher output power of the two failed transmitters is statistically significant and there is less than a 5 percent chance that this observation is due just to random fluctuation. The mechanism of failure and how it is related to output power has not been determined.
