LOWER ALFORD LAKE DAM

NDI No. PA 00053

PHASE I INSPECTION REPORT.

NATIONAL DAM INSPECTION PROGRAM

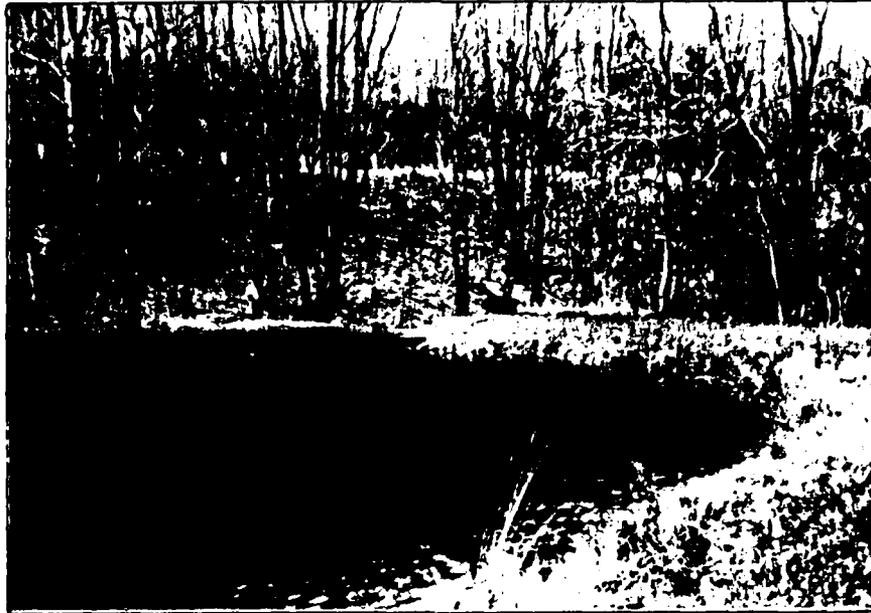
PHOTO 1. View of Upstream Side of Dam from Right Abutment

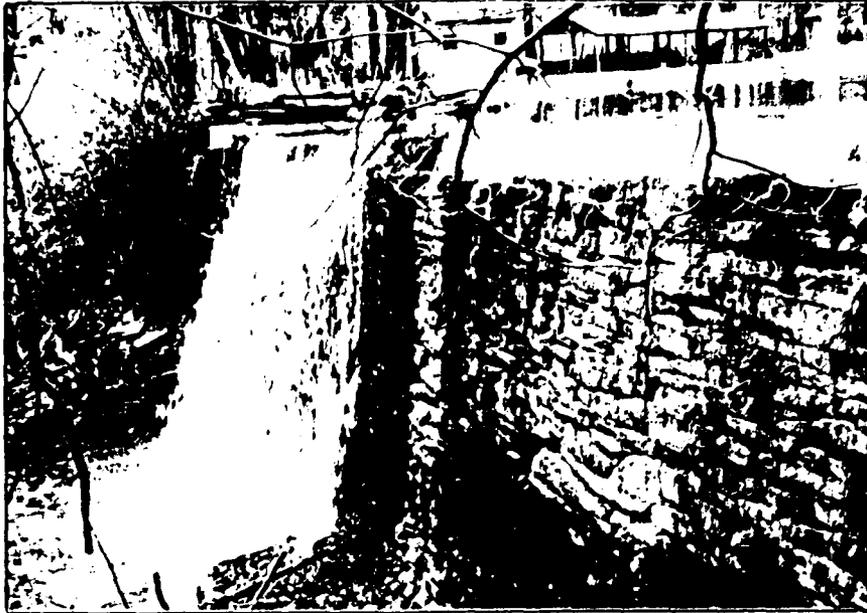
- b. Dam - Some trees and brush were observed on the right downstream face of the dam. These should be cut.
- c. Appurtenant Structures - The spillway crest is slightly irregular, however, this should not significantly affect the performance of the spillway.

PHOTO 5. View of Downstream Side of Dam from Left Abutment

- 2) Cut the brush and trees located on the right downstream face of the dam.
- 3) Remove the debris and cut the vegetation in the downstream channel.
- 4) Provide means to draw down reservoir during an emergency.
