AD-A097 932 NAVAL RESEARCH LAB WASHINGTON DC
MB20B BASE STOCK AS TARNISH PROMOTER OR PREVENTOR. (U)
APR 81 E G SHAFRIN, R J COLTON
UNCLASSIFIED NRL-MR-4497

4. TITLE (and Subtitle) <u>MB20B BASE STOCK AS TARNISH PROMOTER OR PREVENTOR</u>	5. TYPE OF REPORT & PERIOD COVERED Report on one phase of a continuing NRL problem.

MB20B BASE STOCK AS TARNISH PROMOTER OR PREVENTOR

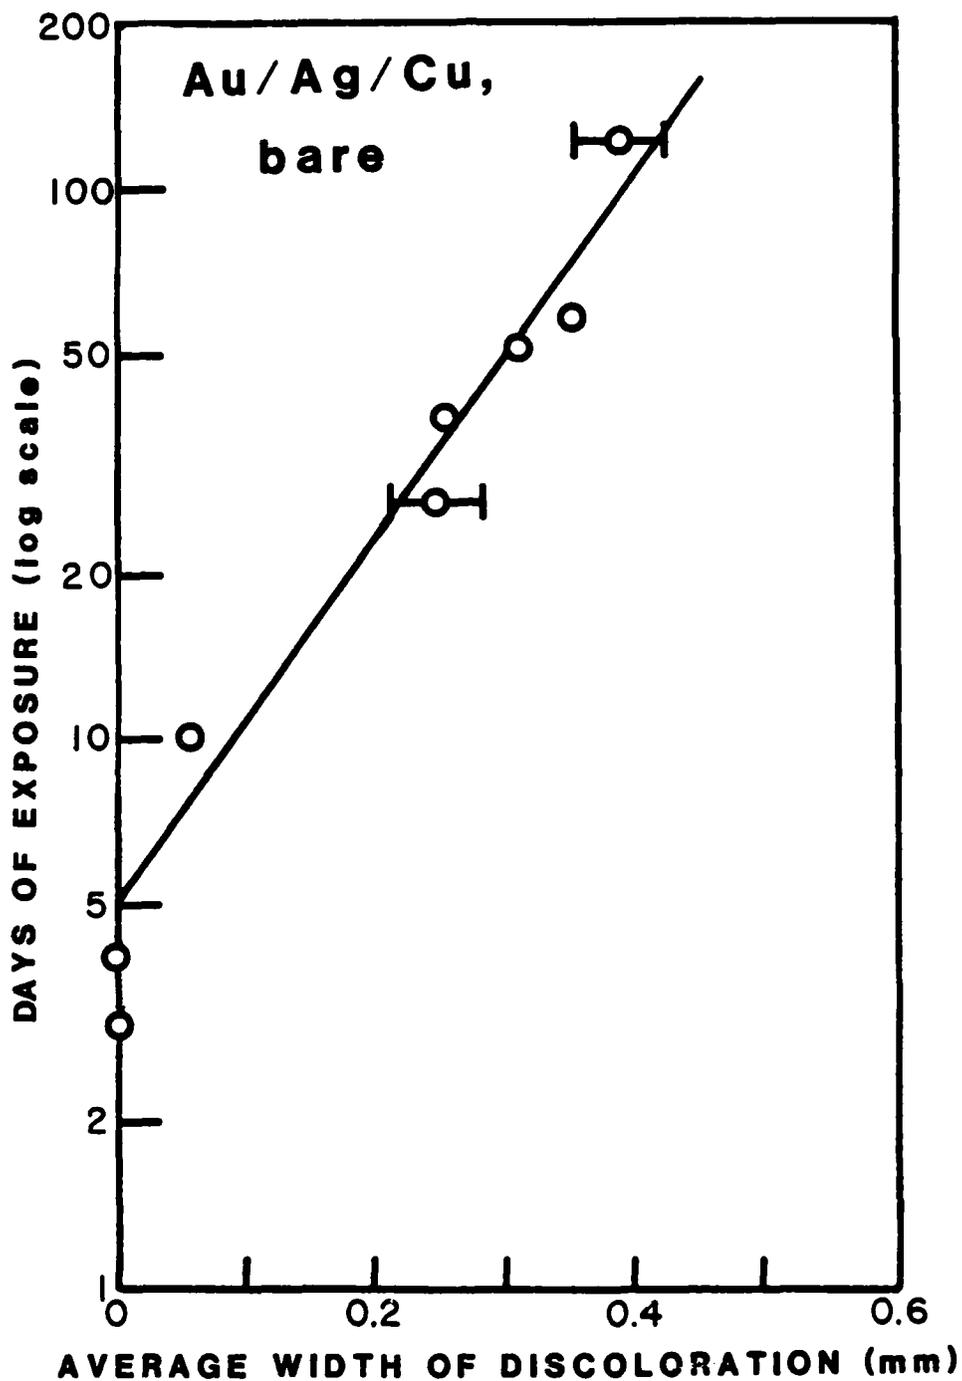
Fig. 1 — Semi-log plot of the rate of growth of the discoloration "halo" parallel to the long sides of a laboratory-induced scar through the gold coating of a bare Au/Ag/Cu reference coupon exposed to the ambient at room temperatures and humidities

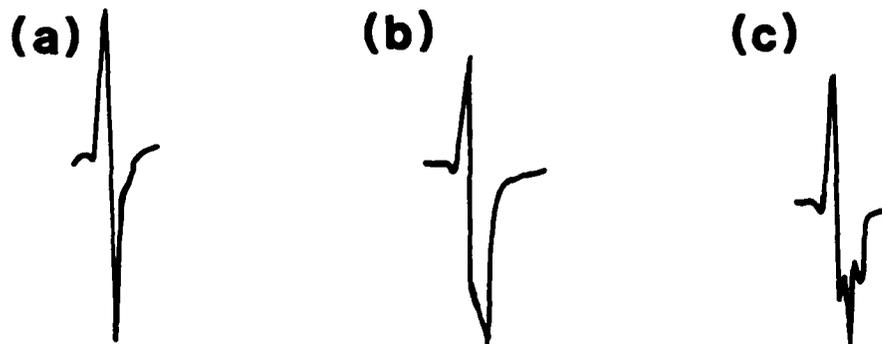
SULFUR AUGER LINESHAPES

*Auger sulfur lineshapes can be used to distinguish various surface compositions (e.g., see Ref. 11). Each of the Auger lineshapes in Fig. 3 however occurs nondiscriminately for "pure" reagent grade chemicals and mineral samples of Ag_2S , Cu_2S , and CuS . This ambiguity requires further investigation.

Fig. 3 — Comparison of the lineshapes for the low-energy sulfur Auger signals. The designations shown here are used to identify lineshapes in data tabulations of Tables III through VI.

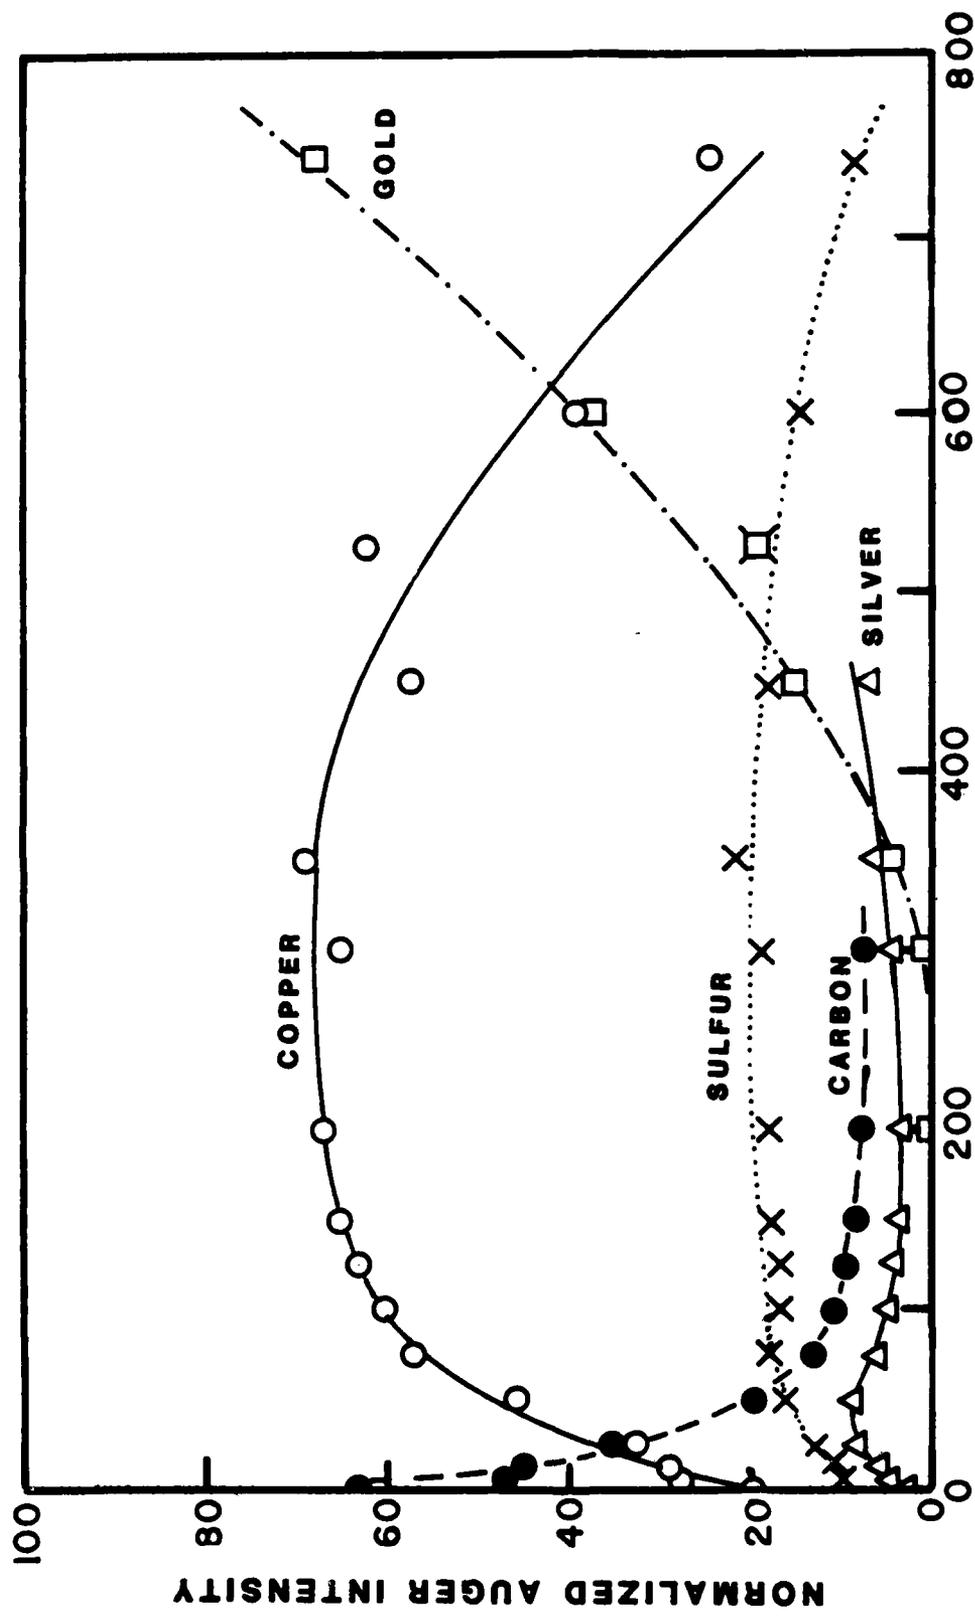
Fig. 5 - Auger/sputter depth profile of a new Au/Ag/Cu female connector after exposure to H₂S with MIL-L-81846 present (#7 of Tables I and VI)
