**DEPARTMENT OF DEFENCE
DEFENCE SCIENCE AND TECHNOLOGY ORGANISATION
AERONAUTICAL RESEARCH LABORATORIES**

Structures Technical Memorandum 327

A REVIEW OF AUSTRALIAN INVESTIGATIONS ON
AERONAUTICAL FATIGUE DURING THE PERIOD
APRIL 1979 TO MARCH 1981

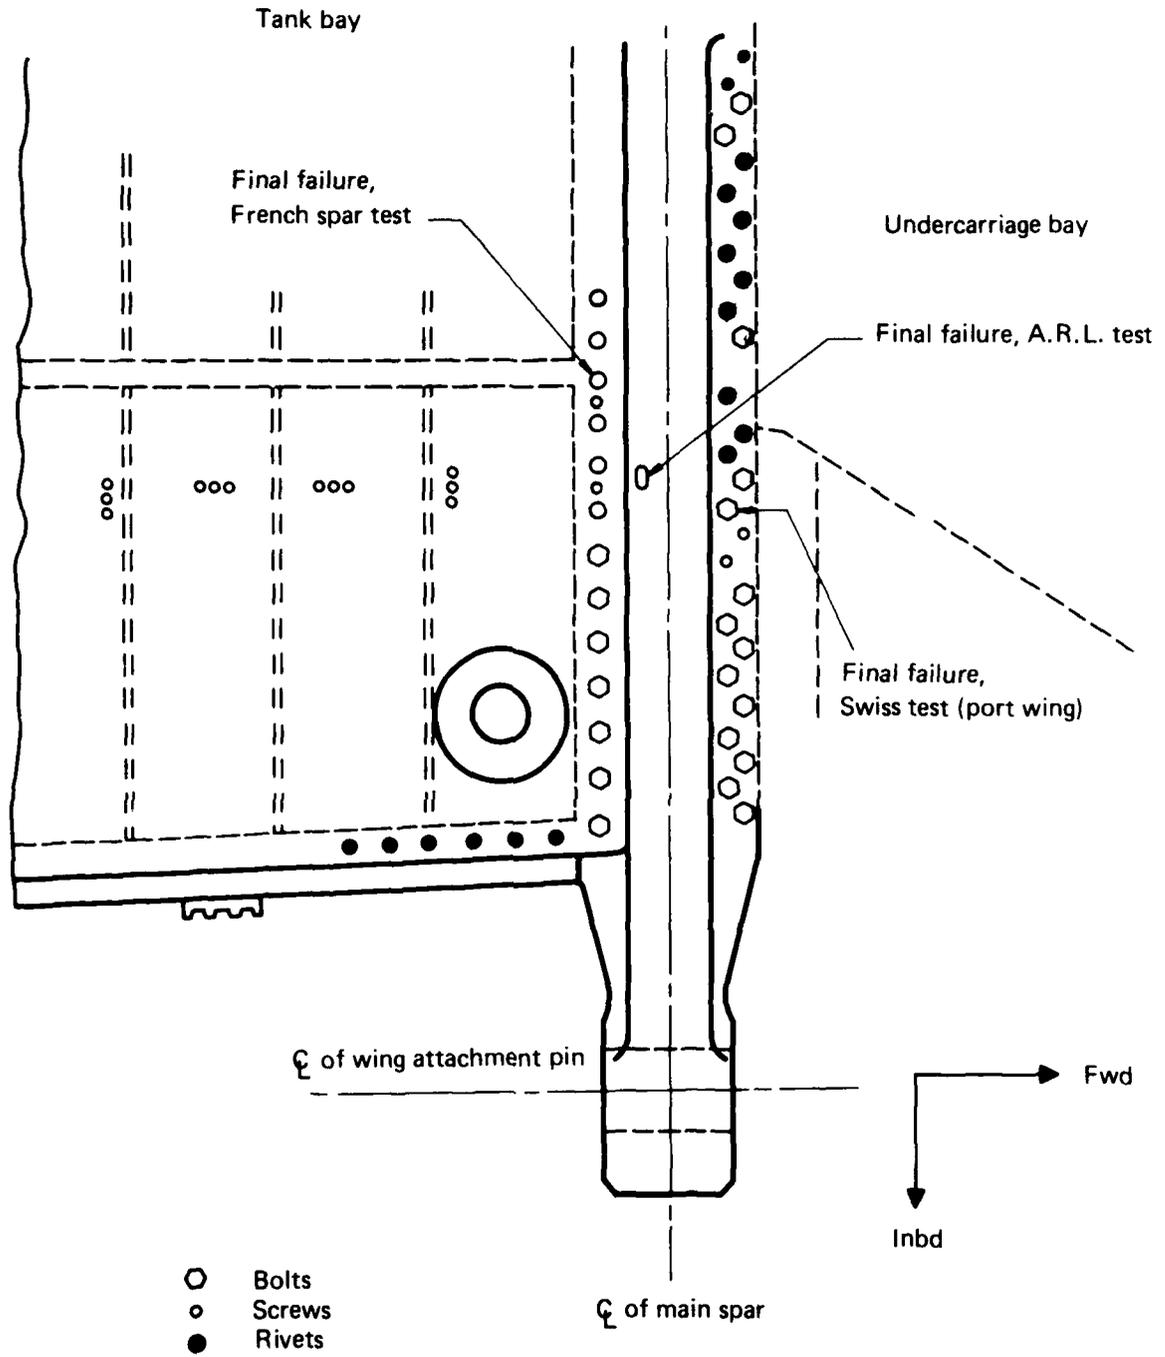
FIG. 9.1 FAILURE INITIATION SITES IN MIRAGE TEST WINGS
(STARBOARD LOWER SURFACE SHOWN)

In September 1979 the discovery of significant cracking in bolt holes in the spars of both wings and indications of cracks at identical locations in a large number of wings of the RAAF fleet aircraft caused immediate concern regarding the safety of the fleet and its ability to meet required life-of-type. These events introduced an urgent need to develop methods for both restoring and extending the fatigue lives of cracked wings; these are reported in some detail in Section 9.4.1: this work is also the main subject matter of a paper to be presented to the forthcoming 11th ICAF Symposium⁵.

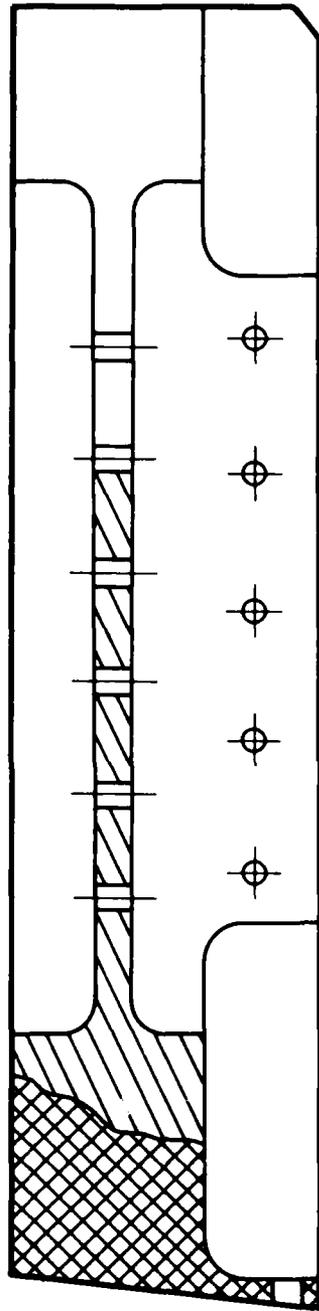
FIG. 9.2 NOMAD PORT STUB WING FRONT SPAR FAILURE – STATION 119

Final overload failure

Fatigue crack

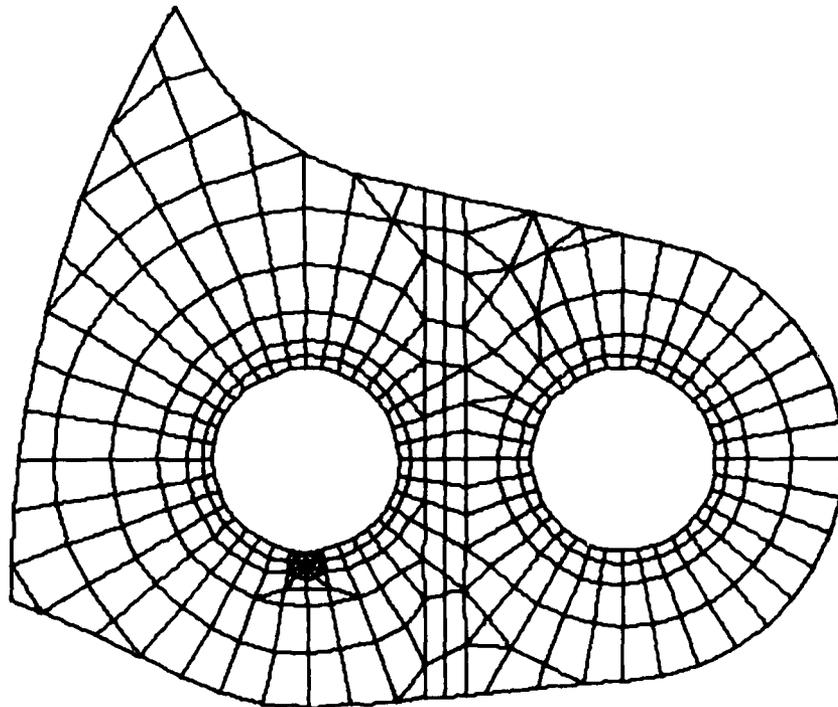
FIG. 9.9 CANBERRA LUG FINITE ELEMENT MESH (CRACK DEPTH = 3.40 mm)

The estimation of residual strength has been approached both analytically and by means of finite element analysis, Fig. 9.9. Analytically, the lug is approximated using Newman's 1976 approach⁸ for through and part-through cracks in a partially pin loaded hole-in-bar. It turns out that the analytical solutions provide stress intensity estimates just above those of the corresponding finite element analysis; their direct use therefore provides a little inbuilt conservatism, as well as complete manipulative flexibility, in crack growth and residual strength assessments. The critical crack depth is typically rather shallow, but above the threshold of detectability.

Crack growth predictions have been made using Forman's equation⁹. Insofar as no retardation is allowed for in that formulation, crack growth predictions are likely to be conservative particularly in the low crack growth rate region. Even so, calculated inspection intervals are reasonable, so that the feasibility of the proposal has in fact been established on the basis of calculations to date¹⁰. Before implementation in service, however, fatigue testing of lug specimens under a representative loading sequence is to be carried out to check all predictions concerning the fatigue and residual strength behaviours of the cracked lug.

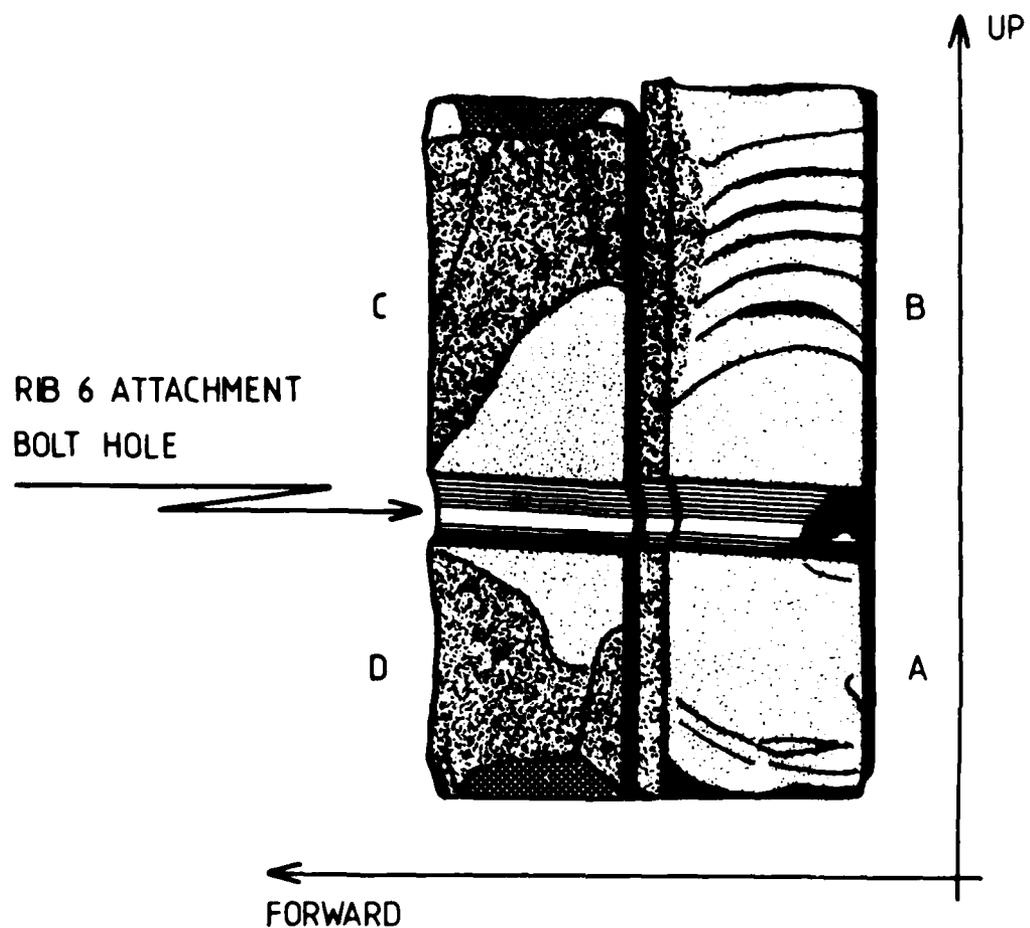
FIG. 9.12 BANDEIRANTE FATIGUE TEST – FRACTURE SURFACES

The lower front spar, manufactured from 2024T351 material, consists of a forward cap and a rear cap with the spar web bolted between the two caps. The rear cap had been cut into three sections, one cut being through the bolt hole and the other cut being through the end of one of the fractures. The four fracture surfaces of the front spar lower cap will be referred as A, B, C and D for convenience, Fig. 9.12.

Visual and low power microscopic examination of the fractures revealed progression bands typical of fatigue crack propagation. Fractures A & B consisted mainly of fatigue with only very small areas of overload. Fractures C & D consisted of smaller areas of fatigue crack propagation and larger areas of final overload failure. This indicates that the overload fractures of C & D occurred when the last load was applied during flight 188,000. Because the proportion of fatigue in fracture D is much smaller than that in fracture C, it is obvious that fatigue crack propagation in fracture D initiated some time after the initiation of the fatigue in fracture C. Fracture A was very smooth and crystalline in appearance with only a very few distinct progression bands near the end of the fracture, whereas fracture B had very distinct progression bands from approximately half way along the fracture. This indicates that fracture B propagated at a much greater rate than fracture A, indicating that fatigue cracking first initiated in fracture A. All four fatigue cracks initiated from multiple origins inside the bore of the bolt hole and towards the rear of the spar.

Examination of fracture C using the optical and the scanning electron microscopes, revealed that the progression bands consisted of a pattern of fairly large bands with a series of nine finer bands in between. These large bands or markings were considered to be the high load (I to J in Fig. 9.11) which occurs once every 1000 flights in the fatigue test program. The spacing of these progression markings was measured back to approximately 2.9 mm from the origin.

Examination of fracture B revealed that the progression markings consisted of coarse bands alternating with three or four finer bands in between. However, the coarse bands only became obvious approximately half way along the fracture. It was considered probable that these coarse bands were due to the F4545 flight cycle imposed upon the high load of the 1000 flight program. The finer bands would then be due to the high load of each 1000 flight program. The first half of the fracture consisted of coarse progression markings separated by bands of nine finer progression markings. It appeared that the overload occurred at a 4545 flight cycle, and considering that the crack growth rate of fracture C increased rapidly after the last 4545 flight cycle (i.e. the 185,000th flight) then it was assumed that the final failure of fracture B occurred at around the 185,000 flight. Subsequently the progression markings were measured to approximately 1 mm from the origin.

Examination of fracture A revealed similar characteristics to the first half of fracture B, having coarser progression markings with nine finer progression markings in between. These coarse progression markings became more pronounced near the end of the fracture and every four or five bands were more prominent indicating a 4545 flight cycle plus a peak load in the 1,000 flight program. In fracture B, the crack growth rate alters at approximately 138,000 flights (See Fig. 9.13) and it was considered that this resulted from the final failure of fracture A. This is in agreement with a pronounced band in fracture A being a F4545 flight cycle at 136,000 flights and another F4545 pronounced band at 131,000 flights. Hence the progression markings were measured to within approximately 1 mm from the origin. Fracture A was examined using the scanning electron microscope and there was no evidence of significant corrosion or fretting at the fatigue origins. A section was taken through one of the origins for metallographic examination. There was no evidence of corrosion or other significant metallurgical defects in the vicinity of the crack origin.

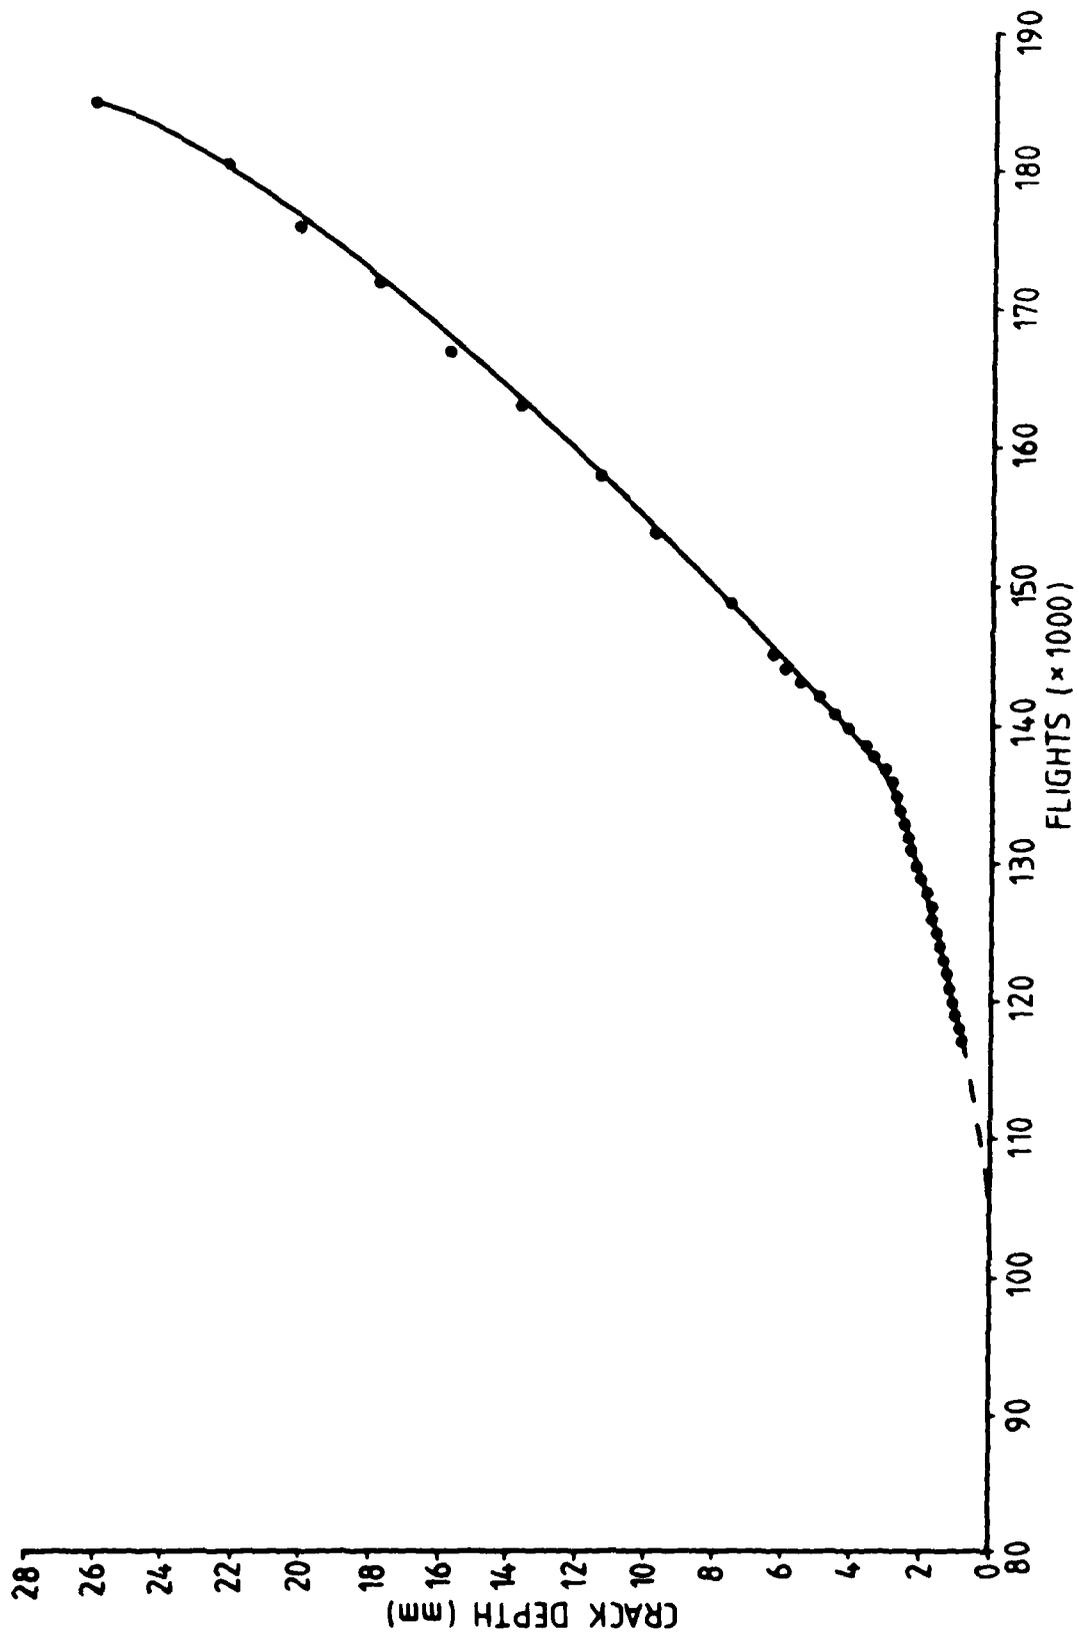
FIG. 9.13 BANDEIRANTE FATIGUE TEST - CRACK GROWTH OF FRACTURE B

By assuming that the coarse progression markings were associated with the 1000 flight block, it was possible to plot crack growth rates; an example is shown at Fig. 9.13. By extrapolating these curves, it is considered that the timing and sequence of events were as follows:

Event	Approx. Test Flights
Fatigue crack A initiated	70,000
Fatigue crack in A propagated 1.5 mm	105,000
Fatigue crack B initiated	
Final failure of A	
Fatigue crack growth rate of B suddenly increases	138,000
Fatigue crack initiated in C	
Fatigue crack D initiated	After 138,000
Final failure of B	
Fatigue crack growth rate suddenly increases in C	185,000
Final failure of C & D	188,000

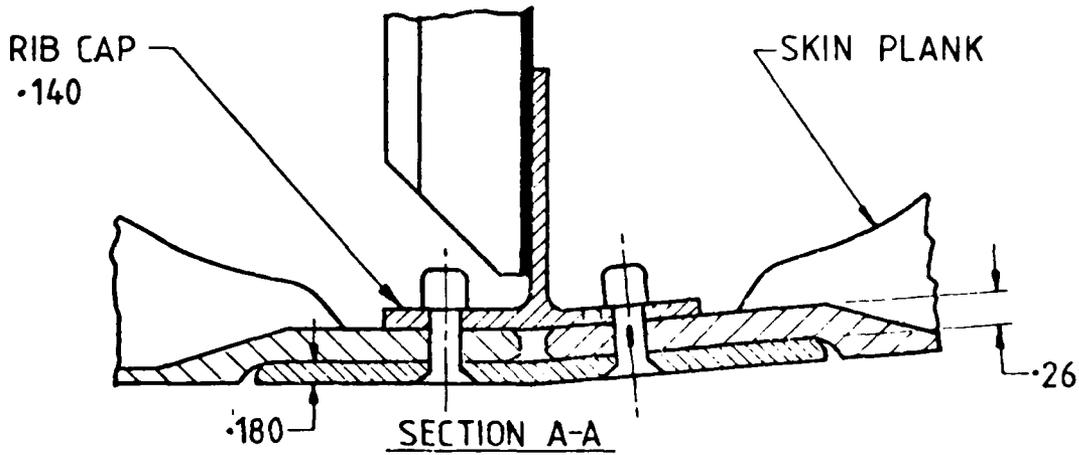
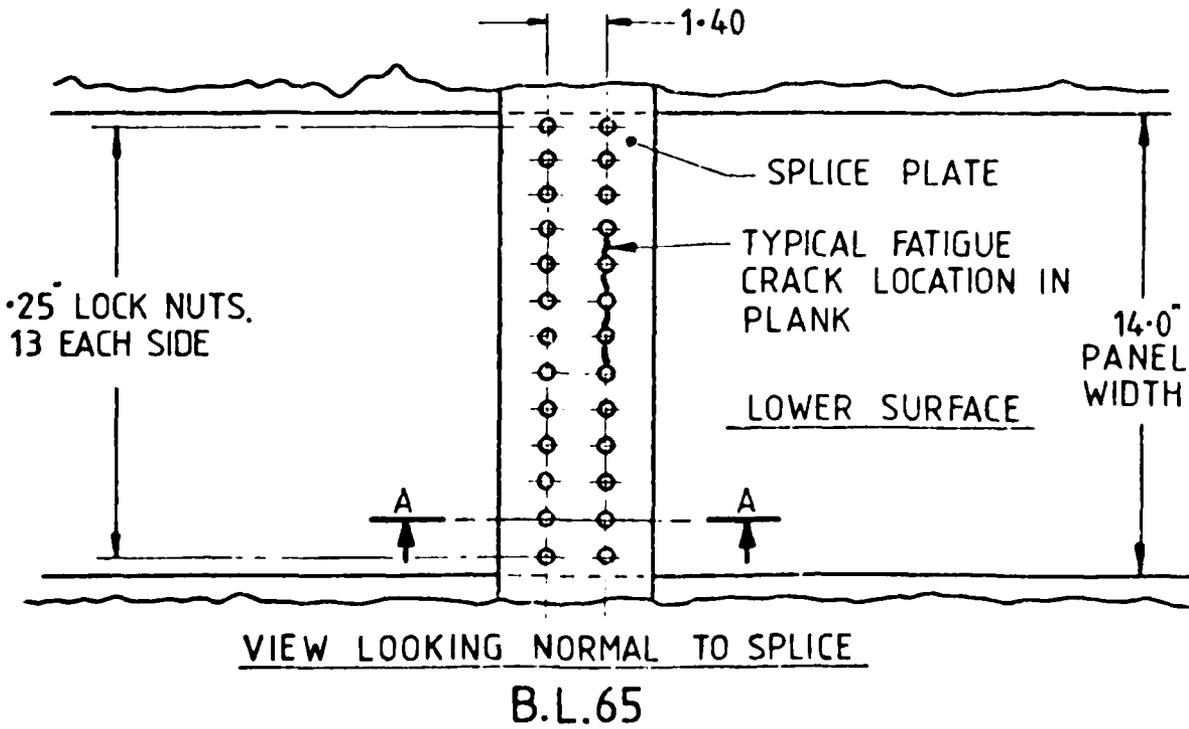
FIG. 9.14 LOWER SURFACE SPLICE JOINT - LOCKHEED L188 ELECTRA

In February 1981, as a result of cracking found in this joint in an overseas aircraft after the discovery of fuel leaks, three Australian Electra aircraft were inspected. Radiographic inspection of one aircraft, as recommended by the manufacturer, indicated that no cracks were present. However, the operator concerned, being aware of the inherent unreliability of radiography for crack detection decided, as a precaution, to try a shear wave ultrasonic technique. Using this method, fatigue cracking at plank fastener holes was discovered in both wings in all three aircraft. In all cases cracking was confirmed by removing fasteners and using an eddy current technique. One aircraft had continuous crack indications between 8 fasteners in one plank and between 5 fasteners in an adjacent plank together with a further 6 cracks in that plank running only on one side of the fasteners. One crack was also found in the internal rib member in the same area. No fuel leaks or stains were evident.
