**N.J. NO NAME
DAM NO. 52
NJ 00806**

**PHASE 1 INSPECTION REPORT
NATIONAL DAM SAFETY PROGRAM**

Rept. no. DAEN/NAP-53842/WJ00806-81/03

Name of Dam: N.J. No Name Dam No. 52 Fed ID # NJ 00806

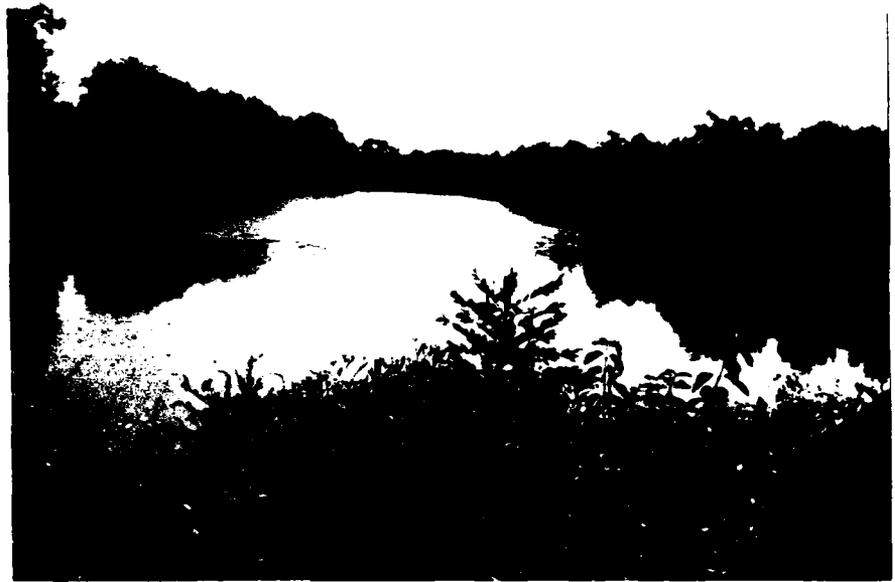
The reservoir of the No Name Dam No. 52 is relatively small in area (4.6 acres), and its contributing drainage area is only 0.13 square miles. The reservoir, however, is between 10 to 16 feet deep, its area having been formed by excavation of the existing marl. The reservoir banks are fairly steep, stable, and overgrown with brush and weeds.

View of Lake from Dam Crest August, 1980
