WESTCOLANG LAKE DAM

NDI I.D. NO. PA-00396
PENNDER I.D. NO. 52-4

PHASE I INSPECTION REPORT
NATIONAL DAM INSPECTION PROGRAM.

GAI CONSULTANTS, INC.
570 BEATTY ROAD
MONROEVILLE, PENNSYLVANIA 15146

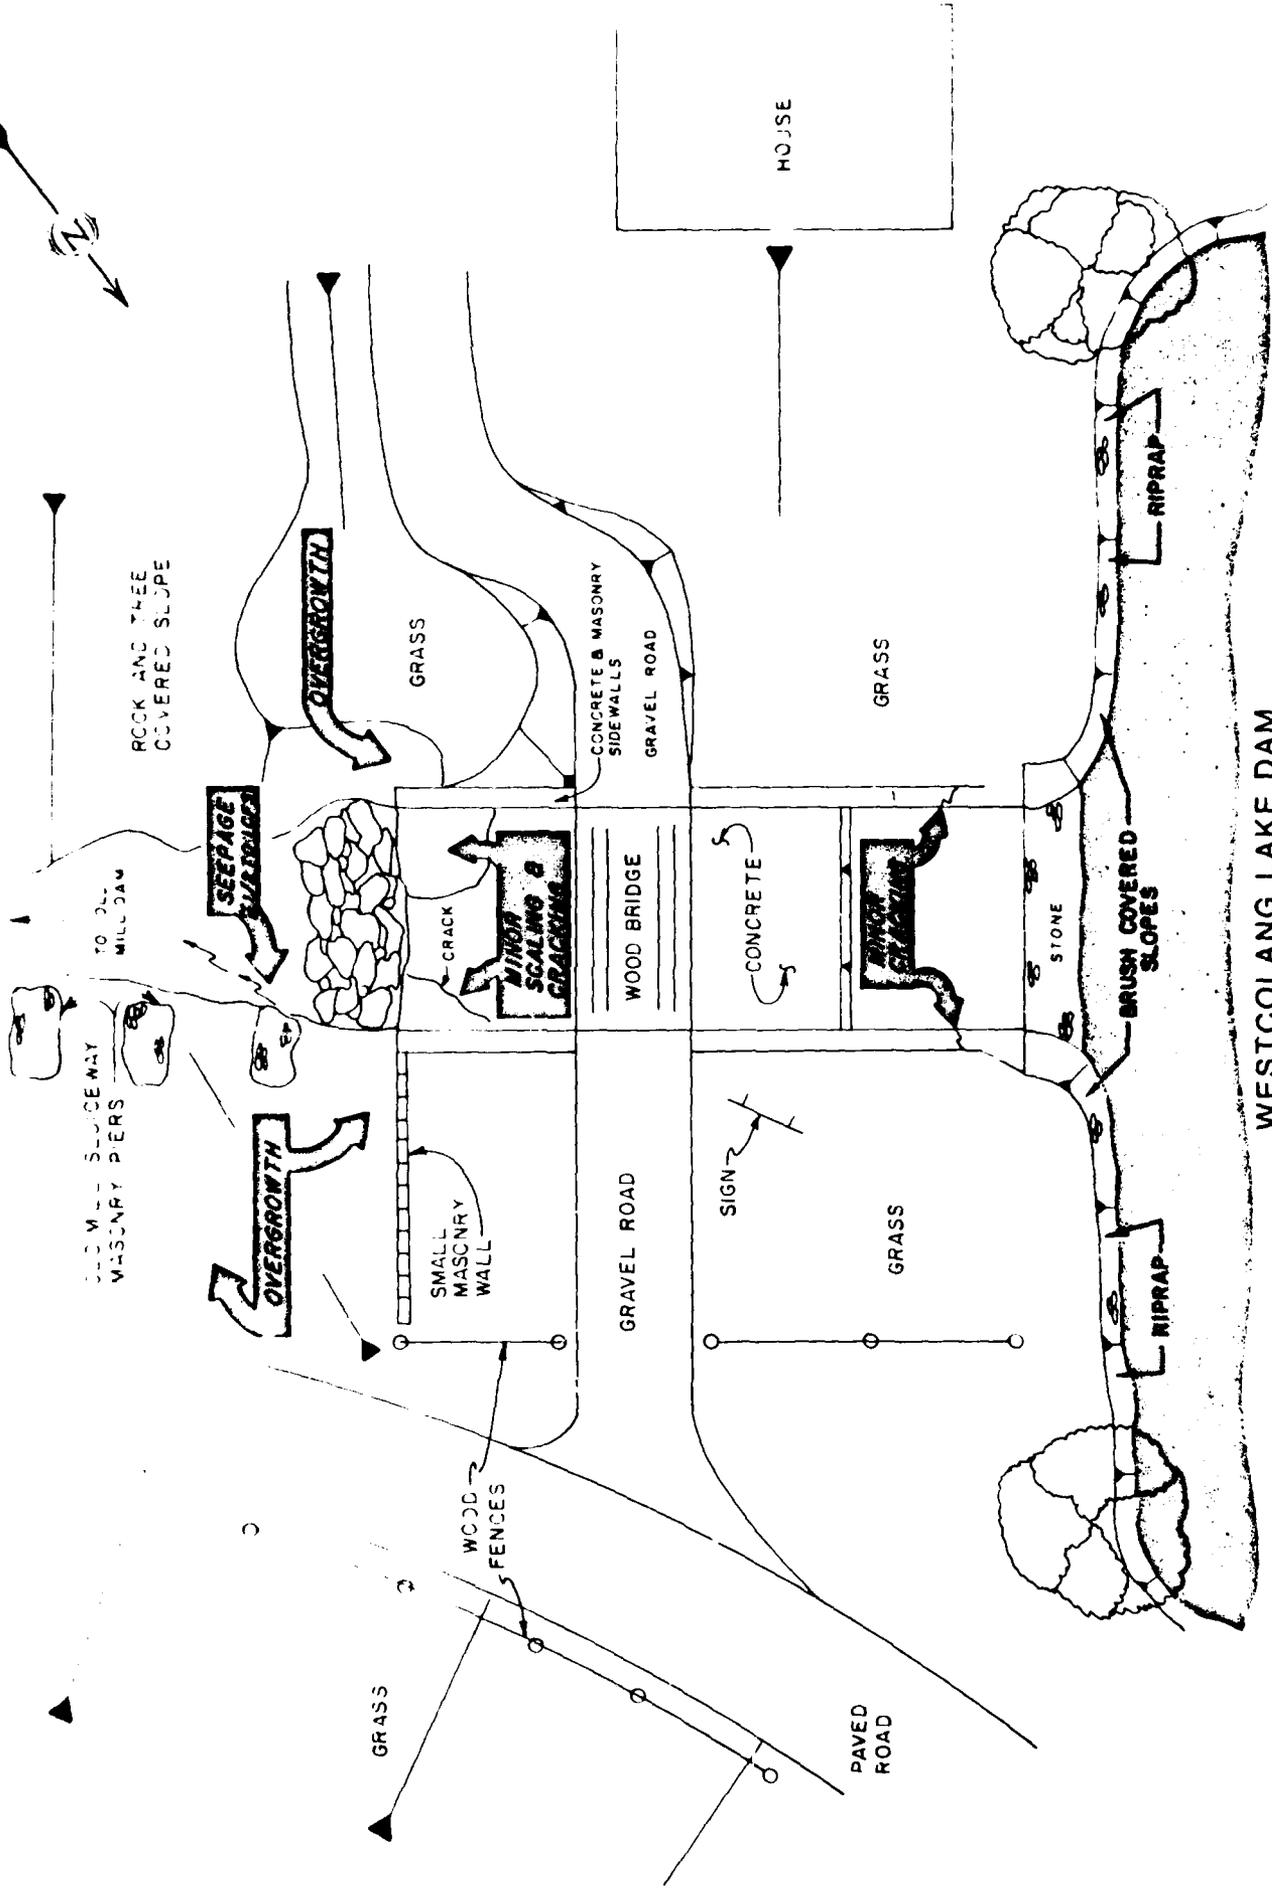
WESTCOLANG LAKE DAM
GENERAL PLAN-FIELD INSPECTION NOTES

b. Embankment. Observations made during the visual inspection reveal the embankment is adequately maintained and presently in good condition. The left and right abutment slopes immediately downstream of the dam are covered with thick brush which partially obscures view of the facility. No evidence of seepage through the downstream embankment face, sloughing, erosion, animal burrows or excessive settlement was noted. Seepage was encountered in the rock lined discharge channel about 30 feet downstream of the embankment. The seepage, estimated at about 1/2 to 1 cfs, appeared to be emanating from the left side of the channel near an old masonry pier that previously supported a sluiceway for the old saw mill no longer in existence (see Photographs 3 and 8, Appendix C and "General Plan - Field Inspection Notes," Appendix A).
