AD-A099 671 NEW JERSEY DEPT OF ENVIRONMENTAL PROTECTION TRENTON F/6 8/8  
NATIONAL DAM SAFETY PROGRAM. SILVER LAKE DAM (NJ00469), WALLKIL--ETC(U)  
MAY 81 R MCDERMOTT, J E GRIBBIN DACW61-79-C-0011

SILVER LAKE DAM (NJ00469)

PHASE I REPORT  
NATIONAL DAM SAFETY PROGRAM

Name of Dam: Silver Lake Dam, I.D. NJ00469  
State Located: New Jersey  
County Located: Sussex  
Drainage Basin: Wallkill River  
Stream: Tributary to Franklin Pond Creek  
Date of Inspection: December 19, 1980

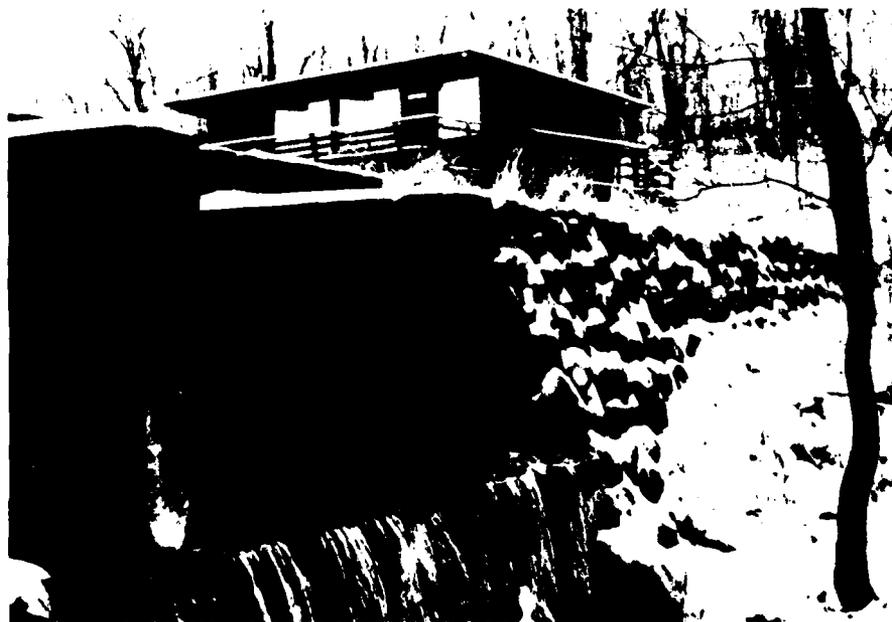
PHOTO 4

The walls forming the upstream and downstream face of embankment appeared to be in satisfactory condition. The crest of dam was uniformly graded and grass covered. An earth slope was observed on the downstream side of the dam extending downward from the toe of the stone rubble wall. The slope, which was covered with trees ranging in size from one inch to six inches, is reportedly part of the original terrain existing before the dam was constructed. At the toe of this slope left of the spillway, two areas of standing water were observed. The standing water could possibly be due to seepage.

DOWNSTREAM SIDE OF SPILLWAY AND  
EMBANKMENT - LEFT SECTION

The observed seepage at the left side of the dam at the toe of slope should be monitored on a periodic basis by a professional engineer experienced in the design and construction of dams in order to detect any changes in volume or condition.

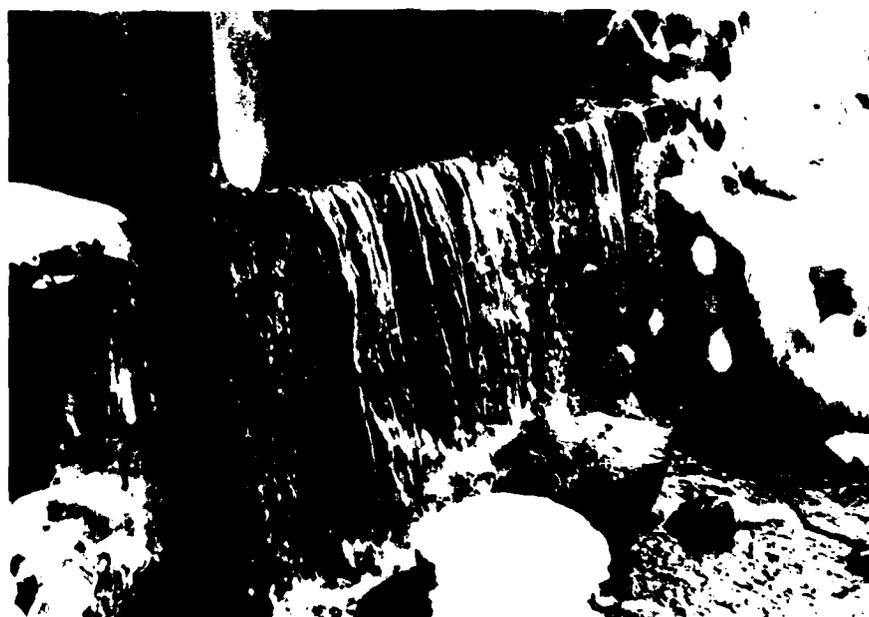
PHOTO 6

SPILOVER AT DOWNSTREAM END OF SPILLWAY
