DEER HEAD LAKE DAM

(NJ 00789)

PHASE I INSPECTION REPORT,  
NATIONAL DAM SAFETY PROGRAM

MAY 1981

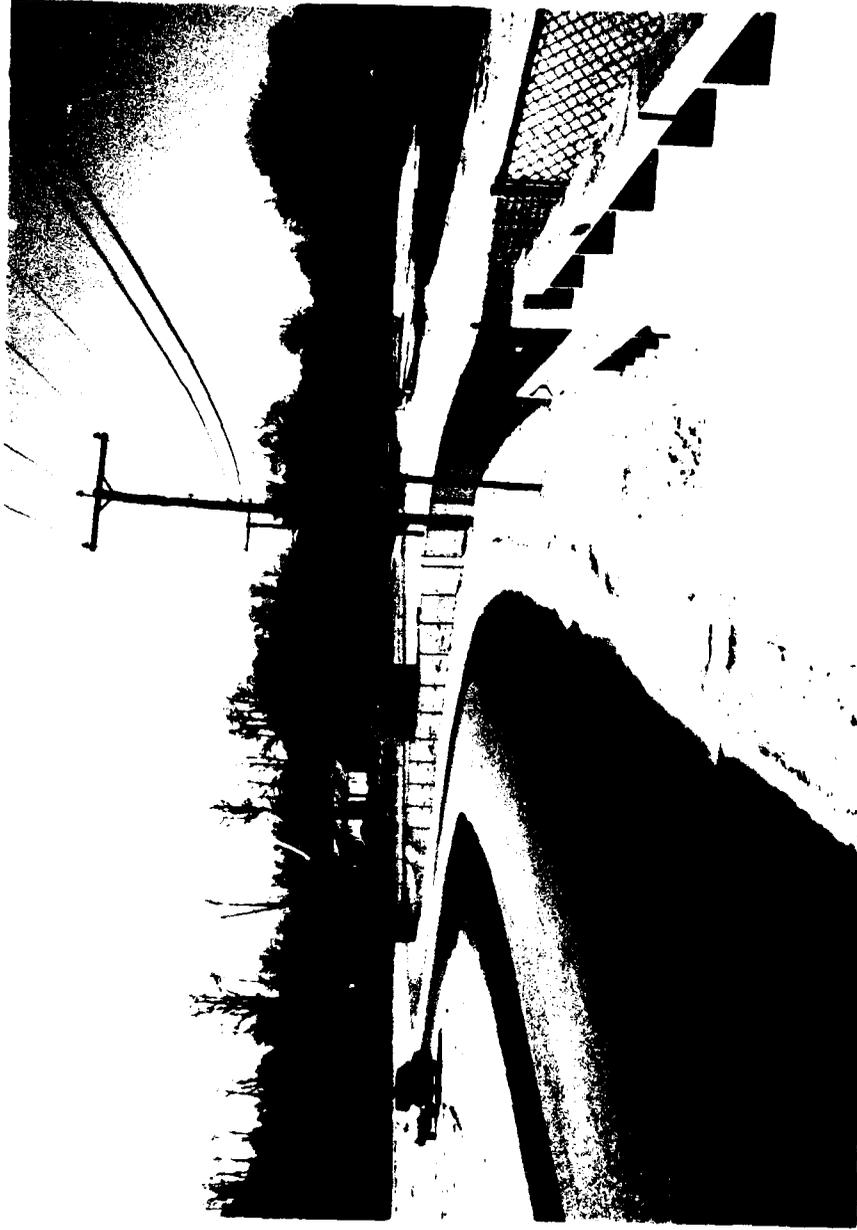
View looking towards right end of dam. Concrete weir spillway is just out of view in the lower right of the photo.

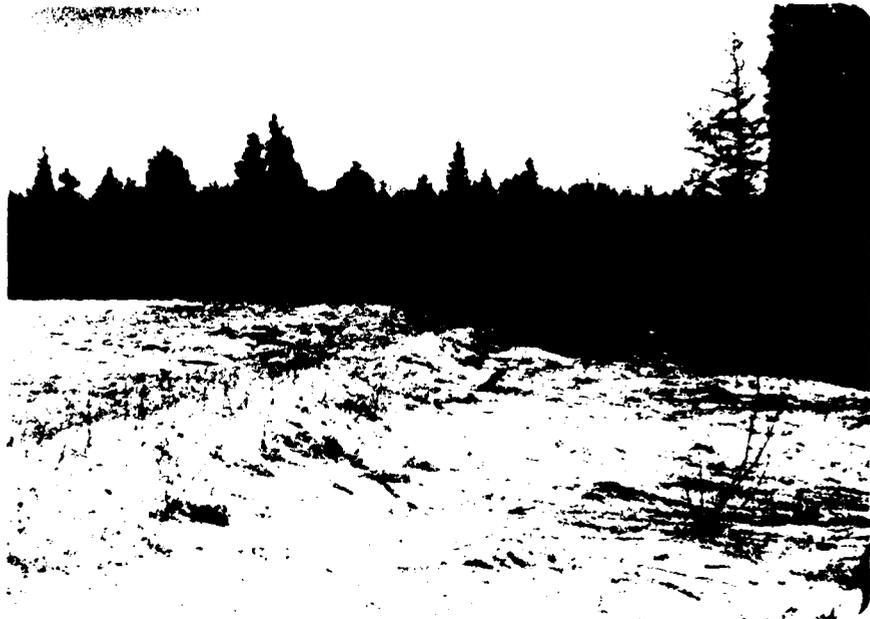
Photo 4 - View of downstream slope looking towards the left end of the dam. (Photo taken February 15, 1981).

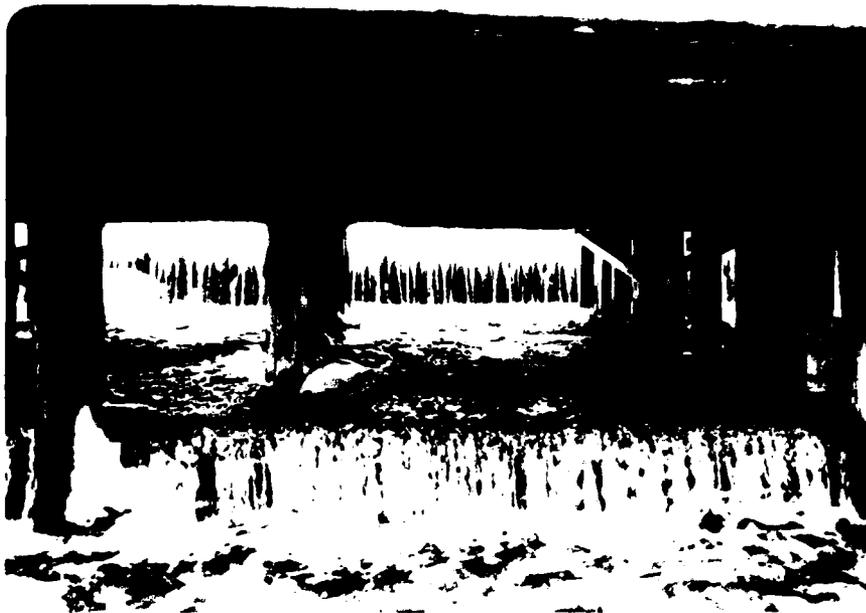
The concrete weir spillway at the left end on the dam is in good condition. The crest and downstream face are spalled. The discharge channel is heavily spalled and sections have cracked and settled. The timber drop inlet at the right end of the dam is in good condition. The horizontal and vertical alignments of both spillways appeared good.

Photo 10 - View of concrete discharge apron showing the cracked and settled sections of the apron. (Photo taken January 14, 1981).

- (1) Repair the stilling basin of the left spillway with epoxy cement.

2. Repair stilling basin of left spillway with epoxy cement within twelve months.
3. Repair concrete surfaces of left spillway with epoxy cement within twelve months.

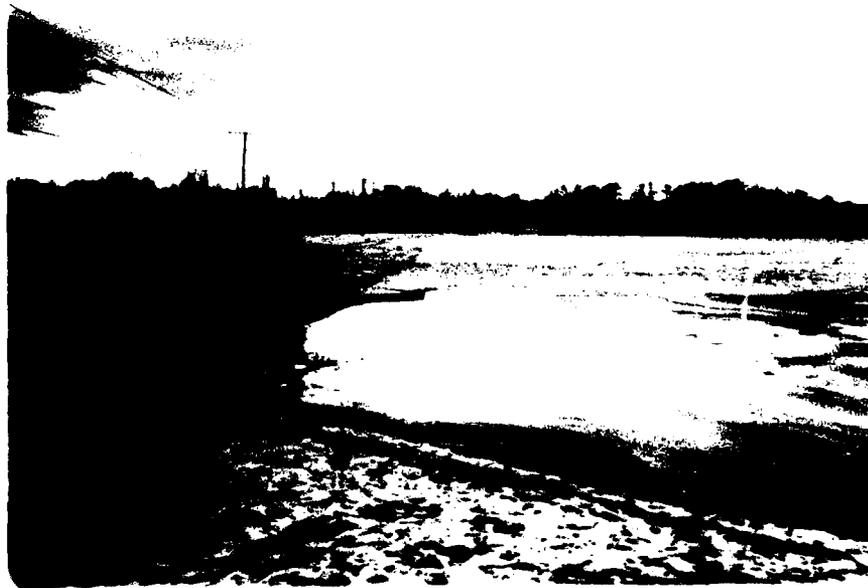
Photo 11 - Upstream view of concrete weir spillway taken from the left shoreline. (Photo taken January 14, 1981).
