MISCELLANEOUS PAPER SL-80-14

INVESTIGATION OF DETERIORATION OF BRICK IN NAVIGATION LOCK CONTROL HOUSE STRUCTURES, TULSA DISTRICT

September 1980
Final Report

Prepared for U. S. Army Engineer District, Tulsa
Tulsa, Okla. 74102

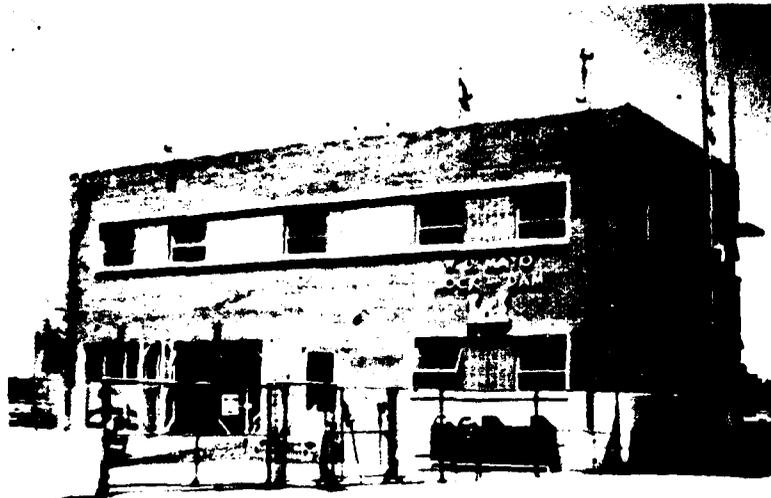
Photo 1. Typical Control House Structure (L&D 14)

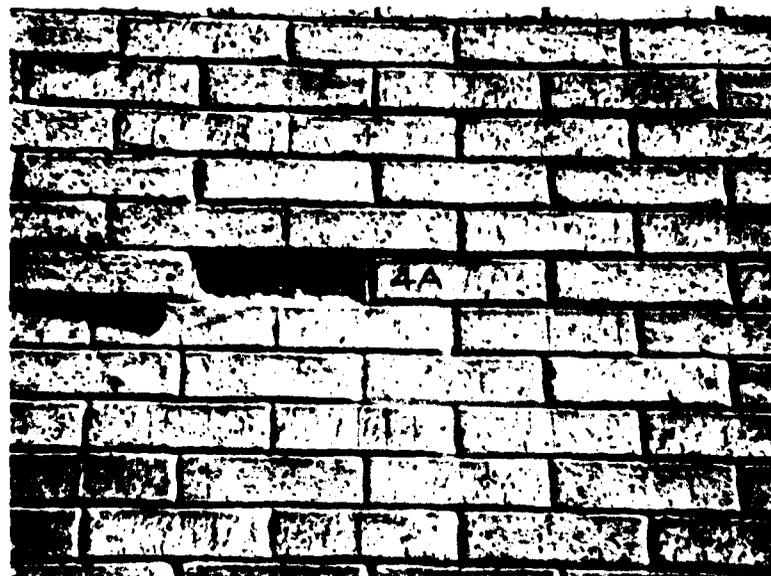
Photo 2. Typical Conditions—nondeteriorated; face popoff; intact face popoff. Control house structure (L&D 15)

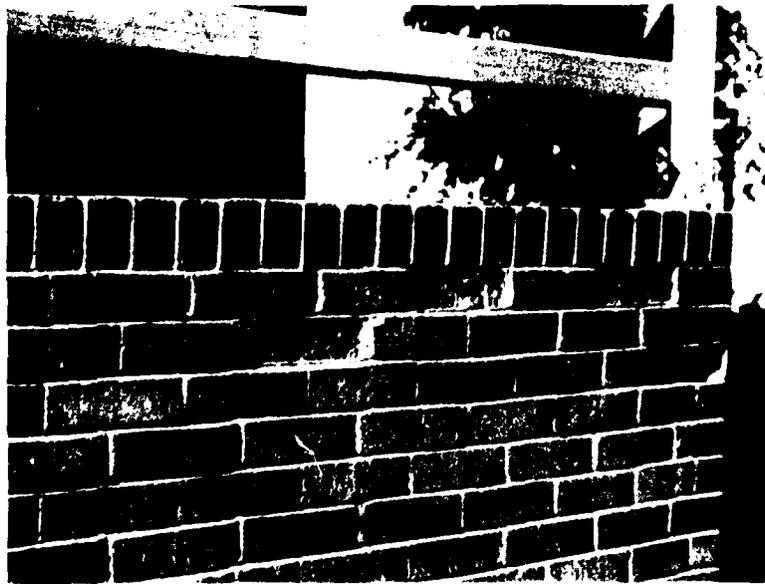
Photo 4. Typical conditions-visitor center (L&D 15)

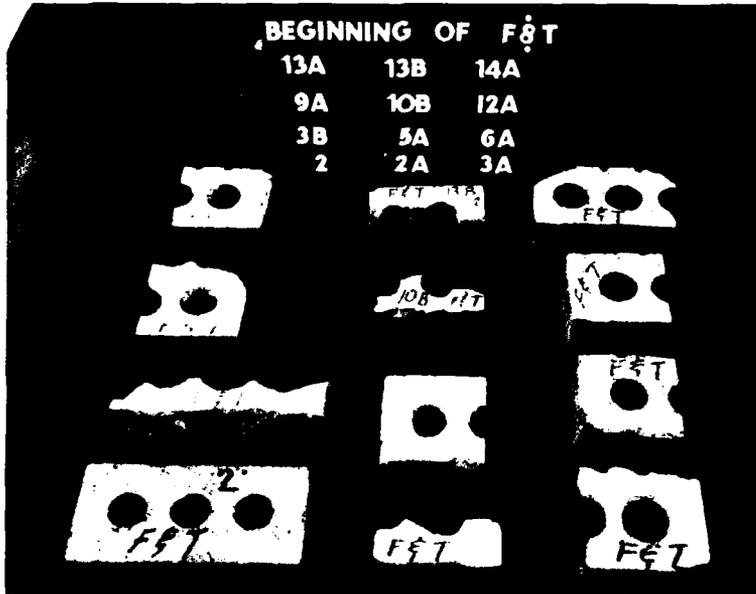
Photo 5. Freeze-thaw samples at 0 cycles

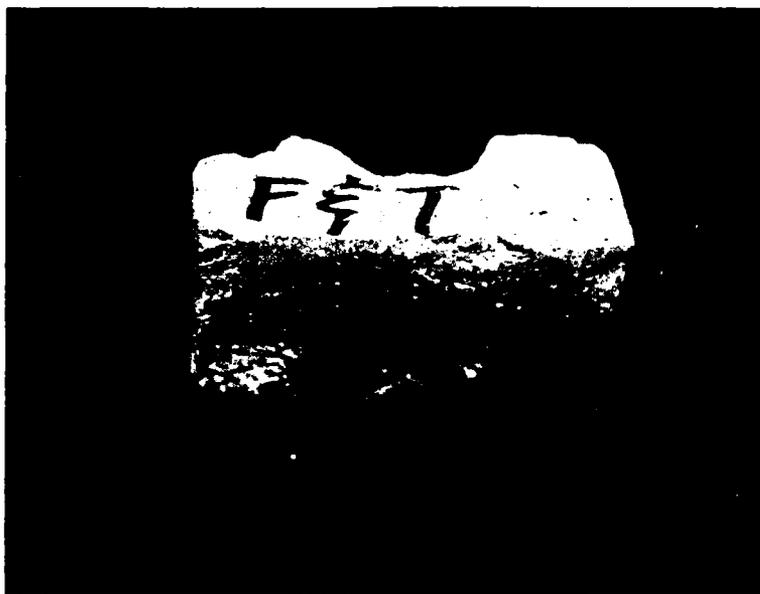
Photo 7. Sample 2A₂ - 50 cycles F-T

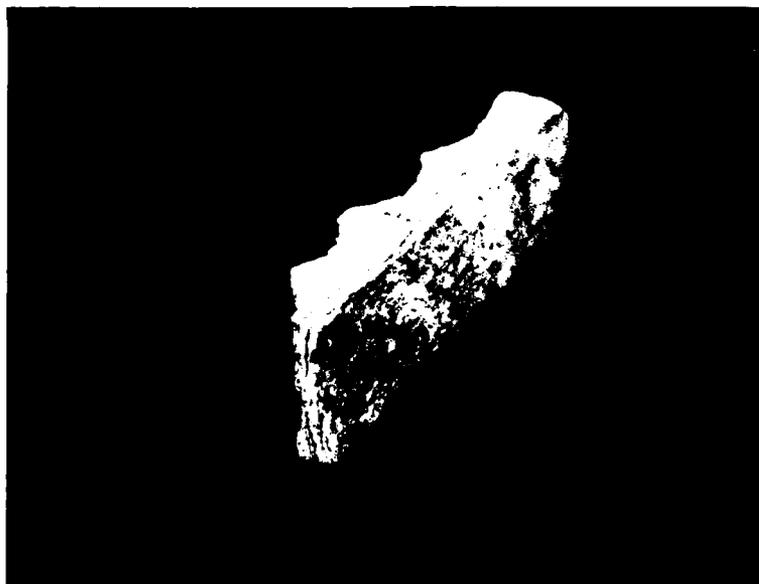
Photo 8. Sample 3B₂ - 50 cycles F-T

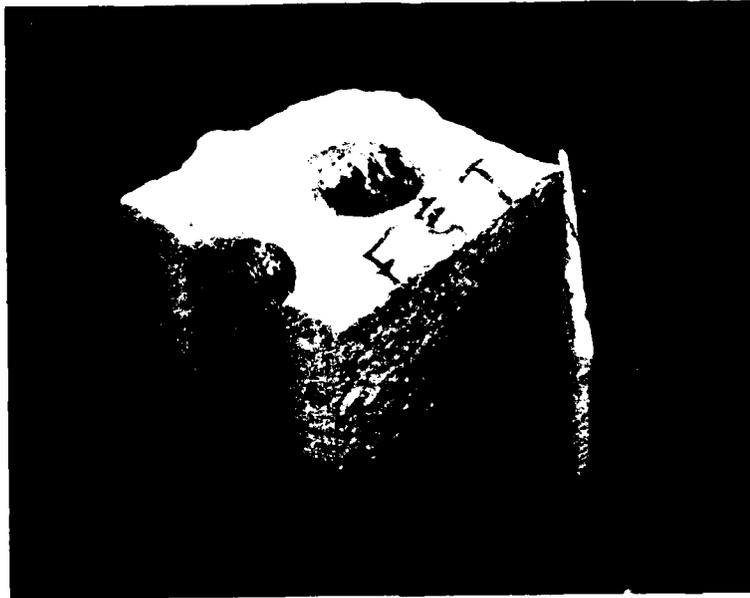
Photo 11. Sample 9A₂ - 50 cycles F-T

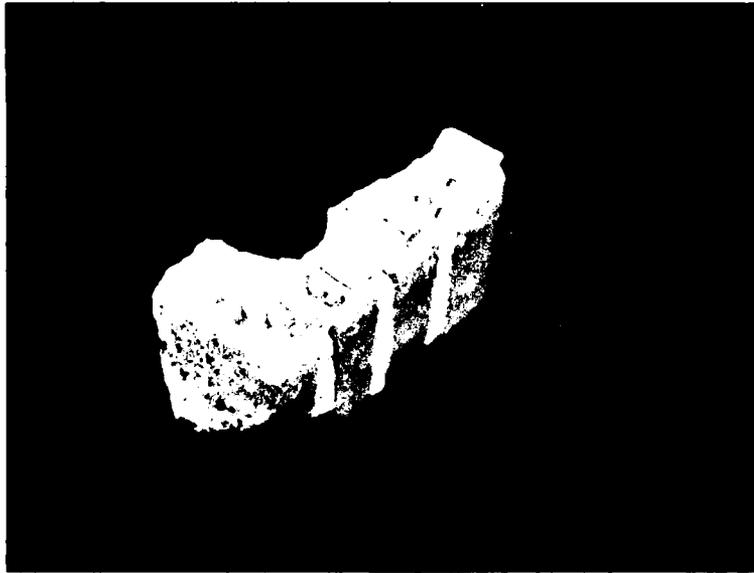
-
- (a) See Photos 5-17 for "before" and "after" conditions of each specimen tested.
- (b) Specimen 13B₂: Back face of brick was used as test face due to destruction of front face in removal.

Photo 16. Sample 13B₂ - 50 cycles F-T
(back face of brick tested)

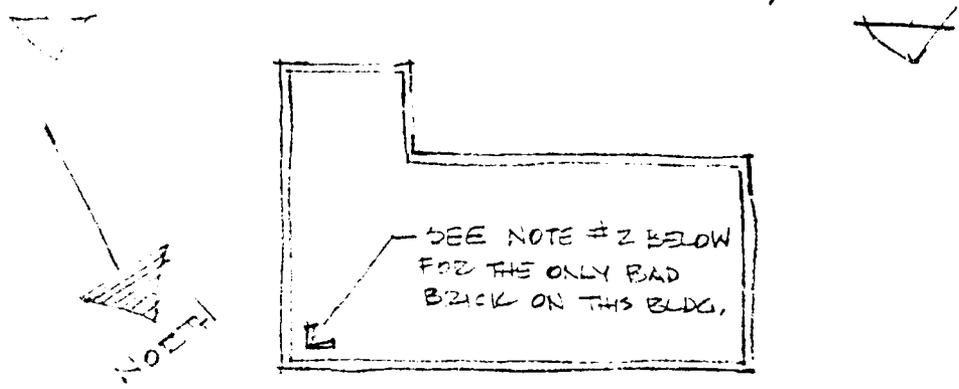
FRONT VIEW OF LOCK CONTROL BLDG.

- 1. ENTIRE BASE OF BLDG. APPEARED TO BE SOUND.
- 2. ABOUT 6 OR 7 BAD BRICK WERE NOTED ON THE INSIDE FACE OF PARAPET AS INDICATED ABOVE.
- 3. FRONT & OIL BLDG IS O.K.
- 4. UPSTREAM CONTROL SHELTER (RIVERWALL) IS O.K.

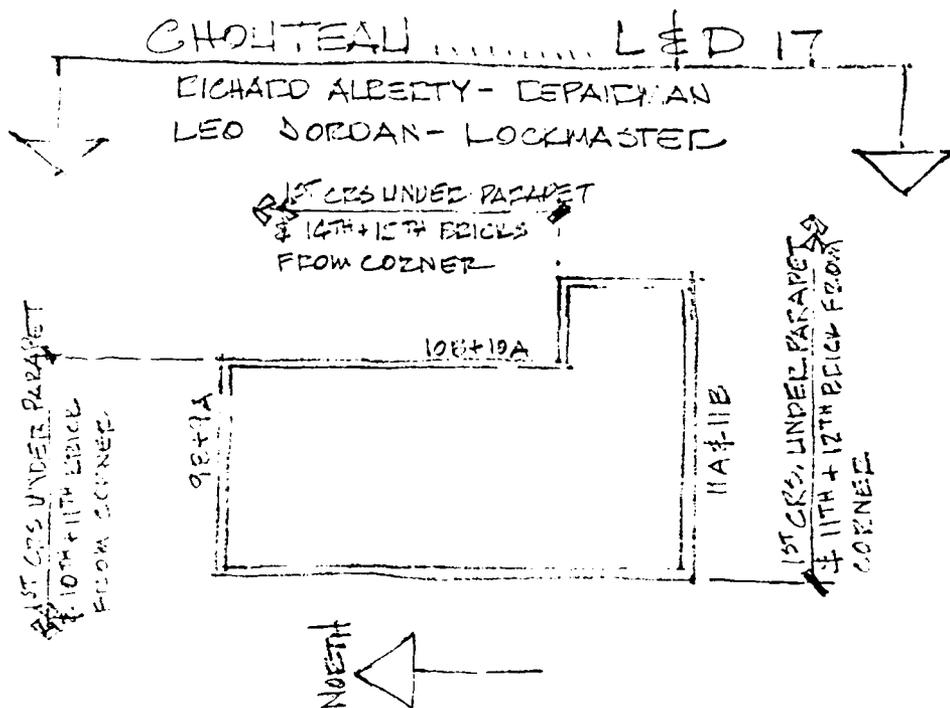
PLAN VIEW OF LOCK CONTROL BLDG.

1. FANT & OIL STORAGE BLDG APPEARS OK
2. CONTROL SHEETER (UPSTREAM) APPEARS OK BUT BRICKS ARE DISCOLORED, THIS CLEARLY INDICATES THE PRESENCE OF MOISTURE. THERE IS NO PATTERN TO THE DISCOLORED BRICK. ONE END BRICK WAS NOTED AT THE NW CORNER OF BLDG.
3. CONTROL SHEETER (DOWNSTREAM) SHOWS NO END BRICK BUT SAME DISCOLORING AS NOTE # 2.
