PARKER STREET DAM

³ NJ 00055

PHASE 1 INSPECTION REPORT
NATIONAL DAM SAFETY PROGRAM

MAY 1981

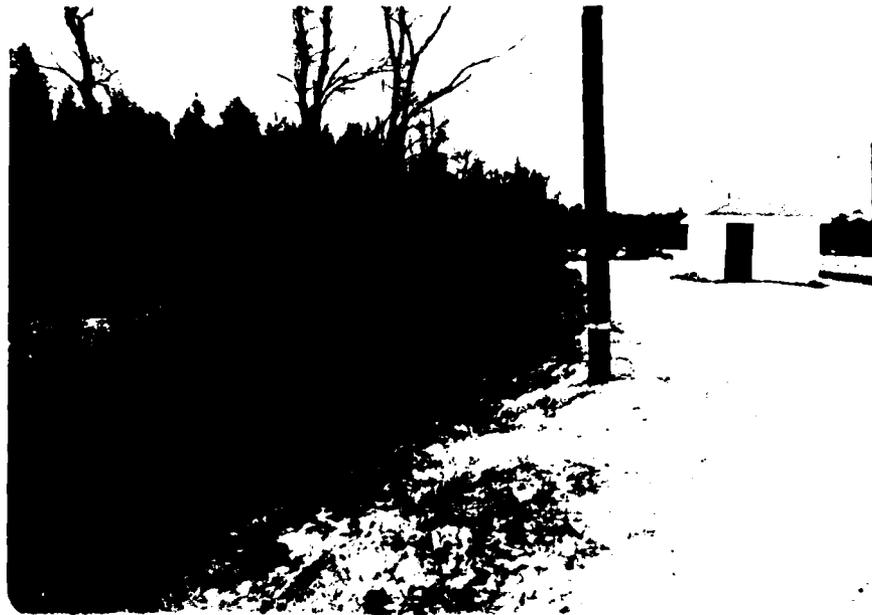
Photo 9 - View of downstream slope at left end of dam.
(Photo taken January 14, 1981).

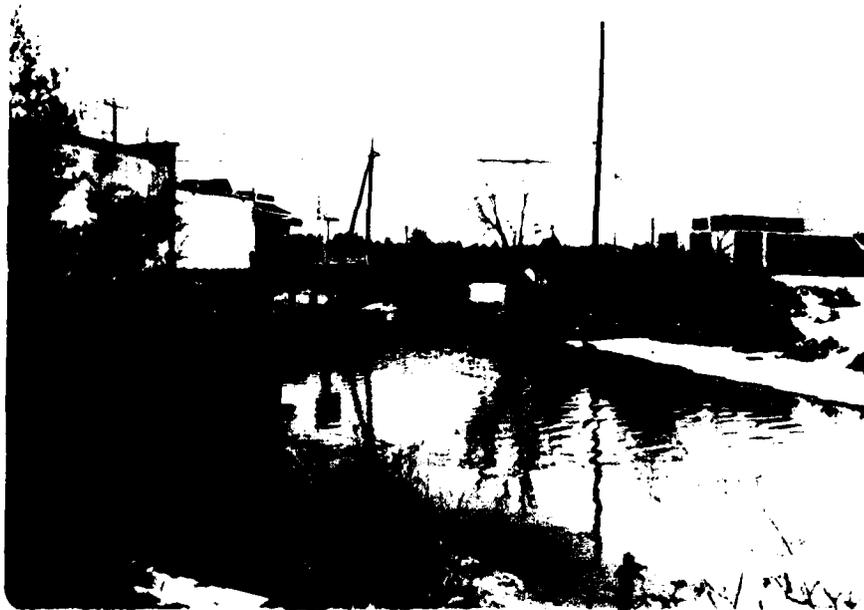
Photo 13 - View of downstream channel at U.S. Route 9 crossing.
(Photo taken January 14, 1981).
